Expertise

Protocol number: 46771857  
Order No. / Reference: 26438457  
Inspection date: 28 Jul 2026

Manufacturer: Mercedes-Benz

Model: C 200 d T 9G-TRONIC Avantgarde Advanced

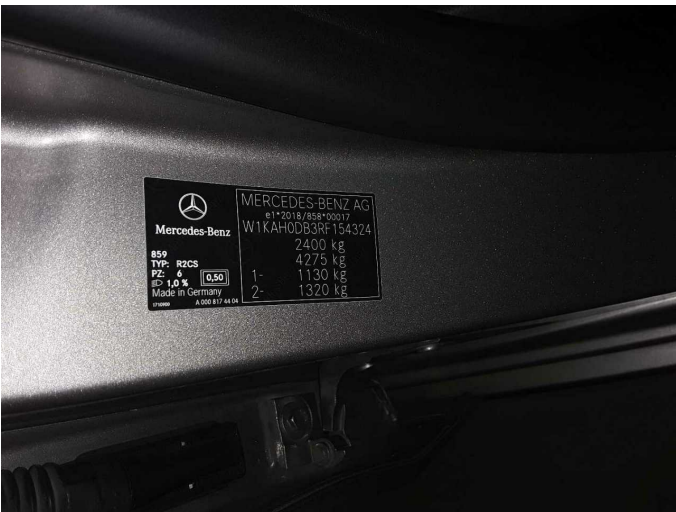
| VIN comparison | The vehicle identification number (VIN) was read from the vehicle and its conformity with the submitted documents was confirmed by the undersigned during the inspection. |

Figure 11: VIN

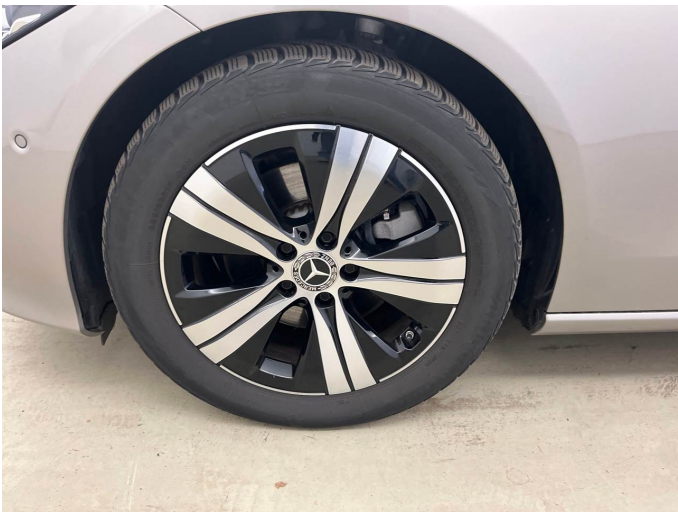
| # | Tyre size | Type of tyre | Manufacturer | Tread depth |
|---|---|---|---|---|
| 1) | 225/50 R17 94H | Winter tyres on Light alloy | Bridgestone | 5mm / 5mm |
| 2) | 225/50 R17 94H | Winter tyres on Light alloy | Bridgestone | 5mm / 5mm |

Figure 12: Mounted tyres

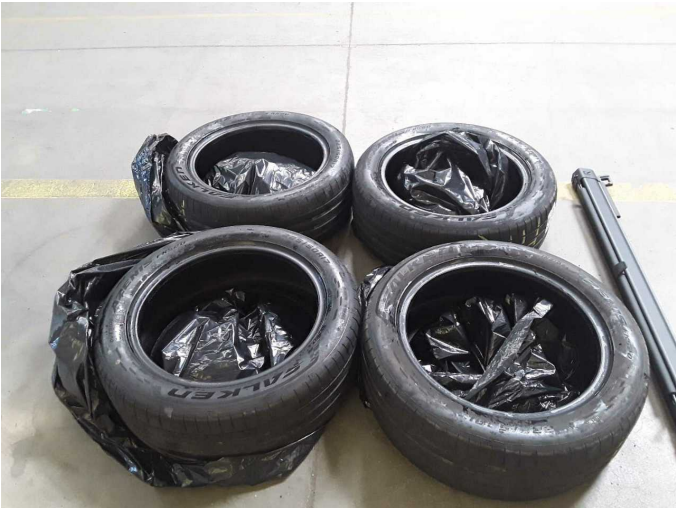
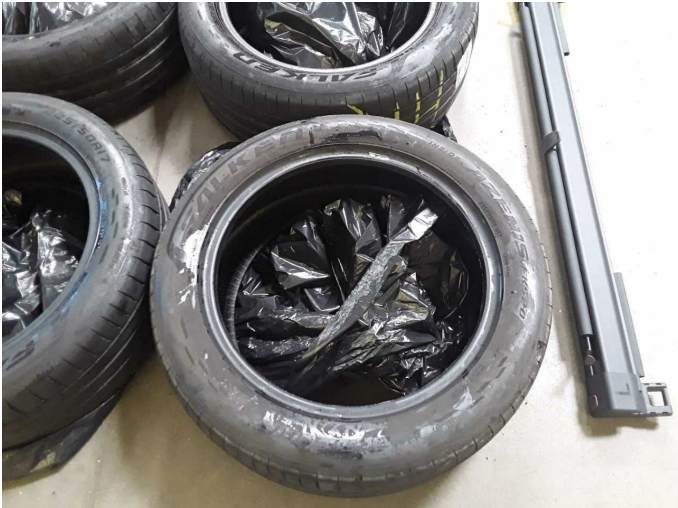
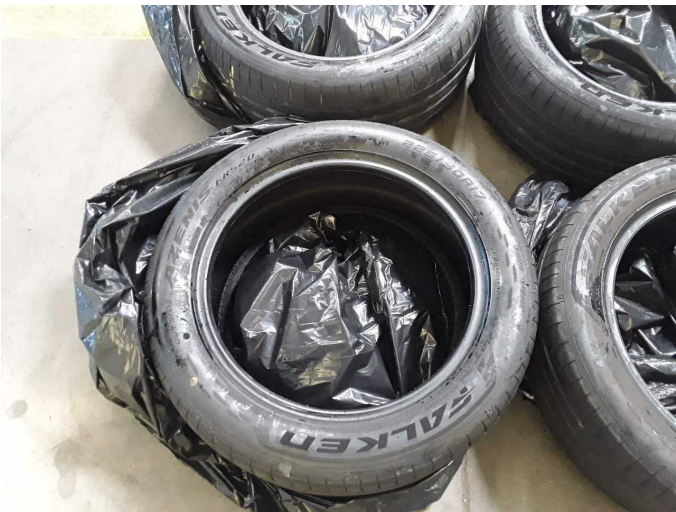
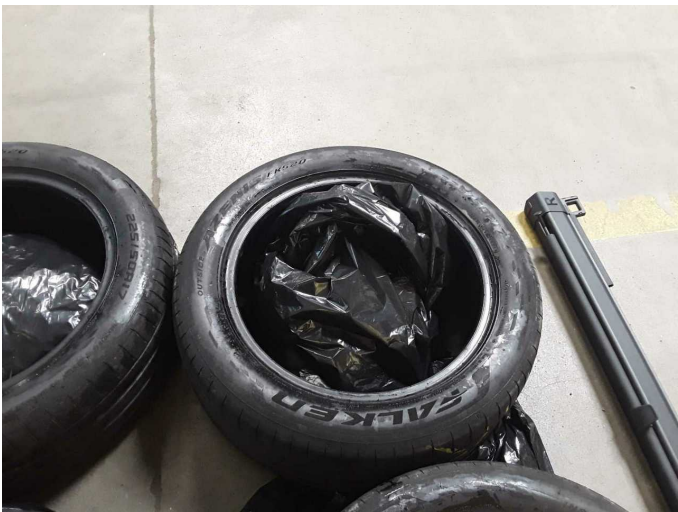
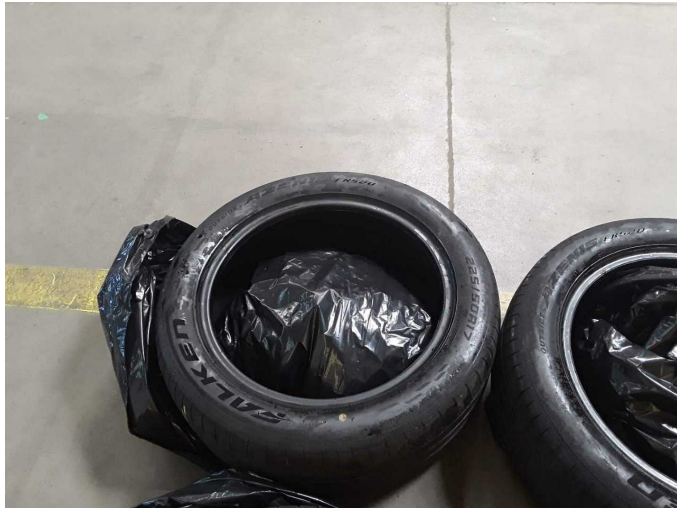
| # | Tyre size | Type of tyre | Manufacturer | Tread depth |
|---|---|---|---|---|
| 1) | 225/50 R17 98Y | Summer tyres (Without wheel rim) | Falken | 5mm / 5mm |
| 2) | 225/50 R17 98Y | Summer tyres (Without wheel rim) | Falken | 5mm / 5mm |

Figure 15: Additional tyres

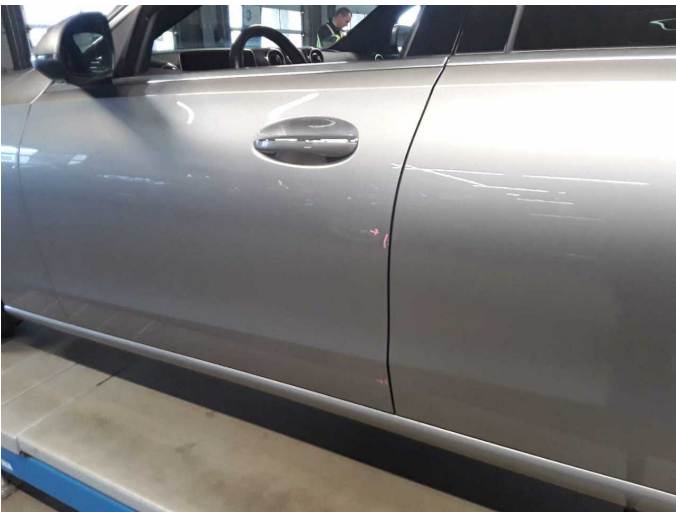
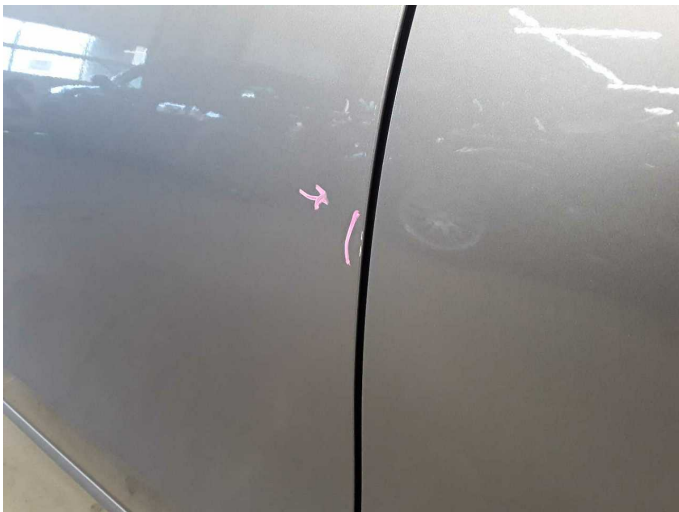
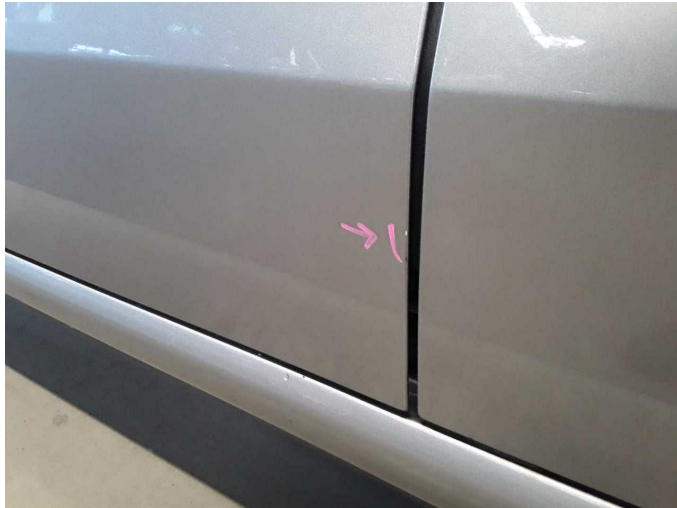
| No. | Component group | Description |
|---|---|---|
| 1 | Door - front left side | Door edge - Scratch(es) - Smart repair |

Damage 1: Door - front left side: Door edge - Scratch(es) - Smart repair

**Damage 1:** Door - front left side: Door edge - Scratch(es) - Smart repair

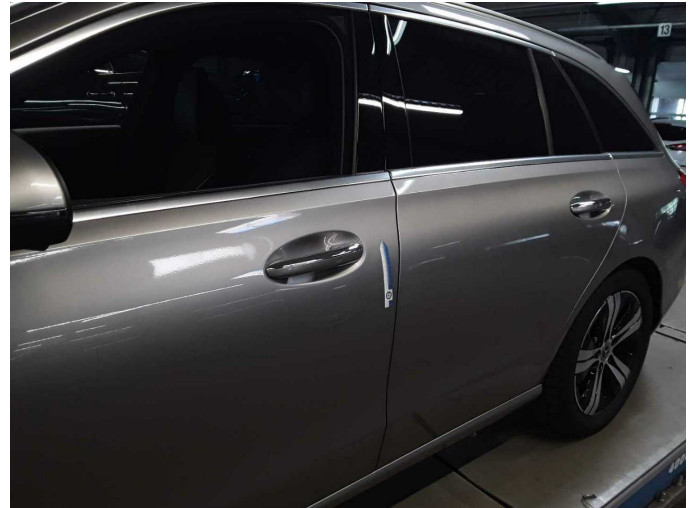
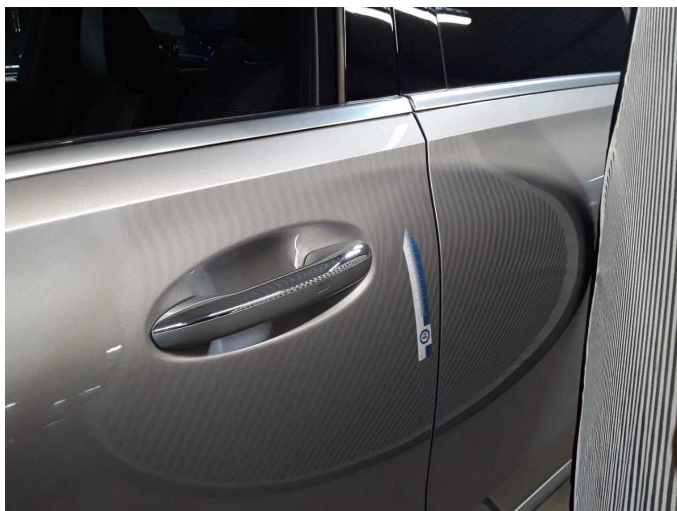
| No. | Component group | Description |
|---|---|---|
| 2 | Door - front left side | Door - dent(s) - Smooth repair work |

**Damage 2:** Door - front left side: Door - dent(s) - Smooth repair work
