Expertise

Protocol number: 46293093
Order No. / Reference: 26600047
Inspection date: 1 Jul 2026

Model: C 220 d T 9G-TRONIC AMG Line

VIN: W1KAH0EB0PF095471

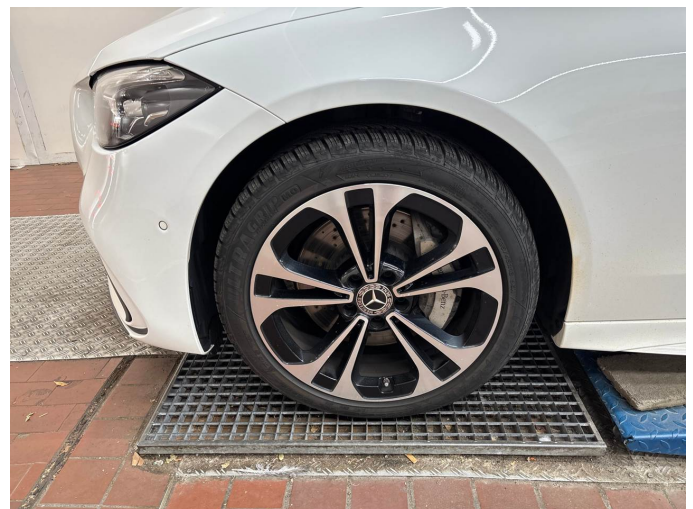
Figure 12: Mounted tyres

Mounted tyres				
#	Tyre size	Type of tyre	Manufacturer	Tread depth
1)	225/45 R18 95H	Winter tyres on Light alloy	Goodyear	7mm / 7mm
2)	225/45 R18 95H	Winter tyres on Light alloy	Goodyear	7mm / 7mm

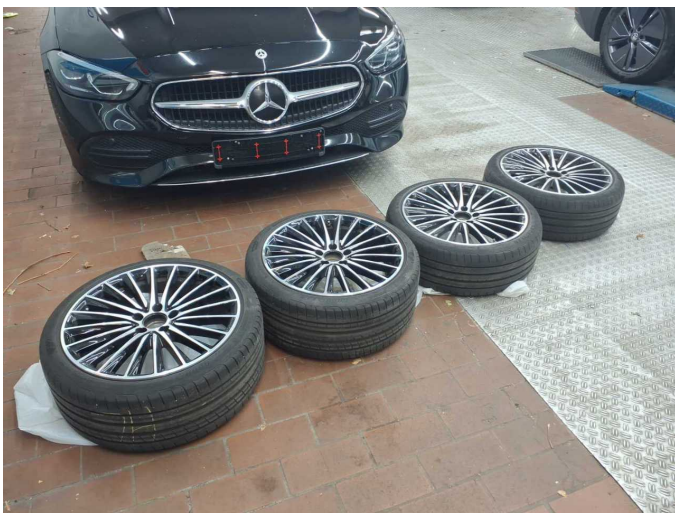
Figure 15: Additional tyres

Additional tyres				
#	Tyre size	Type of tyre	Manufacturer	Tread depth
1)	225/40 R19 93Y	Summer tyres on Light alloy	Goodyear	5mm / 5mm
2)	255/35 R19 96Y	Summer tyres on Light alloy	Goodyear	5mm / 5mm

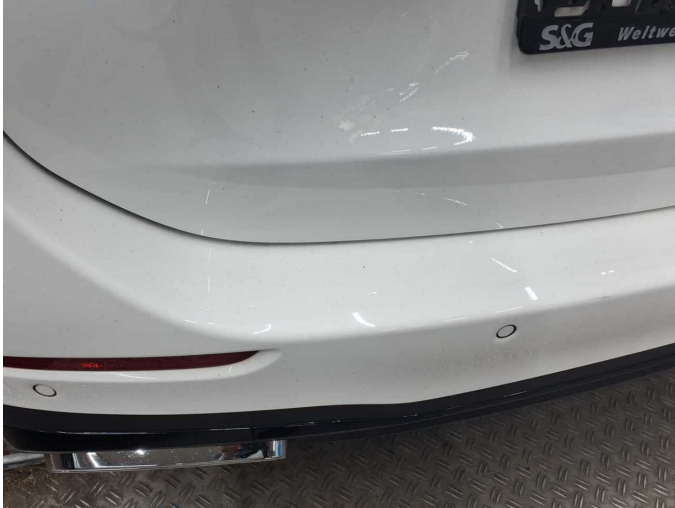
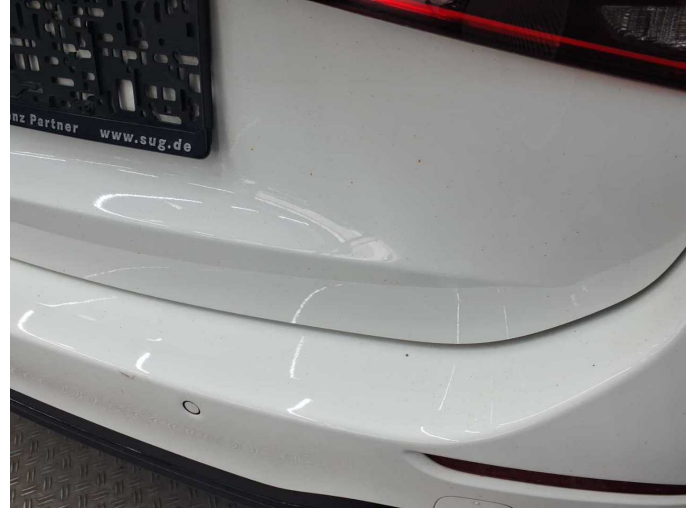
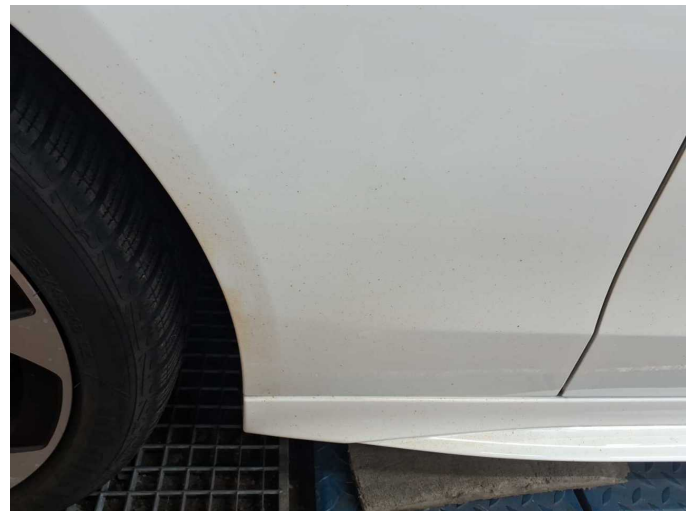
No.	Component group	Description
1	Body	Body (Flugrost) - Conditioning
2	2nd wheel set	3 alloy rims - Scratch(es) - Loss in value
3	Boot lid / rear door	Boot lid - dent(s) - Repair and paint
4	Front bumper	Front bumper - Scratch(es) - Paint

Damage 1: Body: Body (Flugrost) - Conditioning

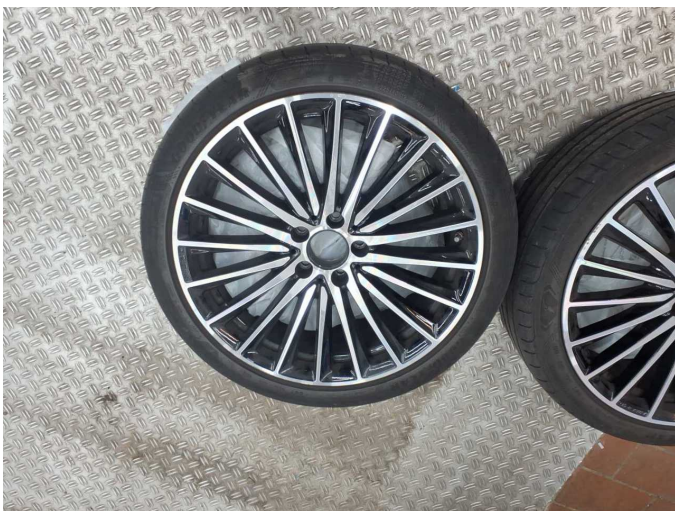
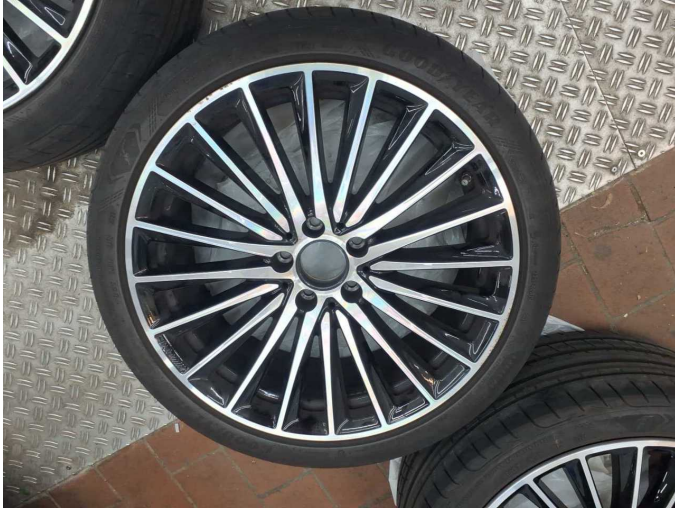
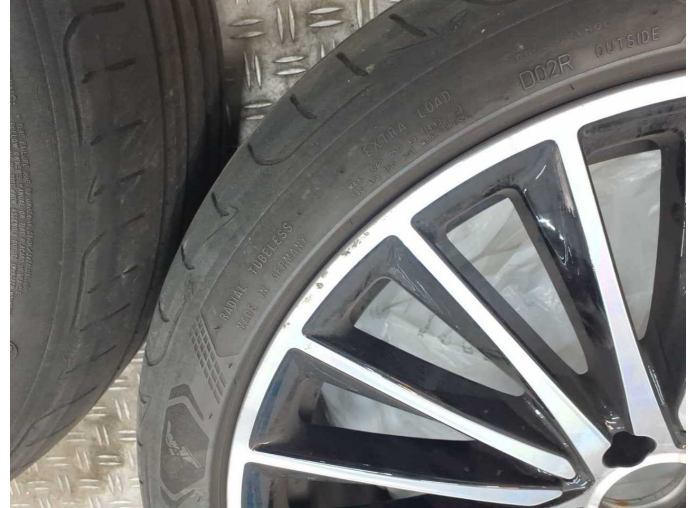
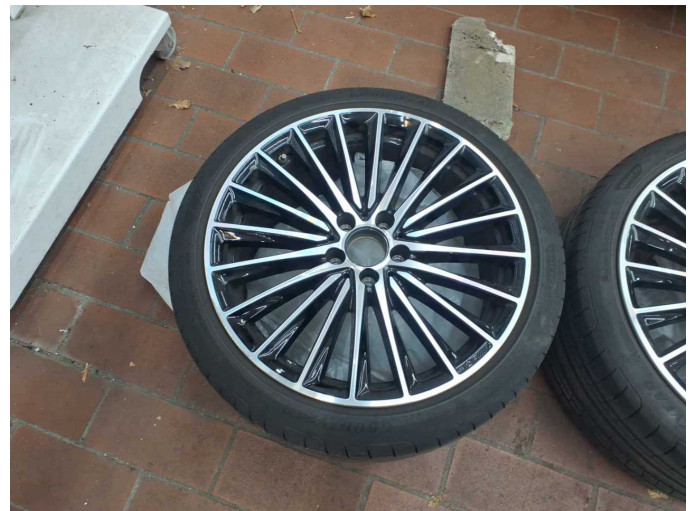
Damage 2: 2nd wheel set: 3 alloy rims - Scratch(es) - Loss in value

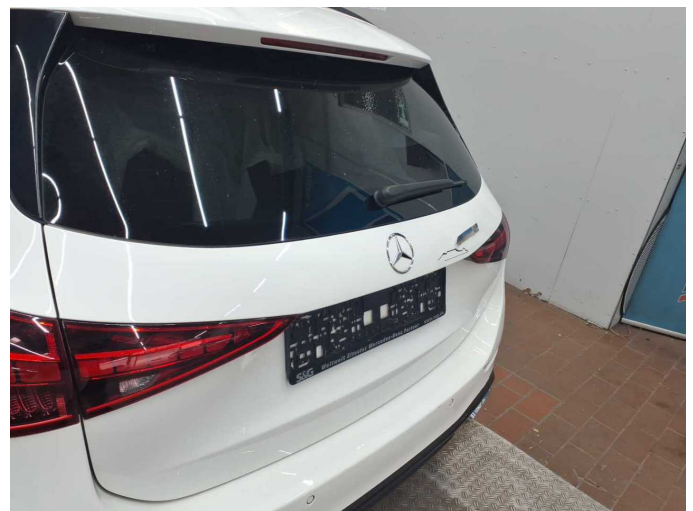
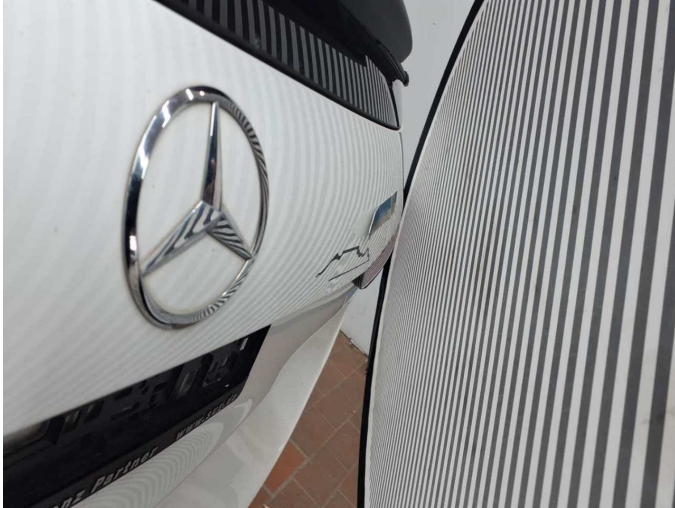
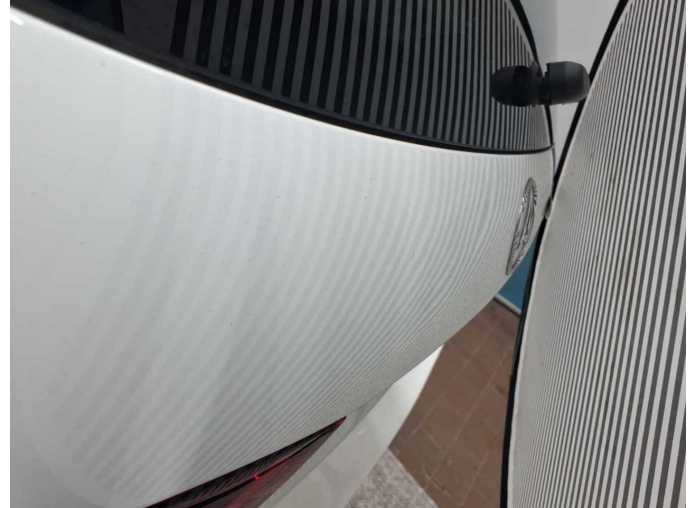
Damage 3: Boot lid / rear door: Boot lid - dent(s) - Repair and paint

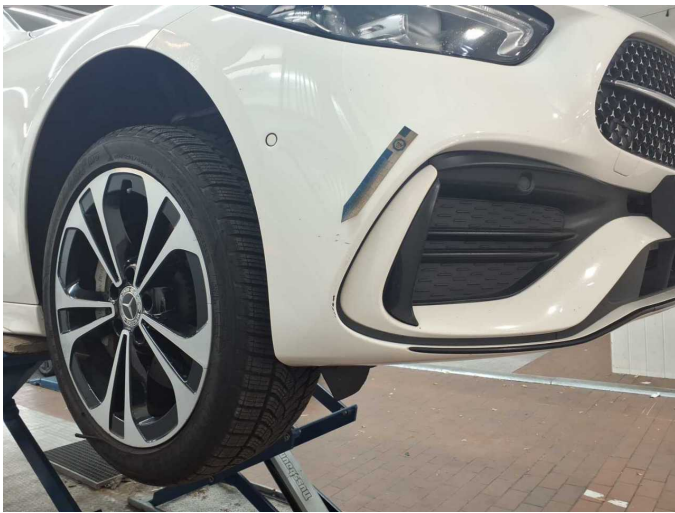
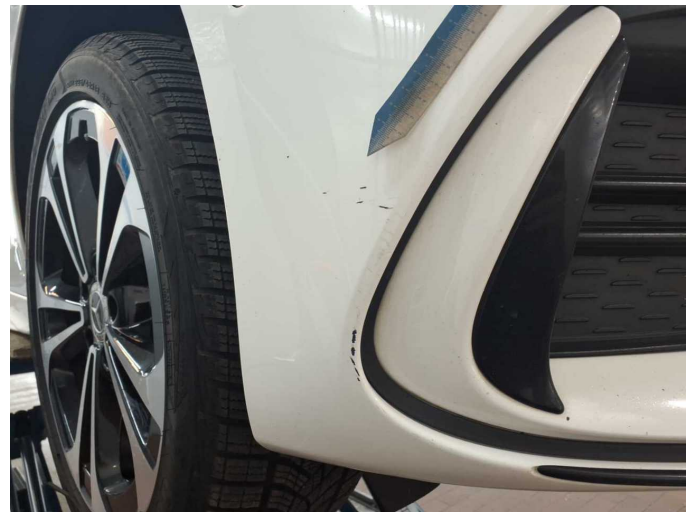
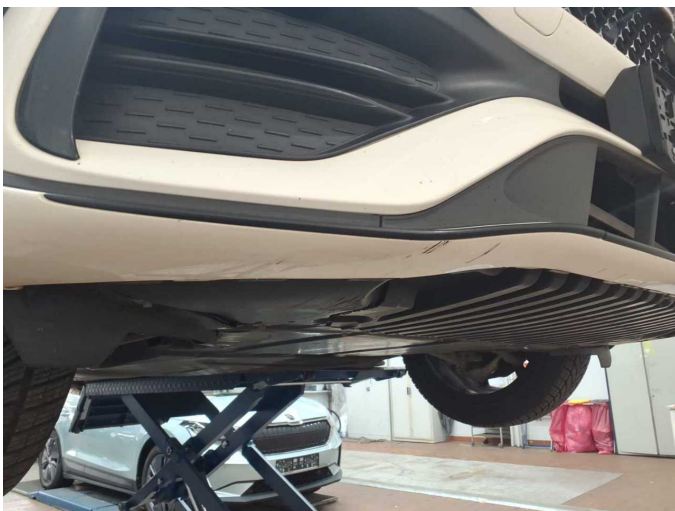
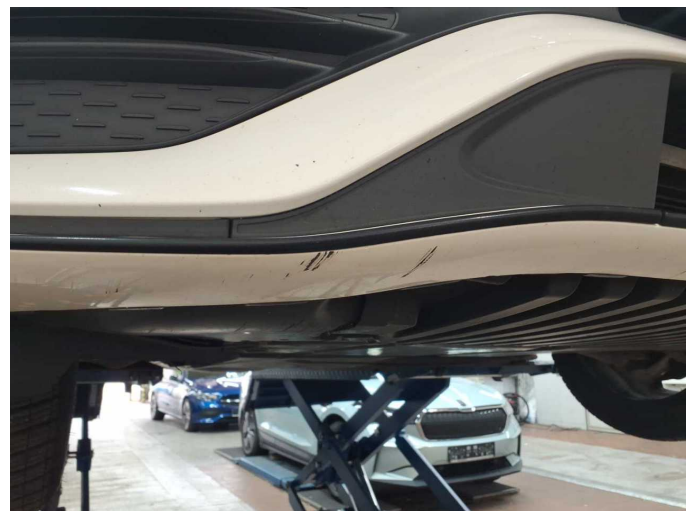
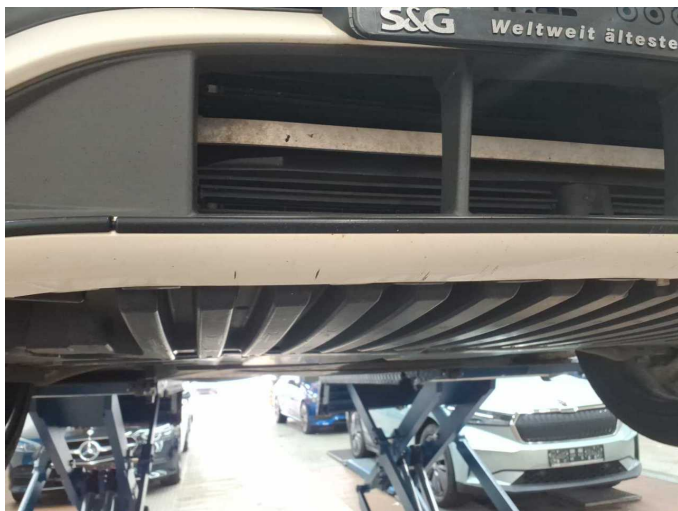
Damage 4: Front bumper: Front bumper - Scratch(es) - Paint
