Expertise

Protocol number: 46665296  
Order No. / Reference: 26701268  
Inspection date: 23 Jul 2026

Manufacturer: Ford

Model: S-Max 2.0 EcoBlue TREND

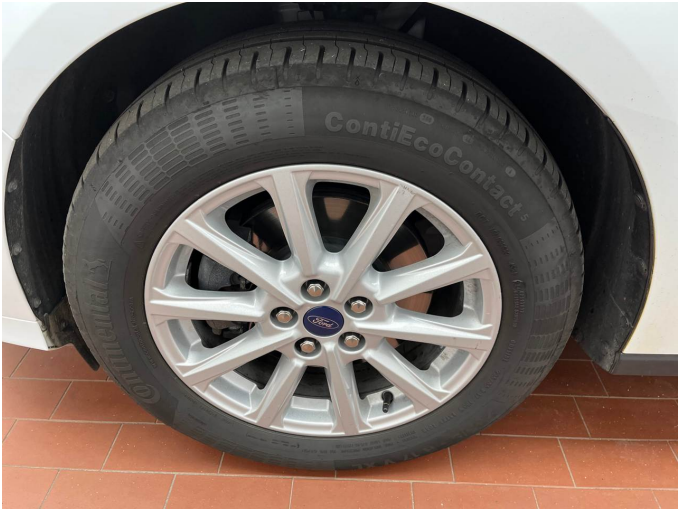
Figure 12: Mounted tyres

| # | Tyre size | Type of tyre | Manufacturer | Tread depth |
|---|---|---|---|---|
| 1) | 235/55 R17 103V | Summer tyres on Light alloy | Continental | 5mm / 5mm |
| 2) | 235/55 R17 103V | Summer tyres on Light alloy | Continental | 4mm / 4mm |

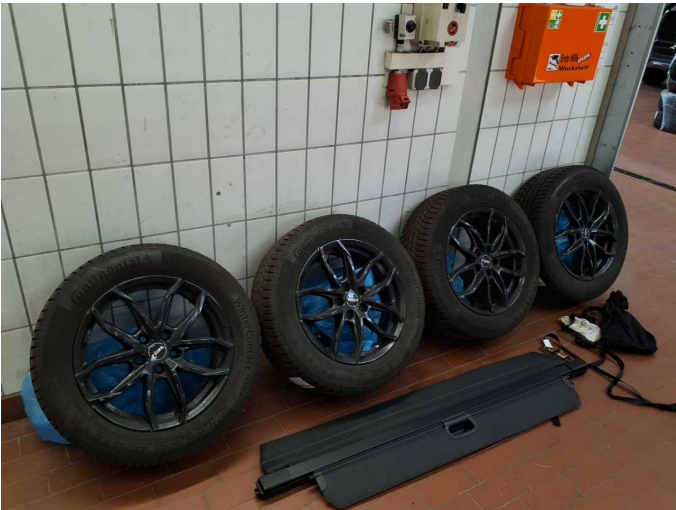
Figure 15: Additional tyres

| # | Tyre size | Type of tyre | Manufacturer | Tread depth |
|---|---|---|---|---|
| 1) | 235/55 R17 103V | Winter tyres on Light alloy | Continental | 7mm / 7mm |
| 2) | 235/55 R17 103V | Winter tyres on Light alloy | Continental | 6mm / 6mm |

Der beiliegende Winterradsatz ist kein Bestandteil der Auslieferungsumfangs.

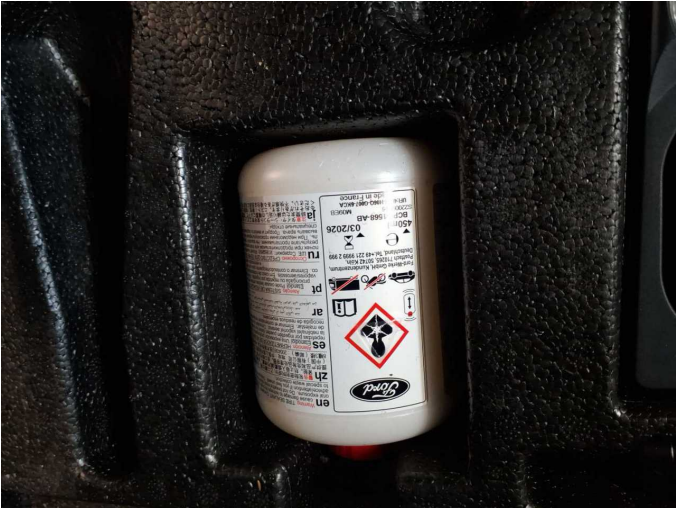
Damage 1: Equipment: Tirefit filler - Due - Replace

| No. | Component group | Description |
|---|---|---|
| 1 | Equipment | Tirefit filler - Due - Replace |

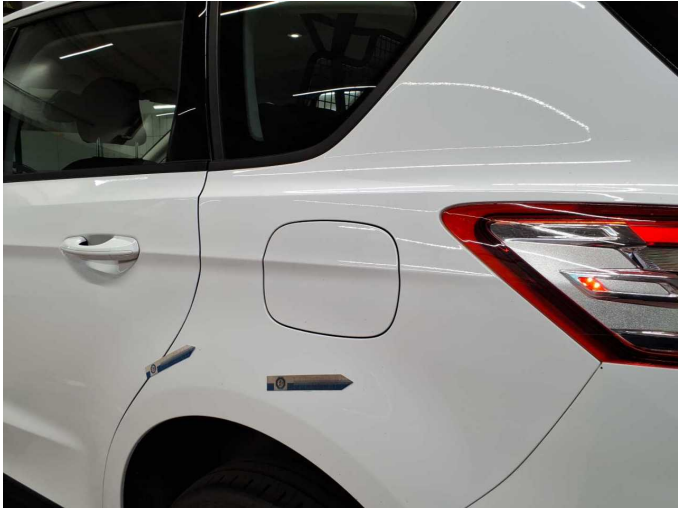
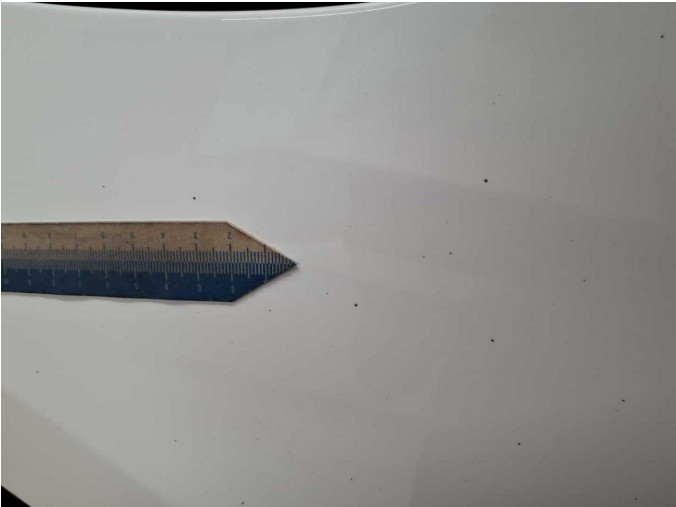
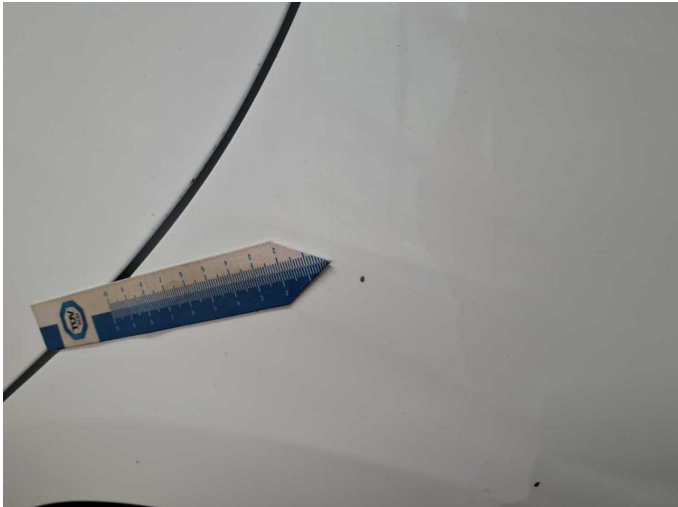
Damage 2: Side panel - rear left side: Side panel - Soiled - Conditioning

| No. | Component group | Description |
|---|---|---|
| 2 | Side panel - rear left side | Side panel - Soiled - Conditioning |

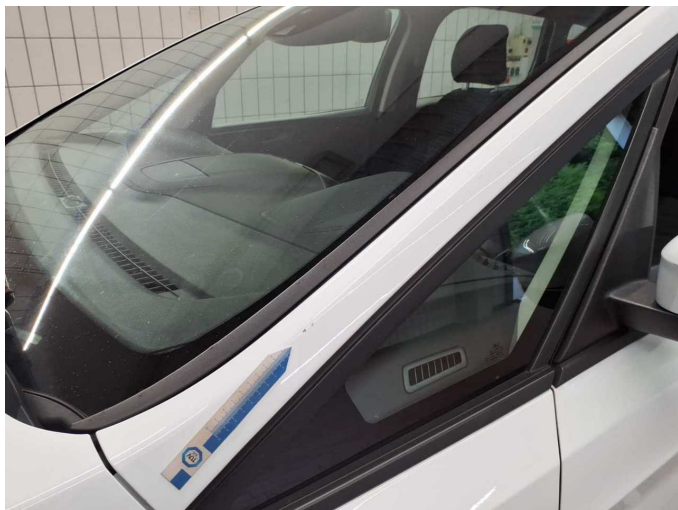
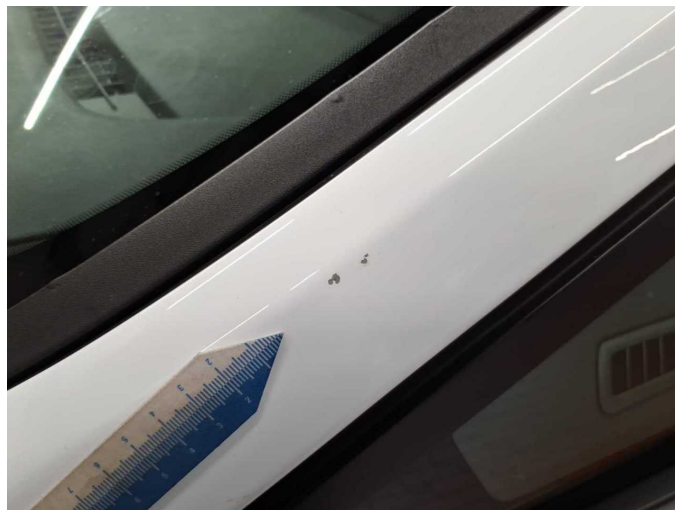
**Damage 3:** Roof: Roof rail - left side - Stone chips - Smart repair

| No. | Component group | Description |
|---|---|---|
| 3 | Roof | Roof rail - left side - Stone chips - Smart repair |

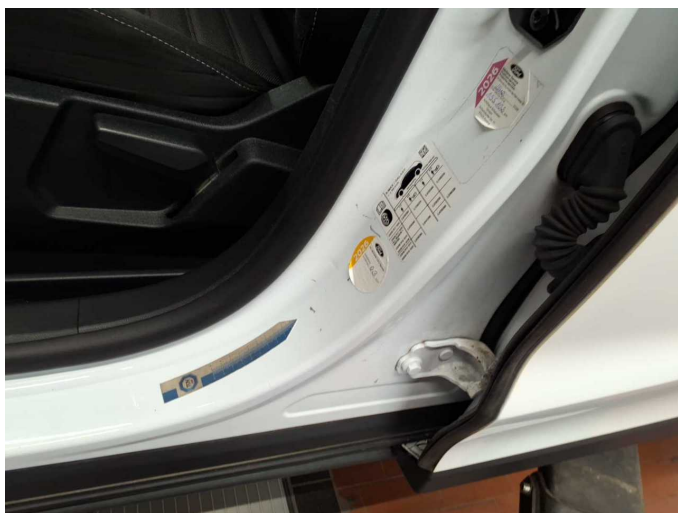
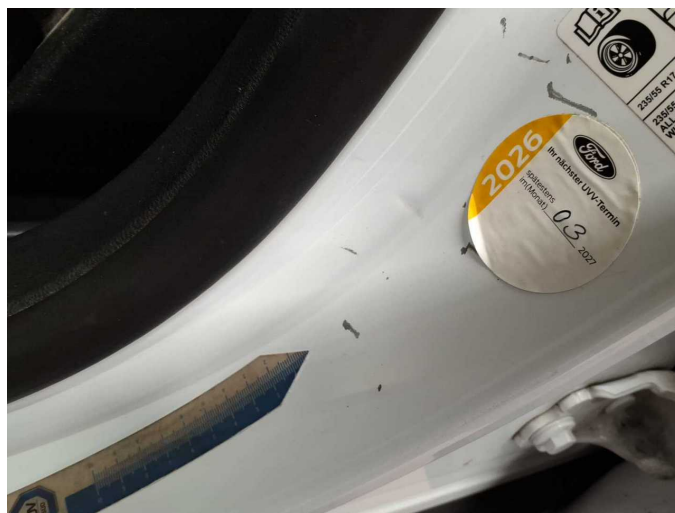
**Damage 4:** Sill - left side: Sill - Scratch(es) - Smart repair

| No. | Component group | Description |
|---|---|---|
| 4 | Sill - left side | Sill - Scratch(es) - Smart repair |

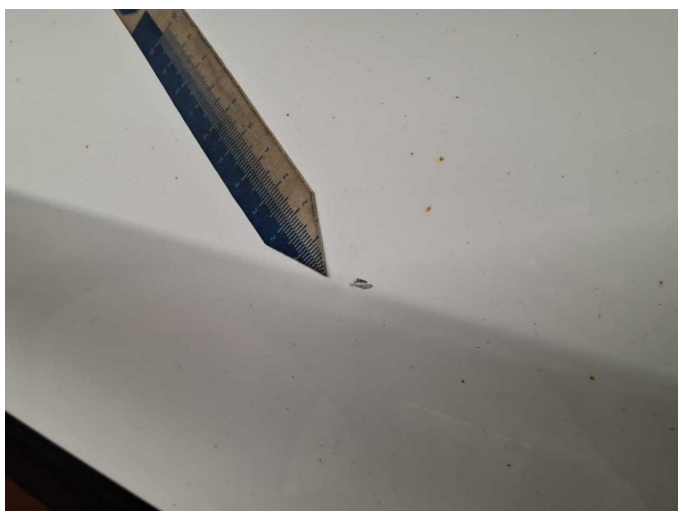
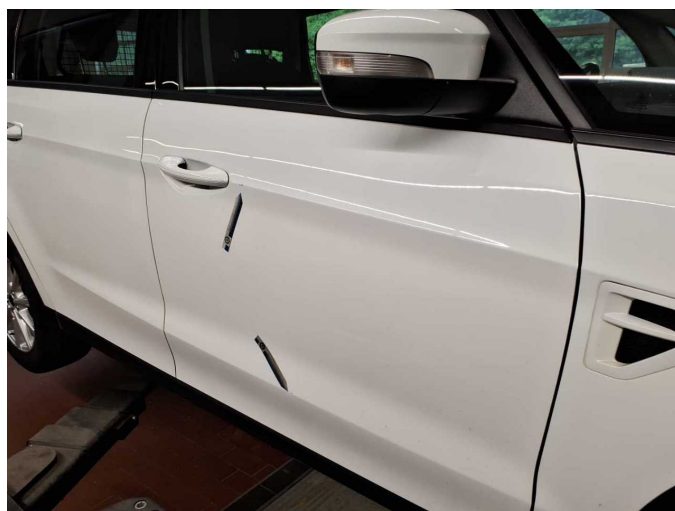
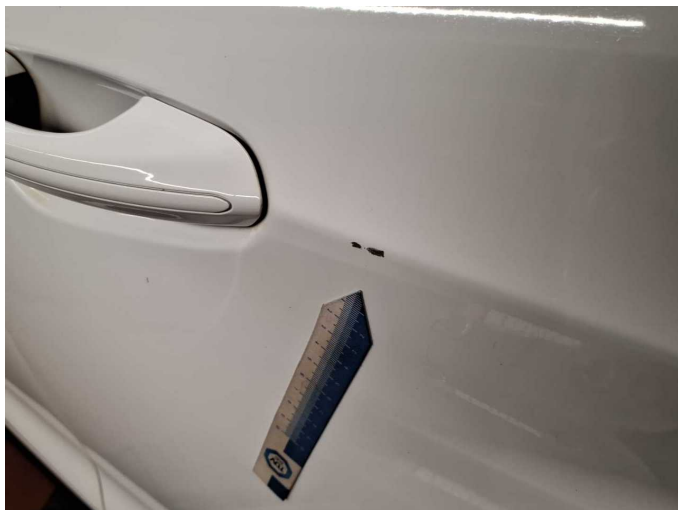
**Damage 5:** Door - front right side: Door - Scratch(es) - Paint

| No. | Component group | Description |
|---|---|---|
| 5 | Door - front right side | Door - Scratch(es) - Paint |

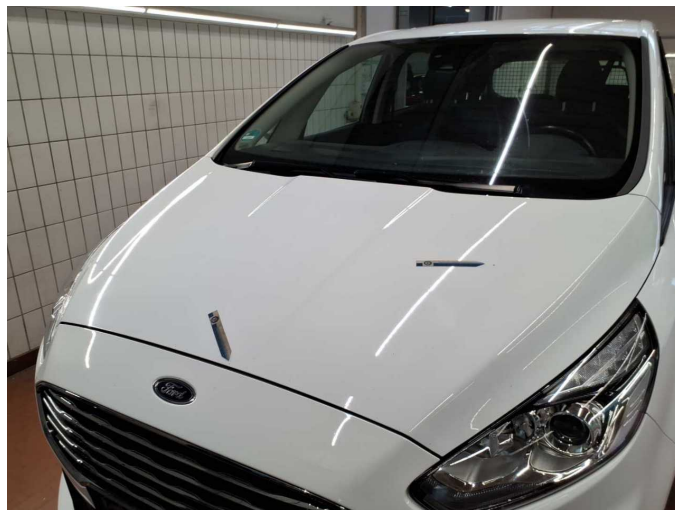
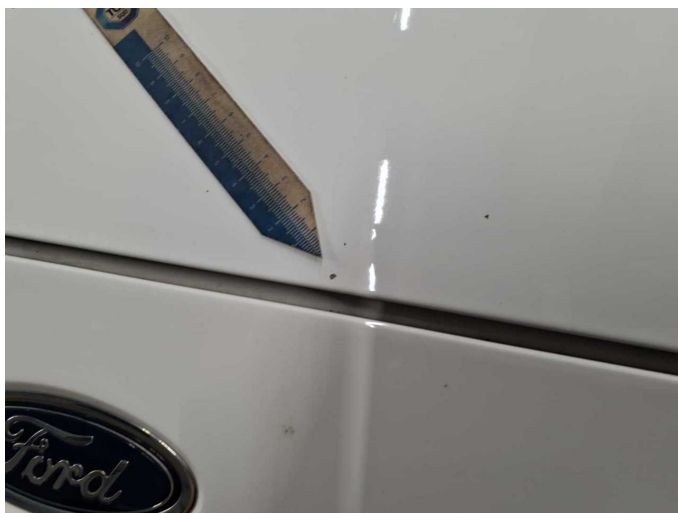
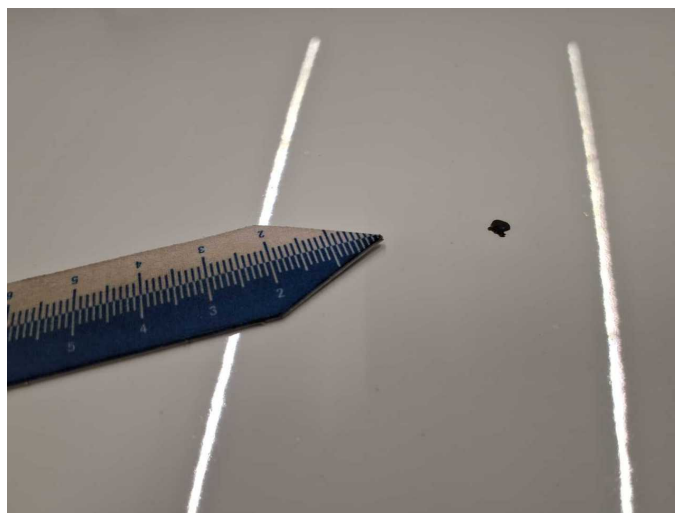
**Damage 6:** Bonnet: Bonnet - Stone chips - Paint

| No. | Component group | Description |
|---|---|---|
| 6 | Bonnet | Bonnet - Stone chips - Paint |

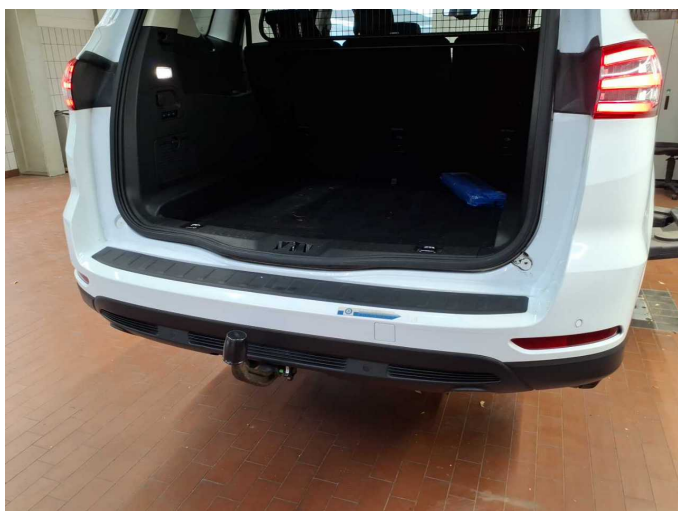
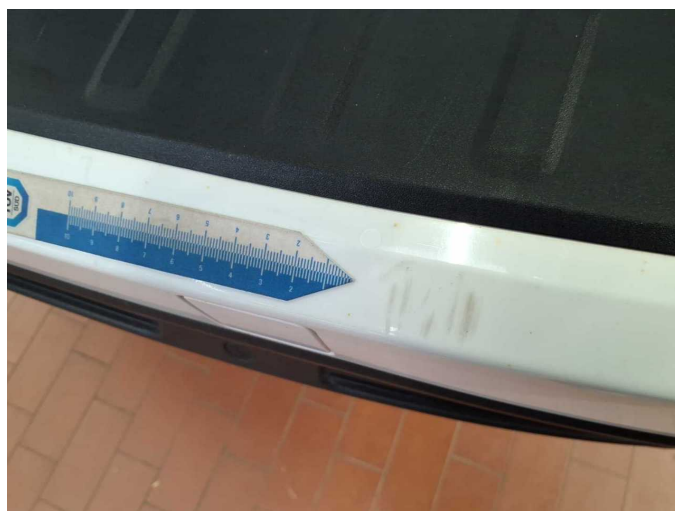
| No. | Component group | Description |
|---|---|---|
| 1 | Rear bumper | Rear bumper - Scratch(es) - No deduction |

**Wear and tear 1:** Rear bumper: Rear bumper - Scratch(es) - No deduction
