Expertise

Protocol number: 46402449  
Order No. / Reference: 26671326  
Inspection date: 8 Jul 2026

Manufacturer: Skoda  
VIN: TMBJG7NX5MY173339

Model: Octavia Combi 2.0 TDI Style

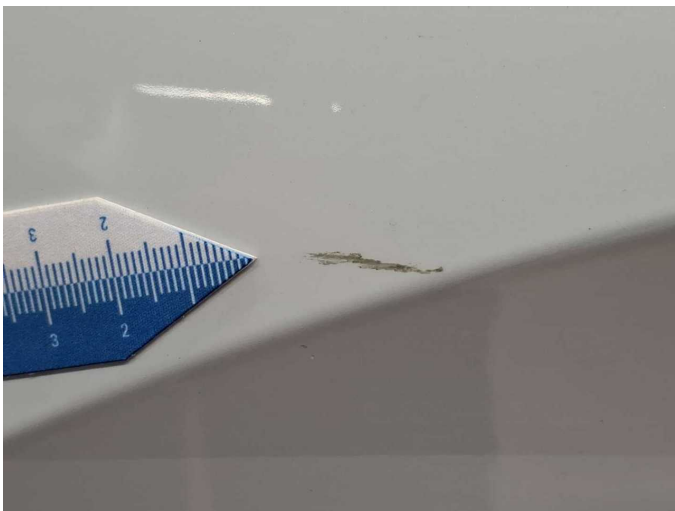
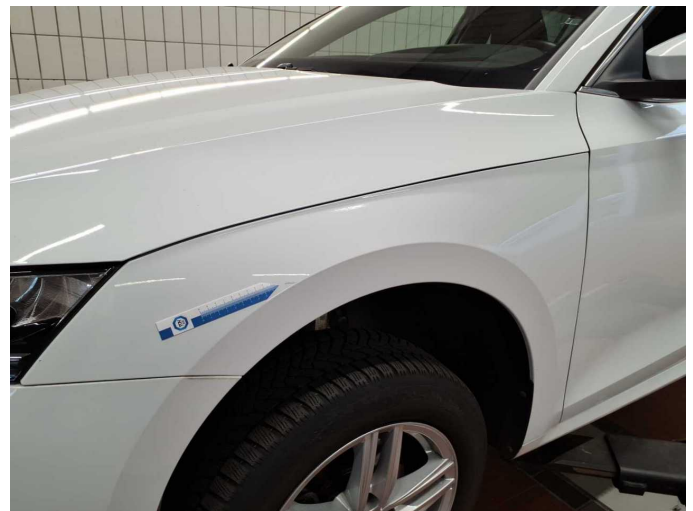
| No. | Component group | Description |
|---|---|---|
| 2 | Mudguard - left side | Mudguard - left side - Soiled - Conditioning |

**Damage 2:** Mudguard - left side: Mudguard - left side - Soiled - Conditioning

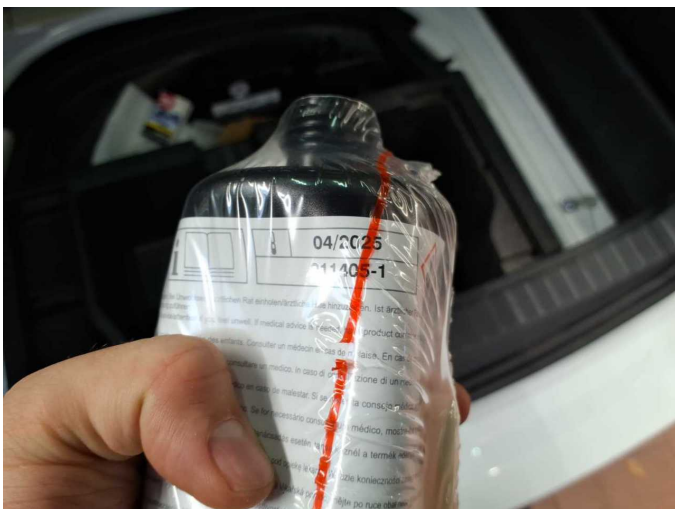
| No. | Component group | Description |
|---|---|---|
| 3 | Equipment | Tirefit filler - Due - Replace |

**Damage 3:** Equipment: Tirefit filler - Due - Replace

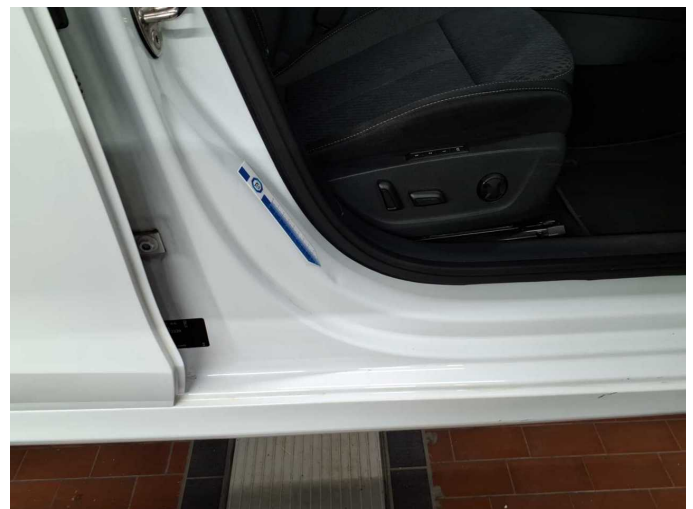
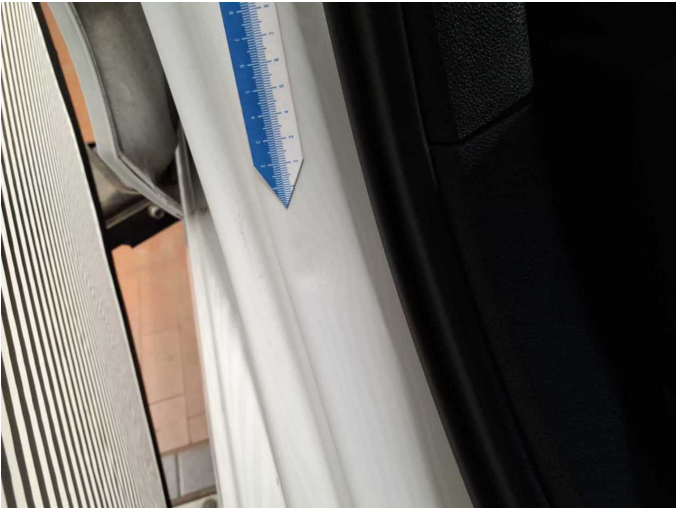
| No. | Component group | Description |
|---|---|---|
| 4 | Sill - right side | Sill - dent(s) - Smooth repair work |

**Damage 4:** Sill - right side: Sill - dent(s) - Smooth repair work

Damage 4: Sill - right side: Sill - dent(s) - Smooth repair work

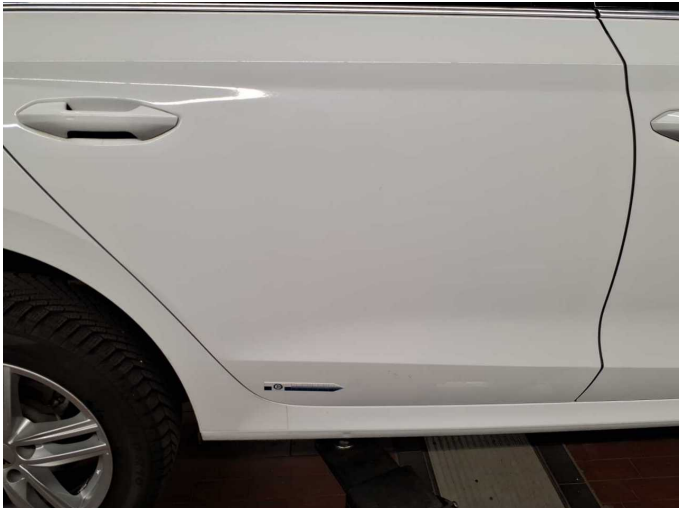
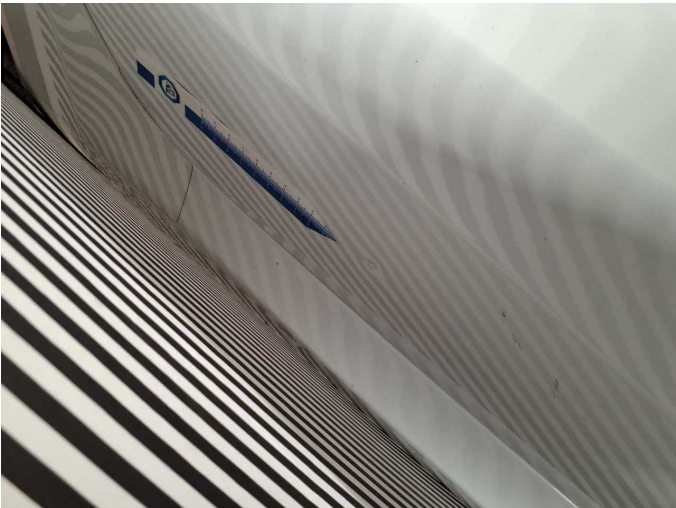
| No. | Component group | Description |
|---|---|---|
| 5 | Door - rear right side | Door - dent(s) - Smooth repair work |

Damage 5: Door - rear right side: Door - dent(s) - Smooth repair work

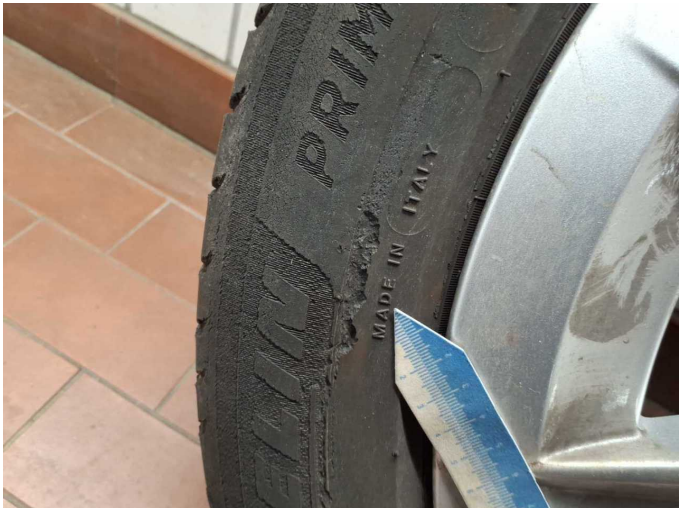
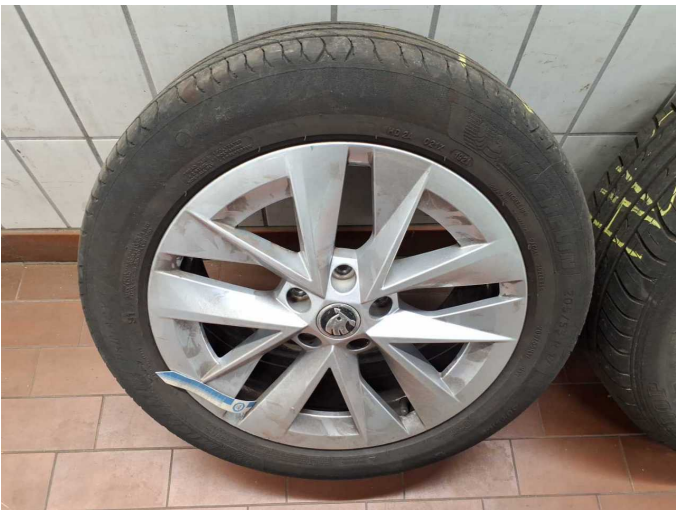
| No. | Component group | Description |
|---|---|---|
| 6 | 2nd wheel set | 1 tyre - Broken / torn - Replace |

Damage 6: 2nd wheel set: 1 tyre - Broken / torn - Replace

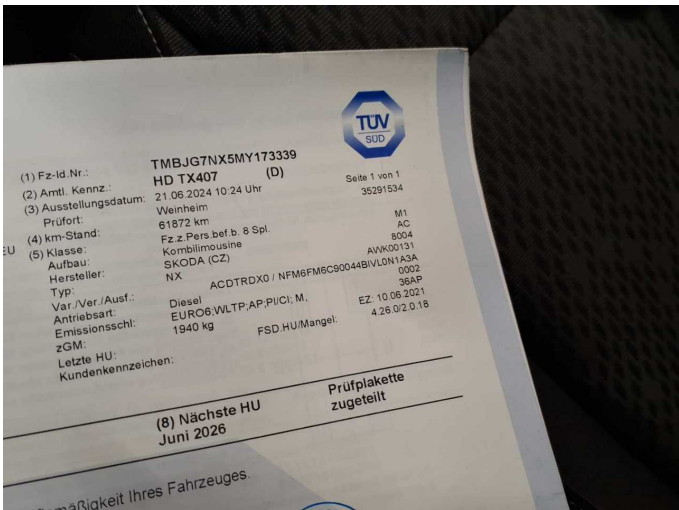
| No. | Component group | Description |
|---|---|---|
| 7 | Misc. | Main inspection - Due - Perform |

Damage 7: Misc.: Main inspection - Due - Perform

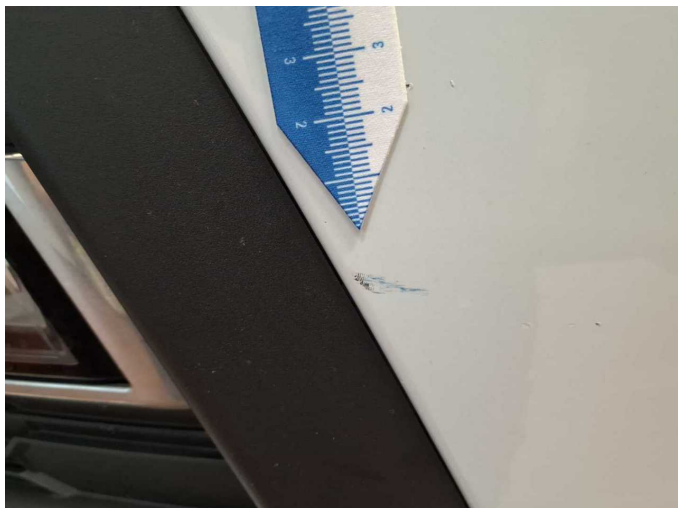
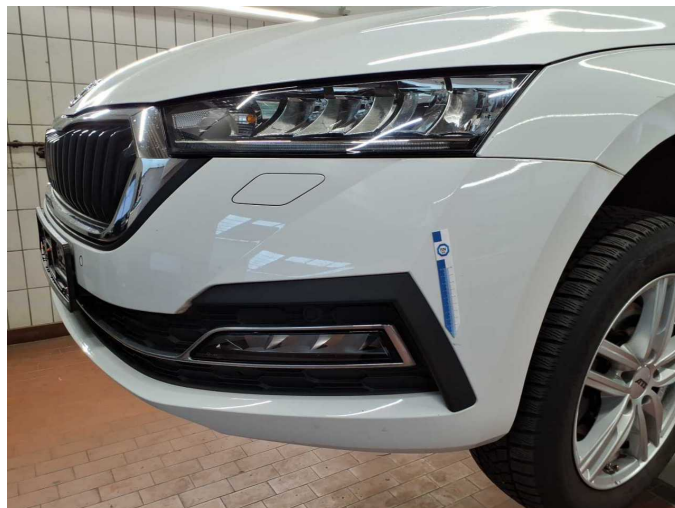
| No. | Component group | Description |
|---|---|---|
| 8 | Front bumper | Front bumper - Scratch(es) - Smart repair |

**Damage 8:** Front bumper: Front bumper - Scratch(es) - Smart repair

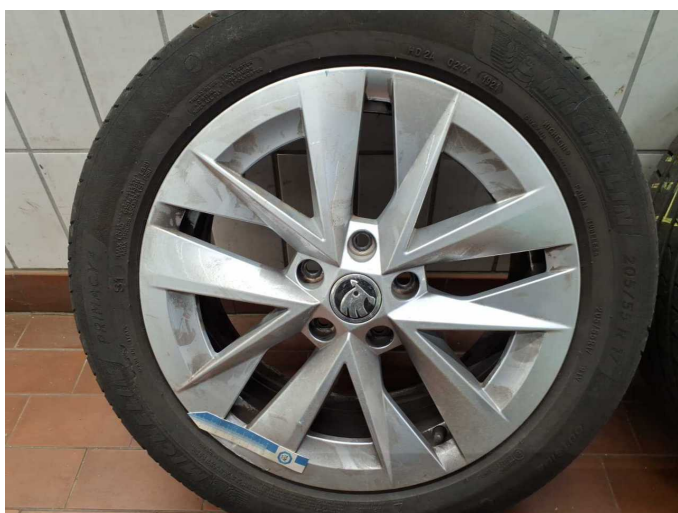
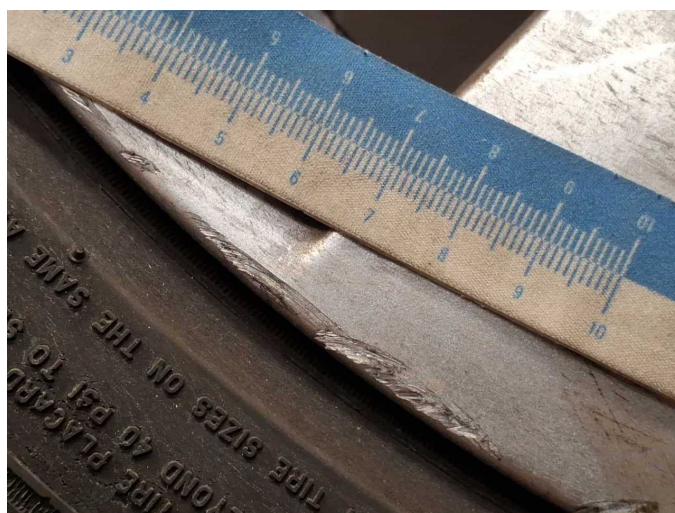
| No. | Component group | Description |
|---|---|---|
| 9 | 2nd wheel set | 1 alloy rim - Scratch(es) - Loss in value |

**Damage 9:** 2nd wheel set: 1 alloy rim - Scratch(es) - Loss in value

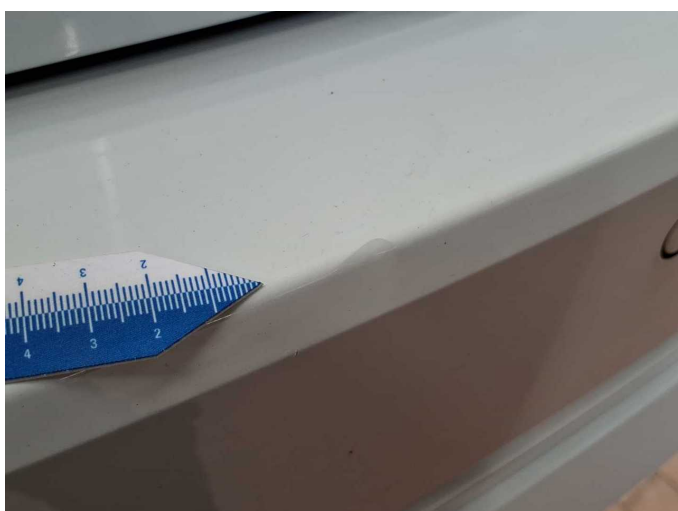
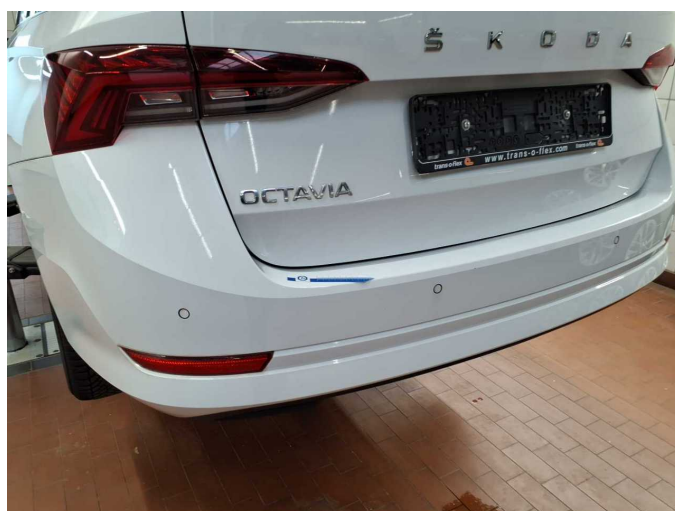
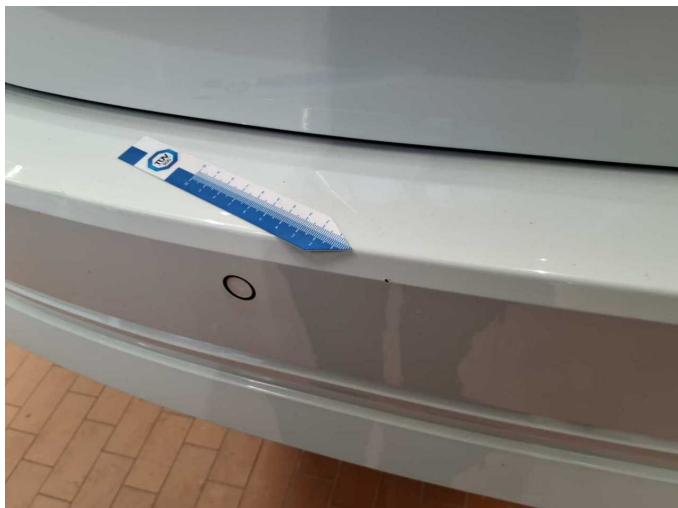
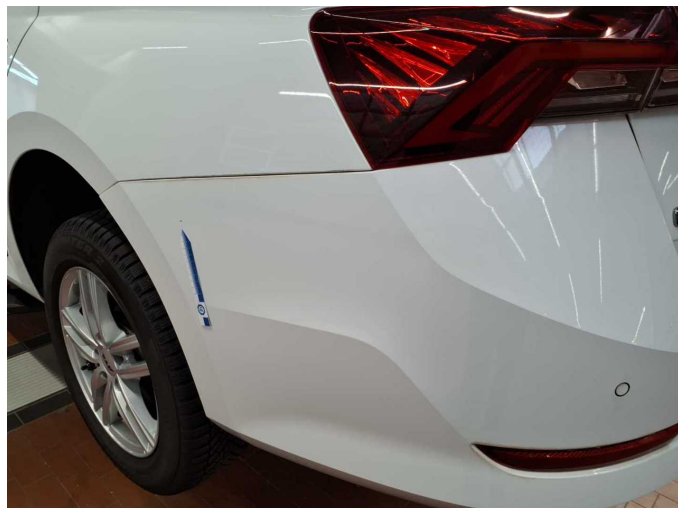
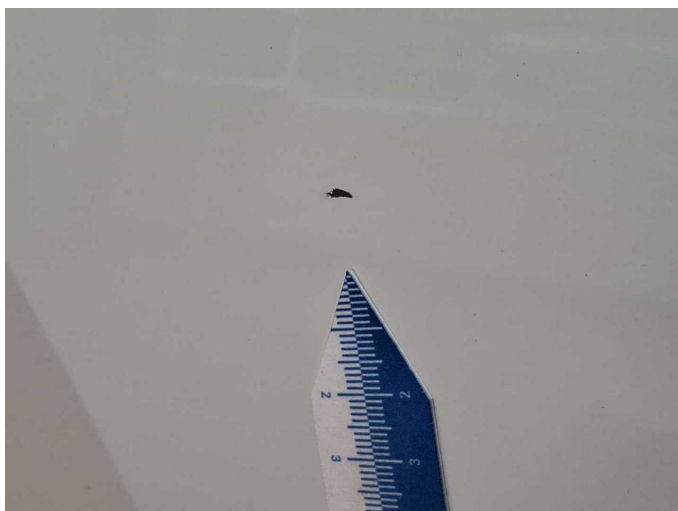
| No. | Component group | Description |
|---|---|---|
| 10 | Rear bumper | Rear bumper - Scratch(es) - Paint |

**Damage 10:** Rear bumper: Rear bumper - Scratch(es) - Paint

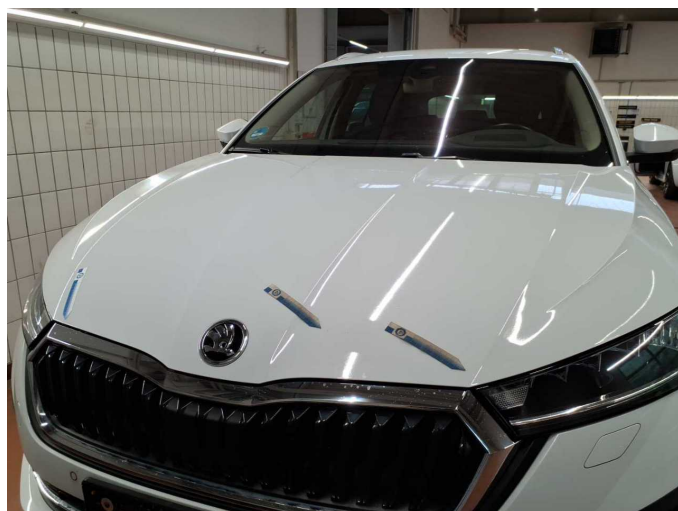
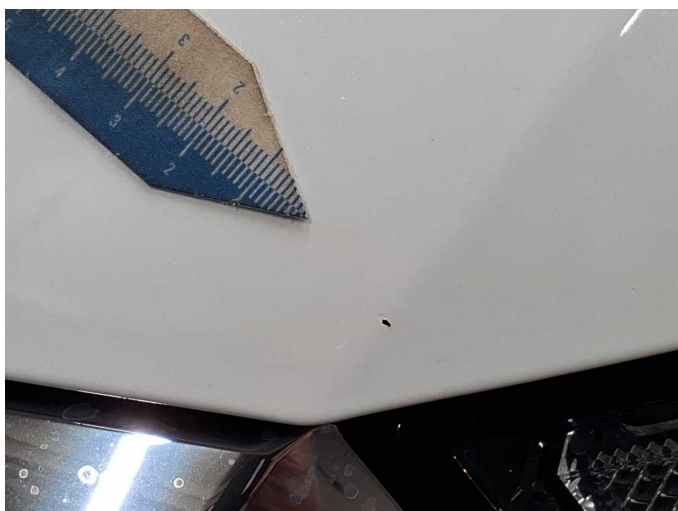
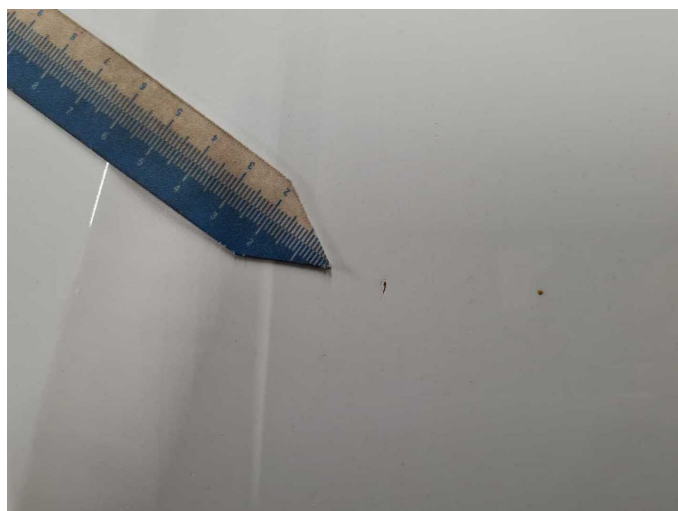
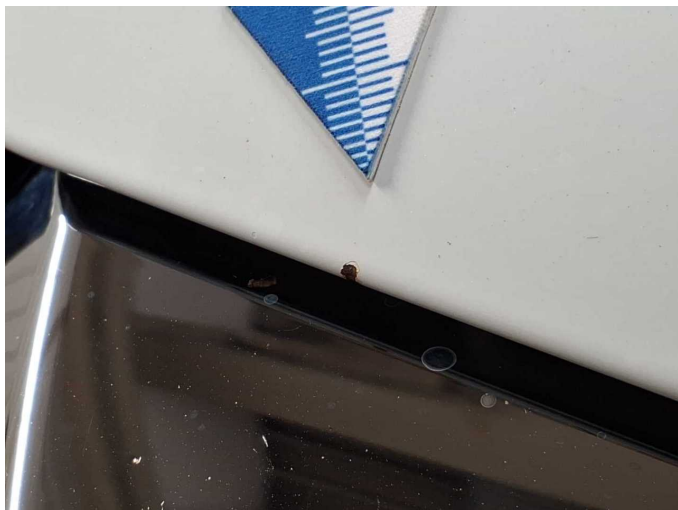
| No. | Component group | Description |
|---|---|---|
| 11 | Bonnet | Bonnet (Rostunterwandert) - Stone chips - Paint |

**Damage 11:** Bonnet: Bonnet (Rostunterwandert) - Stone chips - Paint

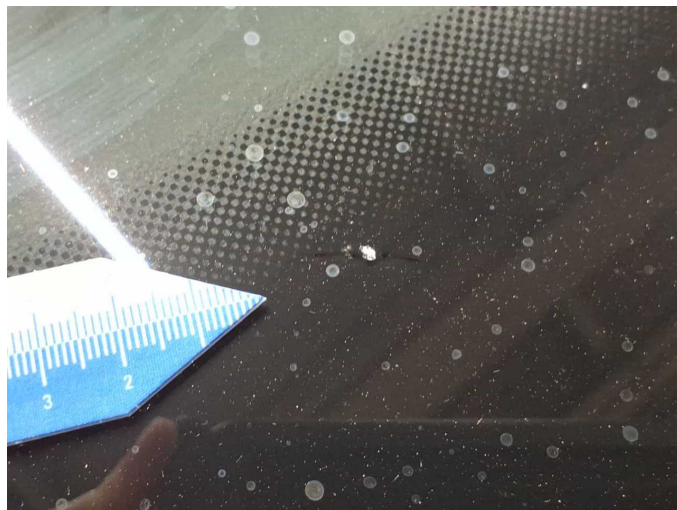
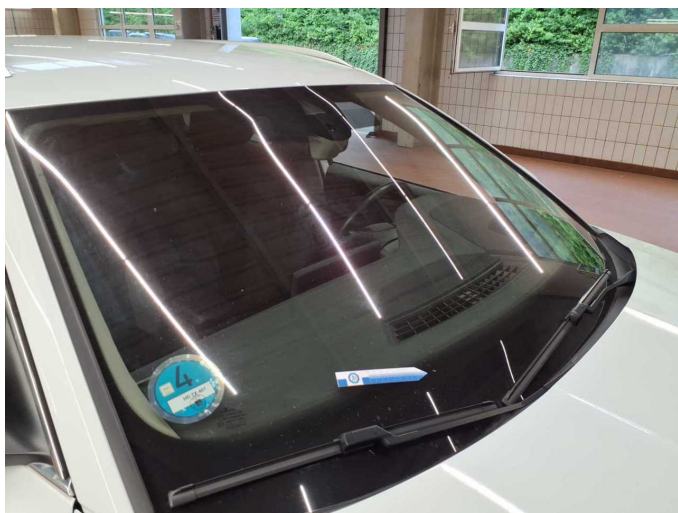
| No. | Component group | Description |
|---|---|---|
| 12 | Vehicle glazing | Windscreen - Stone chips - Replace |

**Damage 12:** Vehicle glazing: Windscreen - Stone chips - Replace

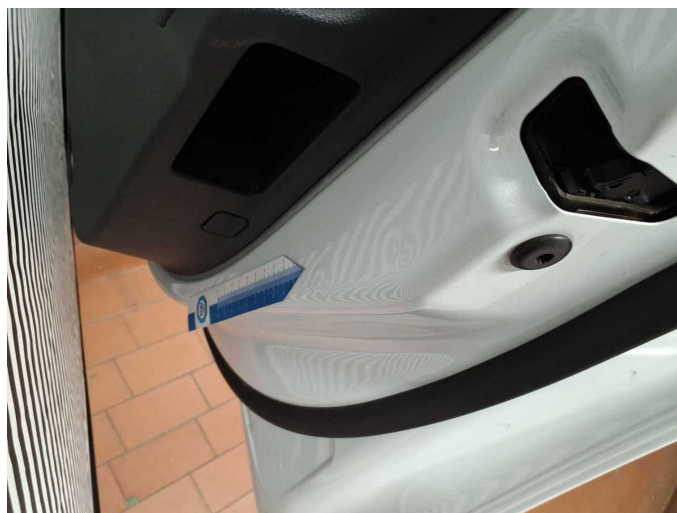
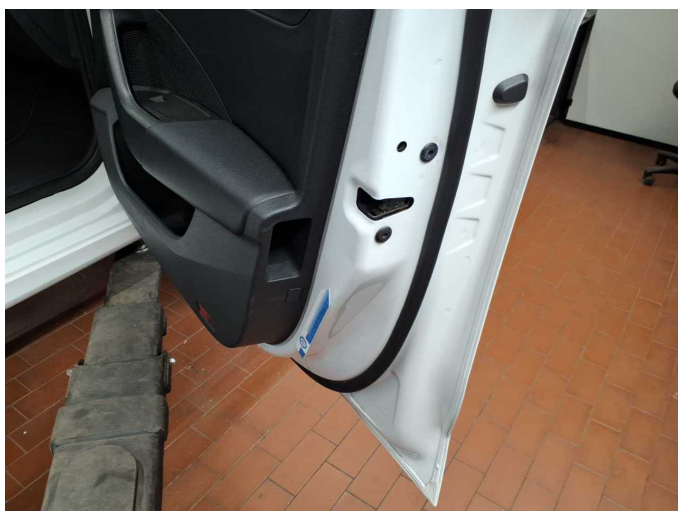
| No. | Component group | Description |
|---|---|---|
| 4 | Door - front right side | Door - dent(s) - No deduction |

**Wear and tear 4:** Door - front right side: Door - dent(s) - No deduction
