Expertise

Protocol number: 46003451  
Order No. / Reference: 26453377  
Inspection date: 17 Jun 2026

Manufacturer: Volkswagen

Model: Passat Variant 2.0 TDI SCR DSG 4Motion Business

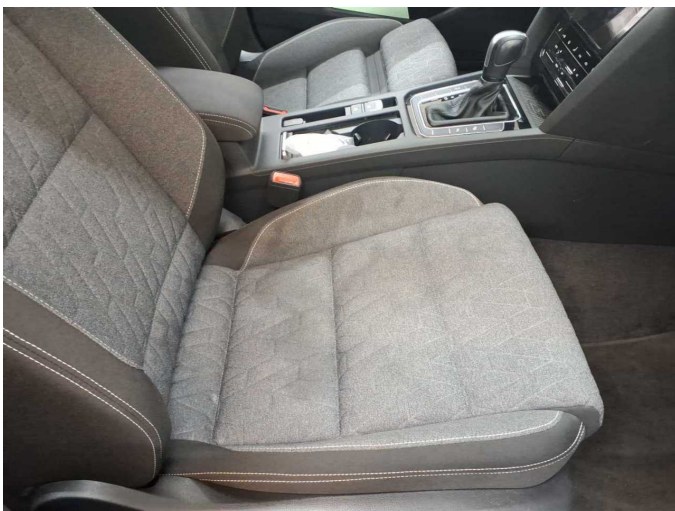
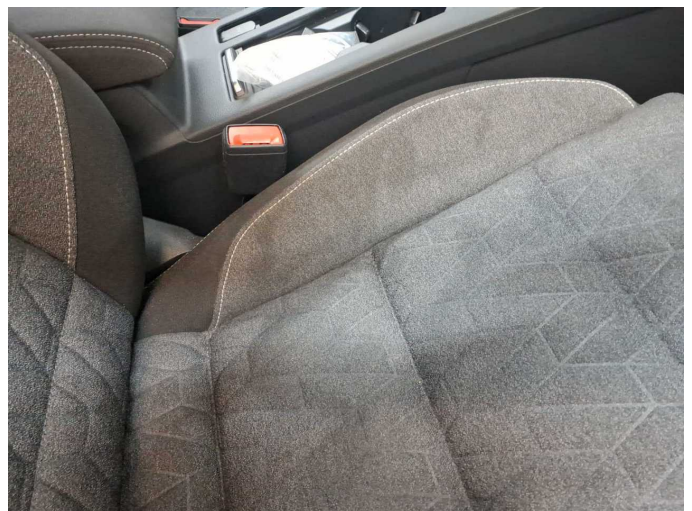
| No. | Component group | Description |
|---|---|---|
| 2 | Seat - front | Seat cover - right side - Soiled - Clean |

Damage 2: Seat - front: Seat cover - right side - Soiled - Clean

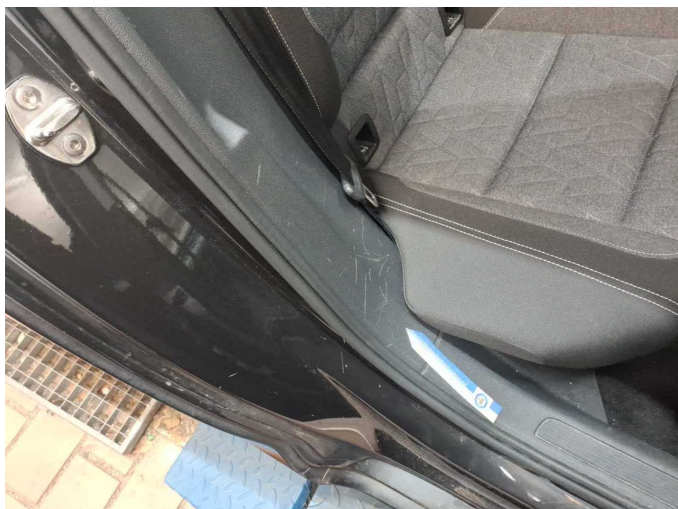
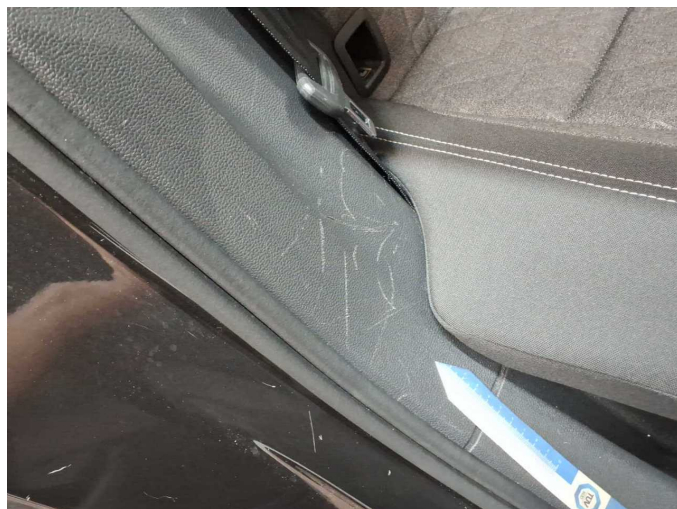
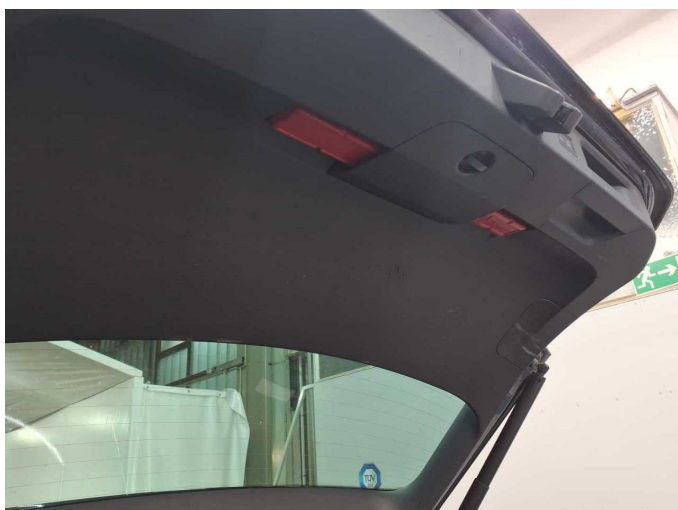
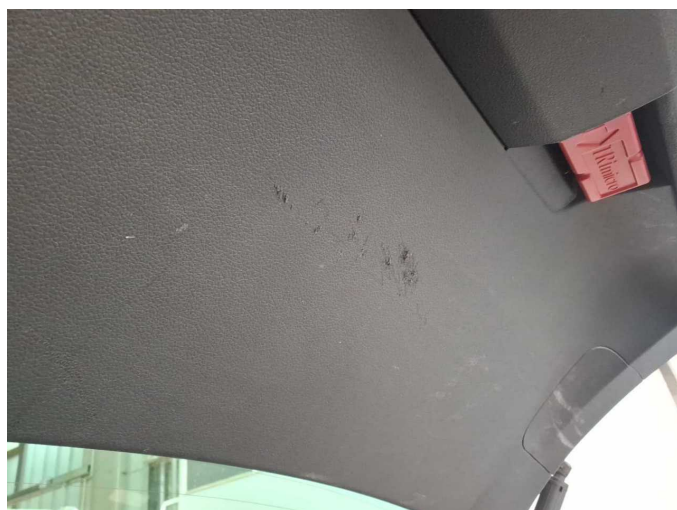
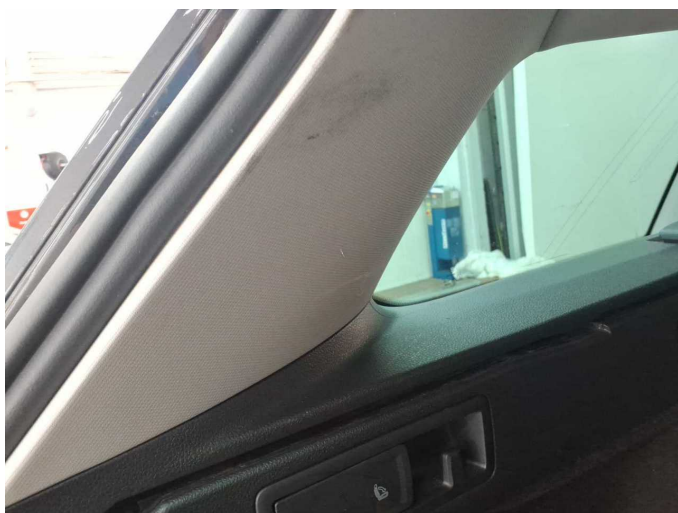
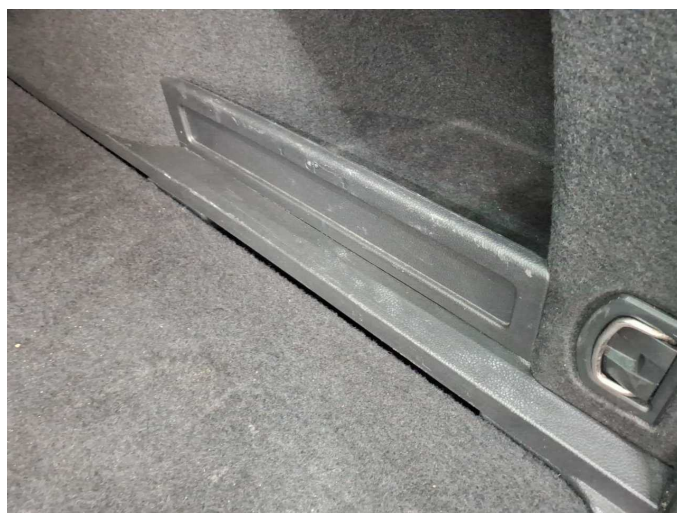
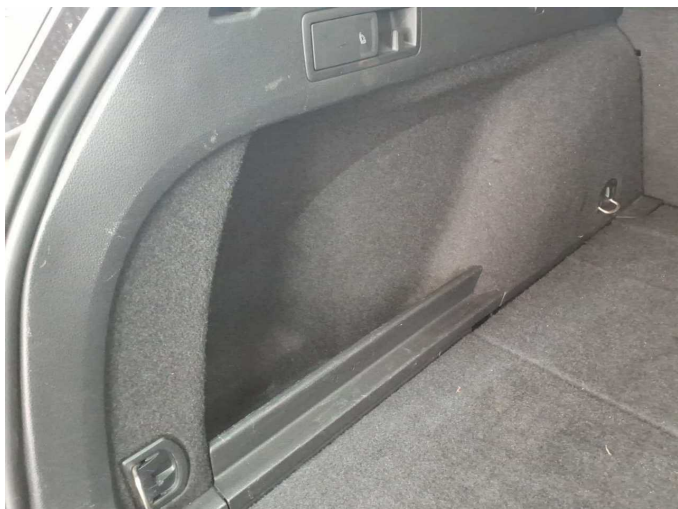
| No. | Component group | Description |
|---|---|---|
| 3 | Interior | Interior - Scratch(es) - Loss in value |

**Damage 3:** Interior: Interior - Scratch(es) - Loss in value

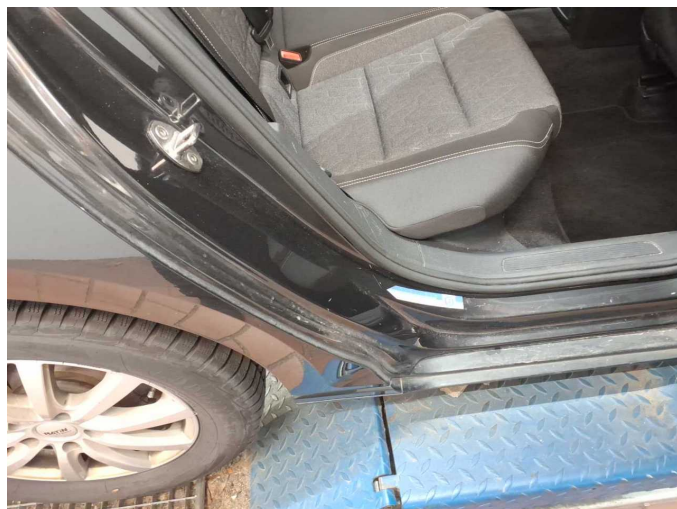
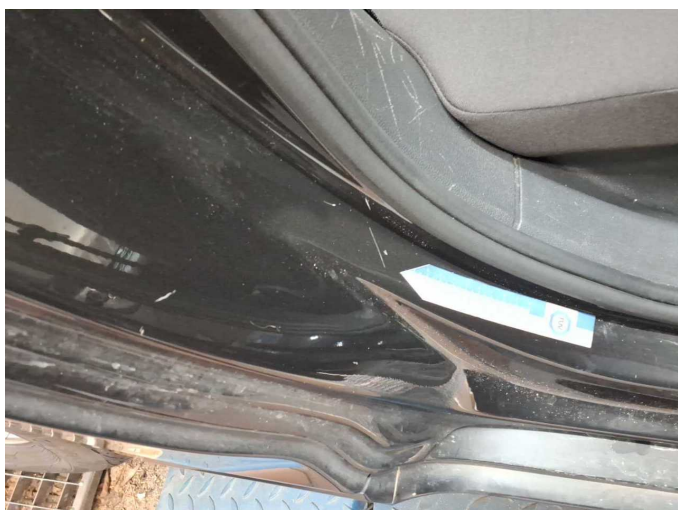
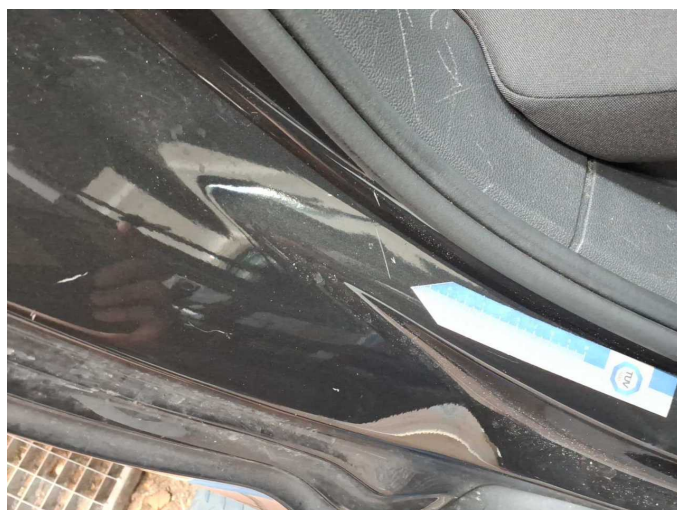
| No. | Component group | Description |
|---|---|---|
| 4 | Side panel - rear right side | Sill - Scratch(es) - Smart repair |

**Damage 4:** Side panel - rear right side: Sill - Scratch(es) - Smart repair

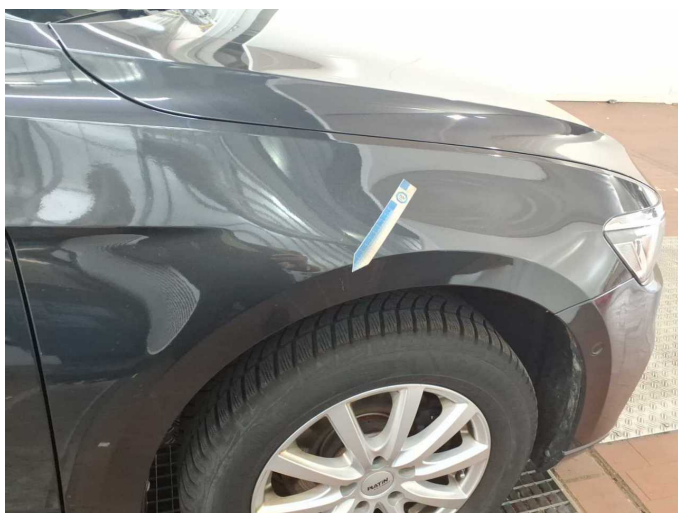
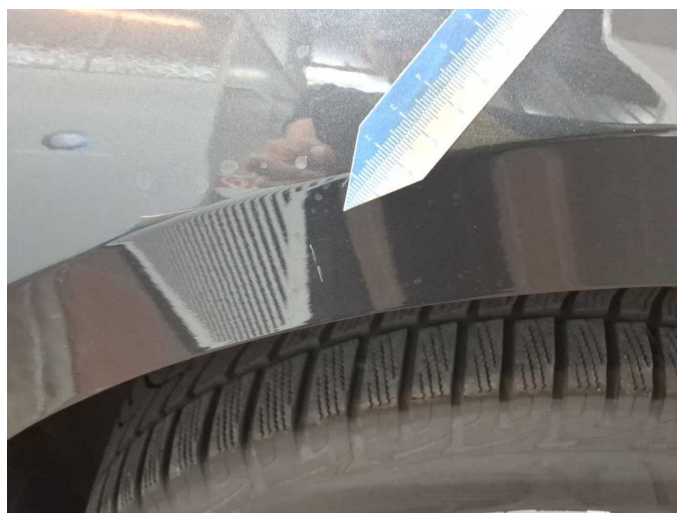
| No. | Component group | Description |
|---|---|---|
| 5 | Mudguard - right side | Mudguard - right side - Scratch(es) - Smart repair |

**Damage 5:** Mudguard - right side: Mudguard - right side - Scratch(es) - Smart repair

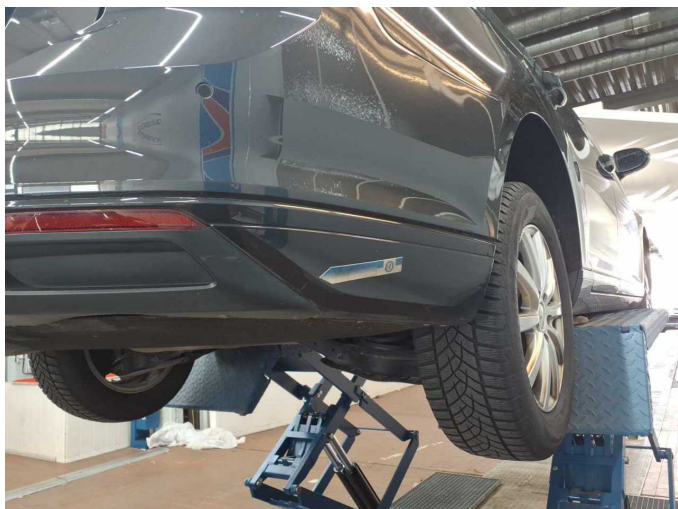
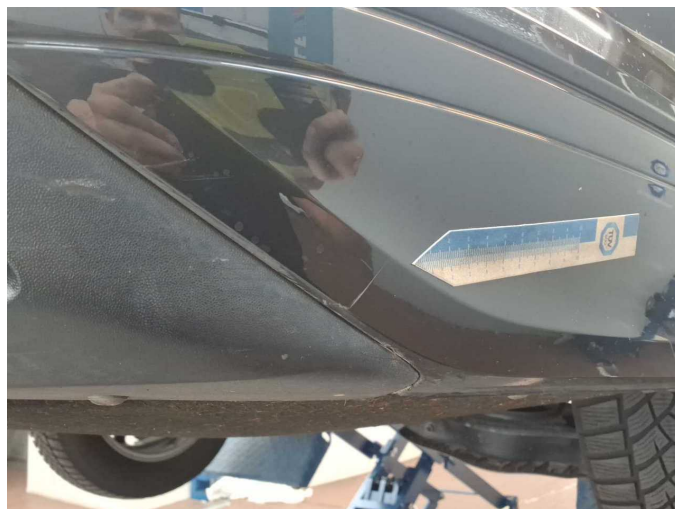
| No. | Component group | Description |
|---|---|---|
| 6 | Rear bumper | Rear bumper - Scratch(es) - Smart repair |

**Damage 6:** Rear bumper: Rear bumper - Scratch(es) - Smart repair

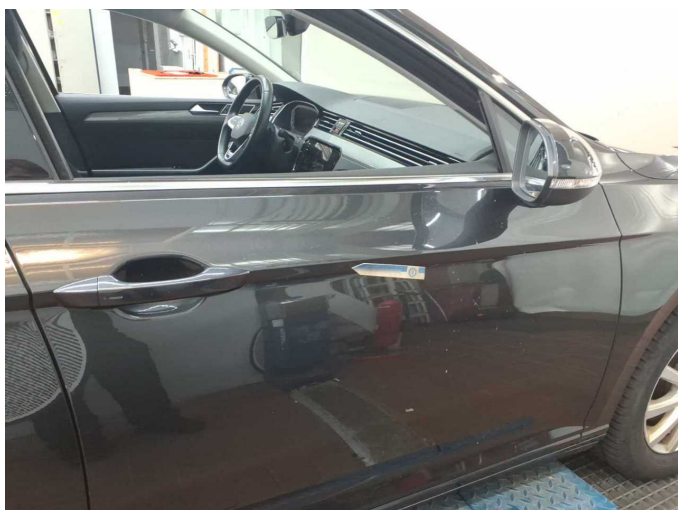
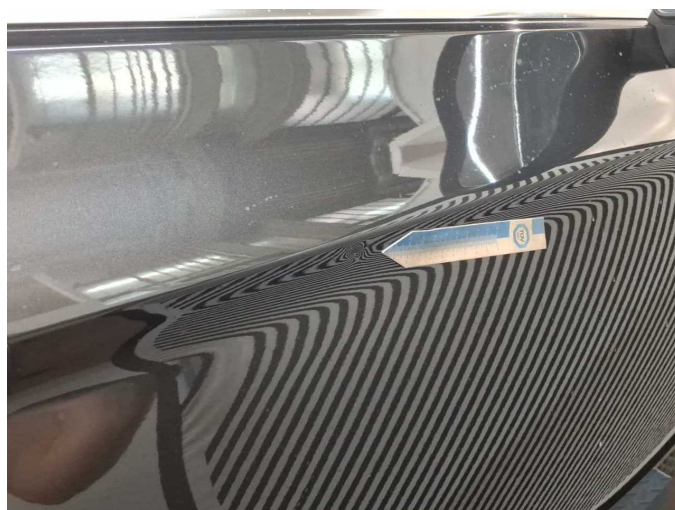
| No. | Component group | Description |
|---|---|---|
| 7 | Door - front right side | Door - dent(s) - Smart repair |

**Damage 7:** Door - front right side: Door - dent(s) - Smart repair

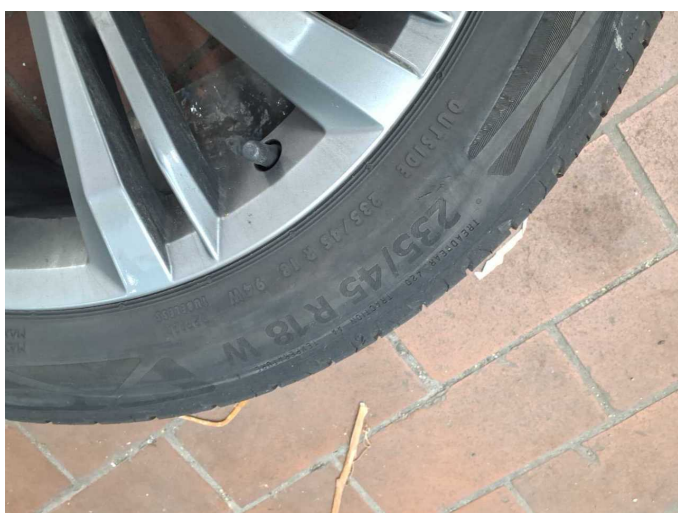
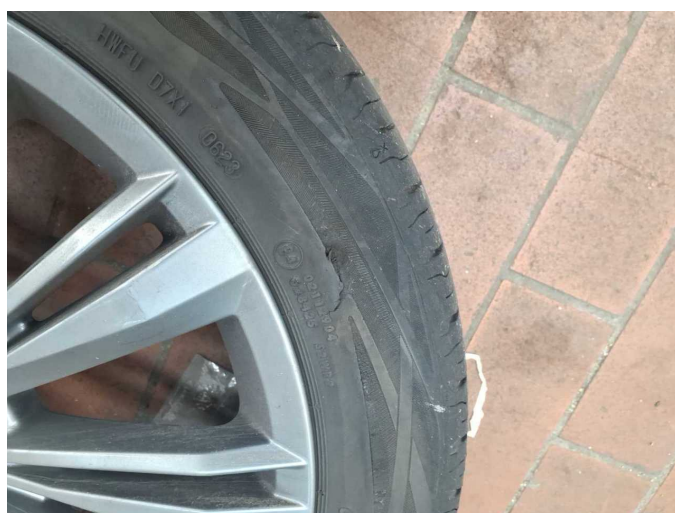
| No. | Component group | Description |
|---|---|---|
| 9 | 2nd wheel set | 1 tyre - Damaged - Replace |

**Damage 9:** 2nd wheel set: 1 tyre - Damaged - Replace

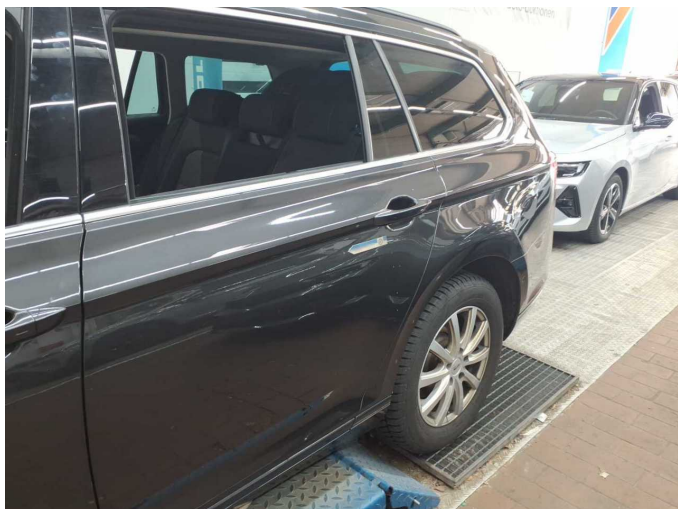
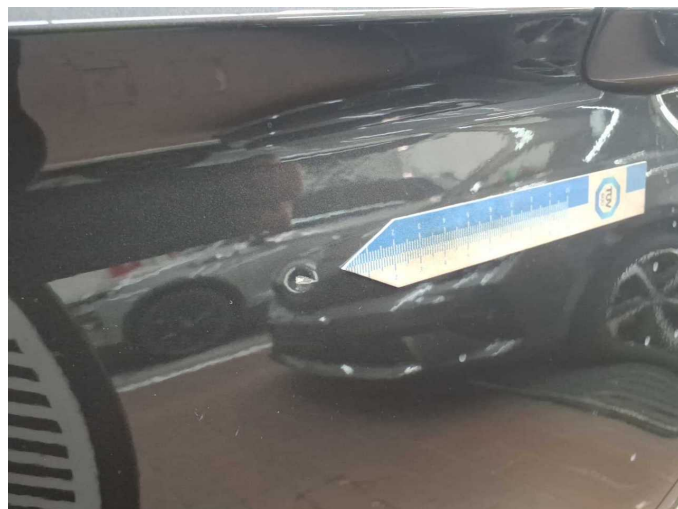
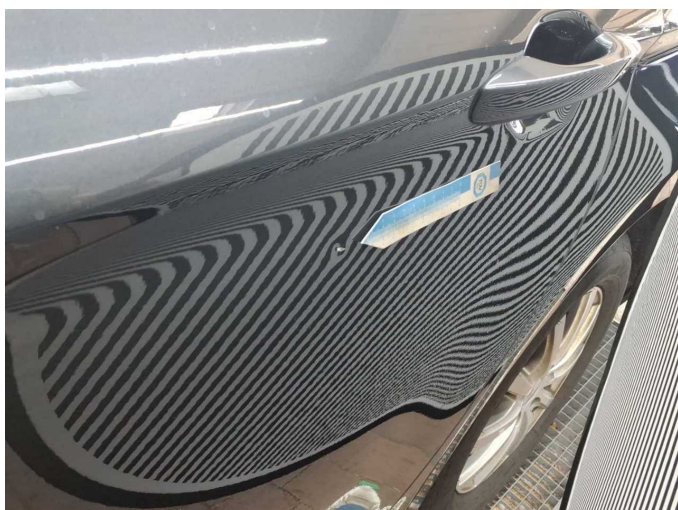
| No. | Component group | Description |
|---|---|---|
| 10 | Door - rear left side | Door - Dent / paintcoat damage - Smart repair |

**Damage 10:** Door - rear left side: Door - Dent / paintcoat damage - Smart repair

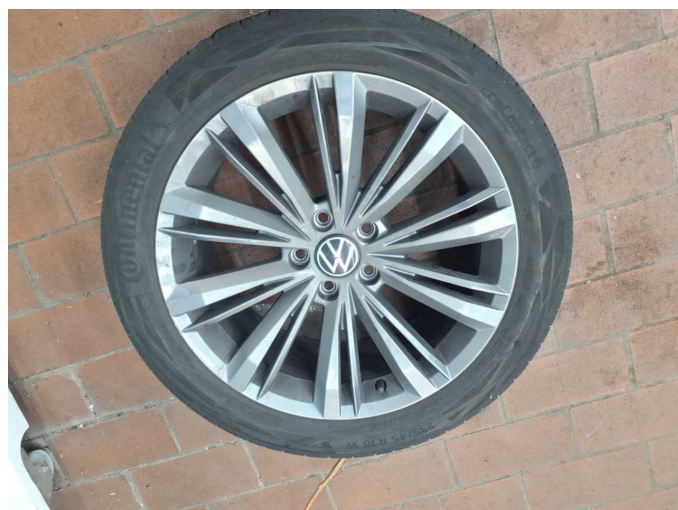
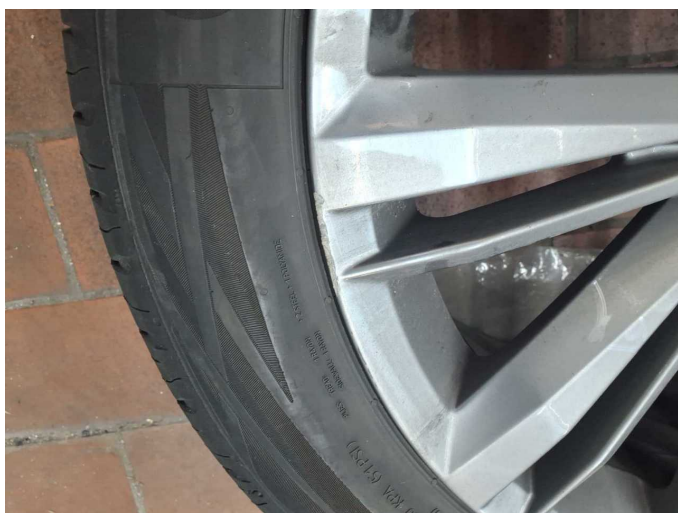
| No. | Component group | Description |
|---|---|---|
| 11 | 2nd wheel set | 1 alloy rim - Scratch(es) - Loss in value |

**Damage 11:** 2nd wheel set: 1 alloy rim - Scratch(es) - Loss in value

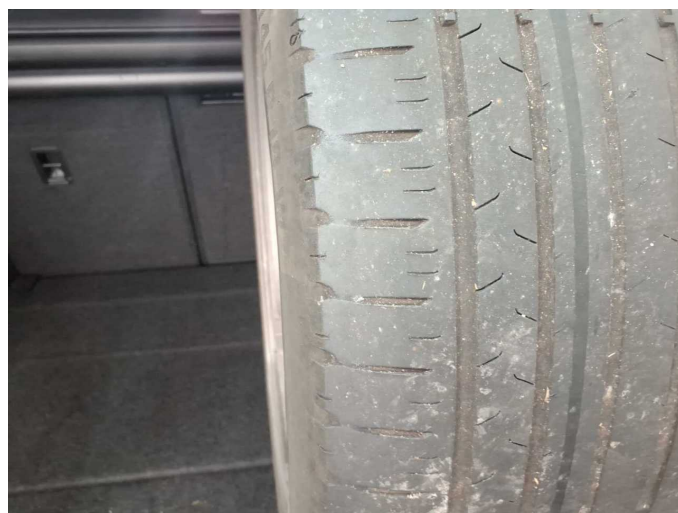
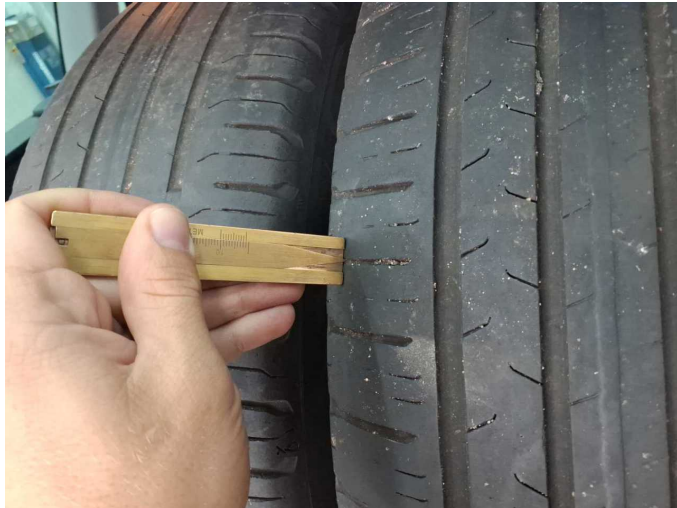
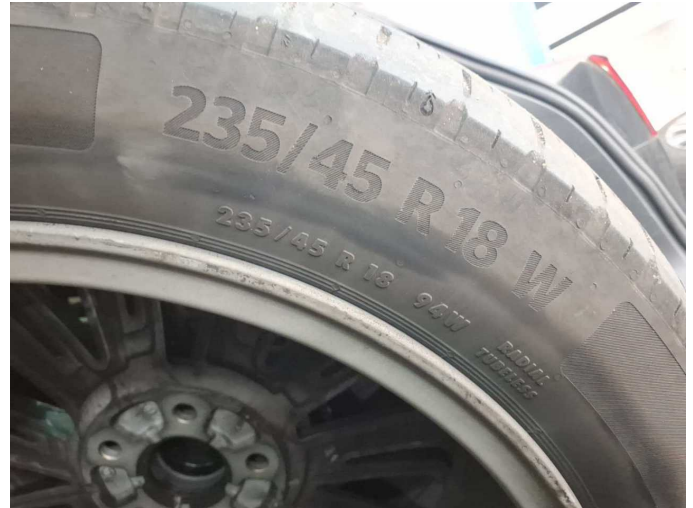
| # | Tyre size | Type of tyre | Manufacturer | Tread depth |
|---|---|---|---|---|
| 1) | 235/45 R18 94W | Summer tyres on Light alloy | Continental | 0mm / 1mm |
| 2) | 235/45 R18 94W | Summer tyres on Light alloy | Continental | 3mm / 3mm |

| No. | Component group | Description |
|---|---|---|
| 12 | 2nd wheel set | 2 tyres - Worn - Replace |

**Damage 12:** 2nd wheel set: 2 tyres - Worn - Replace

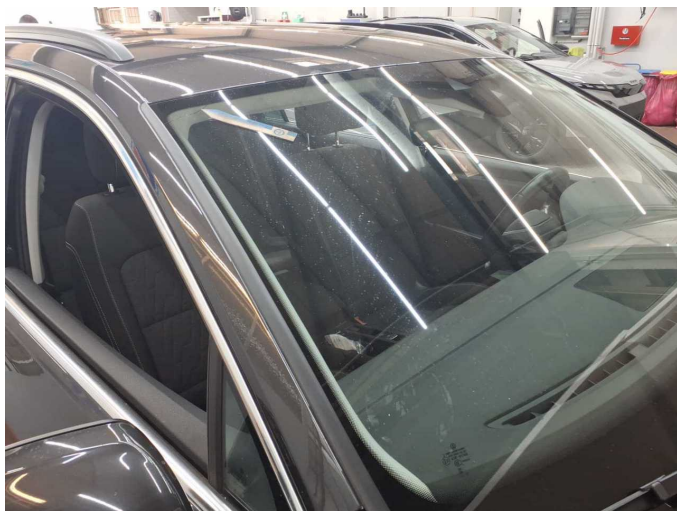
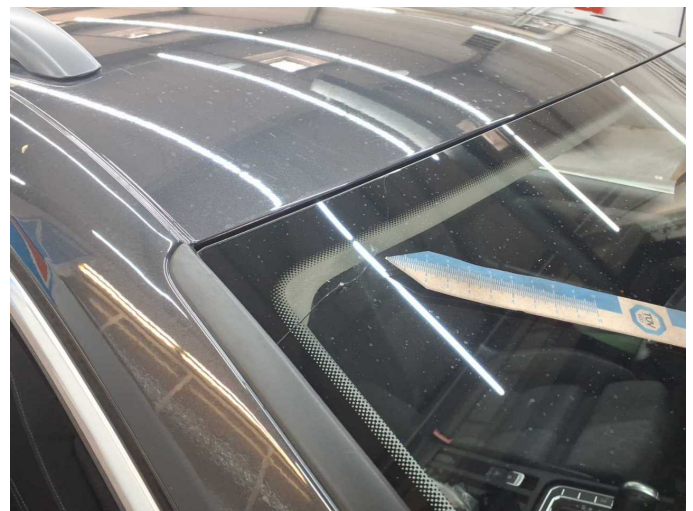
| No. | Component group | Description |
|---|---|---|
| 13 | Vehicle glazing | Windscreen - Broken / torn - repair according to calculation |

**Damage 13:** Vehicle glazing: Windscreen - Broken / torn - repair according to calculation

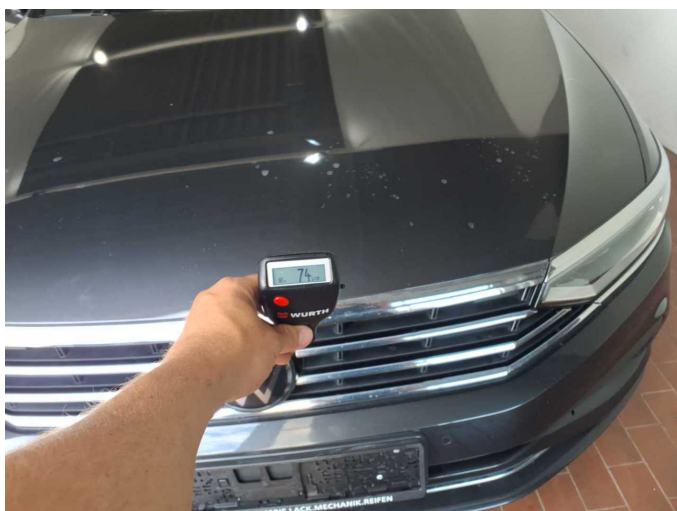
| No. | Previous damage | Extent of damage (Net) |
|---|---|---|
| 1 | Front, Provided by user / customer, from 5 Aug 2024 | 917,02 € |

**Previous damage 1:** Front

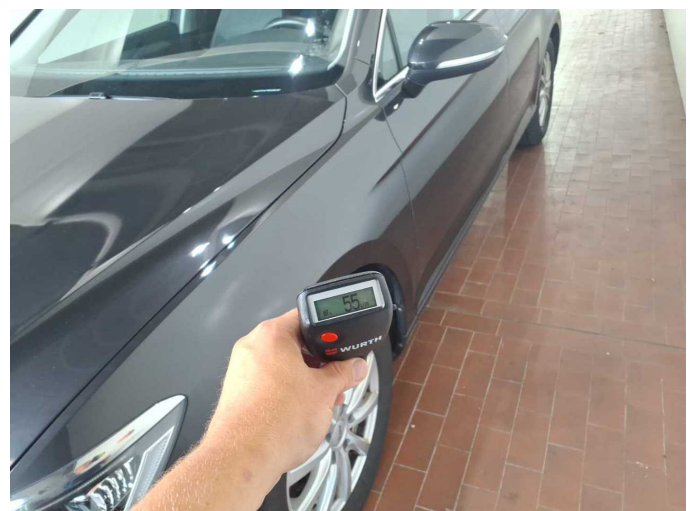
| No. | Previous damage | Extent of damage (Net) |
|---|---|---|
| 2 | Side - left, Provided by user / customer, from 6 Mar 2024 | 1.758,42 € |

**Previous damage 2:** Side - left
