Expertise

Protocol number: 46593670  
Order No. / Reference: 26701579  
Inspection date: 17 Jul 2026

Manufacturer: Skoda  
VIN: TMBJJ8NX1PY152841

Model: Octavia Combi 2.0 TDI DSG Style

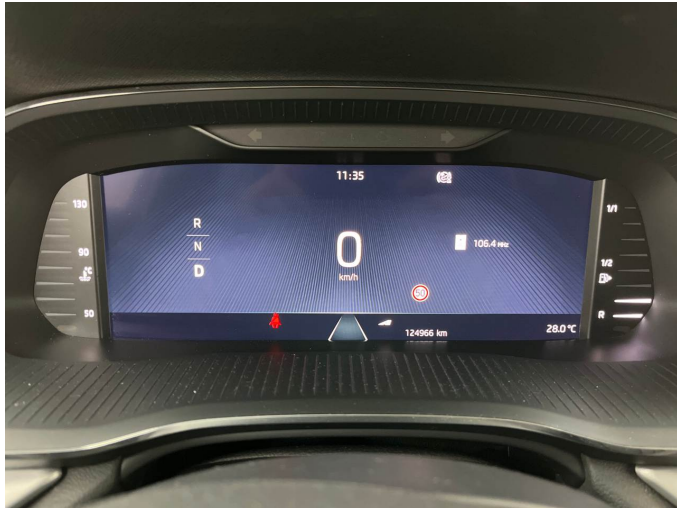
Figure 7: Instrument cluster

| Vehicle details | |
|---|---|
| Mileage (Read) | 124,966 km |

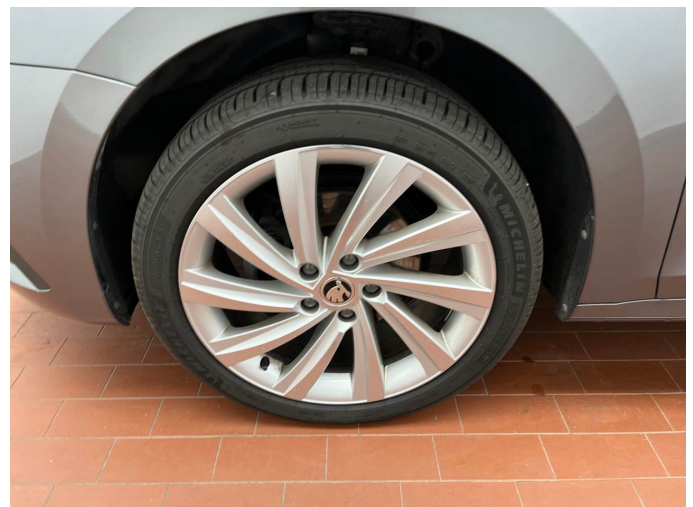
Figure 12: Mounted tyres

| # | Tyre size | Type of tyre | Manufacturer | Tread depth |
|---|---|---|---|---|
| 1) | 225/45 R18 95Y | Summer tyres on Light alloy | Michelin | 5mm / 5mm |
| 2) | 225/45 R18 95Y | Summer tyres on Light alloy | Michelin | 4mm / 4mm |

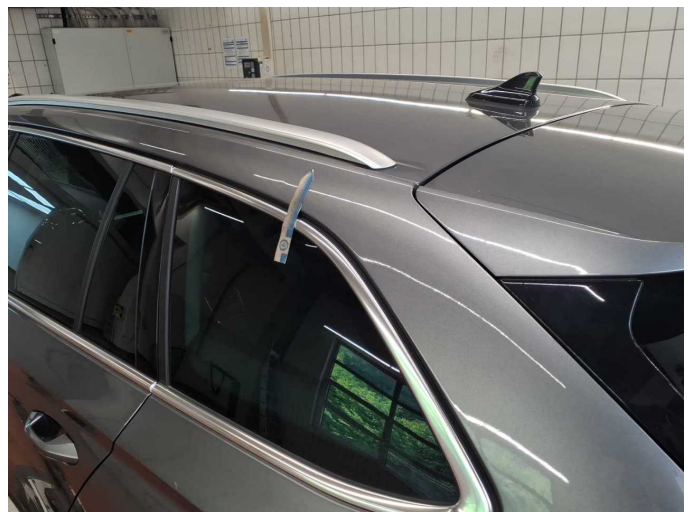
| No. | Component group | Description |
|---|---|---|
| 1 | Roof | Roof rail - left side - dent(s) - Smooth repair work |

Damage 1: Roof: Roof rail - left side - dent(s) - Smooth repair work

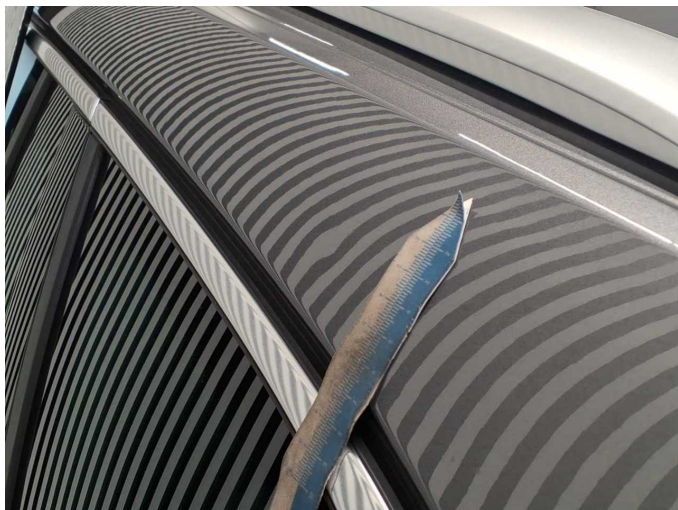
**Damage 1:** Roof: Roof rail - left side - dent(s) - Smooth repair work

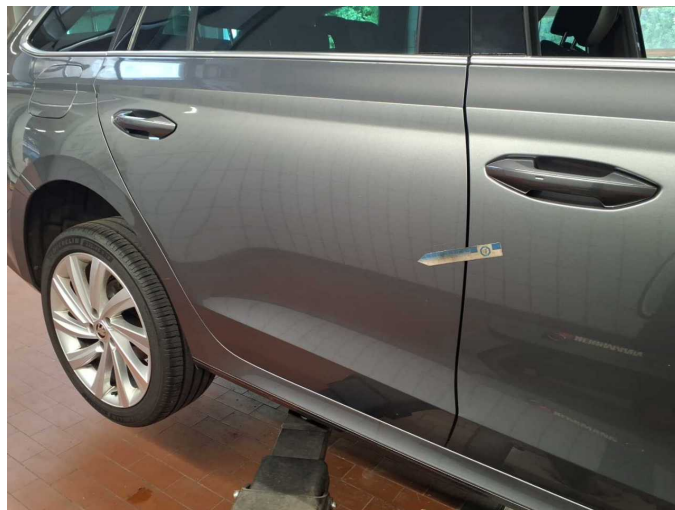
| No. | Component group | Description |
|---|---|---|
| 2 | Door - rear right side | Door - Scratch(es) - Smart repair |

**Damage 2:** Door - rear right side: Door - Scratch(es) - Smart repair

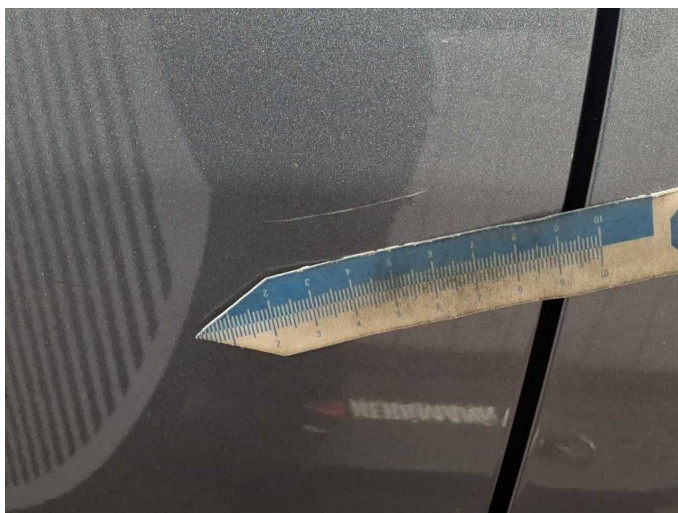
**Damage 2:** Door - rear right side: Door - Scratch(es) - Smart repair

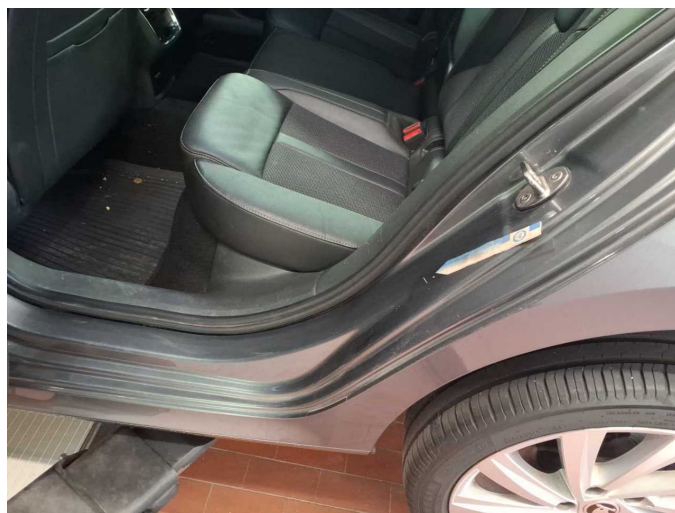
| No. | Component group | Description |
|---|---|---|
| 3 | Side panel - rear left side | Sill - Scratch(es) - Smart repair |

**Damage 3:** Side panel - rear left side: Sill - Scratch(es) - Smart repair

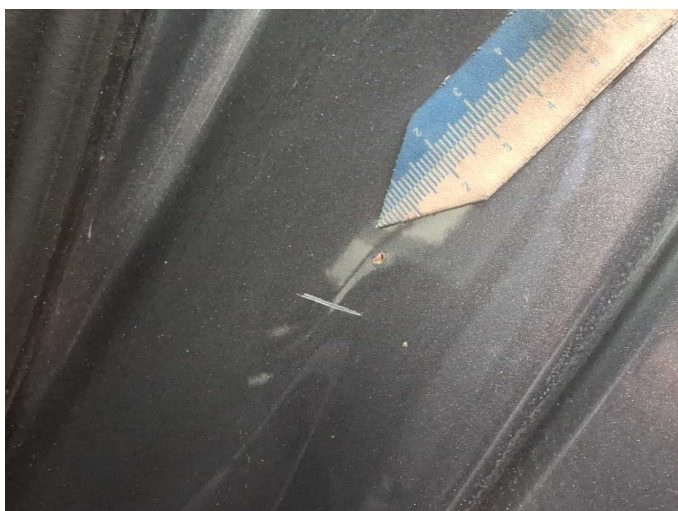
**Damage 3:** Side panel - rear left side: Sill - Scratch(es) - Smart repair

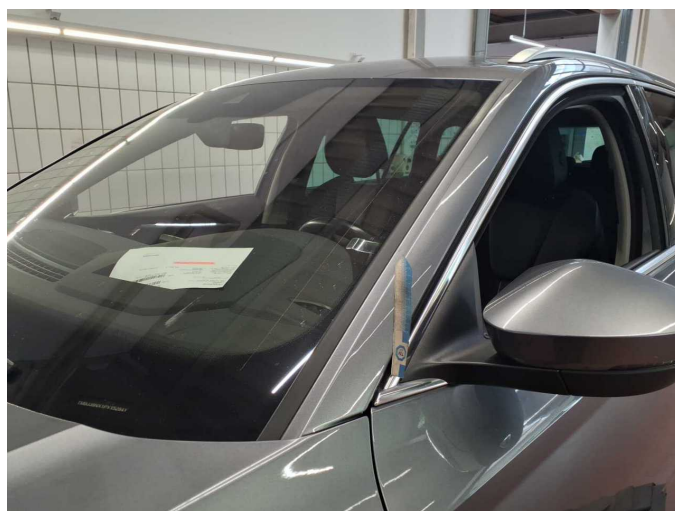
| No. | Component group | Description |
|---|---|---|
| 4 | Body | A-pillar - left side - Stone chips - Smart repair |

**Damage 4:** Body: A-pillar - left side - Stone chips - Smart repair

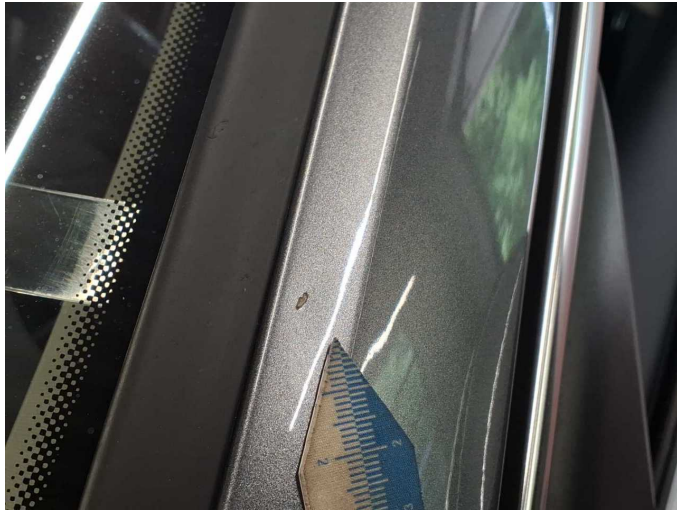
**Damage 4:** Body: A-pillar - left side - Stone chips - Smart repair

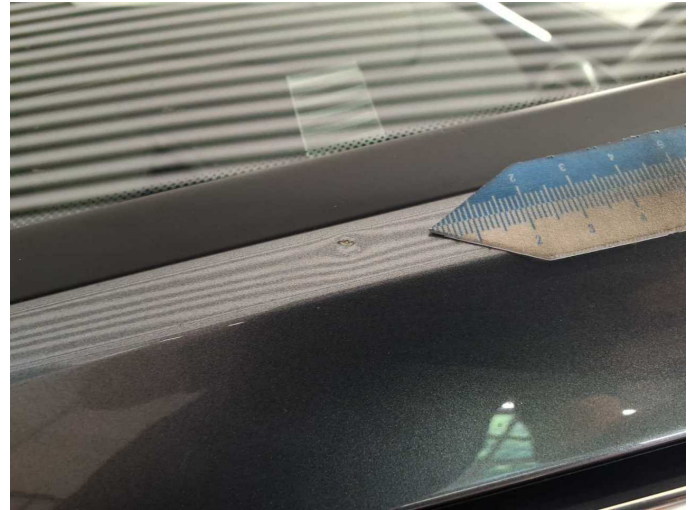
**Damage 4:** Body: A-pillar - left side - Stone chips - Smart repair

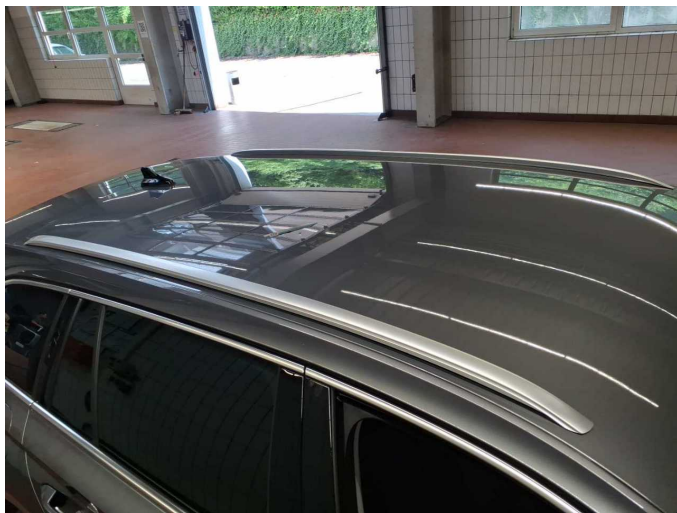
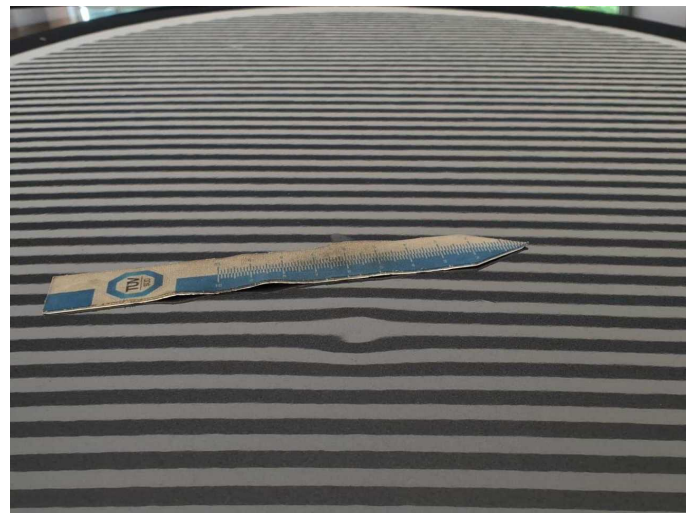
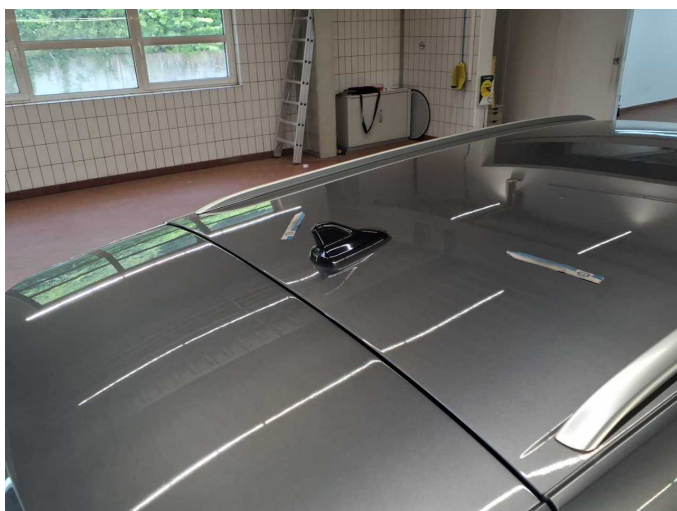
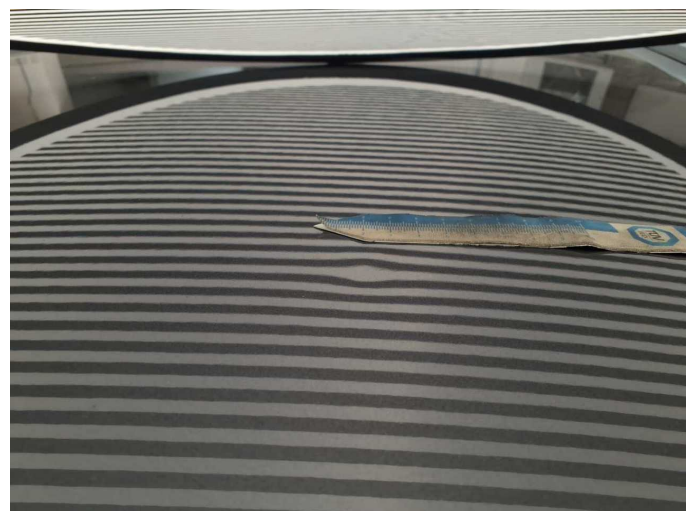
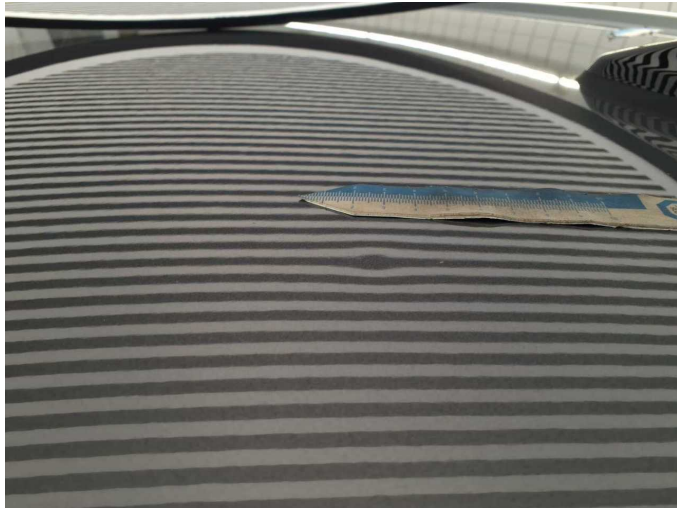
| No. | Component group | Description |
|---|---|---|
| 5 | Roof | Roof - dent(s) - Smooth repair work |

**Damage 5:** Roof: Roof - dent(s) - Smooth repair work

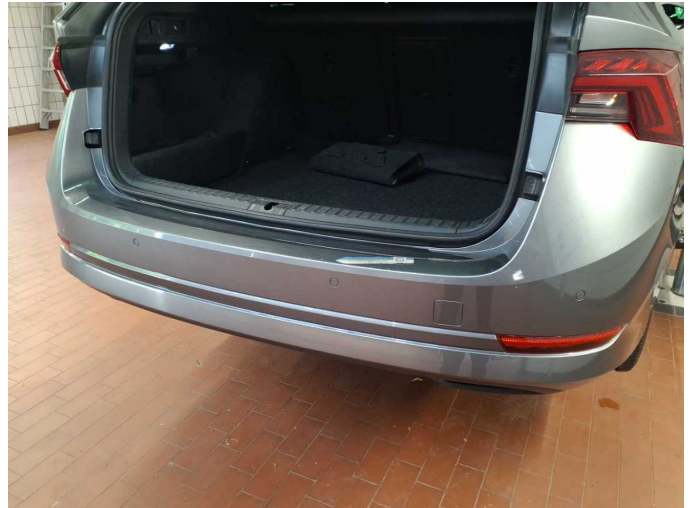
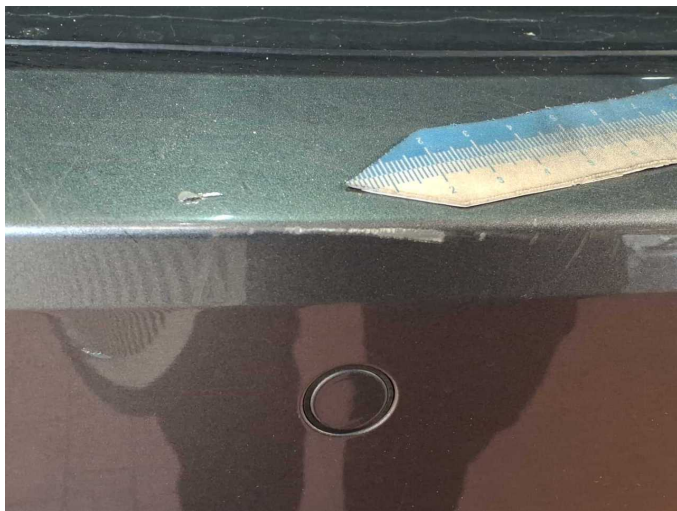
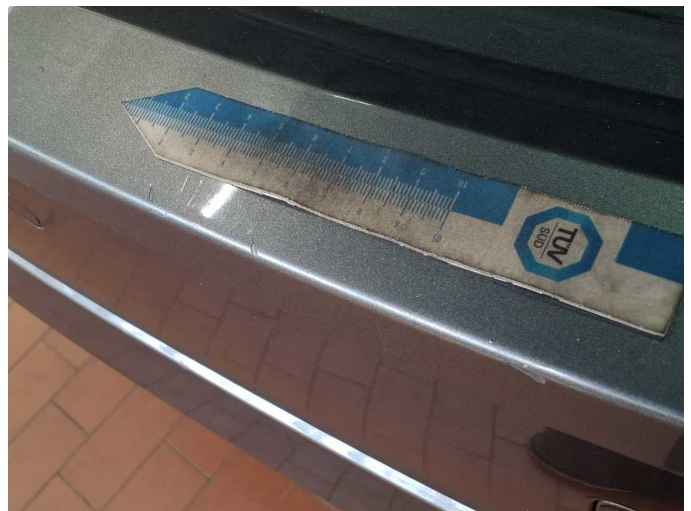
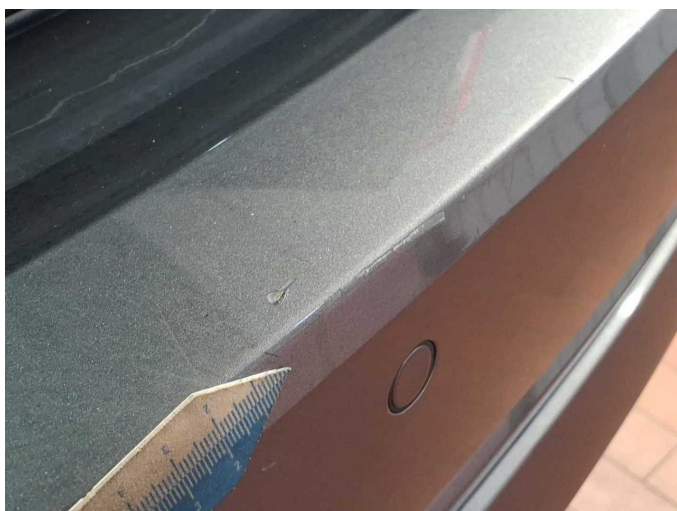
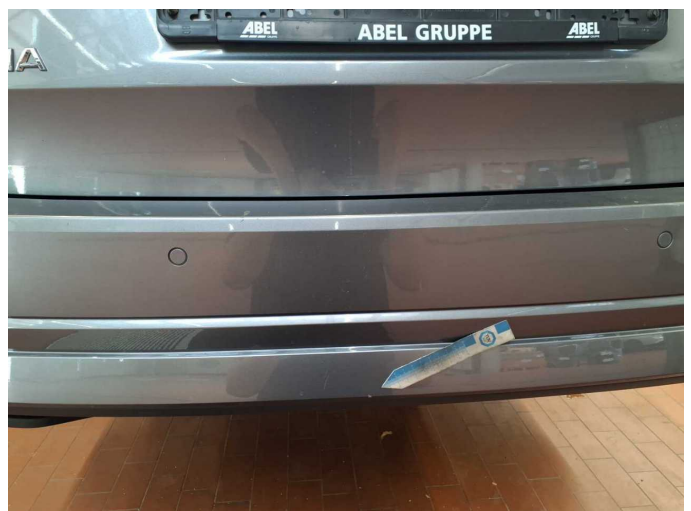
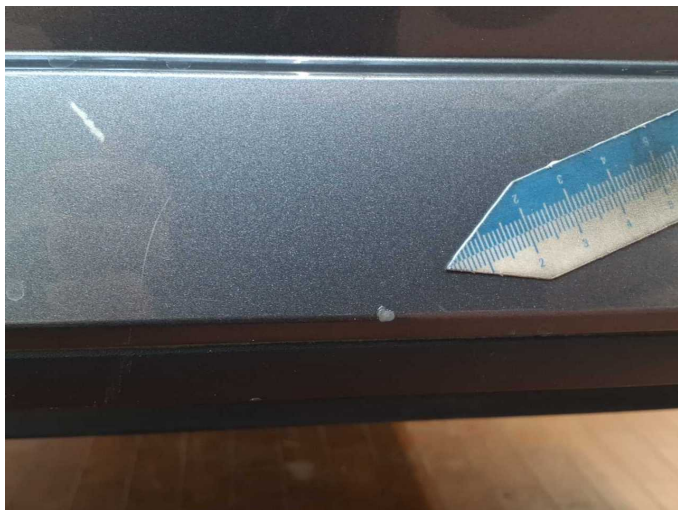
| No. | Component group | Description |
|---|---|---|
| 6 | Rear bumper | Rear bumper - Scratched - Paint |

**Damage 6:** Rear bumper: Rear bumper - Scratched - Paint

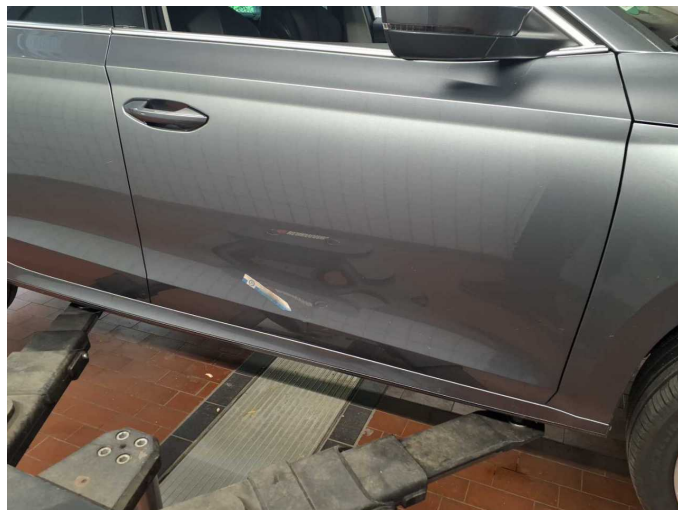
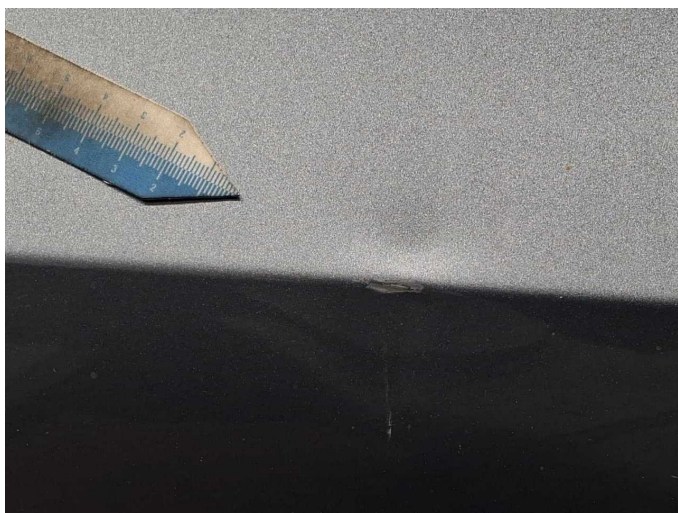
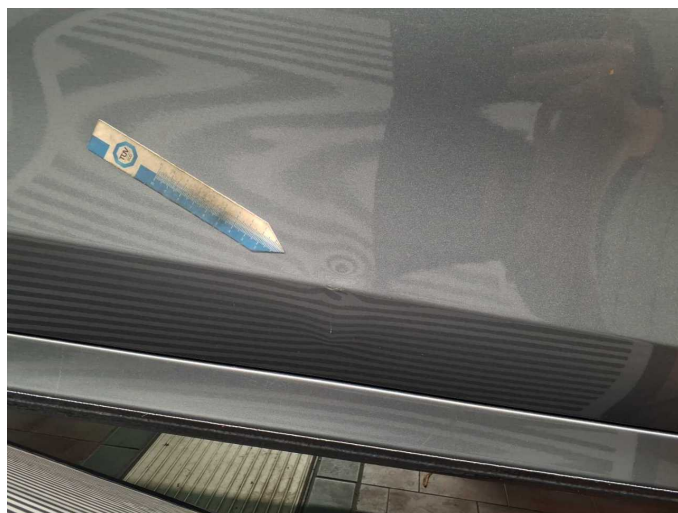
| No. | Component group | Description |
|---|---|---|
| 7 | Door - front right side | Door - Dent / paintcoat damage - Repair and paint |

**Damage 7:** Door - front right side: Door - Dent / paintcoat damage - Repair and paint
