Expertise

Protocol number: 46506214  
Order No. / Reference: 26664323  
Inspection date: 14 Jul 2026

Manufacturer: Opel

Model: Crossland 1.5 Diesel Ultimate

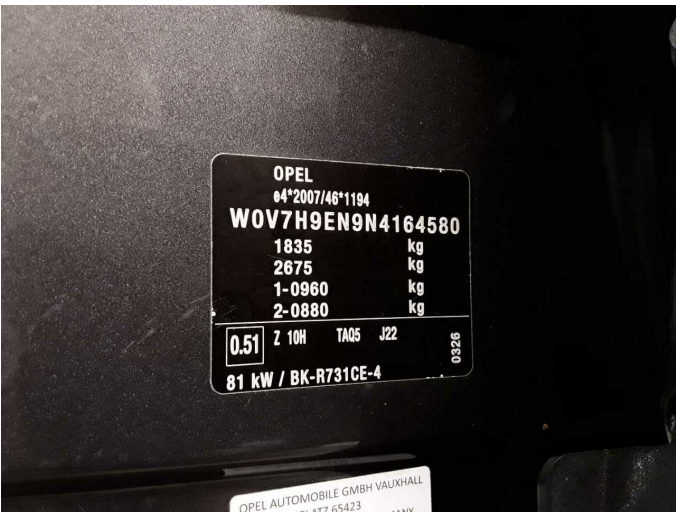
Figure 11: VIN

| VIN comparison | The vehicle identification number (VIN) was read from the vehicle and its conformity with the submitted documents was confirmed by the undersigned during the inspection. |

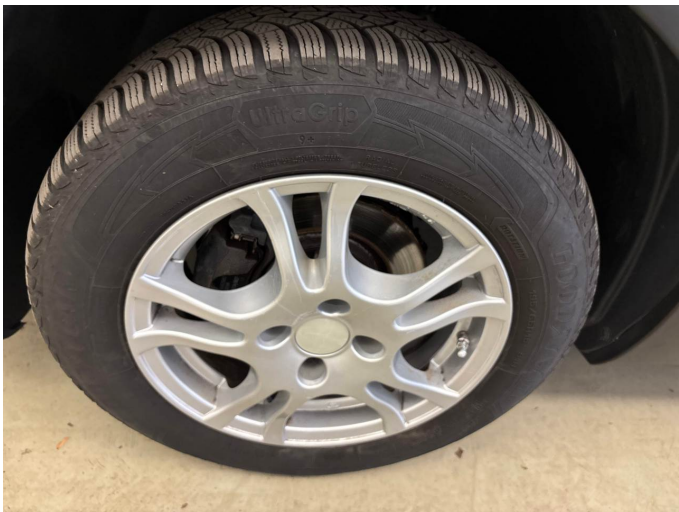
Figure 12: Mounted tyres

| # | Tyre size | Type of tyre | Manufacturer | Tread depth |
|---|---|---|---|---|
| 1) | 195/65 R15 91H | Winter tyres on Light alloy | Goodyear | 5mm / 5mm |
| 2) | 195/65 R15 91H | Winter tyres on Light alloy | Goodyear | 5mm / 5mm |

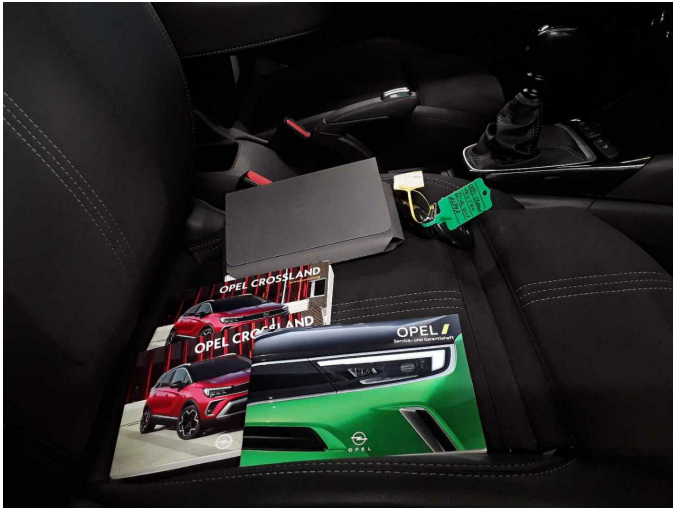
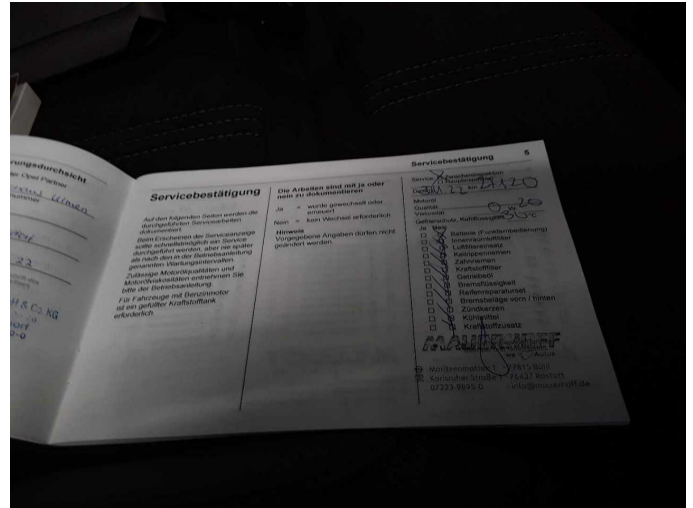
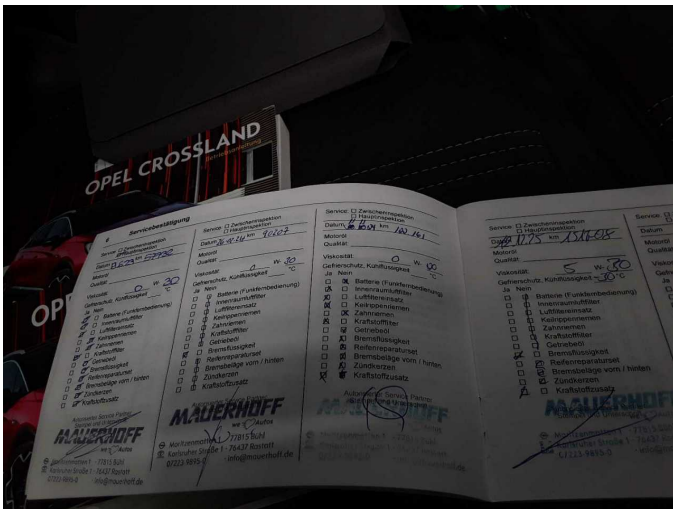
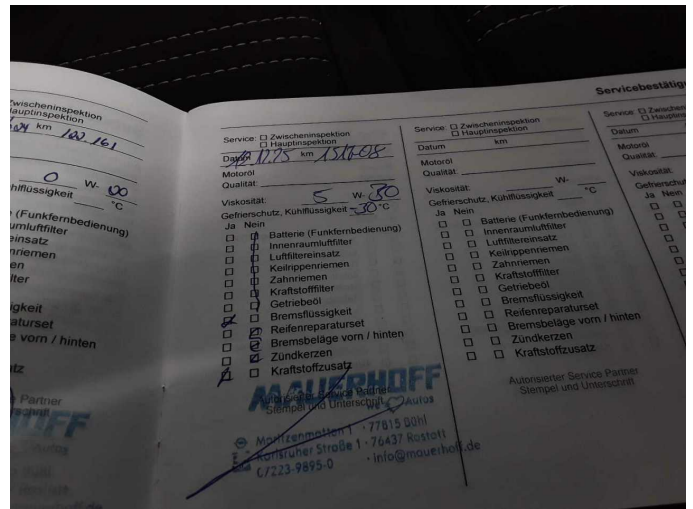
Figure 13: Documents

| Documents submitted | At the time of the inspection, the vehicle registration certificate Part 2 (title) was available, but the vehicle registration certificate Part 1 (document) was not. (Copy) |

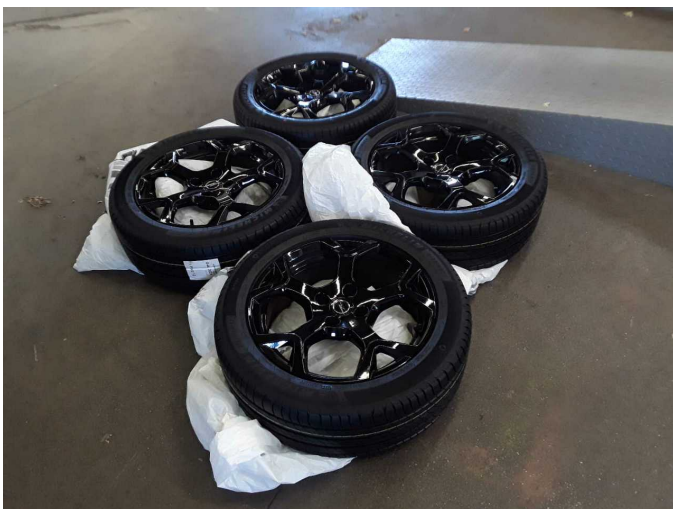
Figure 17: Additional tyres

| # | Tyre size | Type of tyre | Manufacturer | Tread depth |
|---|---|---|---|---|
| 1) | 215/50 R17 95W | Summer tyres on Light alloy | Michelin | 7mm / 7mm |
| 2) | 215/50 R17 95W | Summer tyres on Light alloy | Michelin | 7mm / 7mm |

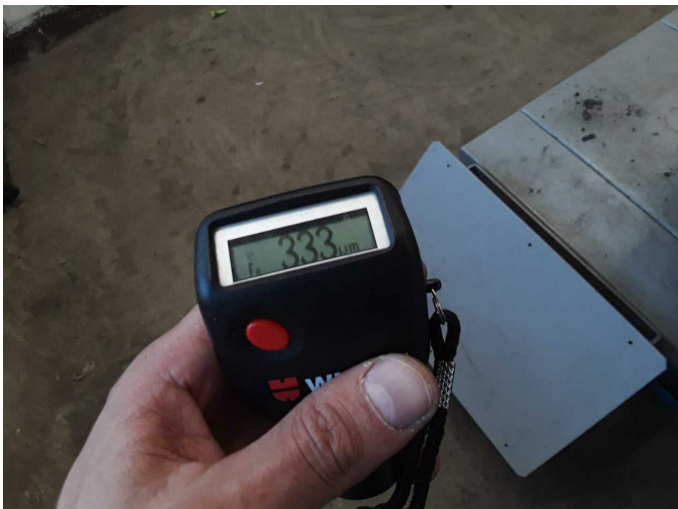
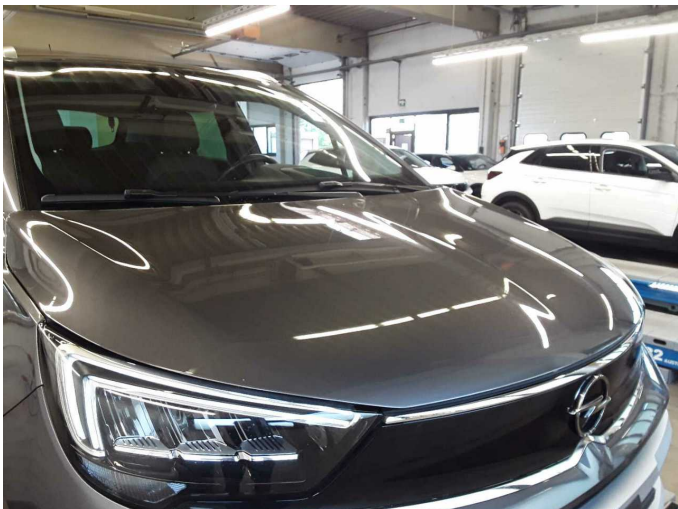
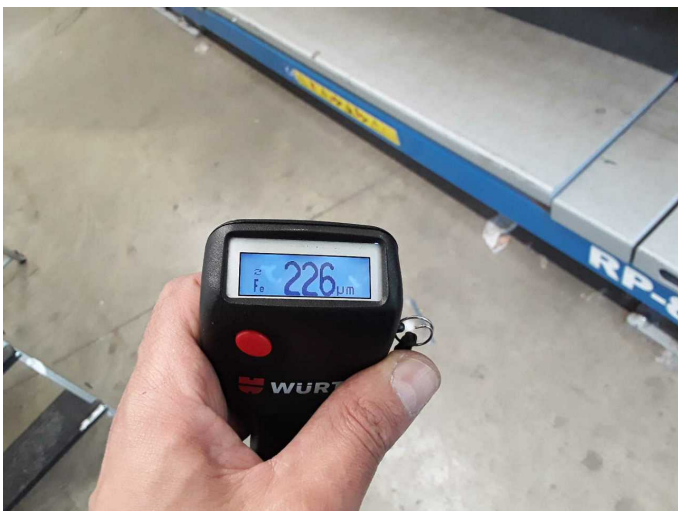
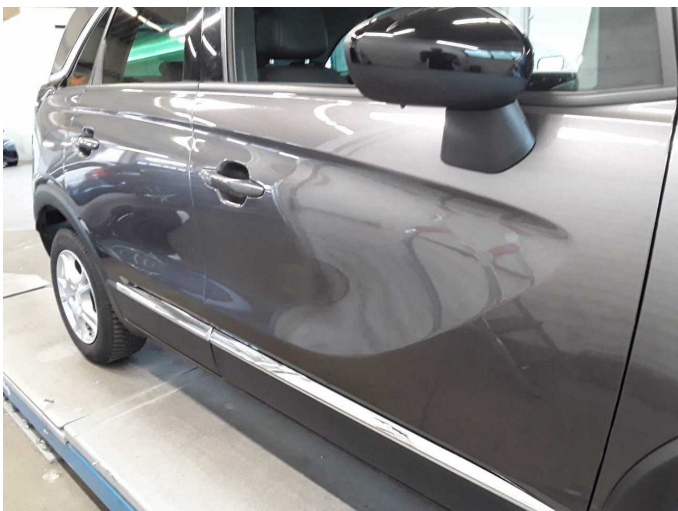
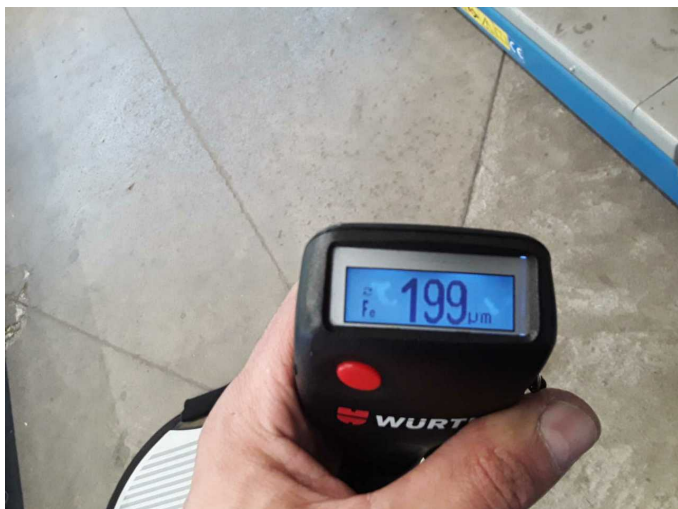
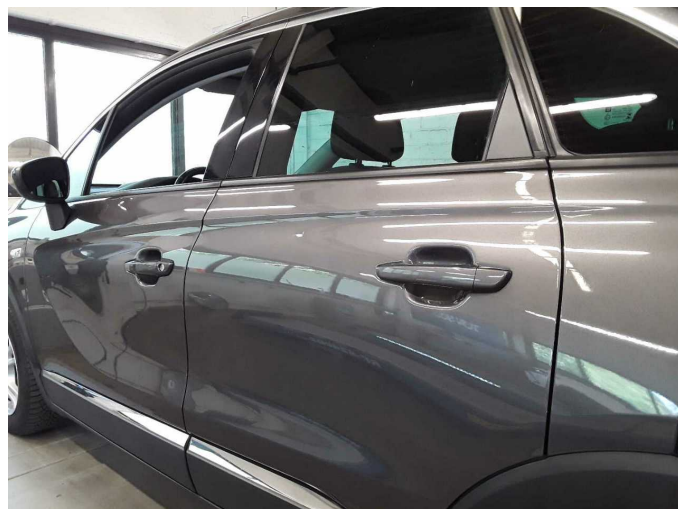
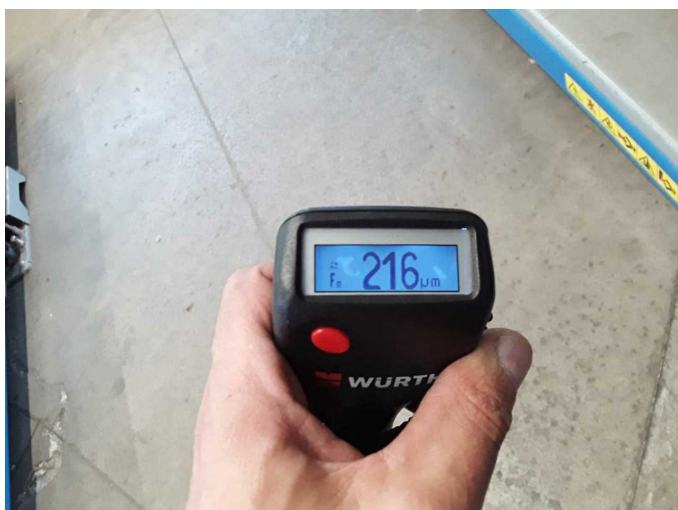
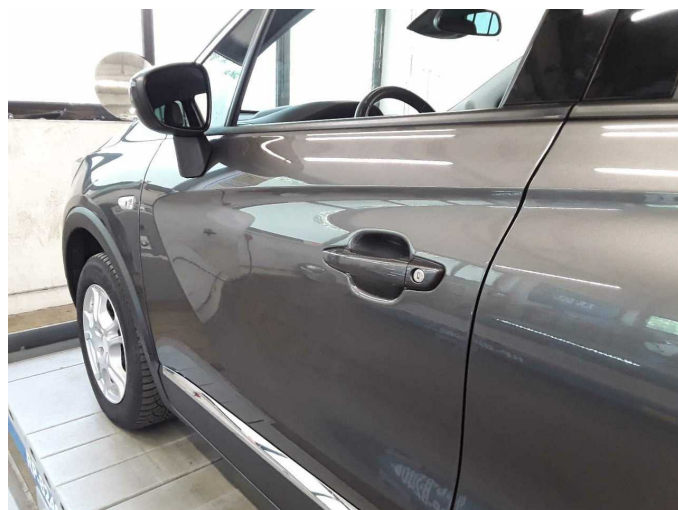
| 1 | Bonnet, Door - rear right side, Door - front left side, Door - front right side, Professionally carried out, Invoice of repair done | Non-existent |

| Bonnet | 333 µm | Door - rear right side | 199 µm |
| Door - front left side | 216 µm | Door - front right side | 226 µm |

Repainting 1: Bonnet, Door - rear right side, Door - front left side, Door - front right side
