Expertise

Protocol number: 46838494  
Order No. / Reference: 26675740  
Inspection date: 31 Jul 2026

| Manufacturer: Ford | Model: Mondeo Turnier 2.0 EcoBlue Aut. Titanium |

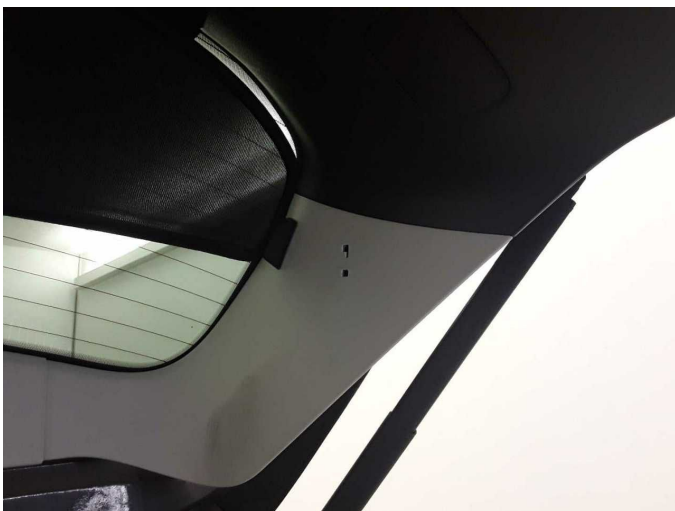
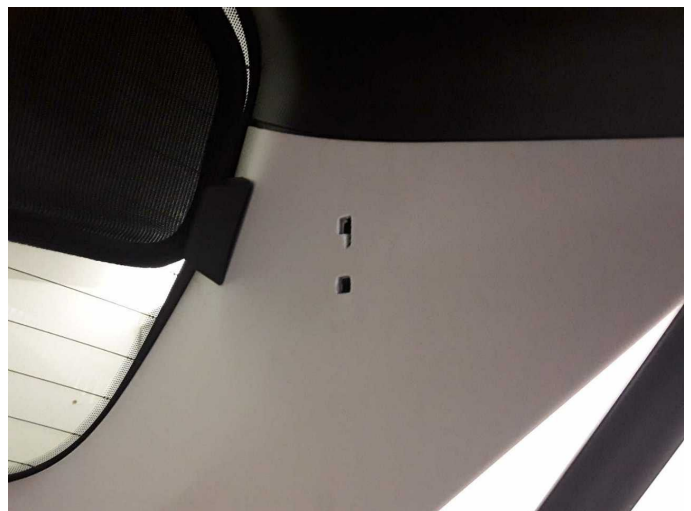
| No. | Component group | Description |
|---|---|---|
| 2 | Boot lid / rear door | Trim - standard - lower (Halterung fehlt) - Missing - Replace |

**Damage 2:** Boot lid / rear door: Trim - standard - lower (Halterung fehlt) - Missing - Replace

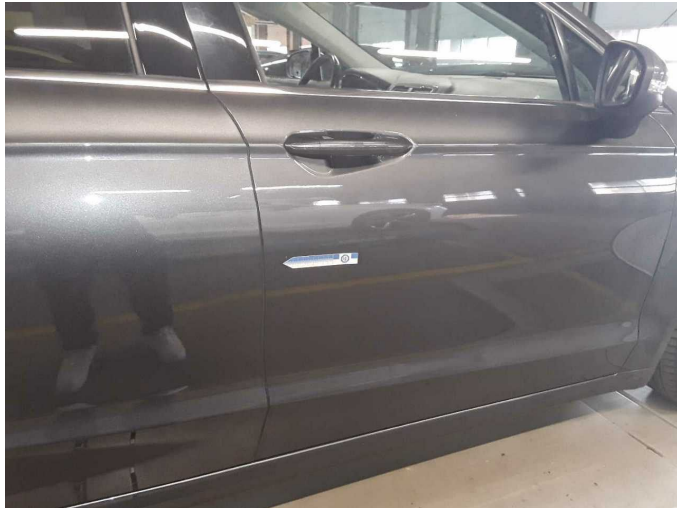
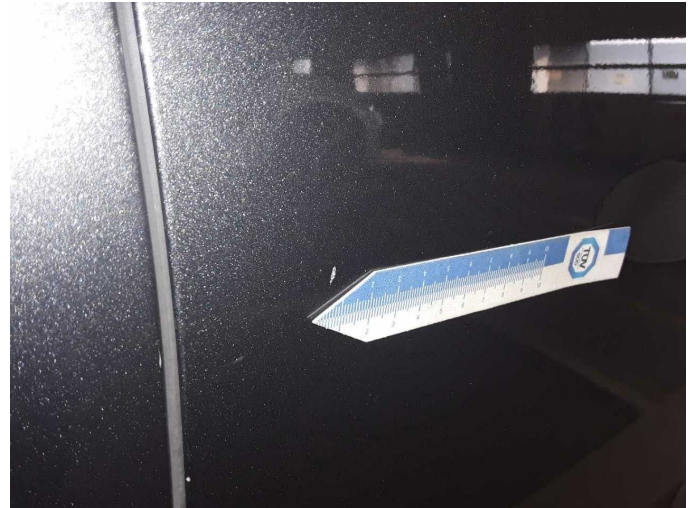
| No. | Component group | Description |
|---|---|---|
| 3 | Door - front right side | Door (unterhalb) - Scratch(es) - Smart repair |

**Damage 3:** Door - front right side: Door (unterhalb) - Scratch(es) - Smart repair

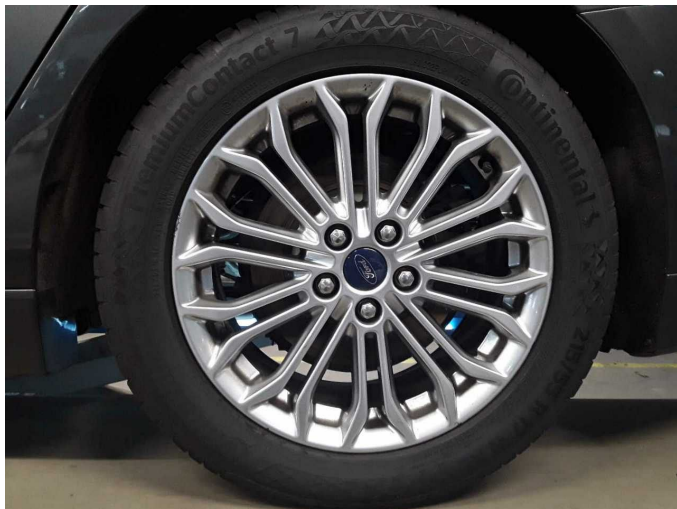
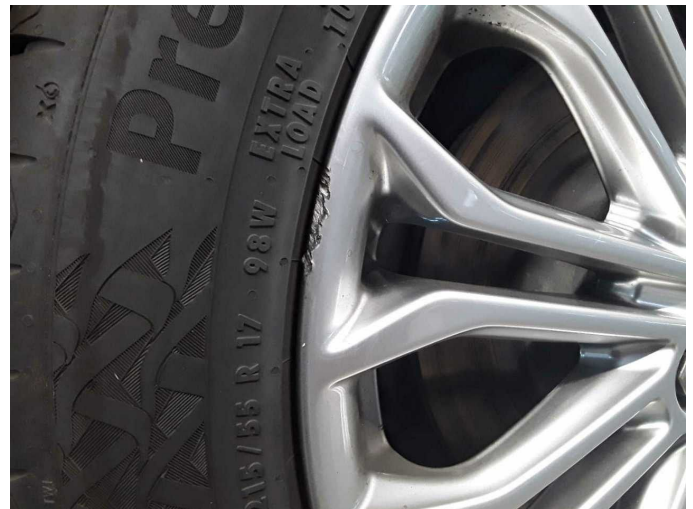
| No. | Component group | Description |
|---|---|---|
| 4 | Wheel / tyres | Alloy rim - rear left side (Materialabtrag) - Scratched - Loss in value |

**Damage 4:** Wheel / tyres: Alloy rim - rear left side (Materialabtrag) - Scratched - Loss in value

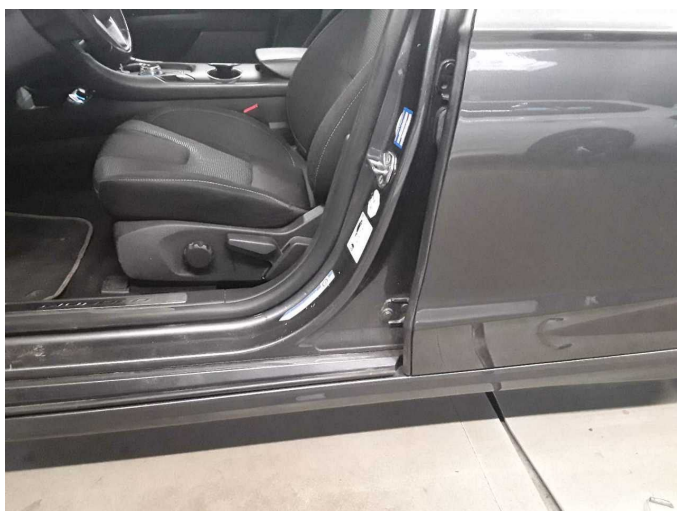
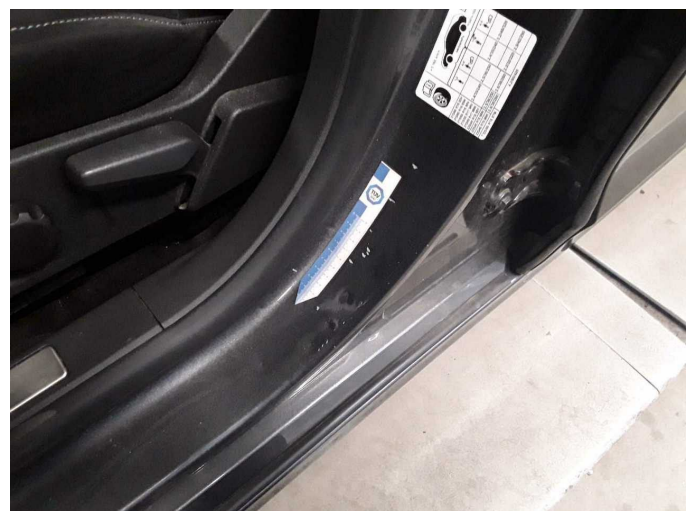
| No. | Component group | Description |
|---|---|---|
| 5 | Body | B-pillar - left side - Dent / paintcoat damage - Repair and paint |

**Damage 5:** Body: B-pillar - left side - Dent / paintcoat damage - Repair and paint

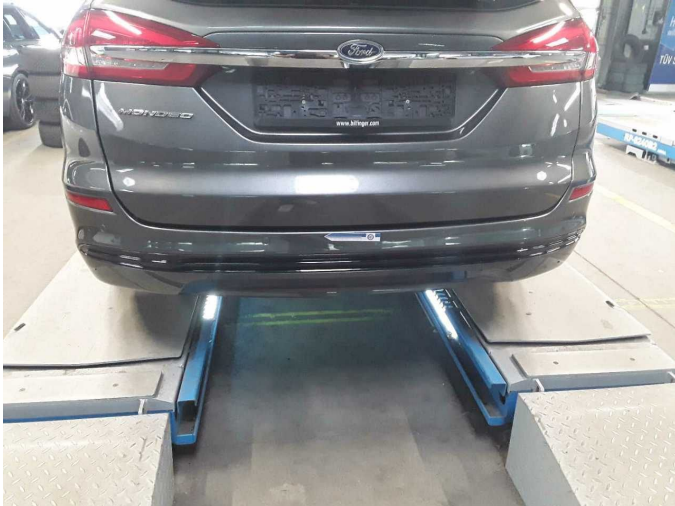
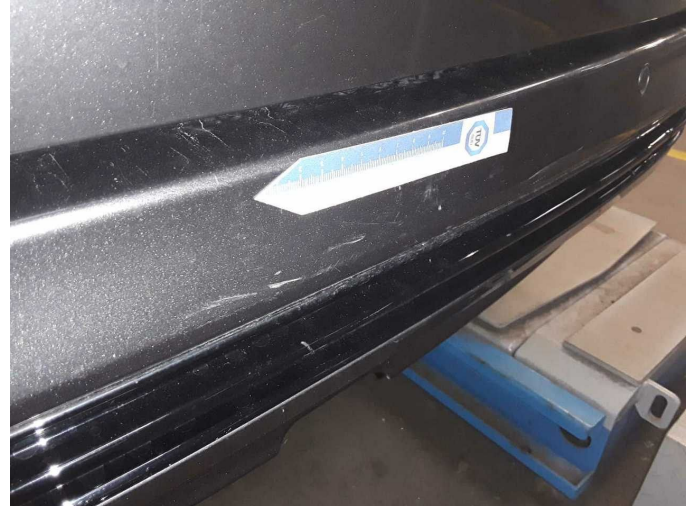
| No. | Component group | Description |
|---|---|---|
| 6 | Rear bumper | Rear bumper - Dent / paintcoat damage - Paint |

**Damage 6:** Rear bumper: Rear bumper - Dent / paintcoat damage - Paint

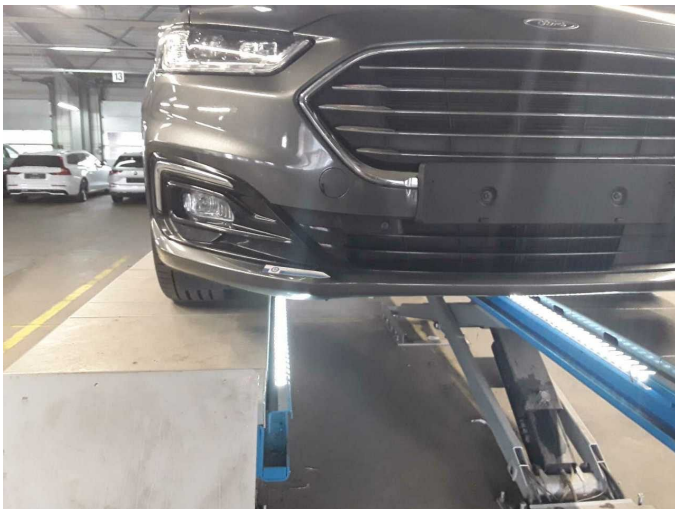
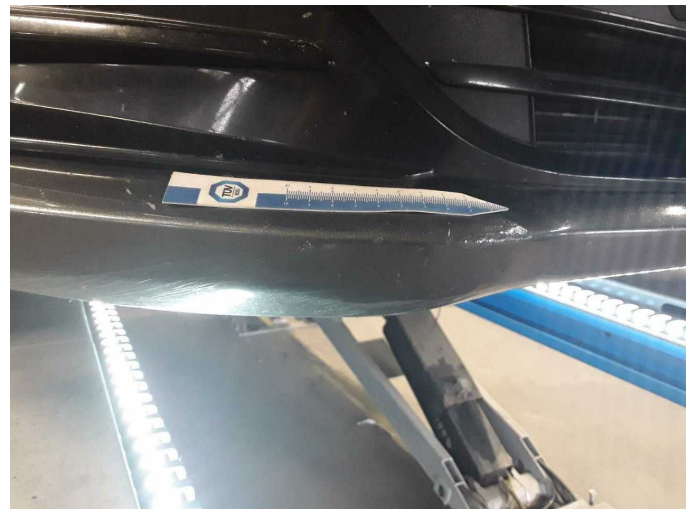
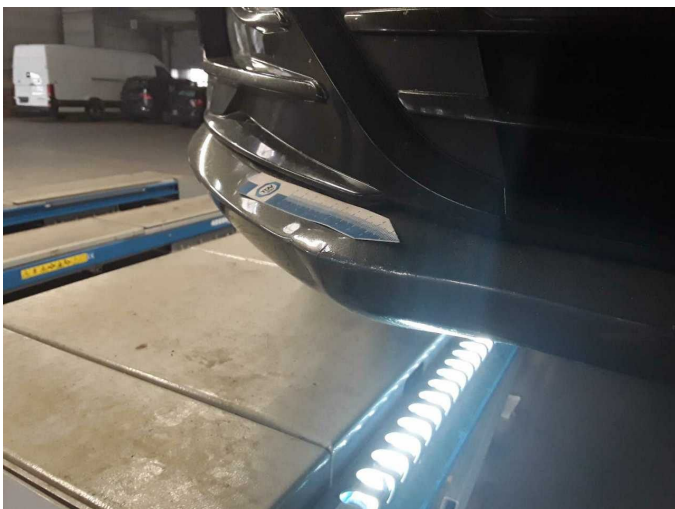
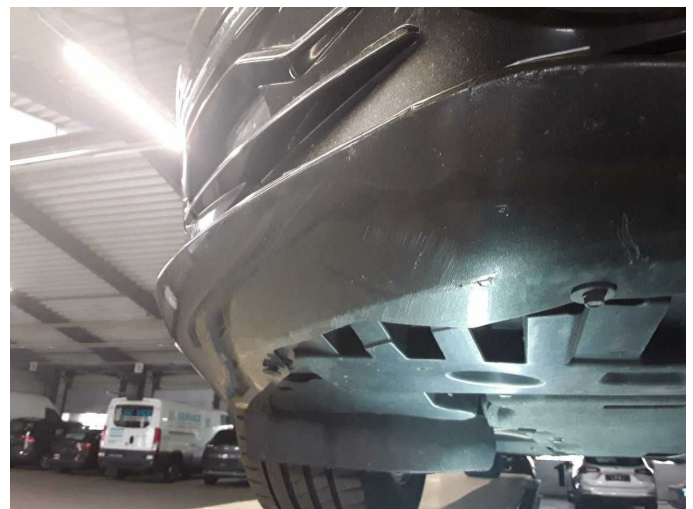
| No. | Component group | Description |
|---|---|---|
| 7 | Front bumper | Front bumper - Deformed - Repair and paint |

**Damage 7:** Front bumper: Front bumper - Deformed - Repair and paint
