Expertise

Protocol number: 46182534
Order No. / Reference: 26430816
Inspection date: 26 Jun 2026

Model: Passat Variant 2.0 TDI SCR DSG Business

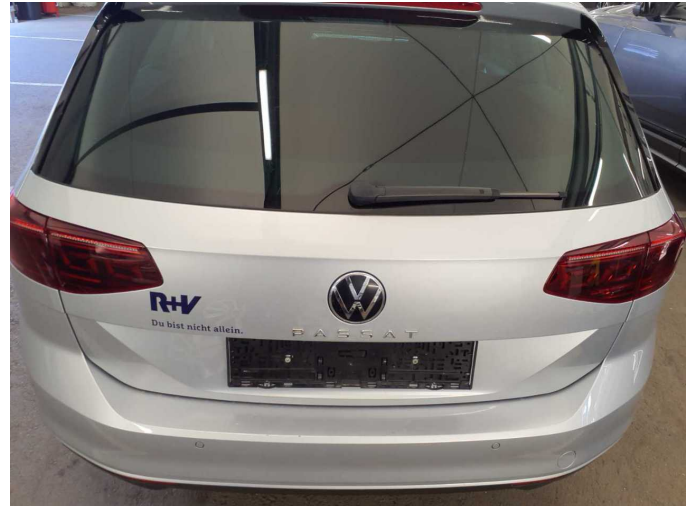
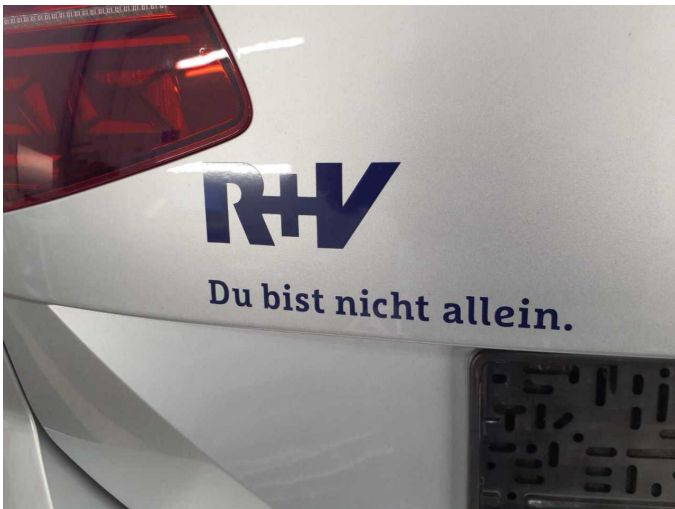
Damage 1: Boot lid / rear door: Boot lid - Glued / labelled - De-glue / neutralise

| No. | Component group | Description |
|---|---|--|
| 1 | Boot lid / rear door | Boot lid - Glued / labelled - De-glue / neutralise |

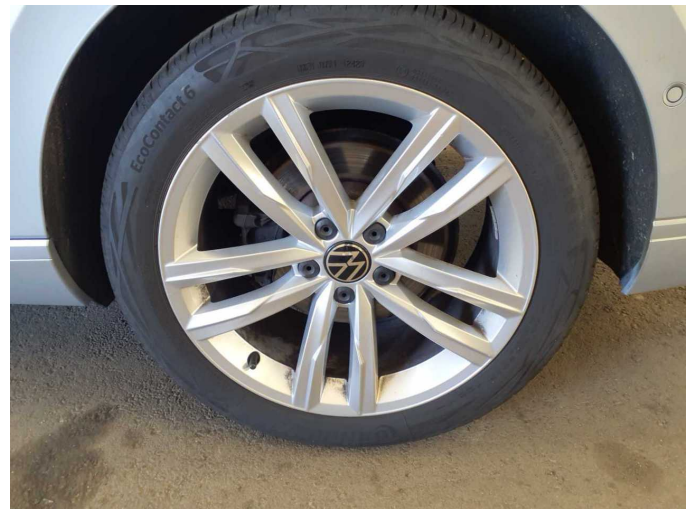
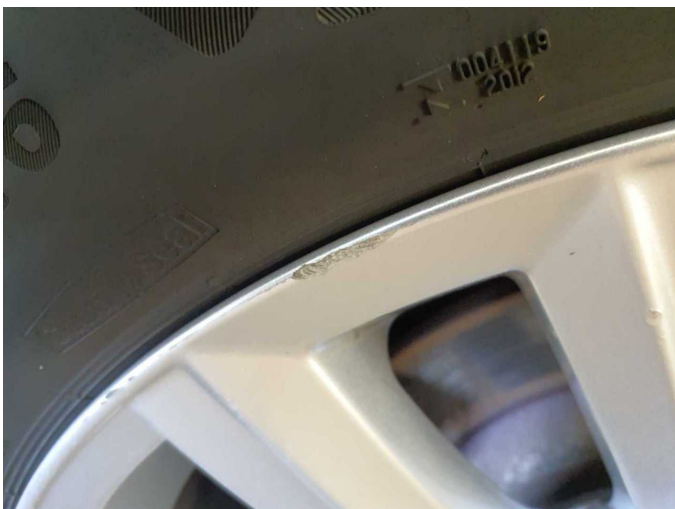
Damage 2: Wheel / tyres: Alloy rim - rear left side - Scratch(es) - Loss in value

| No. | Component group | Description |
|---|---|--|
| 2 | Wheel / tyres | Alloy rim - rear left side - Scratch(es) - Loss in value |

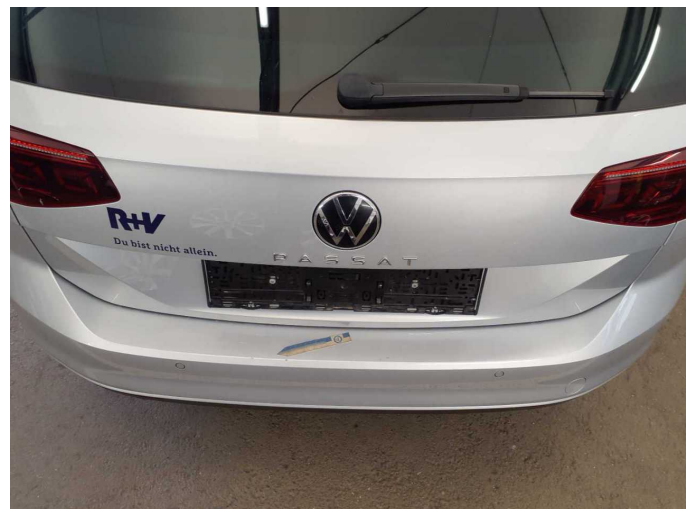
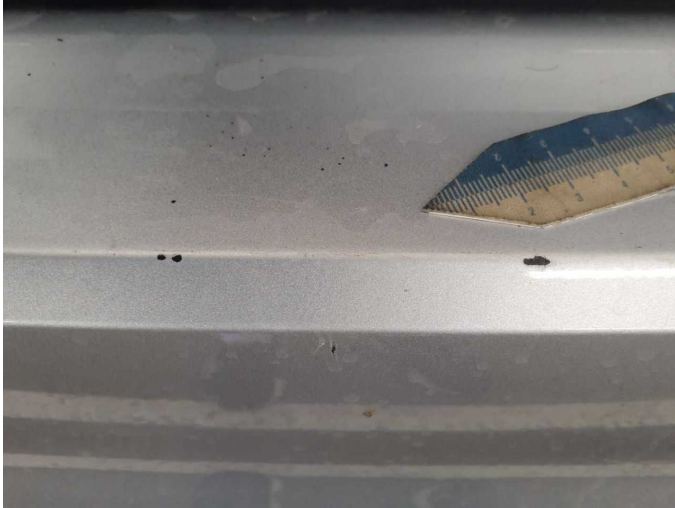
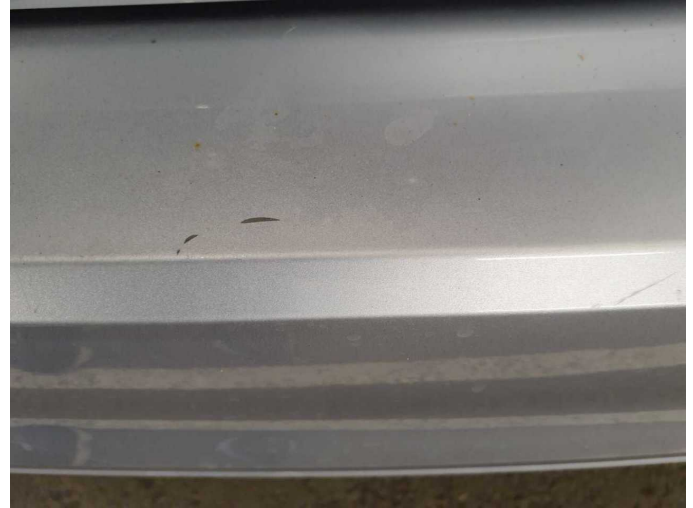
Damage 3: Rear bumper: Rear bumper - Scratch(es) - Smart repair

| No. | Component group | Description |
|---|---|--|
| 3 | Rear bumper | Rear bumper - Scratch(es) - Smart repair |

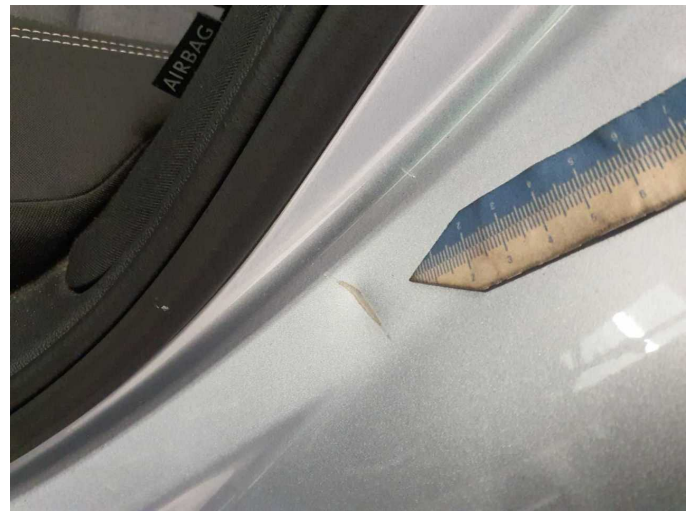
Damage 4: Side panel - rear left side: Sill - Dent / paintcoat damage - Repair and paint

| No. | Component group | Description |
|---|---|--|
| 4 | Side panel - rear left side | Sill - Dent / paintcoat damage - Repair and paint |

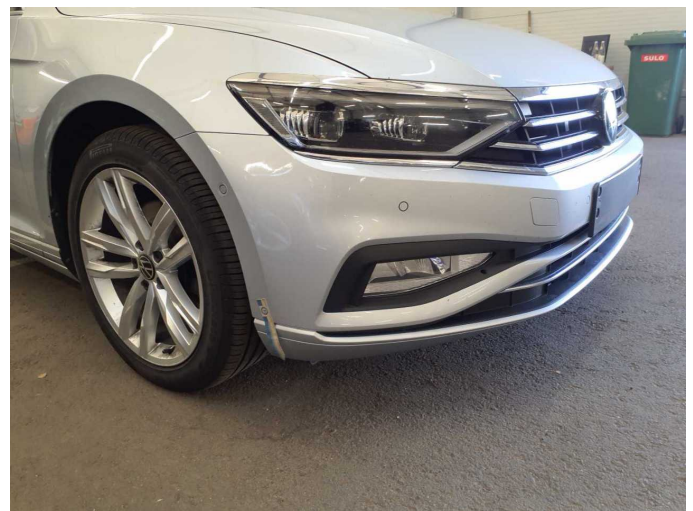
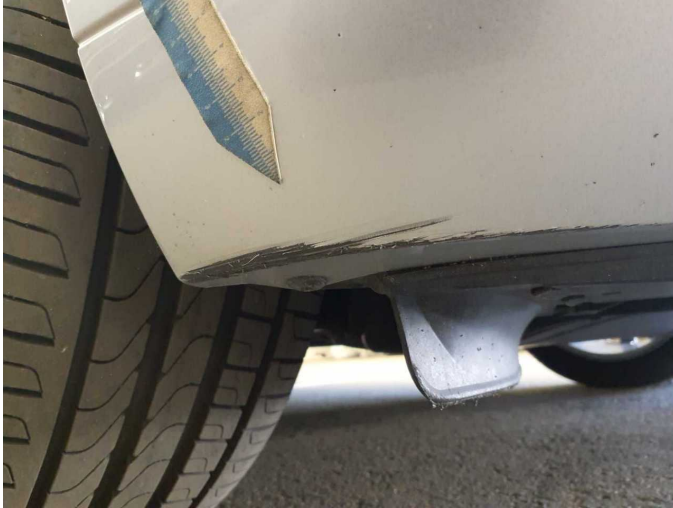
Damage 5: Front bumper: Front bumper - Scratch(es) - Paint

| No. | Component group | Description |
|---|---|--|
| 5 | Front bumper | Front bumper - Scratch(es) - Paint |

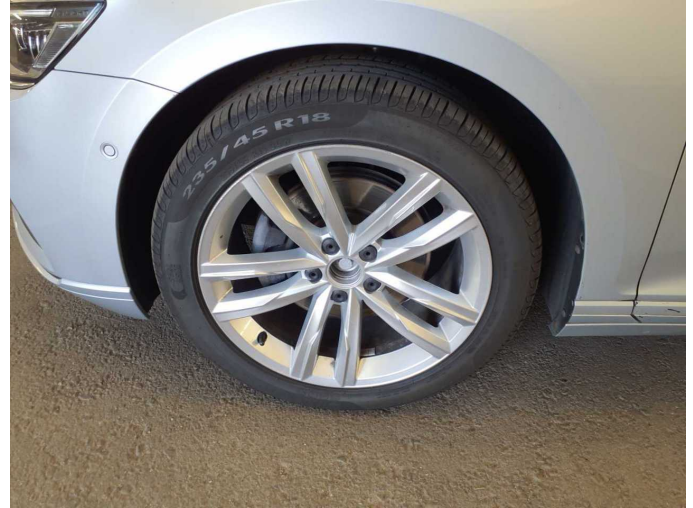
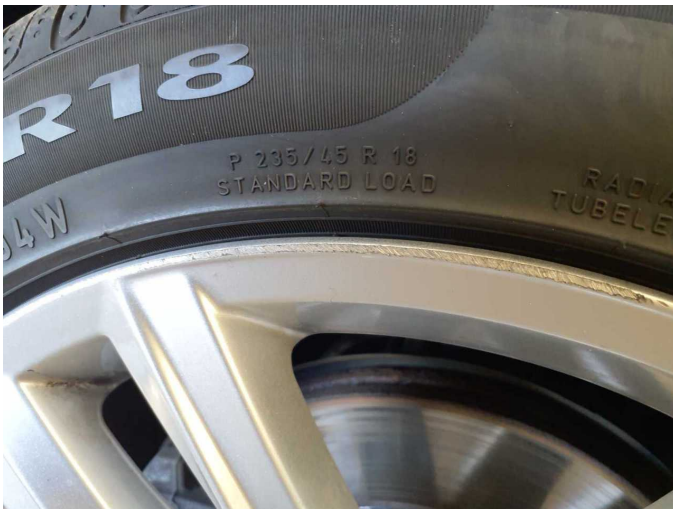
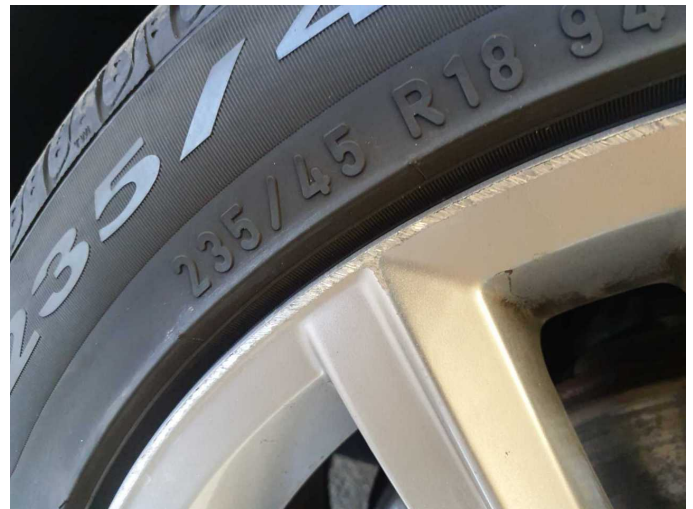
Damage 6: Wheel / tyres: Alloy rim - front left side (- Materialabtrag) - Scratched - Replace

| No. | Component group | Description |
|---|---|--|
| 6 | Wheel / tyres | Alloy rim - front left side (- Materialabtrag) - Scratched - Replace |

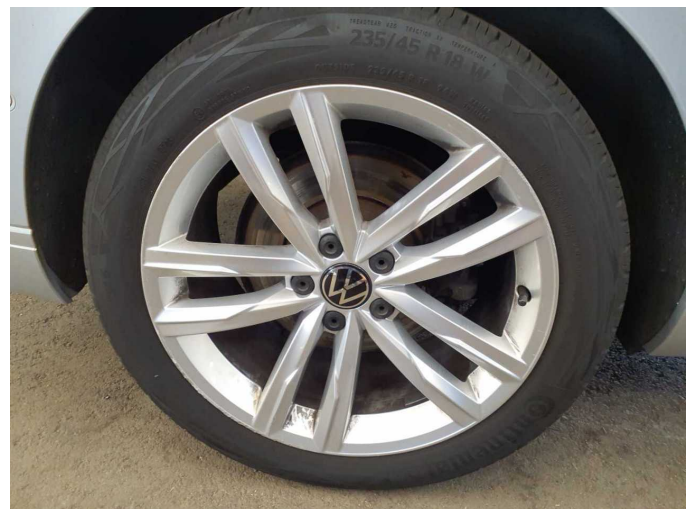
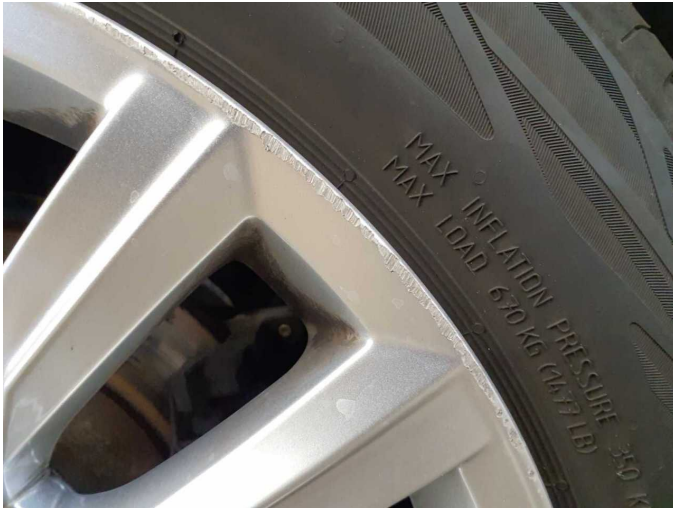
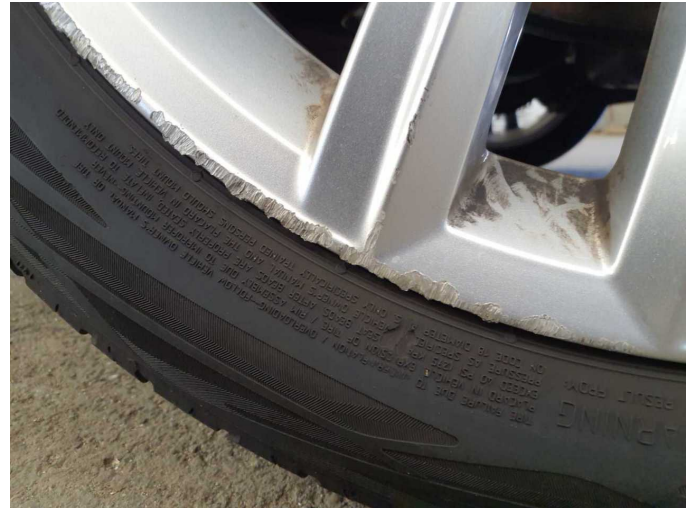
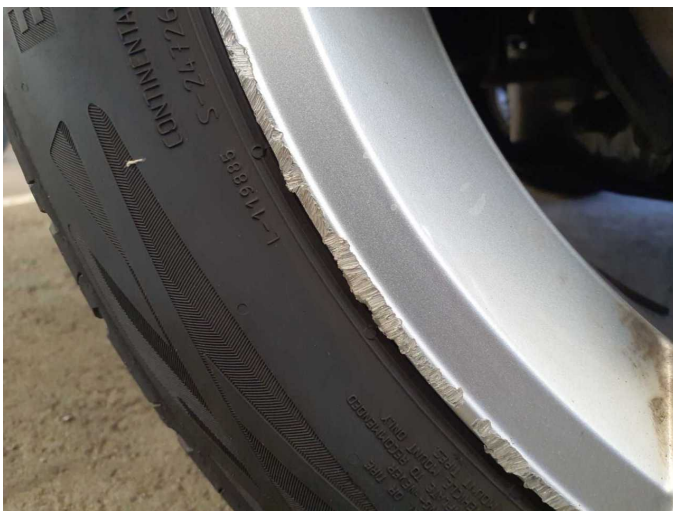
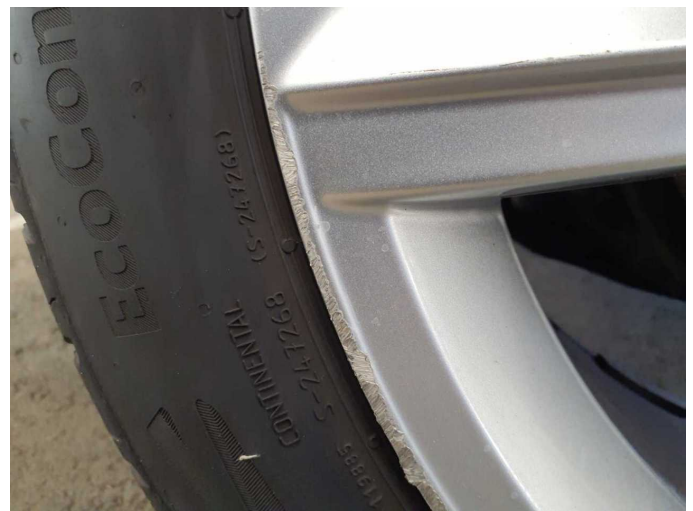
Damage 7: Wheel / tyres: Alloy rim - rear right side (- Materialabtrag) - Scratched - Replace

| No. | Component group | Description |
|---|---|--|
| 7 | Wheel / tyres | Alloy rim - rear right side (- Materialabtrag) - Scratched - Replace |

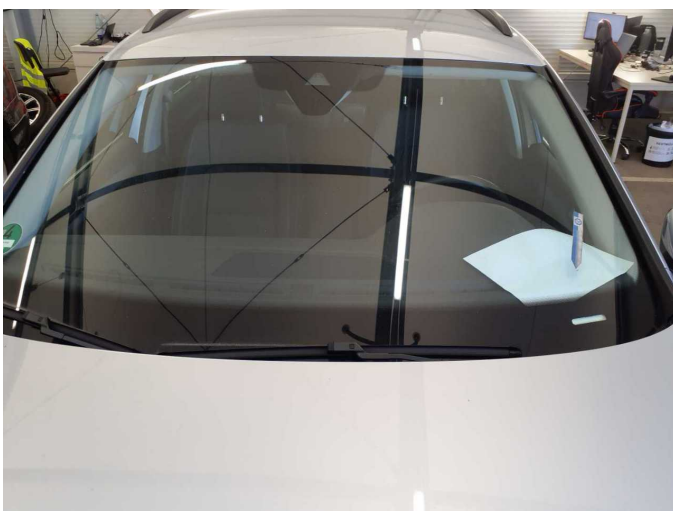
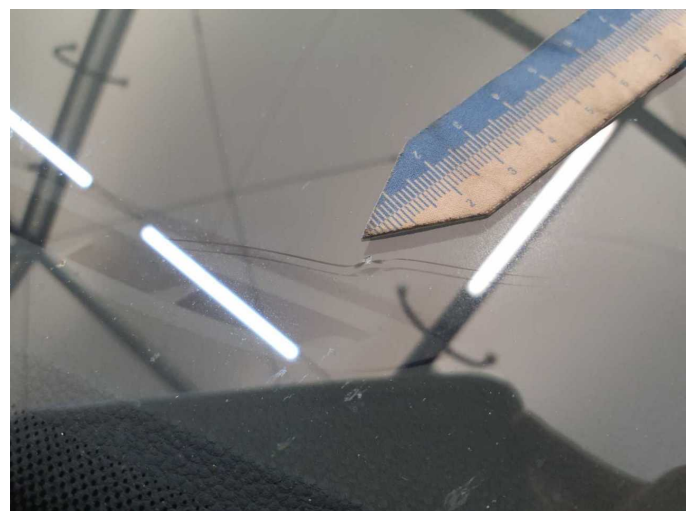
Damage 8: Vehicle glazing: Windscreen with lane departure assistant - Broken / torn - Replace

| No. | Component group | Description |
|---|---|--|
| 8 | Vehicle glazing | Windscreen with lane departure assistant - Broken / torn - Replace |
