Expertise

Protocol number: 46177634  
Order No. / Reference: 26550478  
Inspection date: 26 Jun 2026

Manufacturer: Audi

Model: A6 50 TFSI e quattro S tronic design

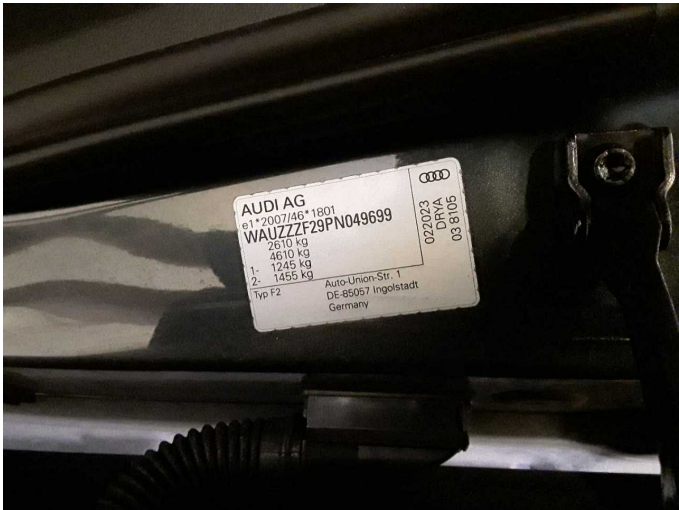
Figure 12: VIN

| VIN comparison | The vehicle identification number (VIN) was read from the vehicle and its conformity with the submitted documents was confirmed by the undersigned during the inspection. |

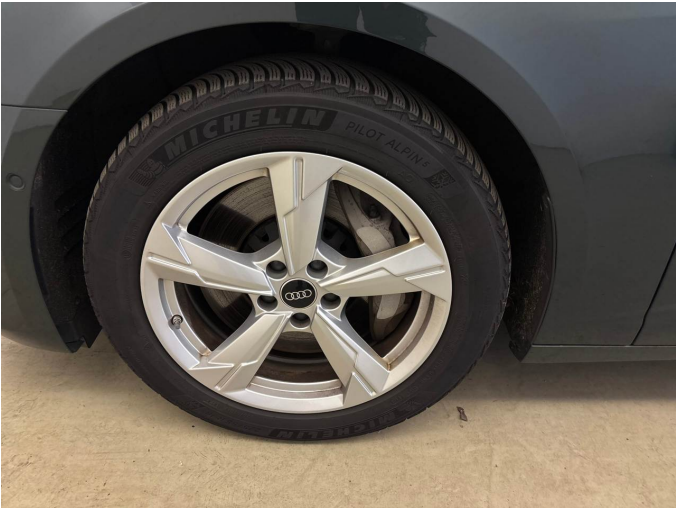
Figure 13: Mounted tyres

| # | Tyre size | Type of tyre | Manufacturer | Tread depth |
|---|---|---|---|---|
| 1) | 225/55 R18 102V | Winter tyres on Light alloy | Michelin | 5mm / 5mm |
| 2) | 225/55 R18 102V | Winter tyres on Light alloy | Michelin | 5mm / 5mm |

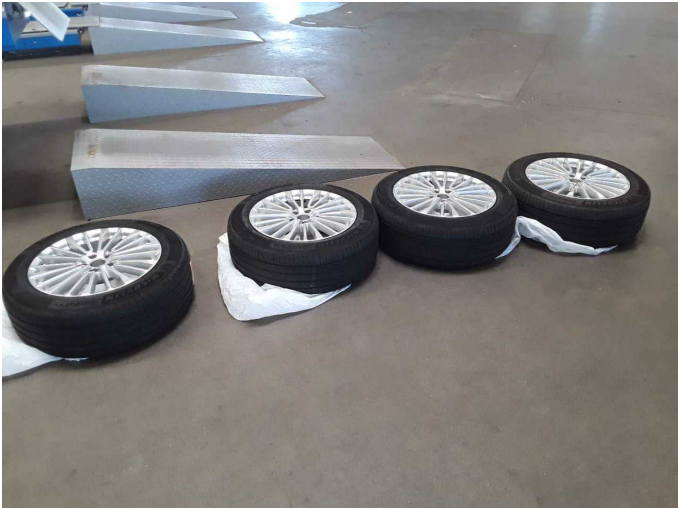
Figure 16: Additional tyres

| # | Tyre size | Type of tyre | Manufacturer | Tread depth |
|---|---|---|---|---|
| 1) | 225/55 R18 102Y | Summer tyres on Light alloy | Michelin | 4mm / 4mm |
| 2) | 225/55 R18 102Y | Summer tyres on Light alloy | Michelin | 3mm / 3mm |

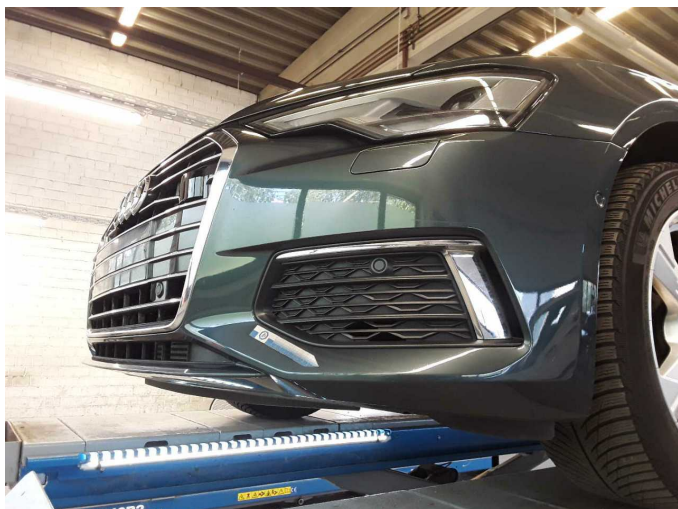
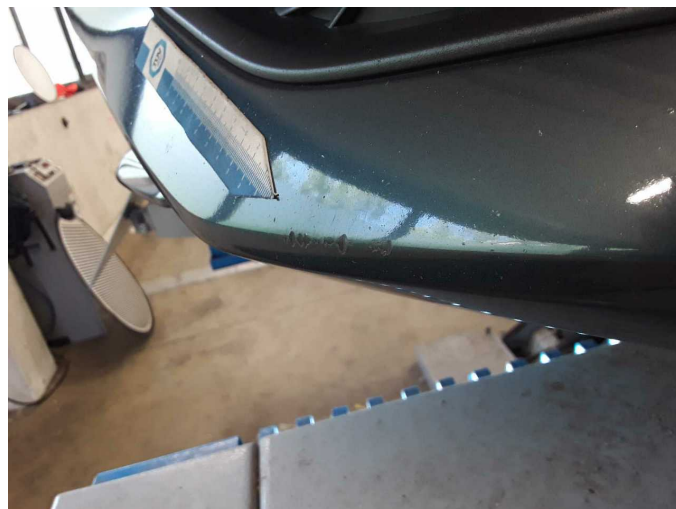
**Damage 1:** Front bumper: Front bumper - Scratched - Smart repair

| No. | Component group | Description |
|---|---|---|
| 1 | Front bumper | Front bumper - Scratched - Smart repair |

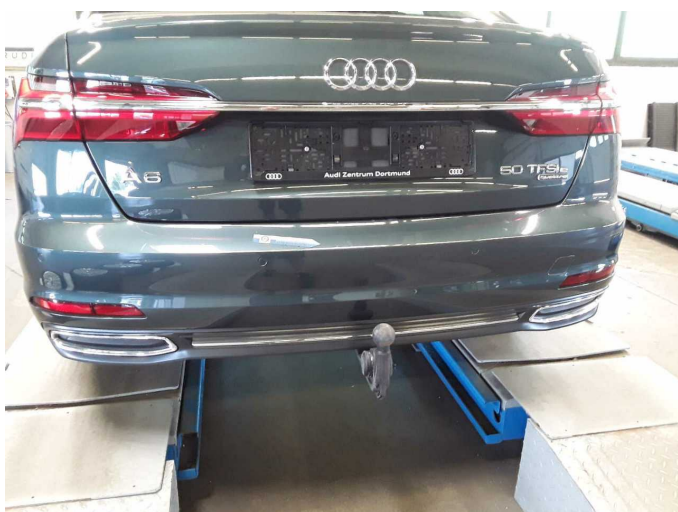
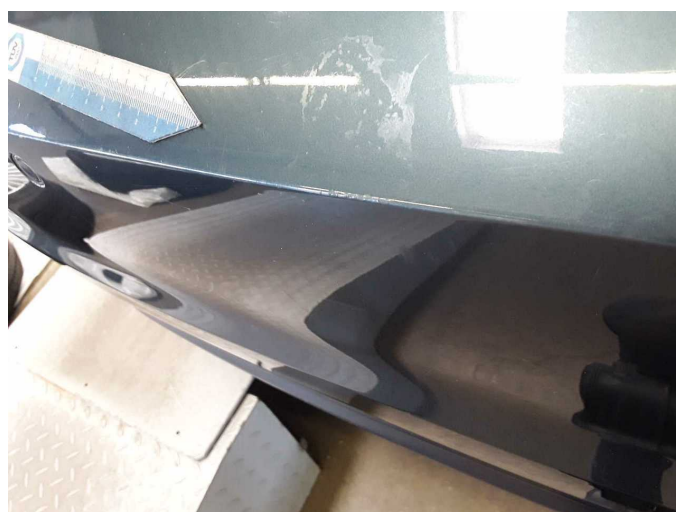
**Damage 2:** Rear bumper: Rear bumper - Scratch(es) - Smart repair

| No. | Component group | Description |
|---|---|---|
| 2 | Rear bumper | Rear bumper - Scratch(es) - Smart repair |

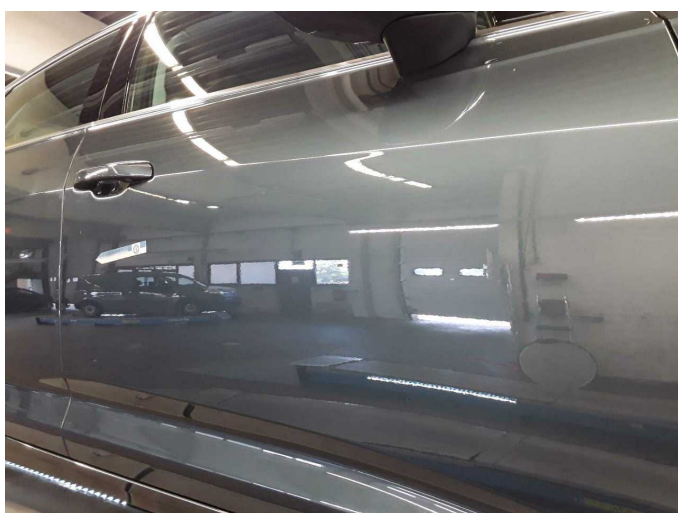
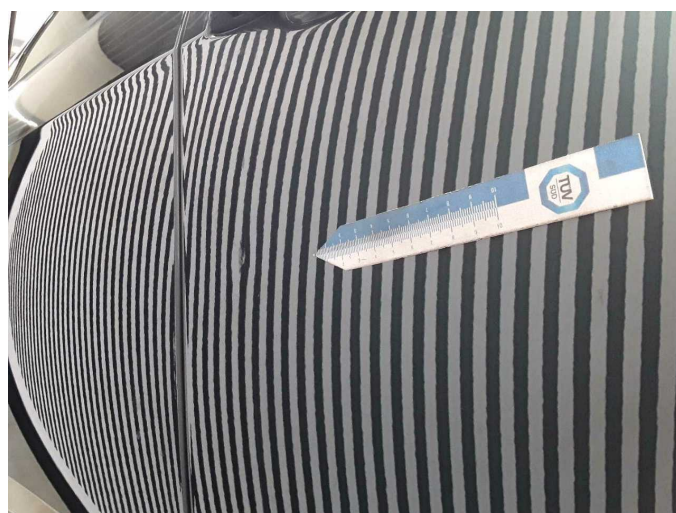
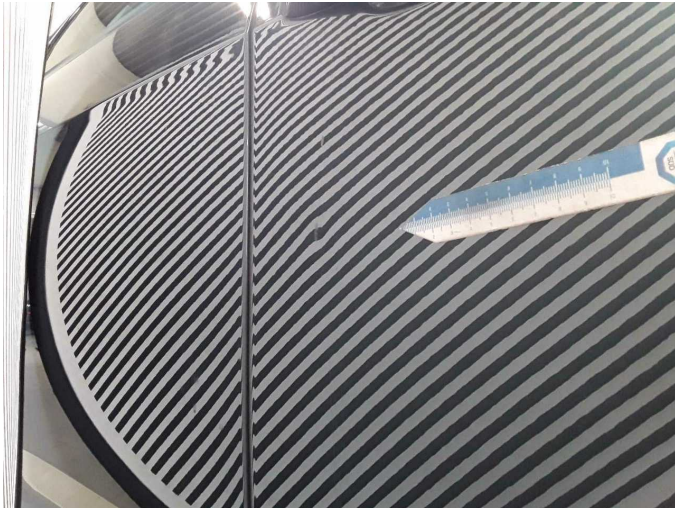
**Damage 3:** Door - front right side: Door - Deformed - Repair and paint

| No. | Component group | Description |
|---|---|---|
| 3 | Door - front right side | Door - Deformed - Repair and paint |

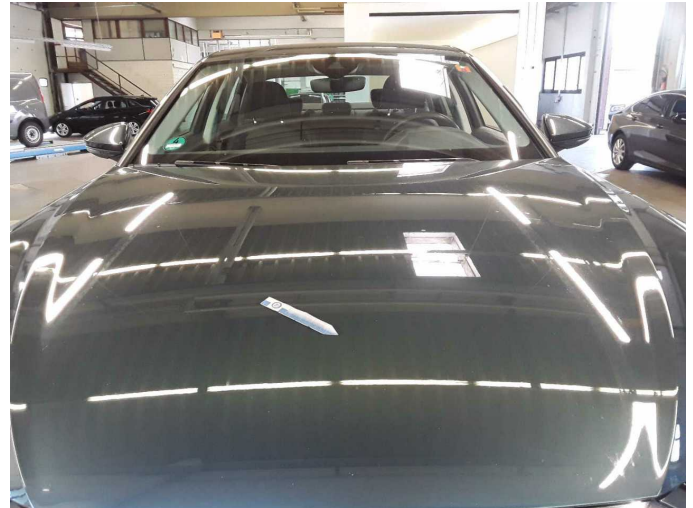
**Wear and tear 1:** Bonnet: Bonnet - Stone chips - No deduction

| No. | Component group | Description |
|---|---|---|
| 1 | Bonnet | Bonnet - Stone chips - No deduction |

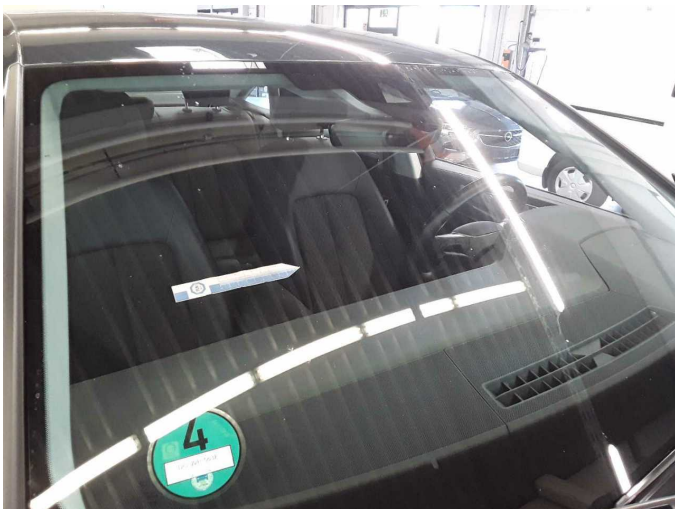
**Wear and tear 2:** Vehicle glazing: Windscreen - Stone chips - No deduction

| No. | Component group | Description |
|---|---|---|
| 2 | Vehicle glazing | Windscreen - Stone chips - No deduction |
