Expertise

Protocol number: 46416654  
Order No. / Reference: 26580568  
Inspection date: 9 Jul 2026

Manufacturer: Mercedes-Benz  
VIN: W1N4N1CBXPJ483712

Model: GLA 200 d 8G-DCT Progressive

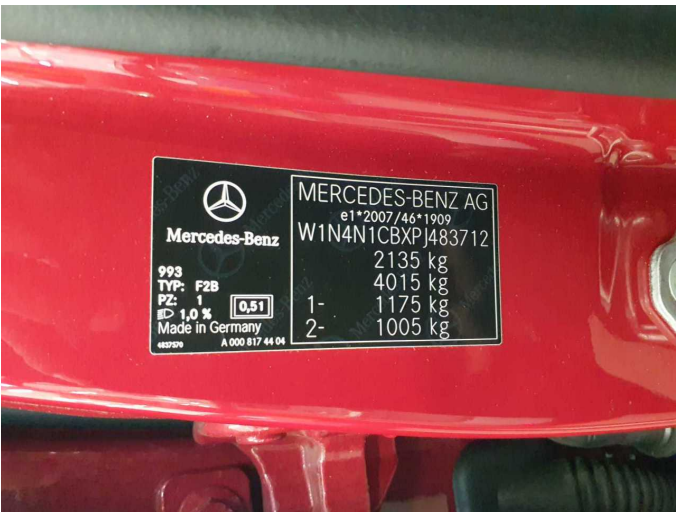
| VIN comparison | The vehicle identification number (VIN) was read from the vehicle and its conformity with the submitted documents was confirmed by the undersigned during the inspection. |

Figure 11: VIN

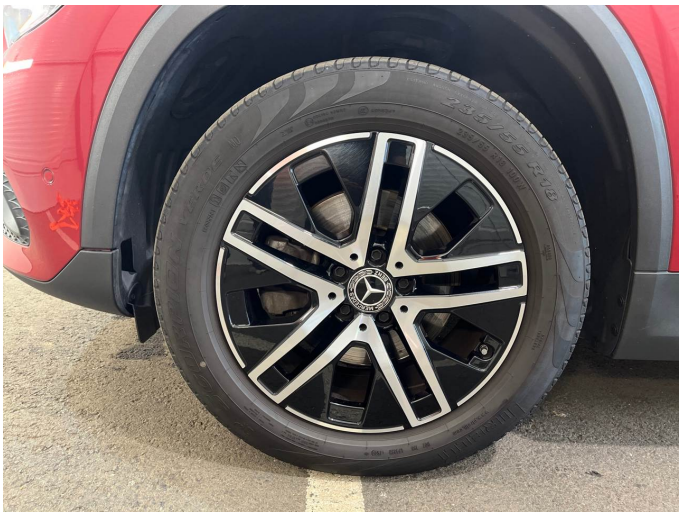
| # | Tyre size | Type of tyre | Manufacturer | Tread depth |
|---|---|---|---|---|
| 1) | 235/55 R18 100W | Summer tyres on Light alloy | Pirelli | 4mm / 4mm |
| 2) | 235/55 R18 100W | Summer tyres on Light alloy | Pirelli | 5mm / 5mm |

Figure 12: Mounted tyres

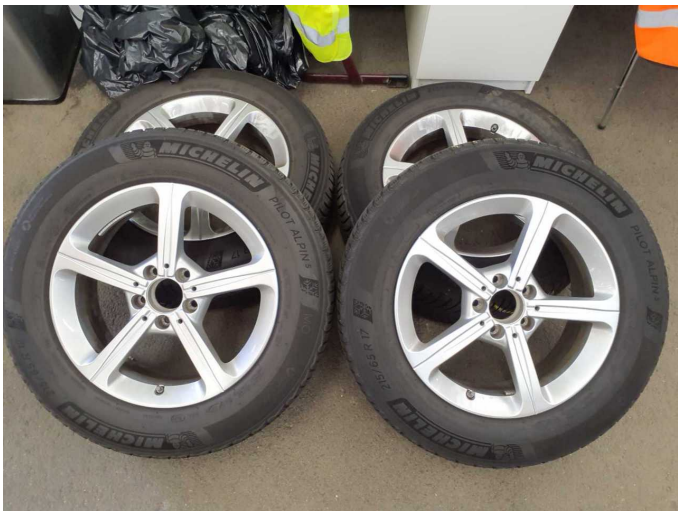
| # | Tyre size | Type of tyre | Manufacturer | Tread depth |
|---|---|---|---|---|
| 1) | 215/65 R17 99H | Winter tyres on Light alloy | Michelin | 6mm / 6mm |
| 2) | 215/65 R17 99H | Winter tyres on Light alloy | Michelin | 6mm / 6mm |

Figure 15: Additional tyres

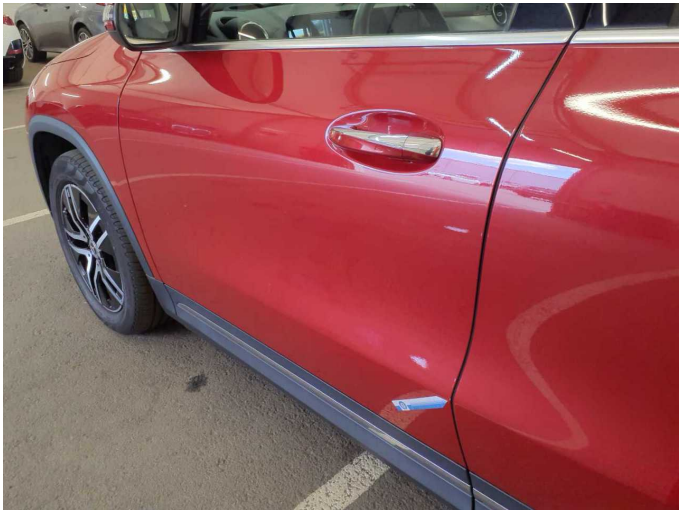
| No. | Component group | Description |
|---|---|---|
| 3 | Door - front left side | Door edge - Scratch(es) - Smart repair |

Damage 3: Door - front left side: Door edge - Scratch(es) - Smart repair

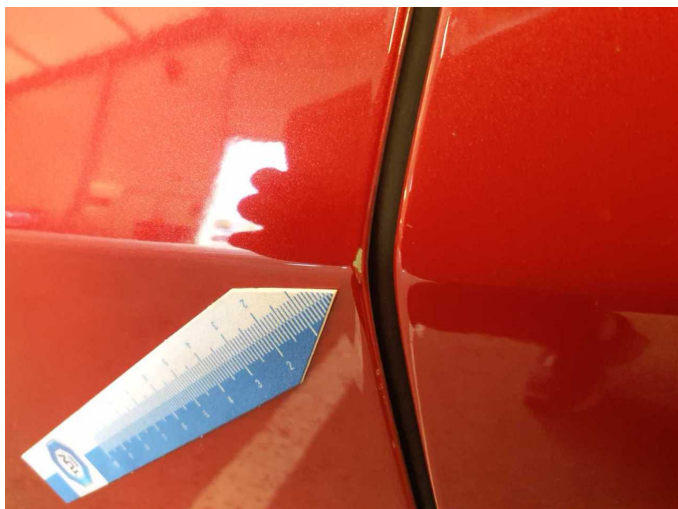
**Damage 3:** Door - front left side: Door edge - Scratch(es) - Smart repair

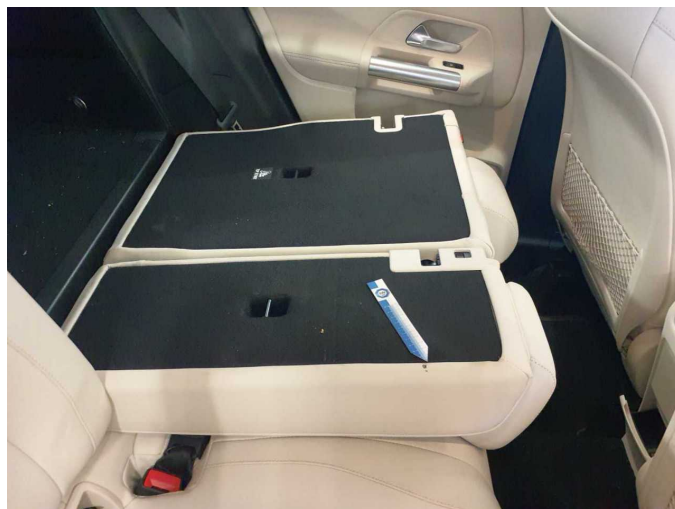
| No. | Component group | Description |
|---|---|---|
| 4 | Seat - rear | Backrest cover - 2nd row - Scratch(es) - Smart repair |

**Damage 4:** Seat - rear: Backrest cover - 2nd row - Scratch(es) - Smart repair

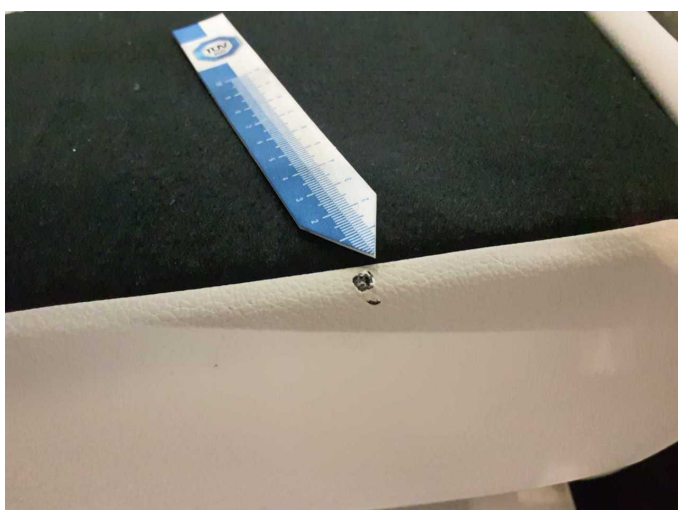
**Damage 4:** Seat - rear: Backrest cover - 2nd row - Scratch(es) - Smart repair

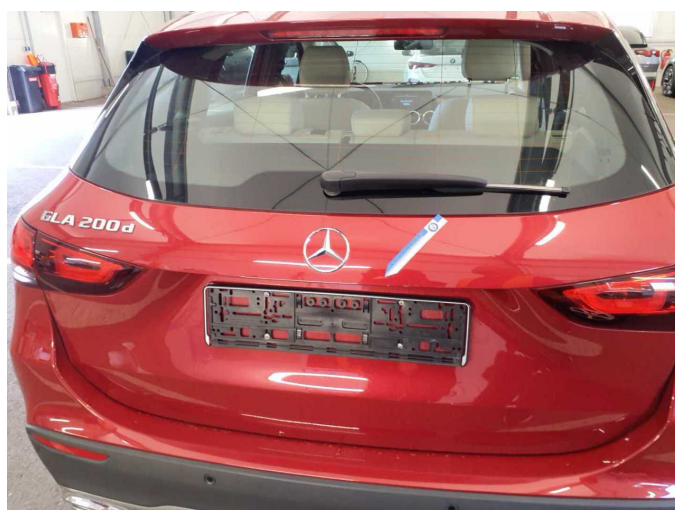
| No. | Component group | Description |
|---|---|---|
| 5 | Boot lid / rear door | Boot lid - Scratch(es) - Paint |

**Damage 5:** Boot lid / rear door: Boot lid - Scratch(es) - Paint

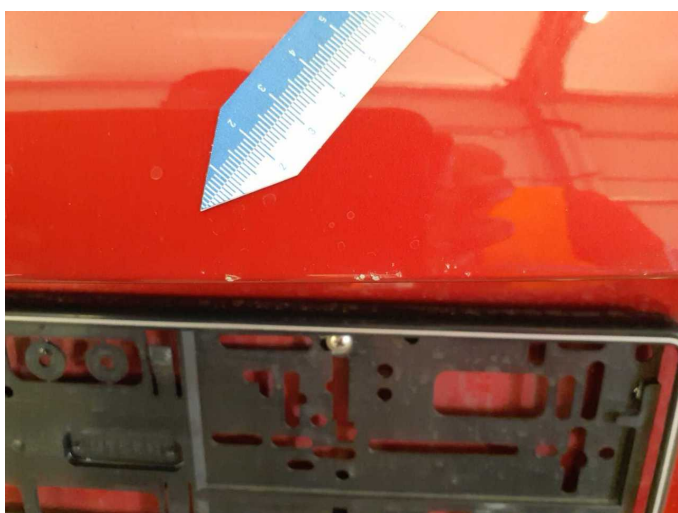
**Damage 5:** Boot lid / rear door: Boot lid - Scratch(es) - Paint

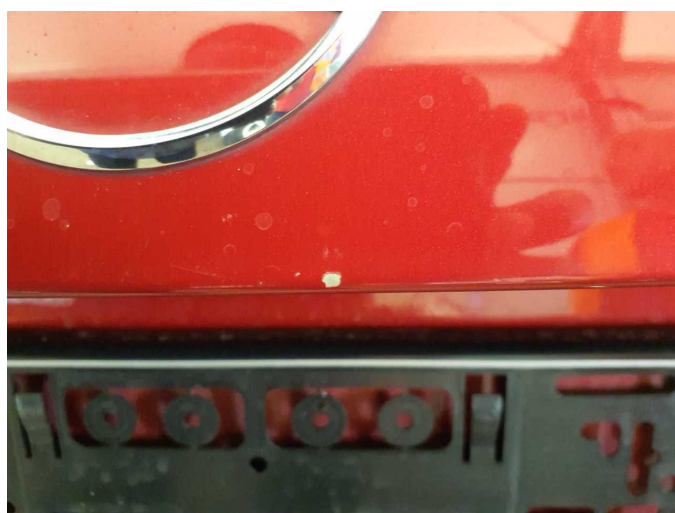
**Damage 5:** Boot lid / rear door: Boot lid - Scratch(es) - Paint

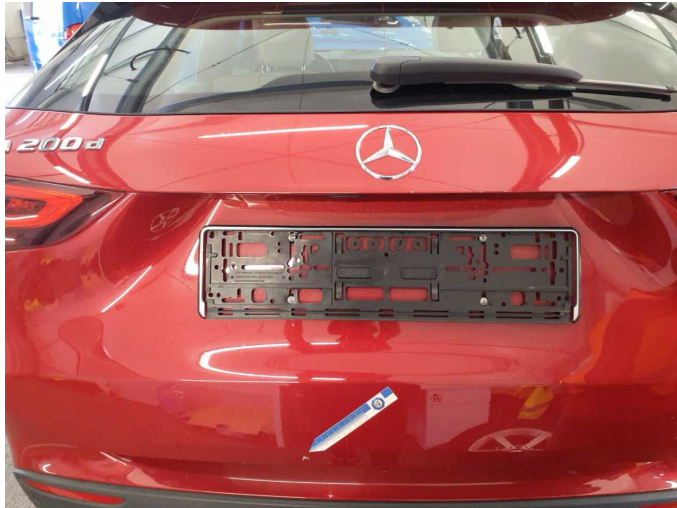
**Damage 5:** Boot lid / rear door: Boot lid - Scratch(es) - Paint

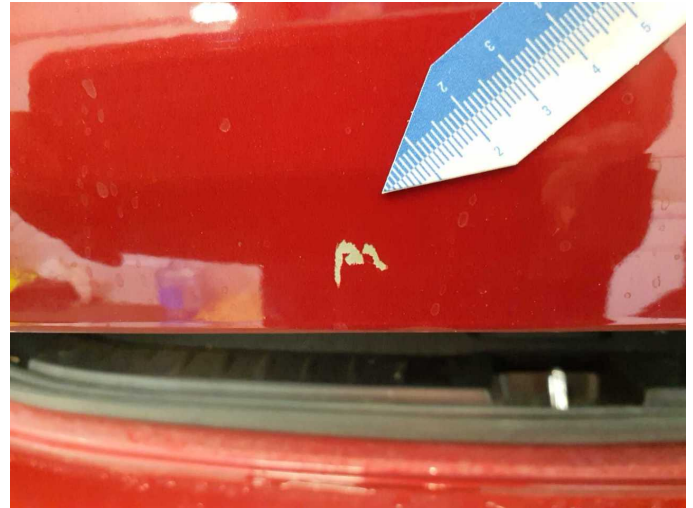
**Damage 5:** Boot lid / rear door: Boot lid - Scratch(es) - Paint
