Expertise

Protocol number: 46912326  
Order No. / Reference: 26671109  
Inspection date: 6 Aug 2026

Manufacturer: Volkswagen

Model: Tiguan 1.4 eHybrid OPF DSG Life

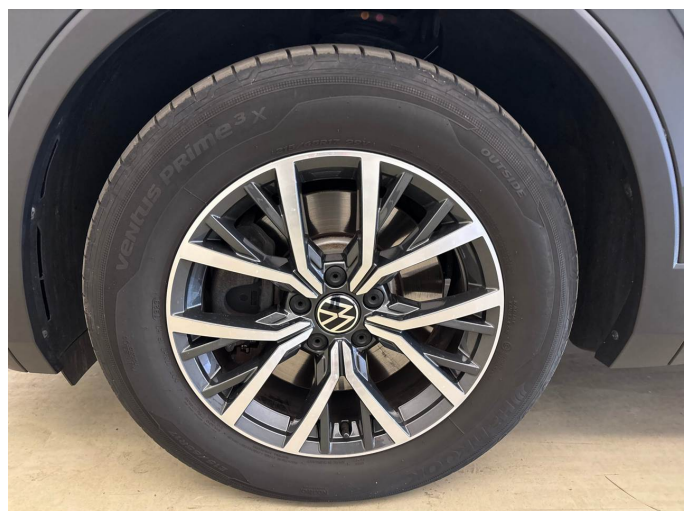
Figure 12: Mounted tyres

| # | Tyre size | Type of tyre | Manufacturer | Tread depth |
|---|---|---|---|---|
| 1) | 215/65 R17 99V | Summer tyres on Light alloy | Hankook | 4mm / 4mm |
| 2) | 215/65 R17 99V | Summer tyres on Light alloy | Hankook | 5mm / 5mm |

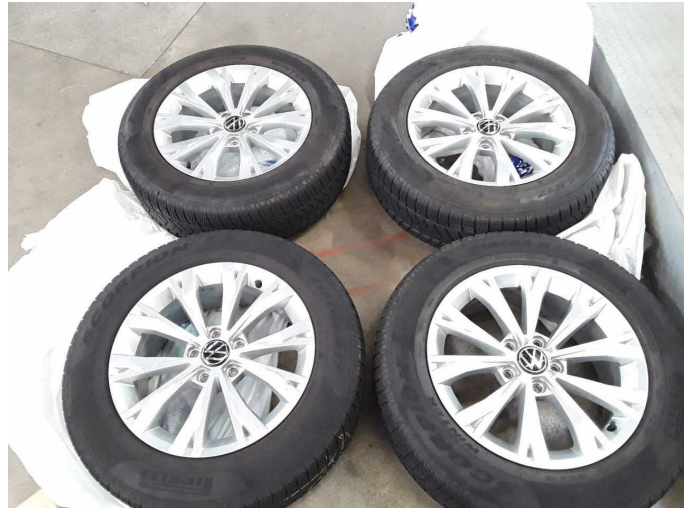
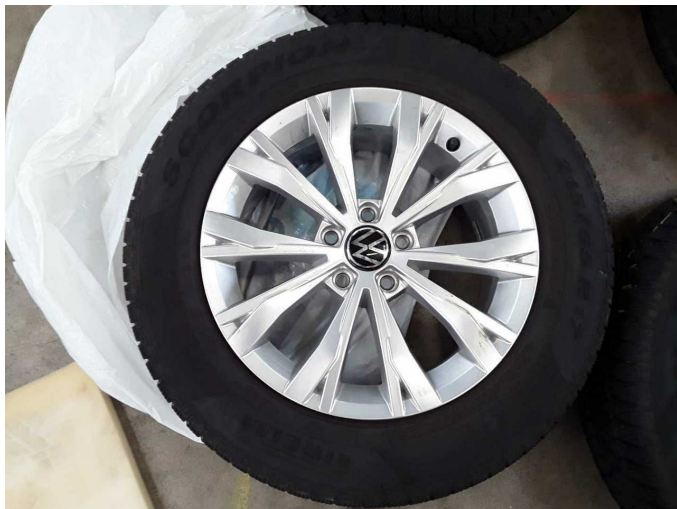
Figure 14: Additional tyres

| # | Tyre size | Type of tyre | Manufacturer | Tread depth |
|---|---|---|---|---|
| 1) | 215/65 R17 99H | Winter tyres on Light alloy | Pirelli | 4mm / 4mm |
| 2) | 215/65 R17 99H | Winter tyres on Light alloy | Pirelli | 6mm / 6mm |

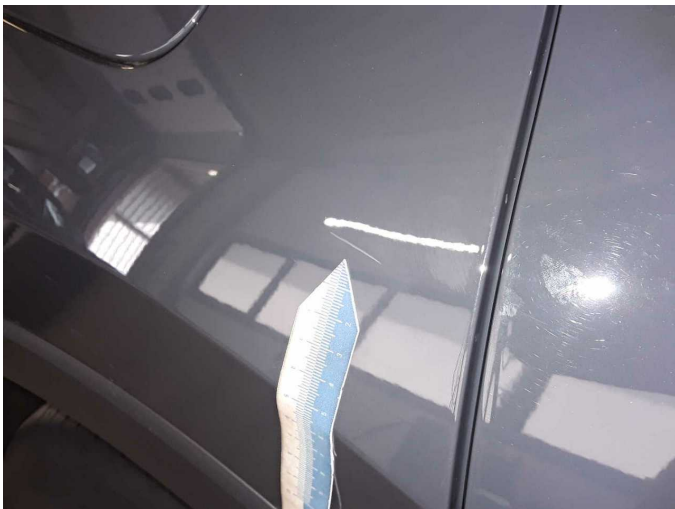
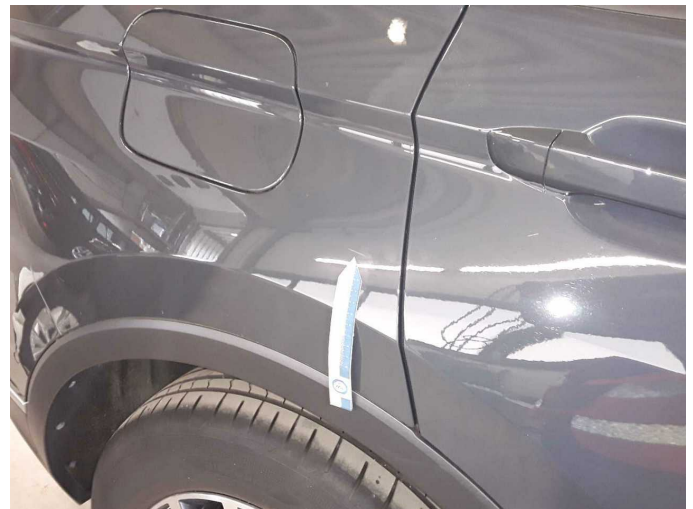
| No. | Component group | Description |
|---|---|---|
| 1 | Side panel - rear right side | Side panel - Scratch(es) - Smart repair |

**Damage 1:** Side panel - rear right side: Side panel - Scratch(es) - Smart repair

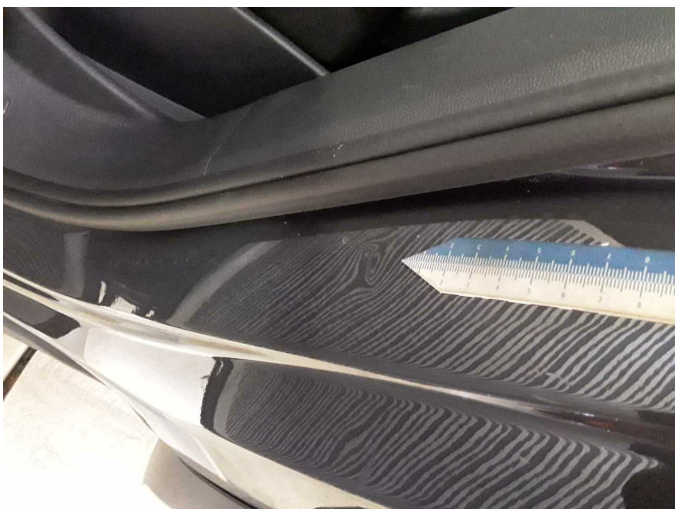
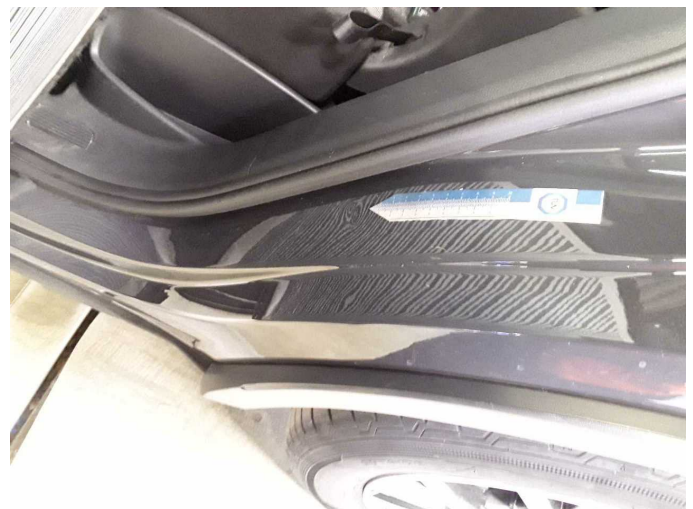
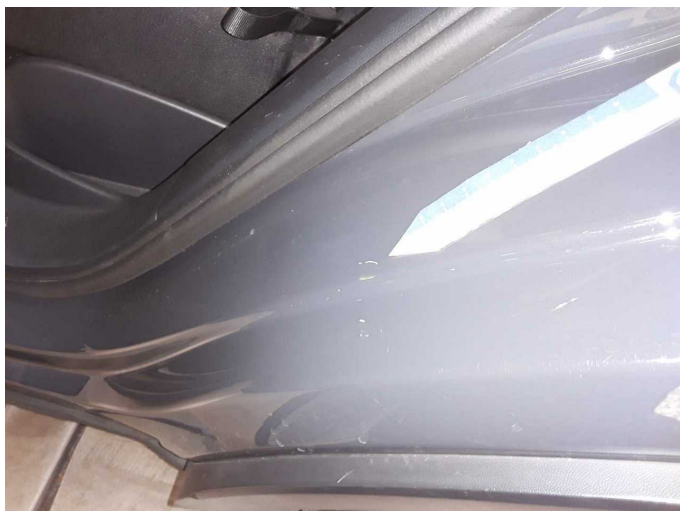
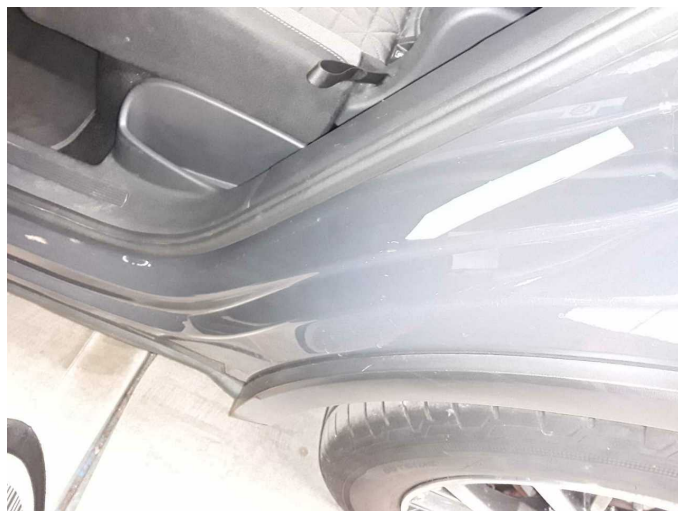
| No. | Component group | Description |
|---|---|---|
| 2 | Side panel - rear left side | Elbow - Dent / paintcoat damage - Smart repair |

**Damage 2:** Side panel - rear left side: Elbow - Dent / paintcoat damage - Smart repair

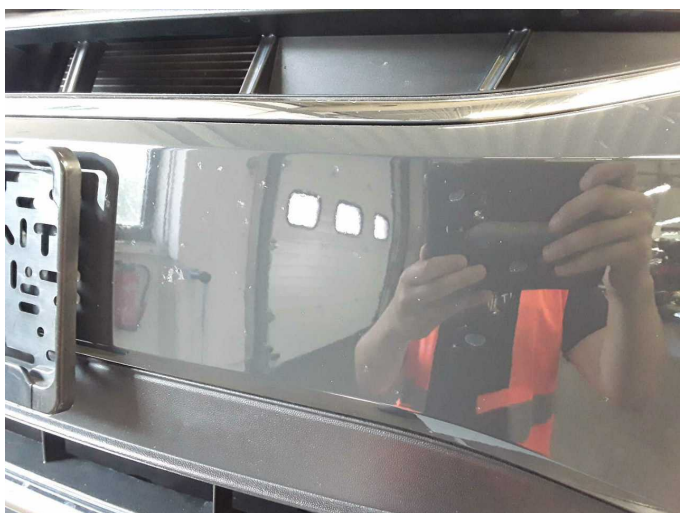
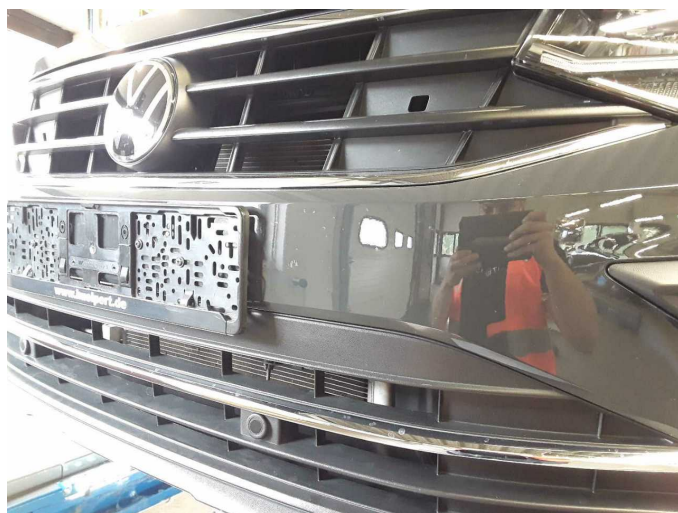
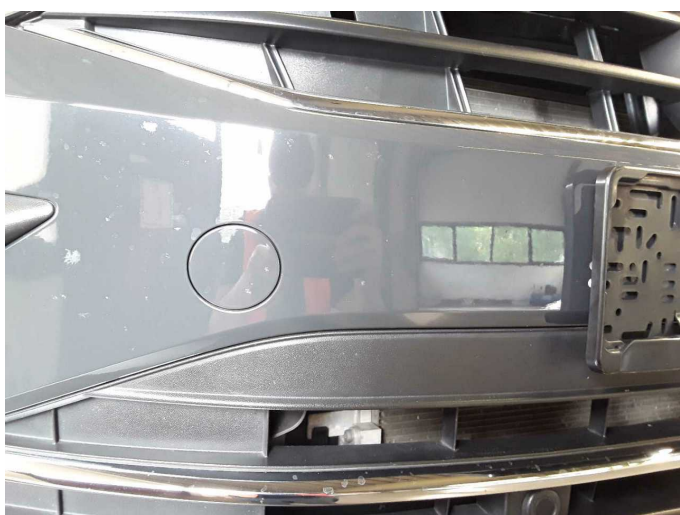
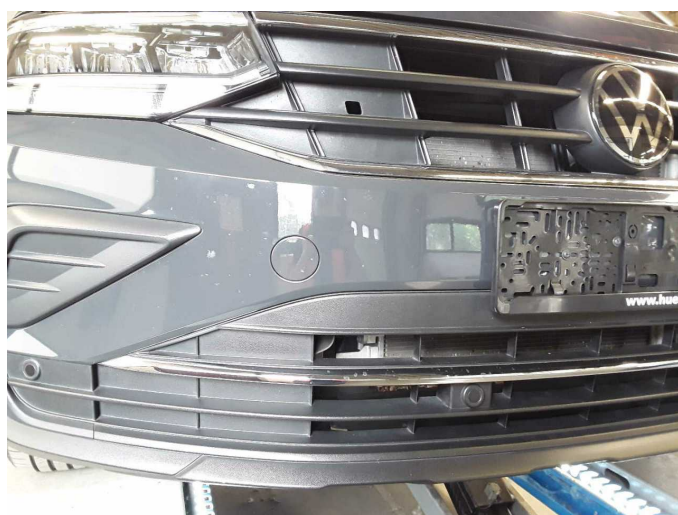
| No. | Component group | Description |
|---|---|---|
| 3 | Front bumper | Front bumper - Stone chips - Paint |

**Damage 3:** Front bumper: Front bumper - Stone chips - Paint

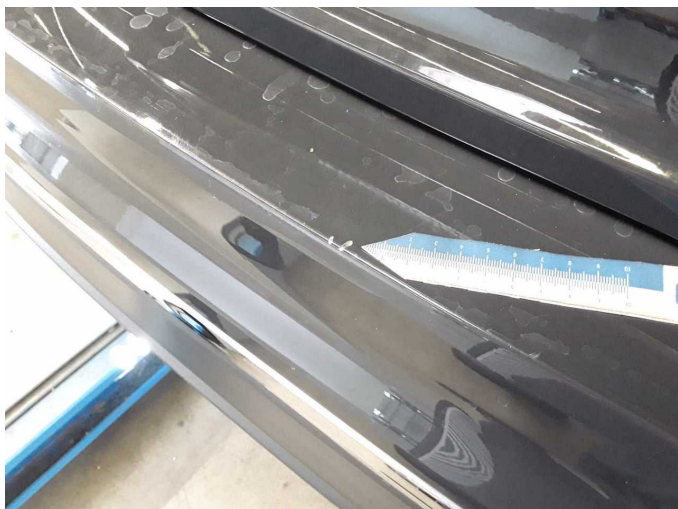
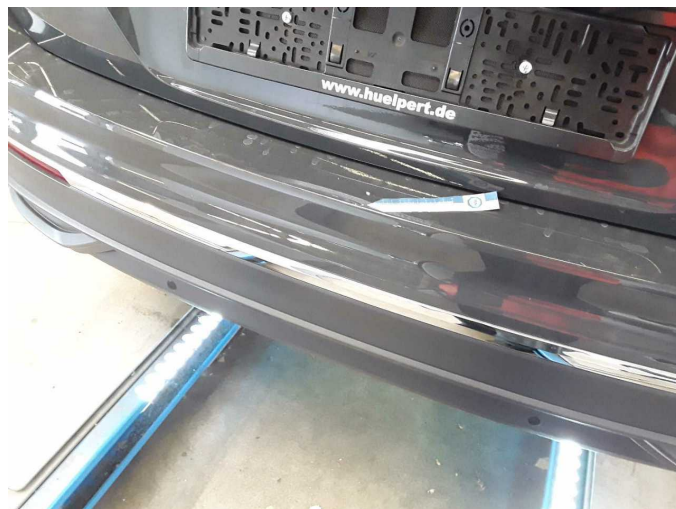
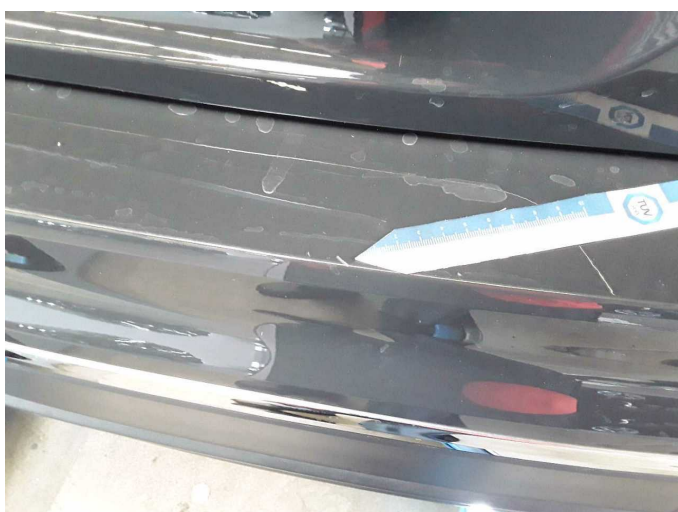
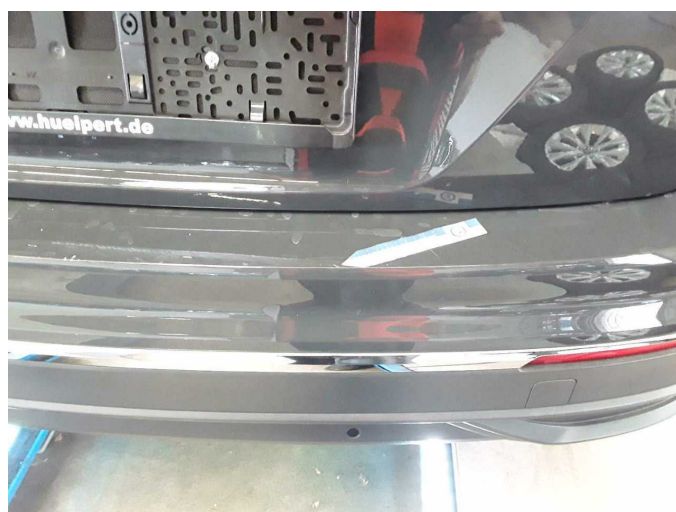
| No. | Component group | Description |
|---|---|---|
| 4 | Rear bumper | Rear bumper - Scratch(es) - Paint |

**Damage 4:** Rear bumper: Rear bumper - Scratch(es) - Paint

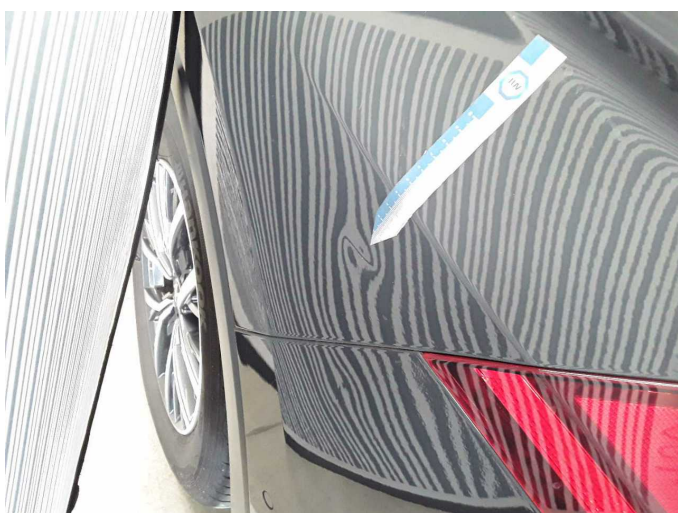
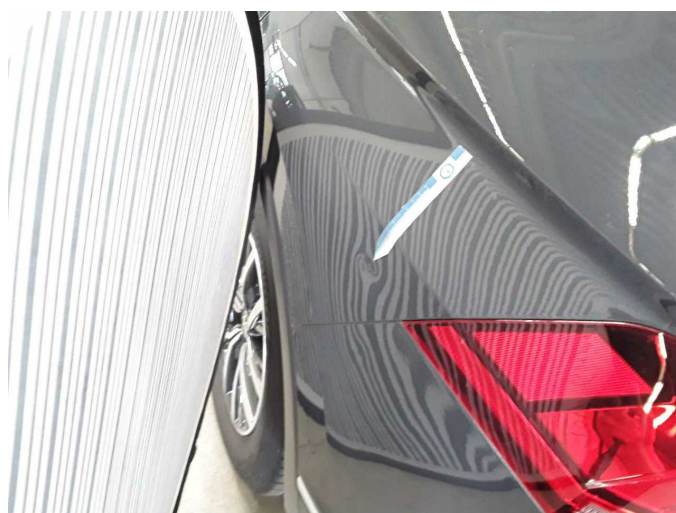
| No. | Component group | Description |
|---|---|---|
| 5 | Side panel - rear left side | Side panel - dent(s) - Repair and paint |

**Damage 5:** Side panel - rear left side: Side panel - dent(s) - Repair and paint

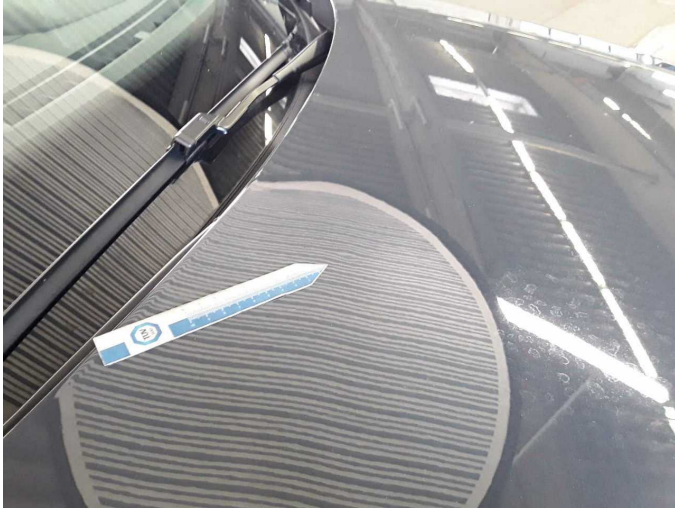
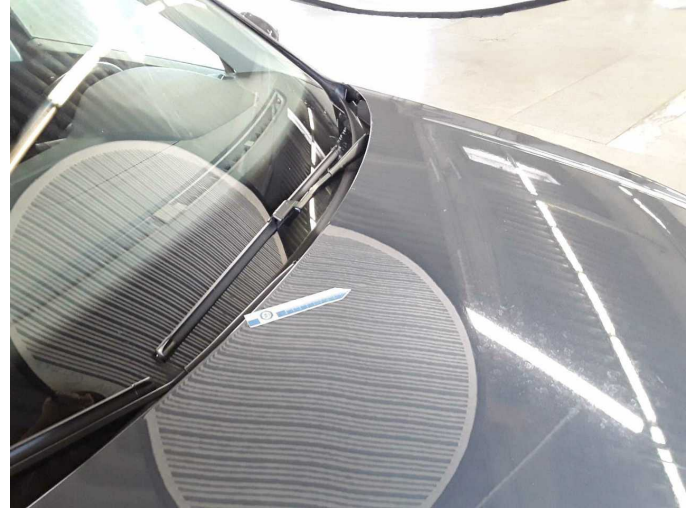
| No. | Component group | Description |
|---|---|---|
| 2 | Bonnet | Bonnet - dent(s) - No deduction |

**Wear and tear 2:** Bonnet: Bonnet - dent(s) - No deduction
