Expertise

Protocol number: 46143916  
Order No. / Reference: 26544752  
Inspection date: 24 Jun 2026

Model: E 220 d T 9G-TRONIC Exclusive

VIN: W1K2132041B070050

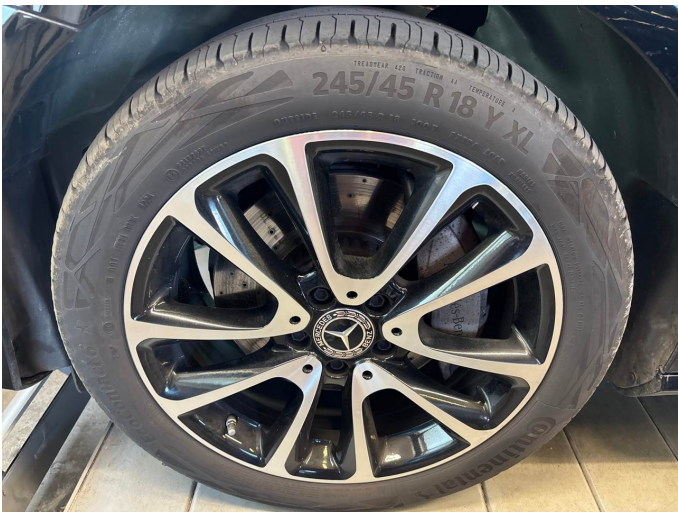
| # | Tyre size | Type of tyre | Manufacturer | Tread depth |
|---|---|---|---|---|
| 1) | 245/45 R18 100Y | Summer tyres on Light alloy | Continental | 3mm / 3mm |
| 2) | 245/45 R18 100Y | Summer tyres on Light alloy | Continental | 4mm / 4mm |

Figure 12: Mounted tyres

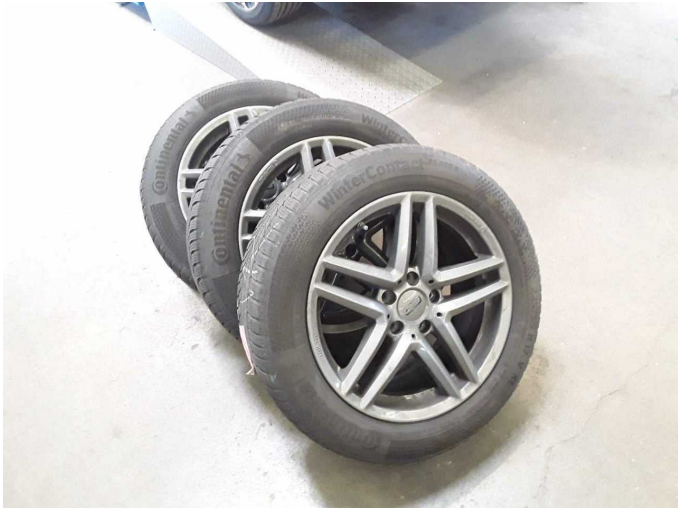
| # | Tyre size | Type of tyre | Manufacturer | Tread depth |
|---|---|---|---|---|
| 1) | 225/55 R17 101V | Winter tyres on Light alloy | Continental | 5mm / 5mm |
| 2) | 225/55 R17 101V | Winter tyres on Light alloy | Continental | 5mm / 5mm |

Figure 14: Additional tyres

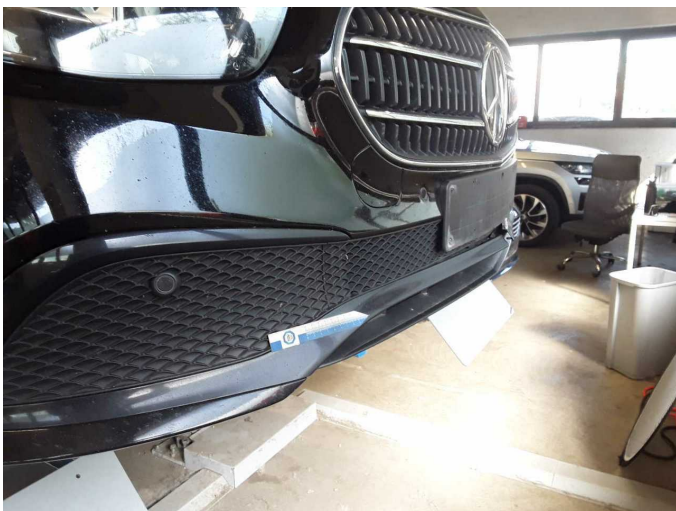
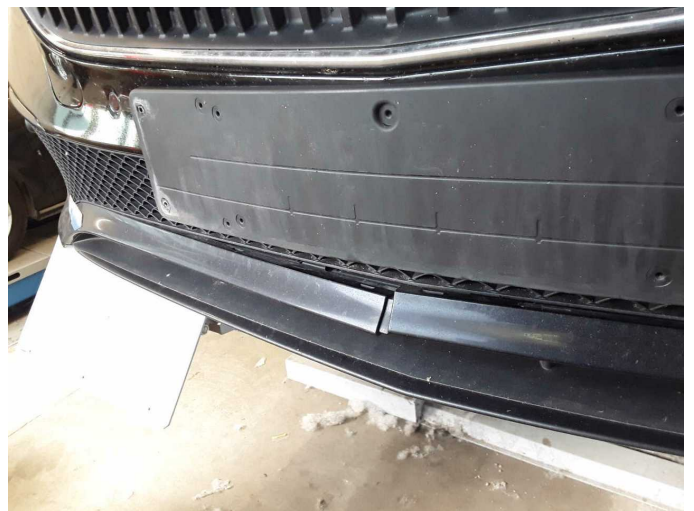
| No. | Component group | Description |
|---|---|---|
| 1 | Front bumper | Spoiler - Loose - Un- / install |

Damage 1: Front bumper: Spoiler - Loose - Un- / install

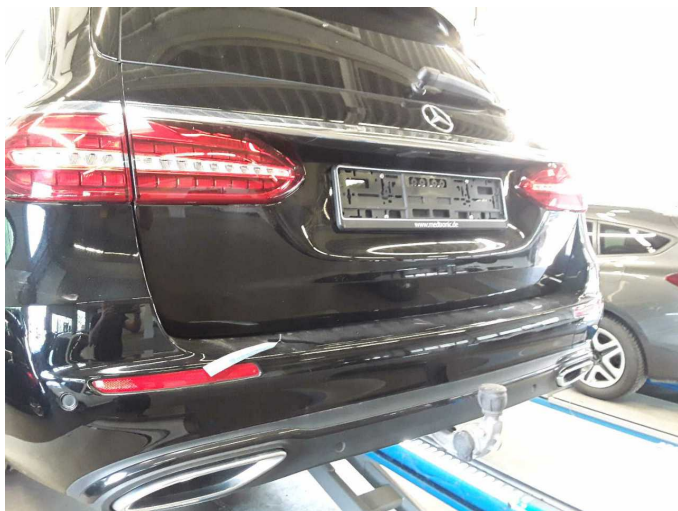
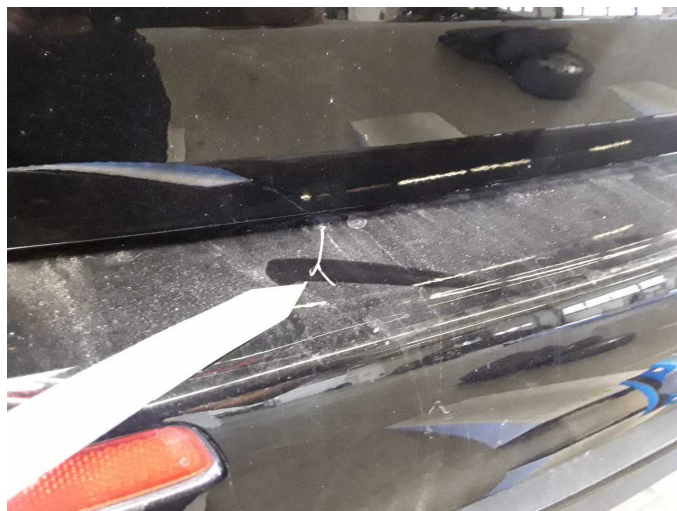
| No. | Component group | Description |
|---|---|---|
| 2 | Rear bumper | Rear bumper - Scratch(es) - Paint |

**Damage 2:** Rear bumper: Rear bumper - Scratch(es) - Paint

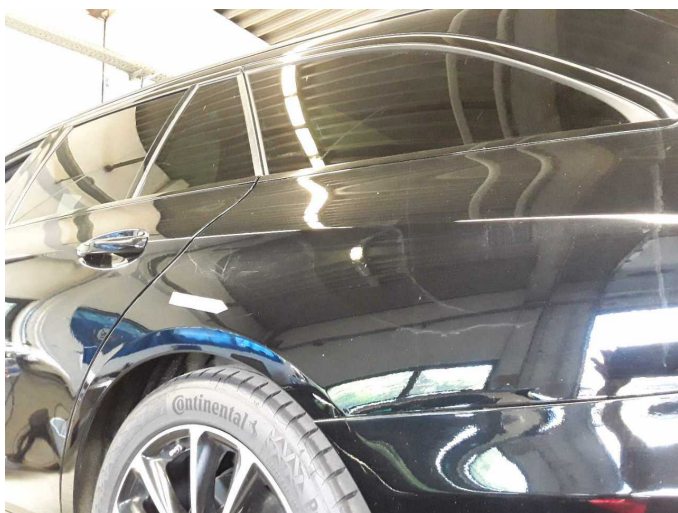
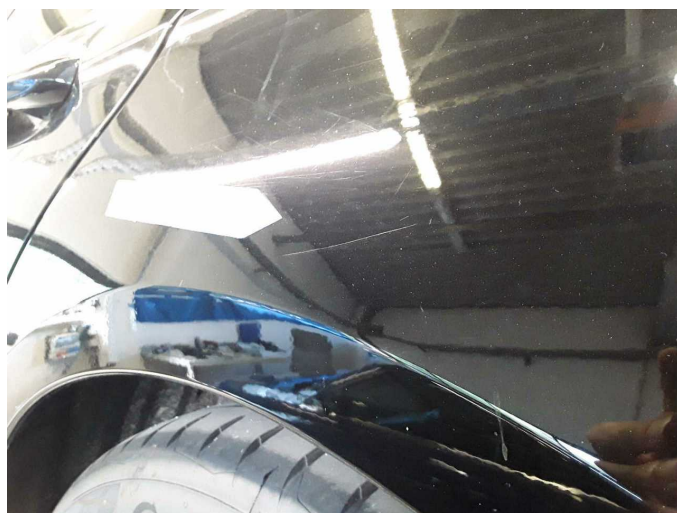
| No. | Component group | Description |
|---|---|---|
| 3 | Side panel - rear left side | Side panel - Scratch(es) - Paint |

**Damage 3:** Side panel - rear left side: Side panel - Scratch(es) - Paint

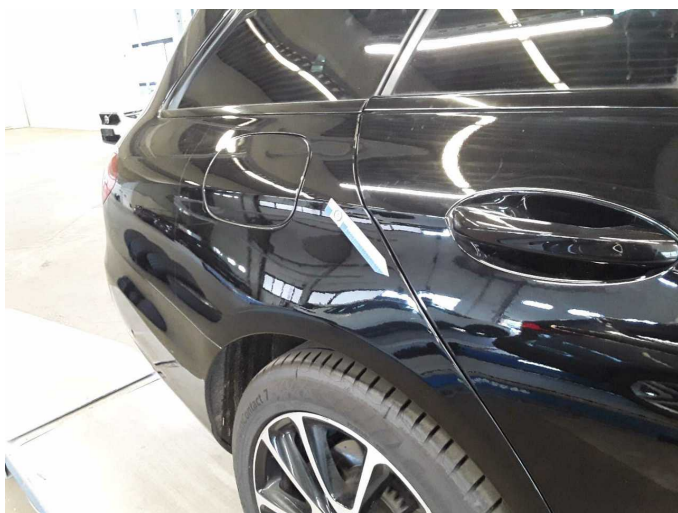
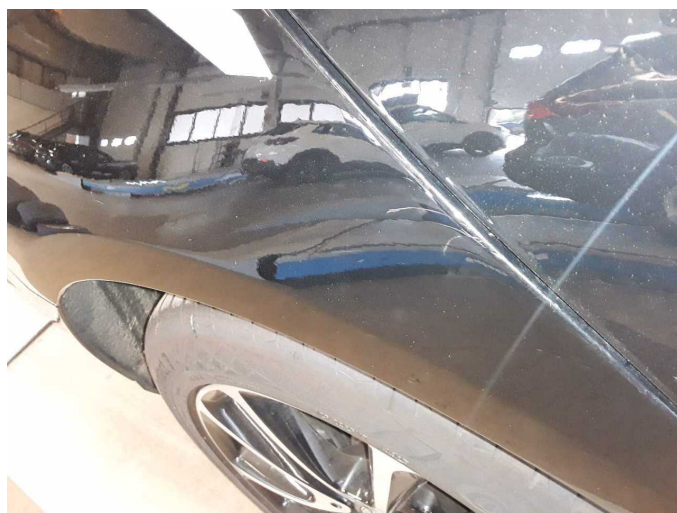
| No. | Component group | Description |
|---|---|---|
| 4 | Side panel - rear left side | Side panel - Scratch(es) - Paint |

**Damage 4:** Side panel - rear left side: Side panel - Scratch(es) - Paint

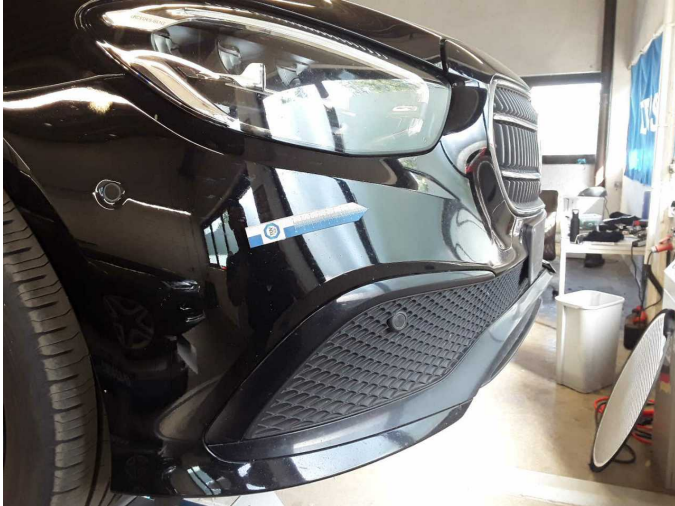
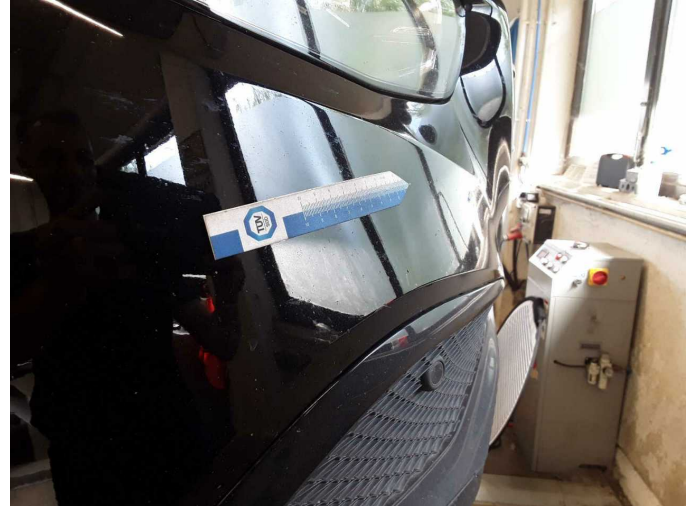
| No. | Component group | Description |
|---|---|---|
| 1 | Front bumper | Front bumper - Stone chips - No deduction |

**Wear and tear 1:** Front bumper: Front bumper - Stone chips - No deduction

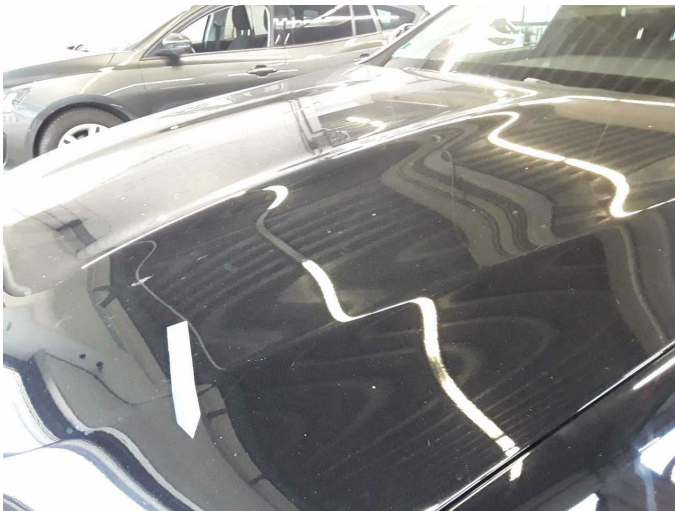
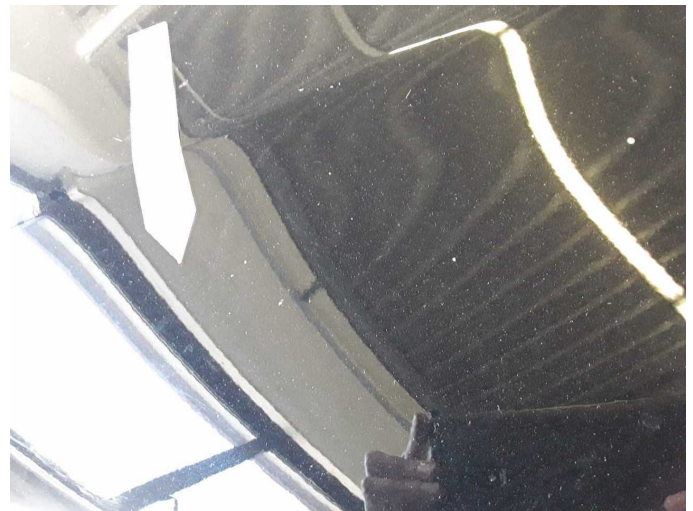
| No. | Component group | Description |
|---|---|---|
| 2 | Bonnet | Bonnet - Stone chips - No deduction |

**Wear and tear 2:** Bonnet: Bonnet - Stone chips - No deduction

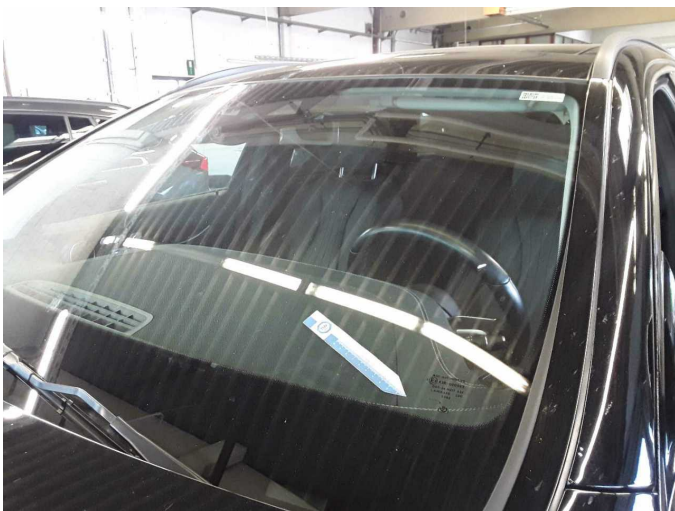
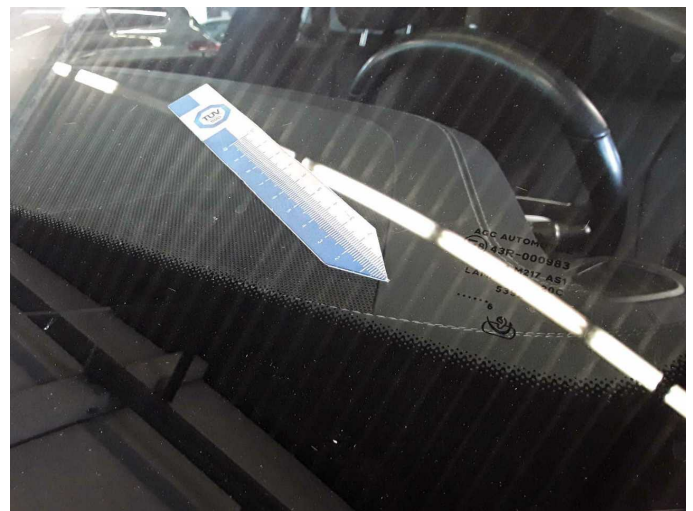
| No. | Component group | Description |
|---|---|---|
| 3 | Vehicle glazing | Windscreen - Stone chips - No deduction |

**Wear and tear 3:** Vehicle glazing: Windscreen - Stone chips - No deduction

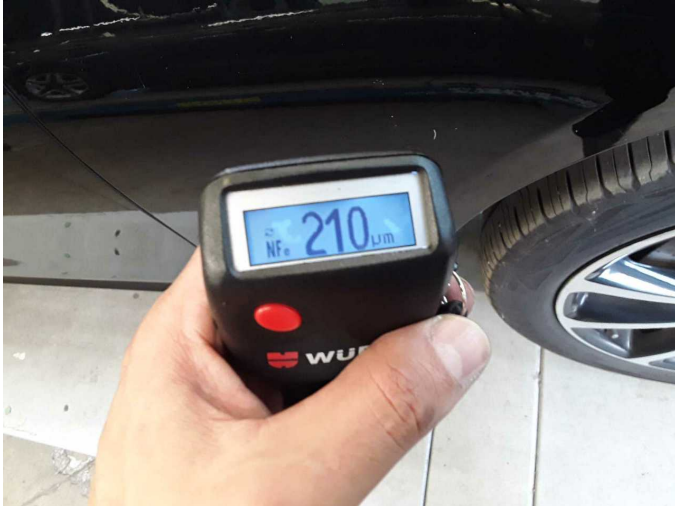
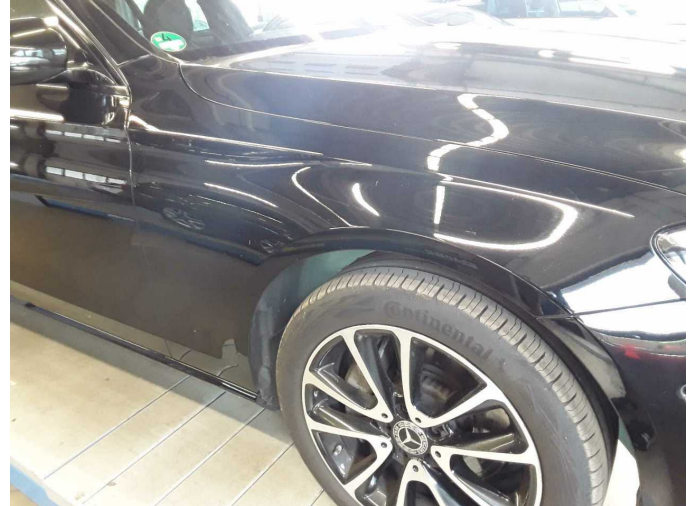
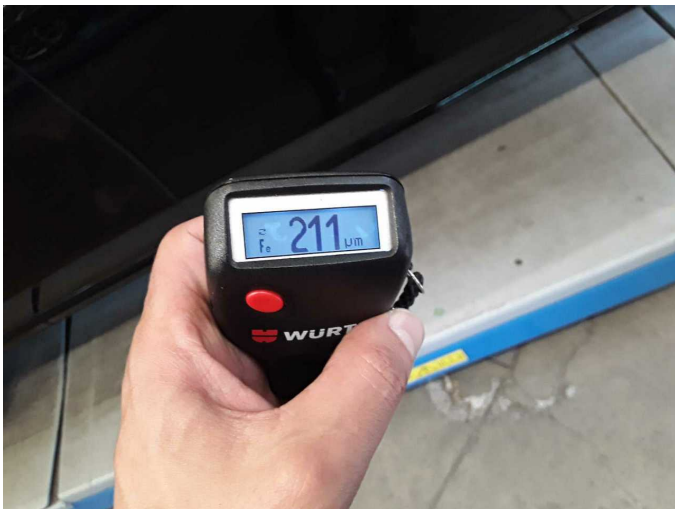
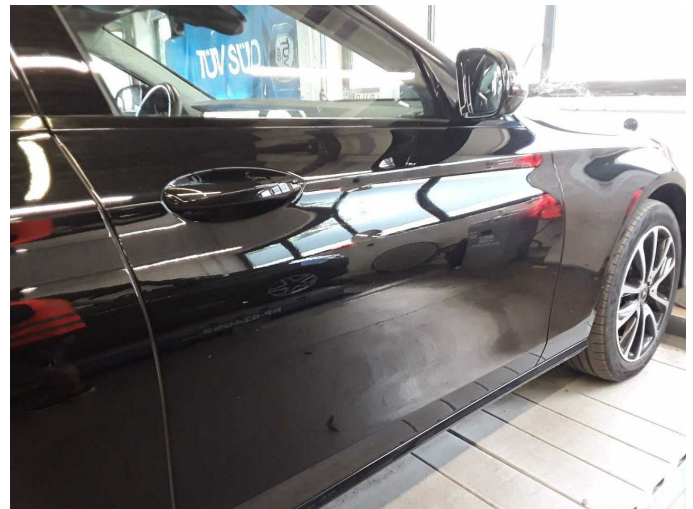
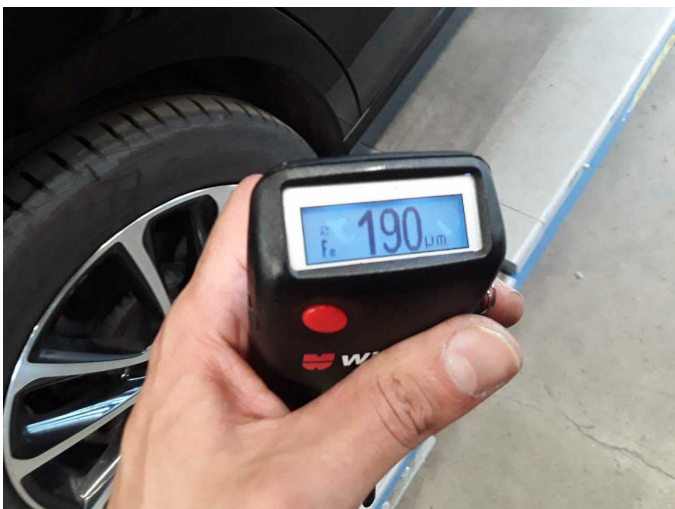
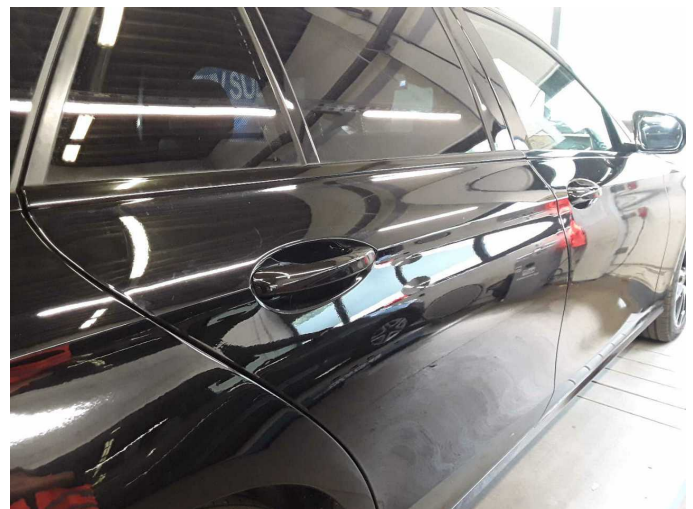
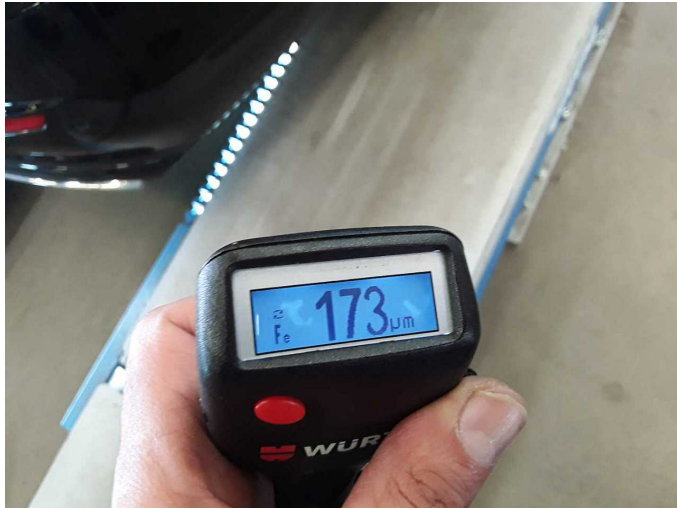
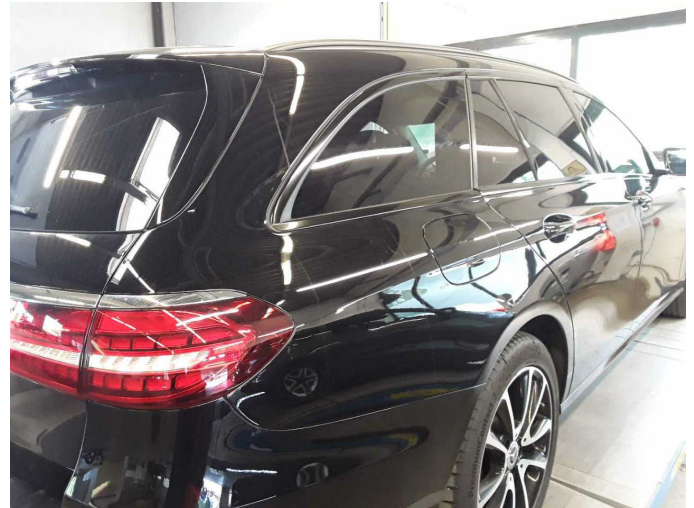
| No. | Repainting |
|---|---|
| 1 | Mudguard - right side, Side panel - rear right side, Door - rear right side, Door - front right side, Professionally carried out, Invoice of repair done<br>Non-existent |

**Repainting 1:** Mudguard - right side, Side panel - rear right side, Door - rear right side, Door - front right side
