Expertise

Protocol number: 46158955  
Order No. / Reference: 26461635-1  
Inspection date: 23 Jun 2026

Manufacturer: Skoda  
VIN: TMBLN9NS9P8516916

Model: Kodiaq 2.0 TDI 4x4 DSG Style

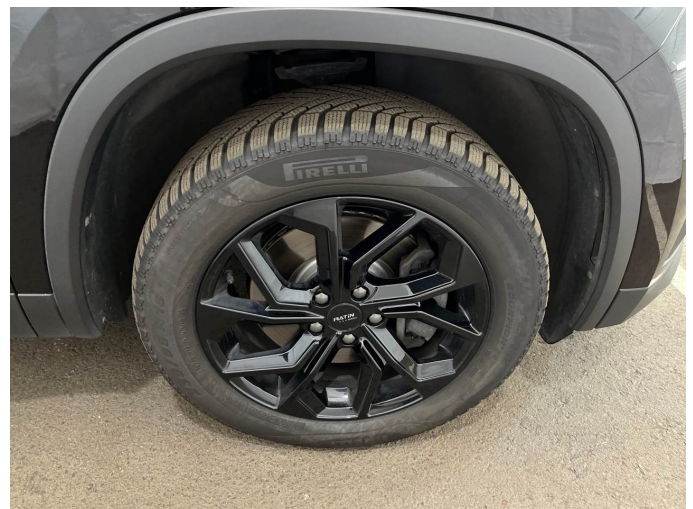
Figure 12: Mounted tyres

| # | Tyre size | Type of tyre | Manufacturer | Tread depth |
|---|---|---|---|---|
| 1) | 235/55 R18 104H | Winter tyres on Light alloy | Pirelli | 6mm / 6mm |
| 2) | 235/55 R18 104H | Winter tyres on Light alloy | Pirelli | 6mm / 6mm |

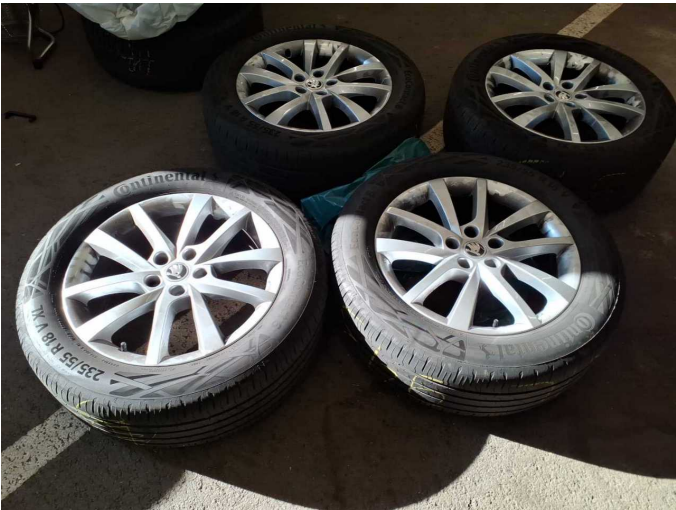
Figure 17: Additional tyres

| # | Tyre size | Type of tyre | Manufacturer | Tread depth |
|---|---|---|---|---|
| 1) | 235/55 R18 104V | Summer tyres on Light alloy | Continental | 5mm / 5mm |
| 2) | 235/55 R18 104V | Summer tyres on Light alloy | Continental | 5mm / 5mm |

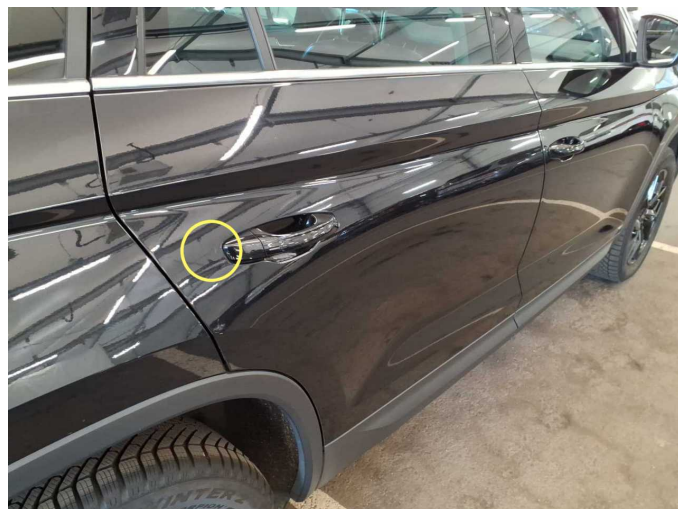
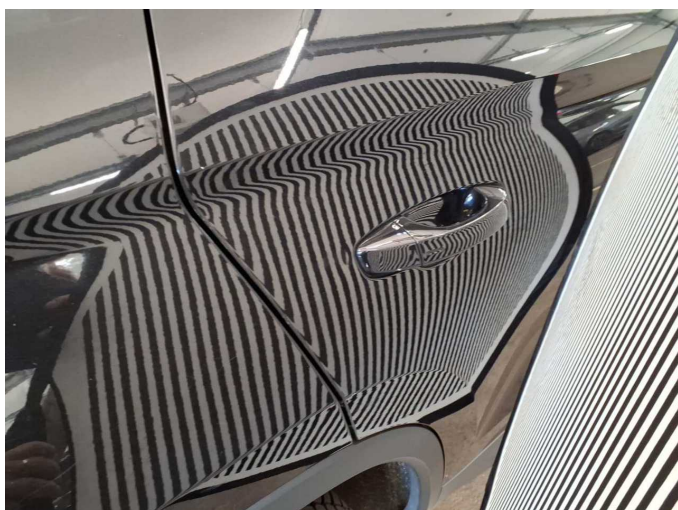
| No. | Component group | Description |
|---|---|---|
| 1 | Door - rear right side | Door - dent(s) - Smooth repair work |

**Damage 1:** Door - rear right side: Door - dent(s) - Smooth repair work

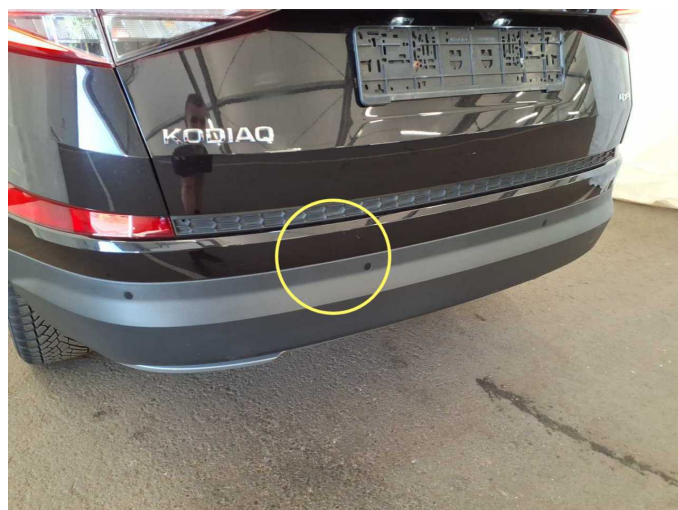
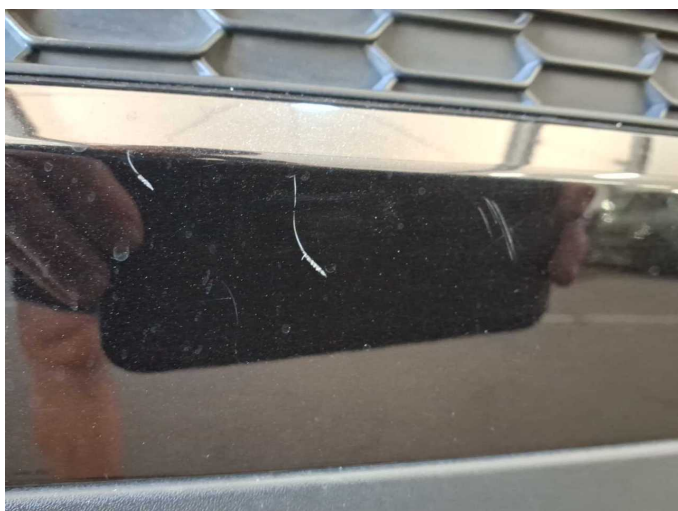
| No. | Component group | Description |
|---|---|---|
| 2 | Rear bumper | Rear bumper - Scratch(es) - Paint |

**Damage 2:** Rear bumper: Rear bumper - Scratch(es) - Paint

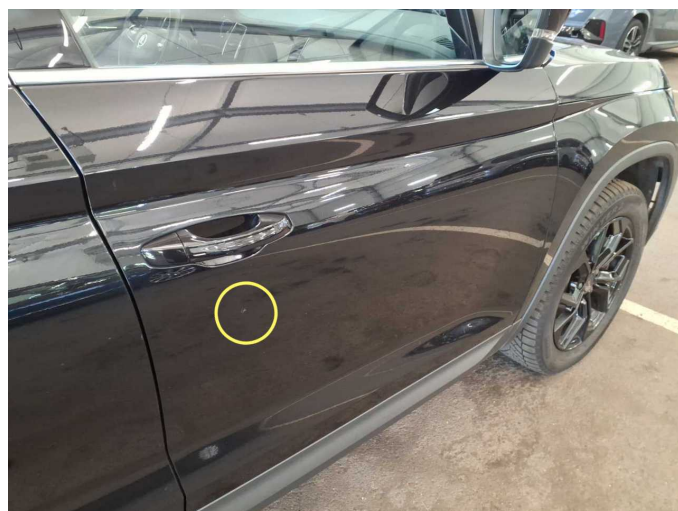
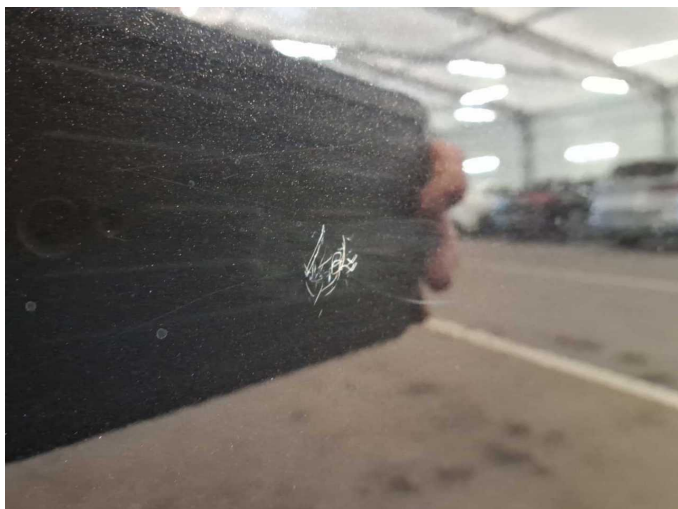
| No. | Component group | Description |
|---|---|---|
| 3 | Door - front right side | Door - Scratch(es) - Paint |

**Damage 3:** Door - front right side: Door - Scratch(es) - Paint

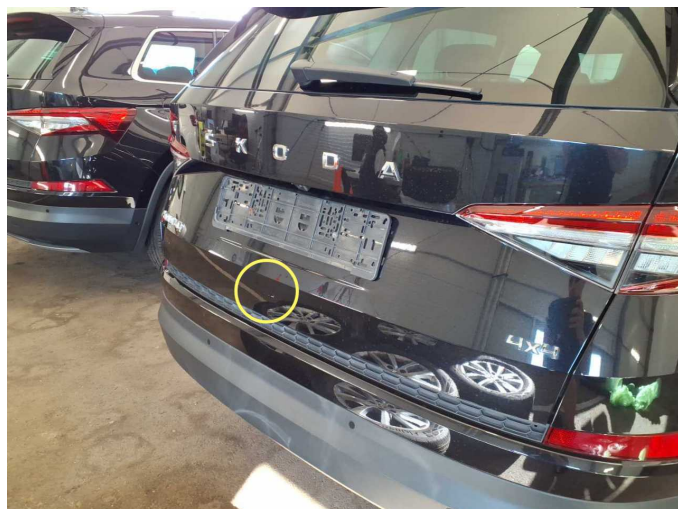
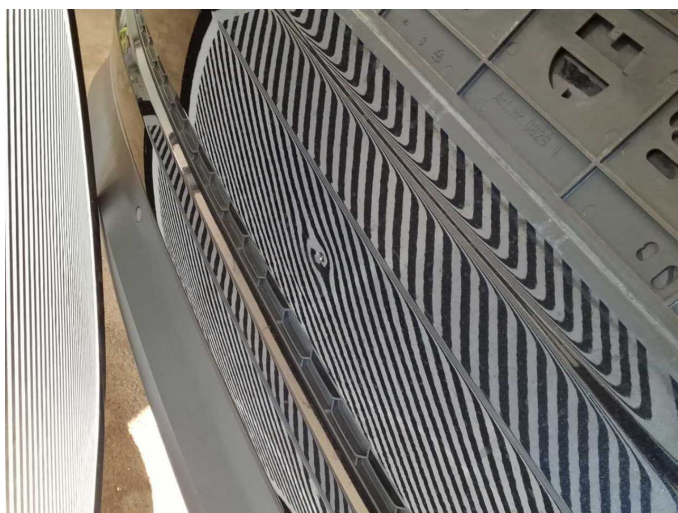
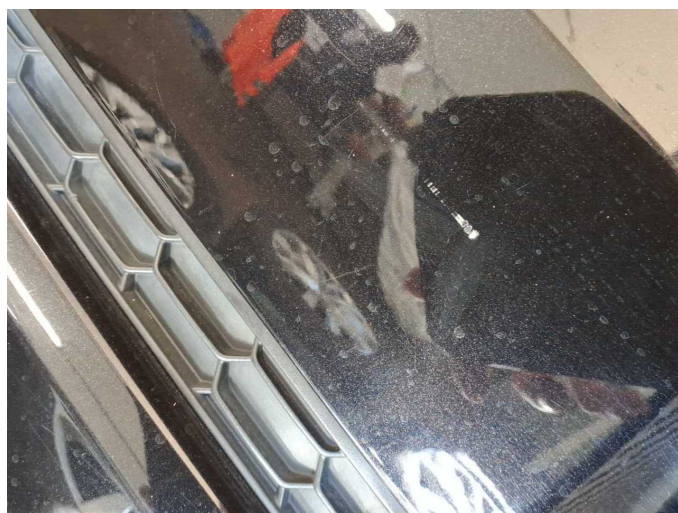
| No. | Component group | Description |
|---|---|---|
| 4 | Boot lid / rear door | Boot lid - Dent / paintcoat damage - Repair and paint |

**Damage 4:** Boot lid / rear door: Boot lid - Dent / paintcoat damage - Repair and paint
