Expertise

Protocol number: 46440954  
Order No. / Reference: 26661913  
Inspection date: 10 Jul 2026

Manufacturer: Volkswagen

Model: ID.4 Performance Pro

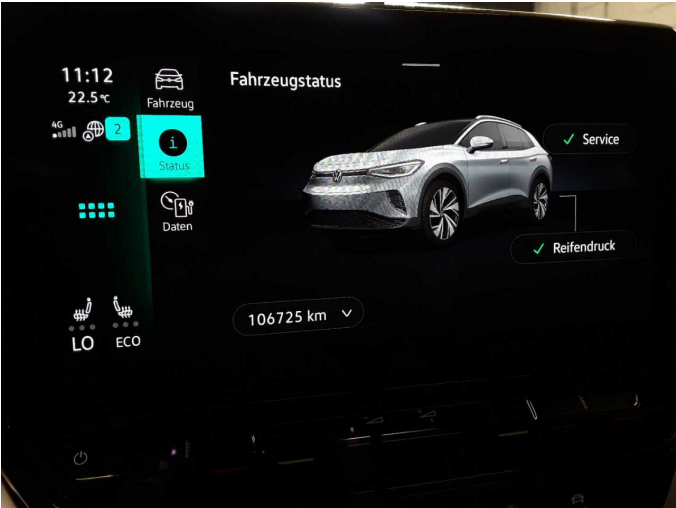
| Vehicle details | |
|---|---|
| Mileage (Read) | 106,725 km |

Figure 7: Instrument cluster

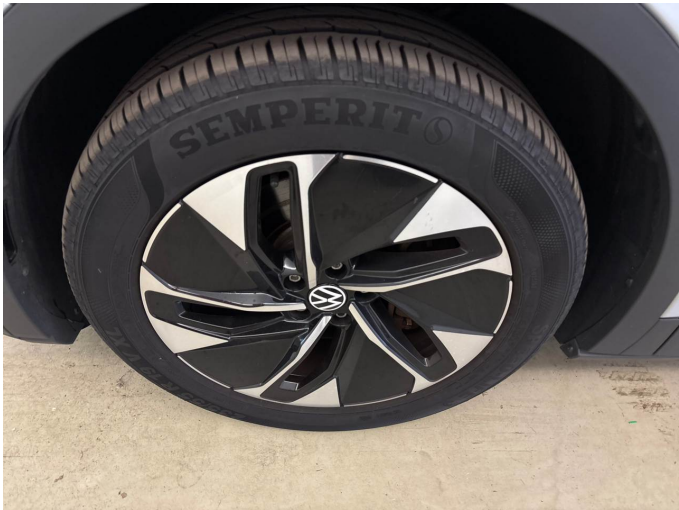
| # | Tyre size | Type of tyre | Manufacturer | Tread depth |
|---|---|---|---|---|
| 1) | 235/55 R19 105V | Summer tyres on Light alloy | Semperit | 5mm / 5mm |
| 2) | 235/55 R19 105V | Summer tyres on Light alloy | Semperit | 5mm / 5mm |

Figure 12: Mounted tyres

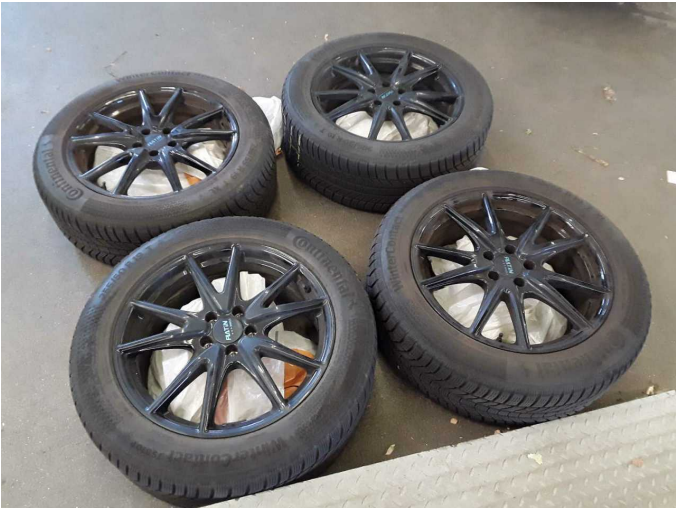
| # | Tyre size | Type of tyre | Manufacturer | Tread depth |
|---|---|---|---|---|
| 1) | 235/55 R19 105T | Winter tyres on Light alloy | Continental | 6mm / 6mm |
| 2) | 235/55 R19 105T | Winter tyres on Light alloy | Continental | 6mm / 6mm |

Figure 15: Additional tyres

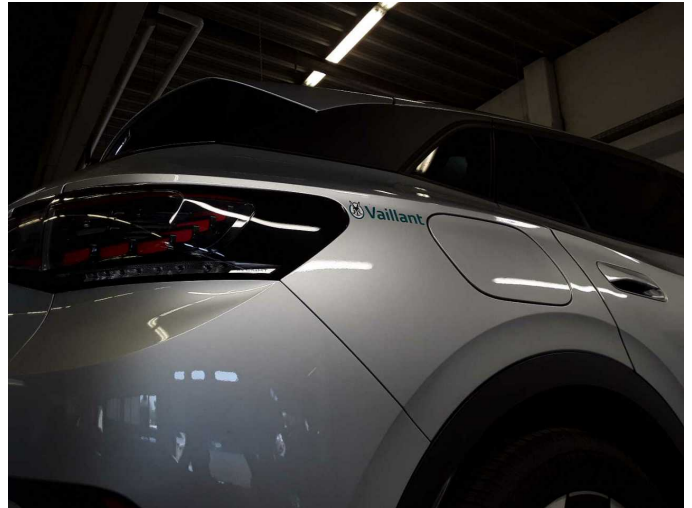
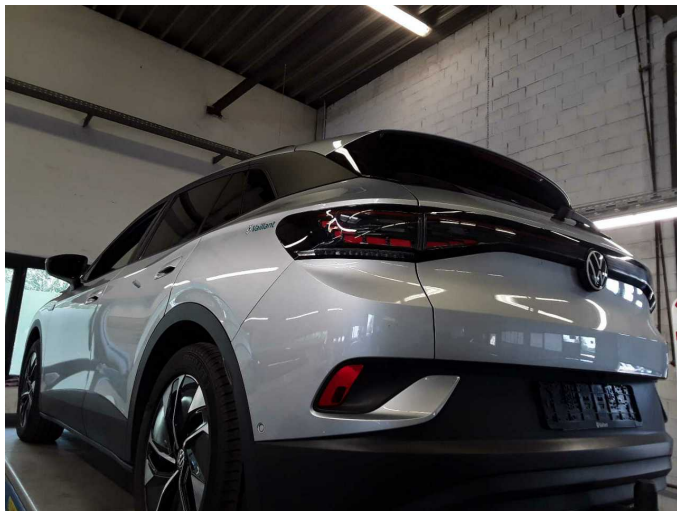
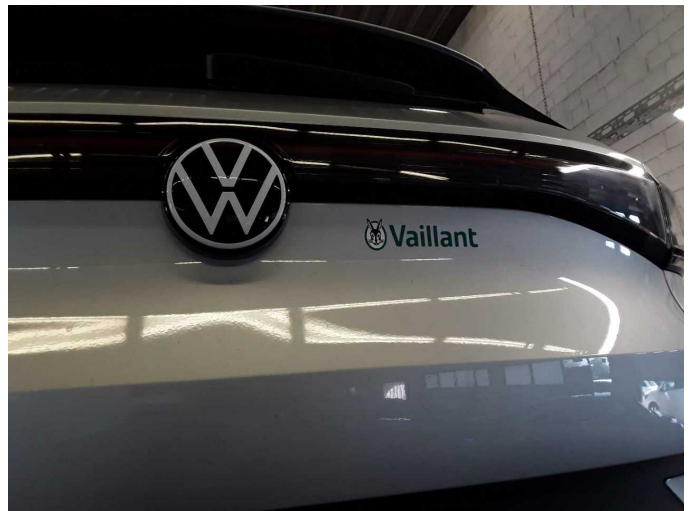
| No. | Component group | Description |
|---|---|---|
| 1 | Body | Body - Glued / labelled - De-glue / neutralise |

**Damage 1:** Body: Body - Glued / labelled - De-glue / neutralise

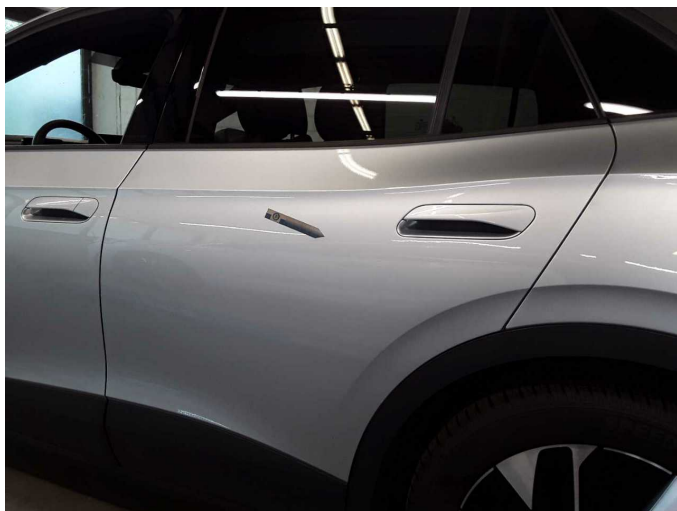
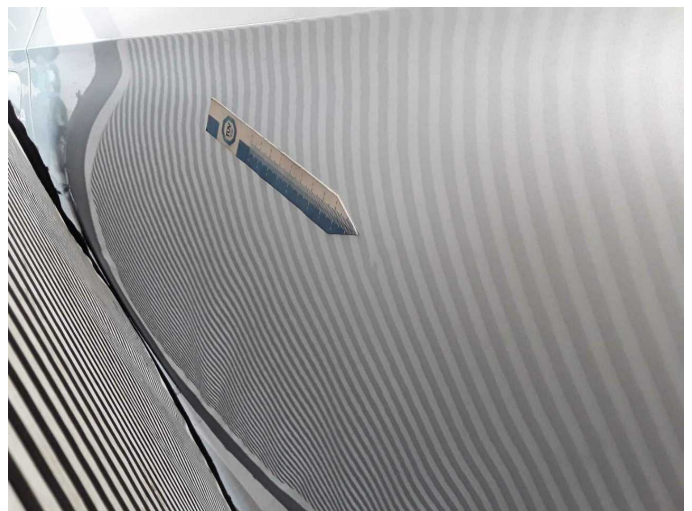
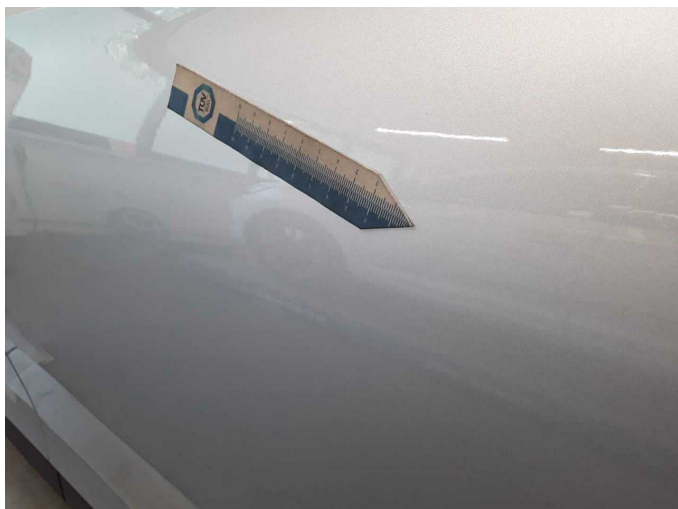
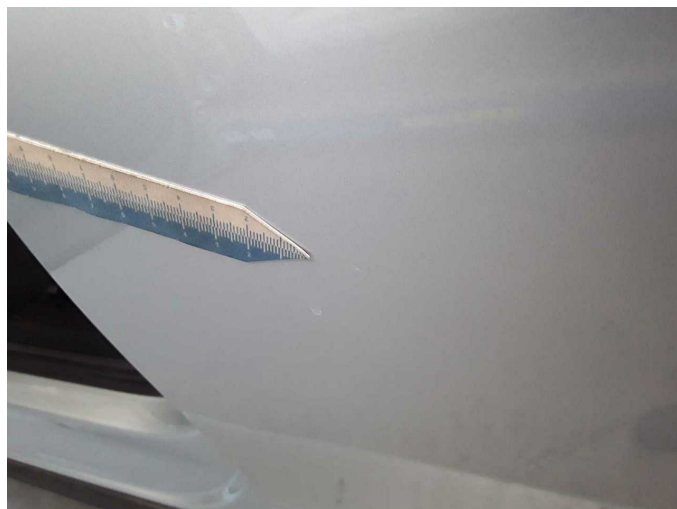
| No. | Component group | Description |
|---|---|---|
| 2 | Door - rear left side | Door - Dent / paintcoat damage - Smart repair |

**Damage 2:** Door - rear left side: Door - Dent / paintcoat damage - Smart repair

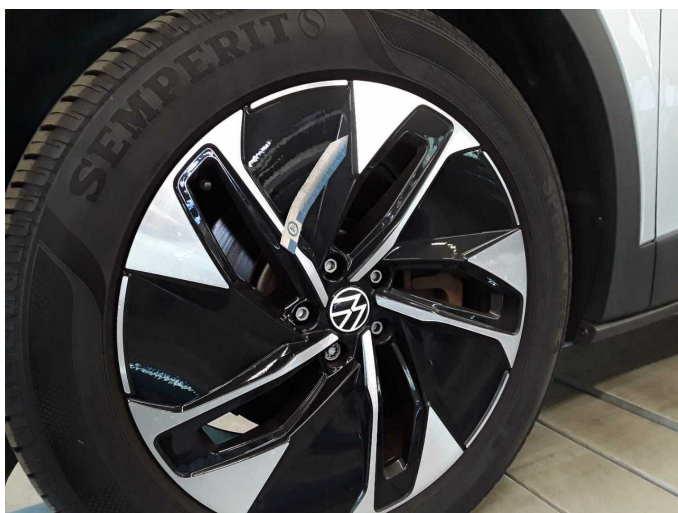
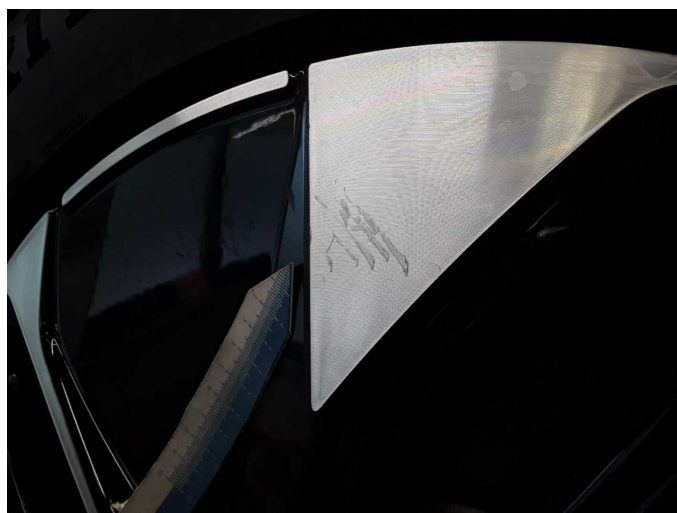
| No. | Component group | Description |
|---|---|---|
| 3 | Wheel / tyres | Alloy rim - front left side - Scratch(es) - Loss in value |

**Damage 3:** Wheel / tyres: Alloy rim - front left side - Scratch(es) - Loss in value

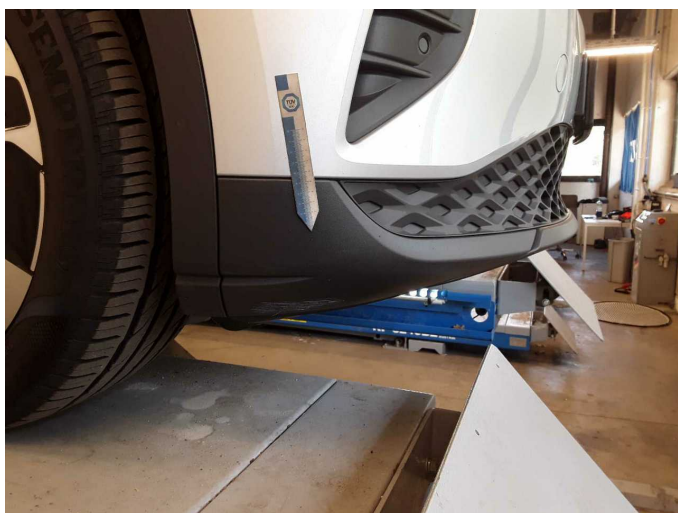
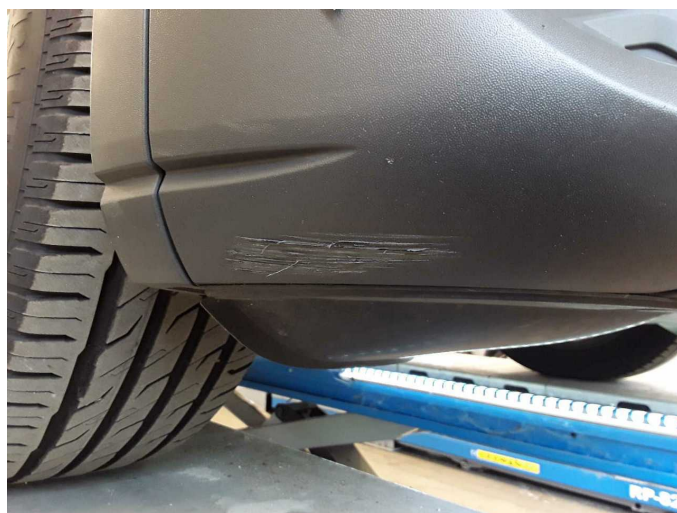
| No. | Component group | Description |
|---|---|---|
| 4 | Front bumper | Spoiler - Scratched - Replace |

**Damage 4:** Front bumper: Spoiler - Scratched - Replace

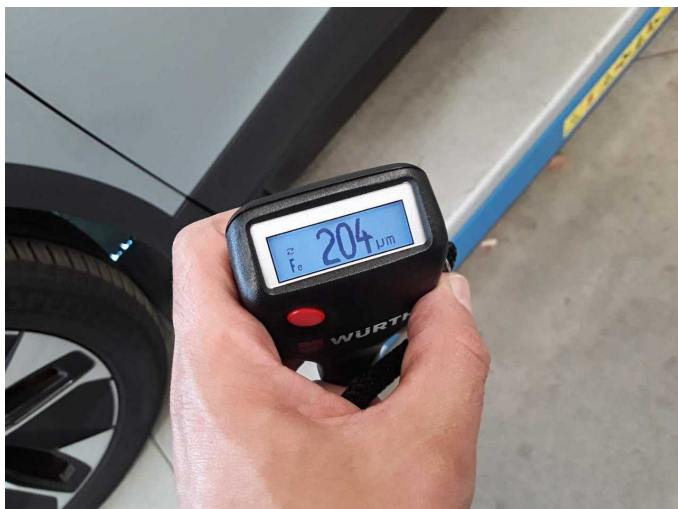
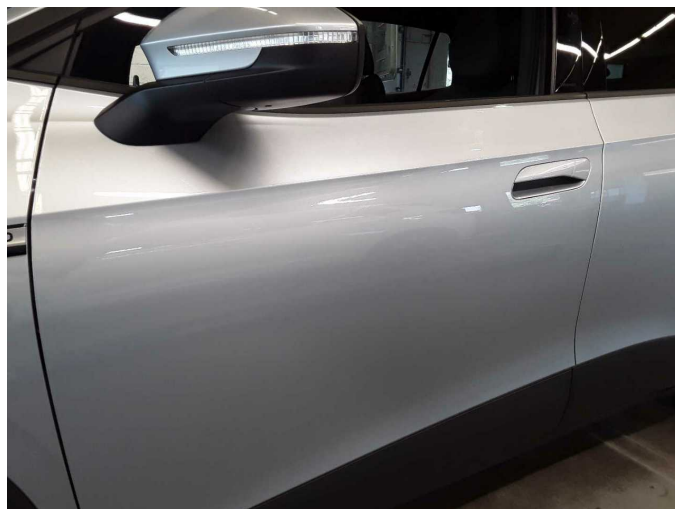
| No. | Repainting |
|---|---|
| 1 | Door - front left side, Professionally carried out, Invoice of repair done Non-existent |

| Door - front left side | 204 µm |

**Repainting 1:** Door - front left side
