Expertise

Protocol number: 46273215  
Order No. / Reference: 26678538  
Inspection date: 2 Jul 2026

Manufacturer: Skoda  
VIN: TMBJJ9NXXMY103056

Model: Octavia Combi 2.0 TDI DSG First Edition

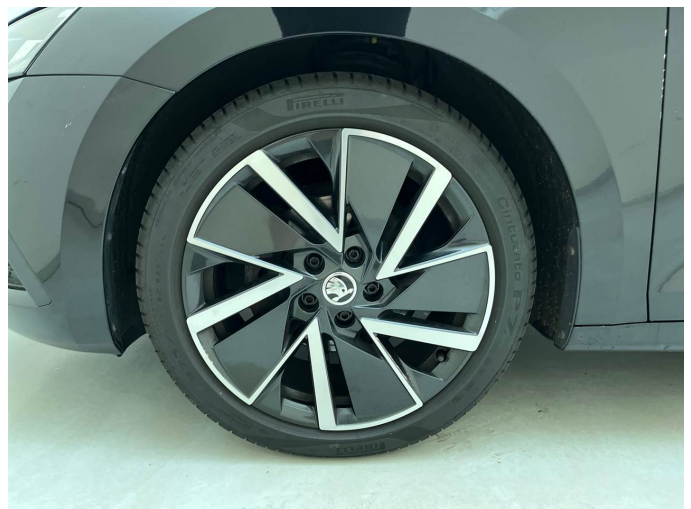
Figure 12: Mounted tyres

| # | Tyre size | Type of tyre | Manufacturer | Tread depth |
|---|---|---|---|---|
| 1) | 225/45 R18 91Y | Summer tyres on Light alloy | Pirelli | 5mm / 5mm |
| 2) | 225/45 R18 91Y | Summer tyres on Light alloy | Goodyear | 4mm / 4mm |

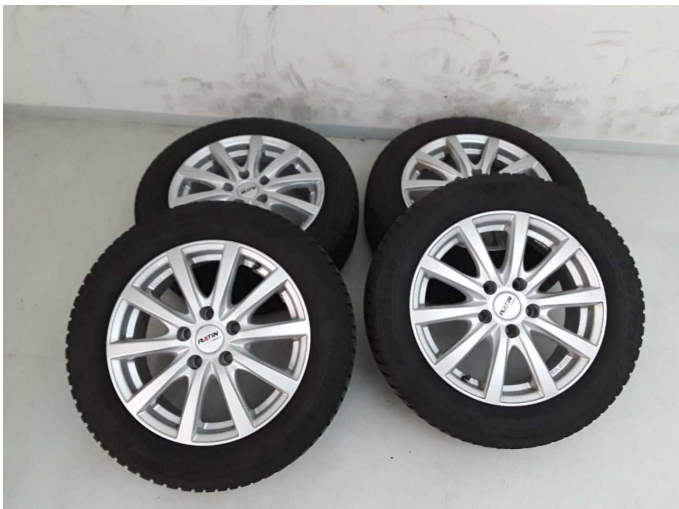
Figure 18: Additional tyres

| # | Tyre size | Type of tyre | Manufacturer | Tread depth |
|---|---|---|---|---|
| 1) | 205/60 R16 92H | Winter tyres on Light alloy | Goodyear | 3mm / 3mm |
| 2) | 205/60 R16 92H | Winter tyres on Light alloy | Goodyear | 5mm / 5mm |

| No. | Component group | Description |
|---|---|---|
| 1 | 2nd wheel set | 2 tyres - does not meet manufacturer specifications - No deduction |

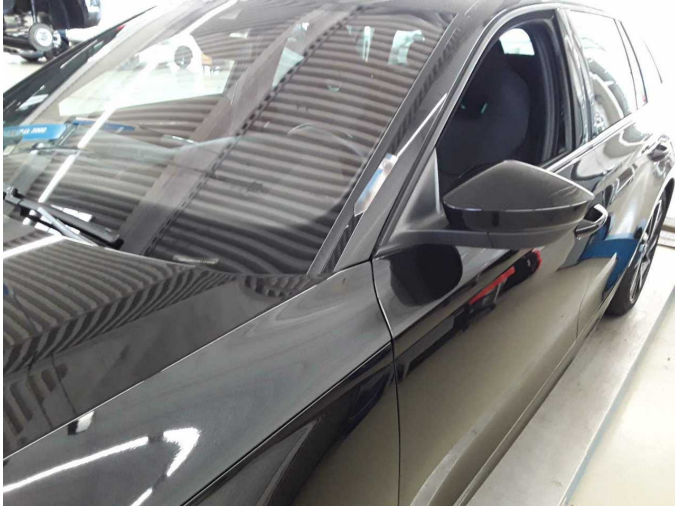
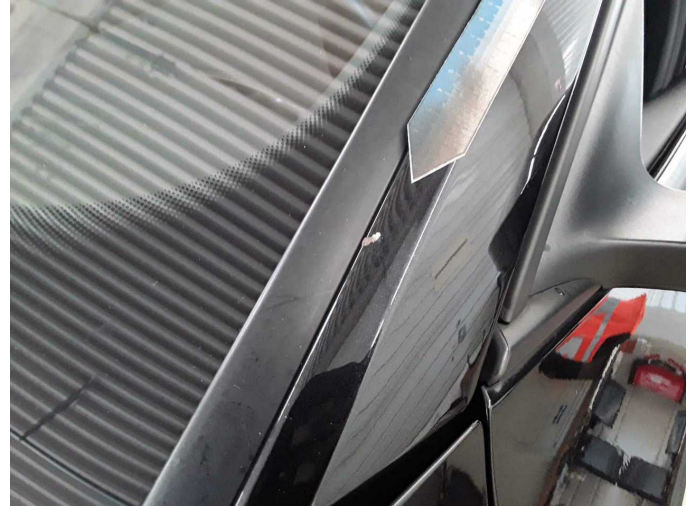
| No. | Component group | Description |
|---|---|---|
| 1 | Body | A-pillar - left side (Korrosion) - Stone chips - Smart repair |

**Damage 1:** Body: A-pillar - left side (Korrosion) - Stone chips - Smart repair

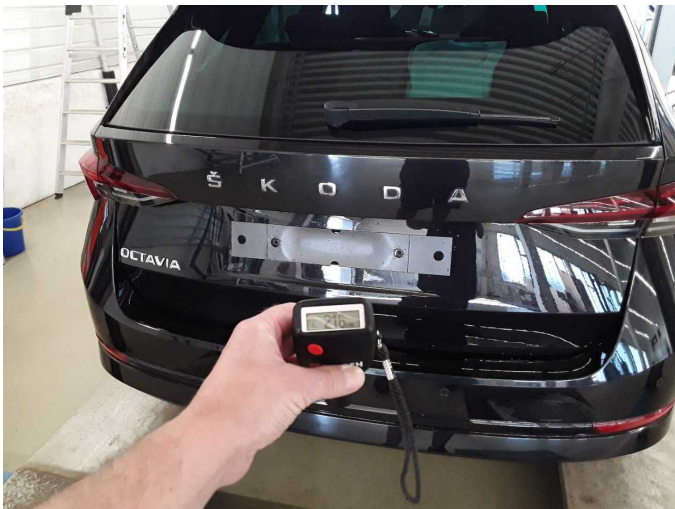
1 Boot lid / rear door, Professionally carried out

Boot lid / rear door 216 µm |

**Boot lid / rear door:** 216  $\mu\text{m}$
