Expertise

Protocol number: 46480466  
Order No. / Reference: 26589008  
Inspection date: 13 Jul 2026

| Manufacturer: MAN | Model: TGE 3.140 4X2F SB 3,5T (03V) |
| VIN: WMA03VUY6P9009542 | |

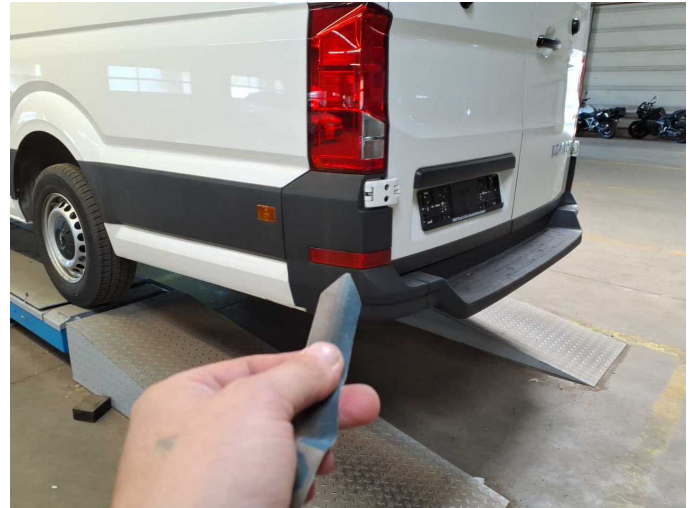
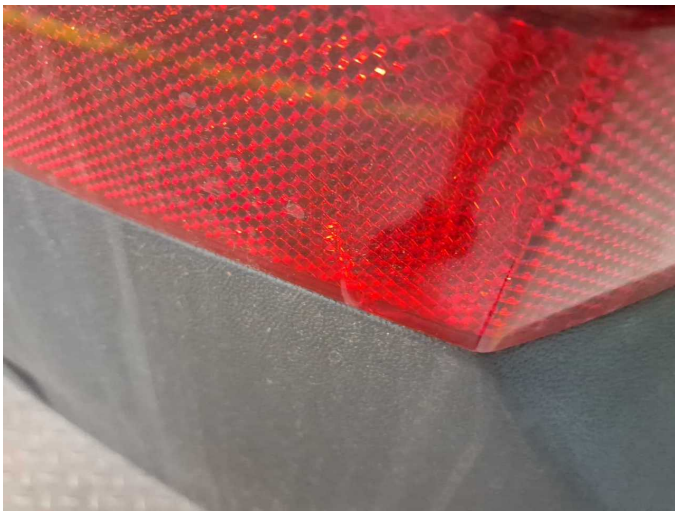
| No. | Component group | Description |
|---|---|---|
| 1 | Tail light | Tail lamp - left side (Reflektor) - Broken / torn - Replace |

**Damage 1:** Tail light: Tail lamp - left side (Reflektor) - Broken / torn - Replace

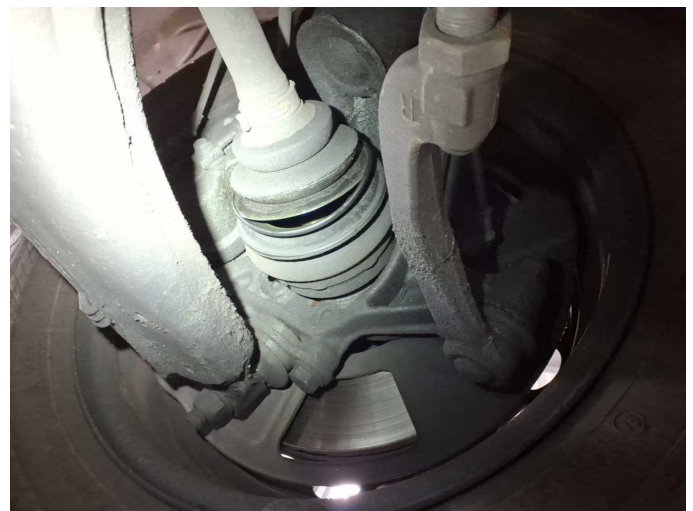
| No. | Component group | Description |
|---|---|---|
| 2 | Drive train | Sleeve prop shaft - front right side - Broken / torn - Replace |

**Damage 2:** Drive train: Sleeve prop shaft - front right side - Broken / torn - Replace
