Expertise

Protocol number: 45883462
Order No. / Reference: 26453961
Inspection date: 10 Jun 2026

Model: Tiguan 2.0 TDI SCR 4MOTION DSG Elegance

VIN: WVGZZZ5NZNW032182

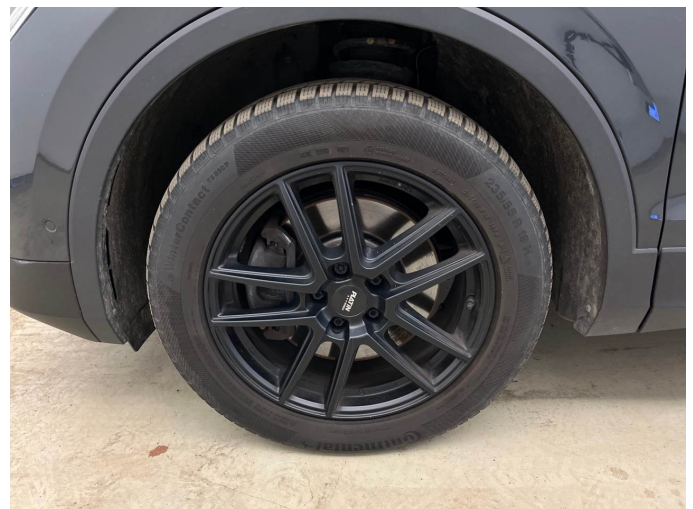
Figure 12: Mounted tyres

Mounted tyres				
#	Tyre size	Type of tyre	Manufacturer	Tread depth
1)	235/55 R18 100H	Winter tyres on Light alloy	Continental	4mm / 4mm
2)	235/55 R18 100H	Winter tyres on Light alloy	Continental	5mm / 5mm
Additional tyres				
#	Tyre size	Type of tyre	Manufacturer	Tread depth
1)	235/50 R19 103W	Summer tyres on Light alloy	Hankook	5mm / 5mm
2)	235/50 R19 103W	Summer tyres on Light alloy	Hankook	6mm / 6mm

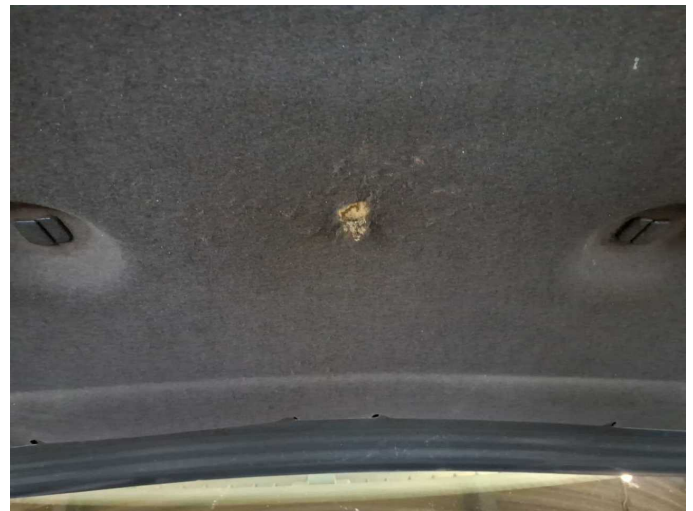
Damage 1: Bonnet: Insulation lining - Damage caused by marten / rodent
- Replace

No.	Component group	Description
1	Bonnet	Insulation lining - Damage caused by marten / rodent - Replace
2	Door - rear right side	Door handle - inside - Deformed - Replace

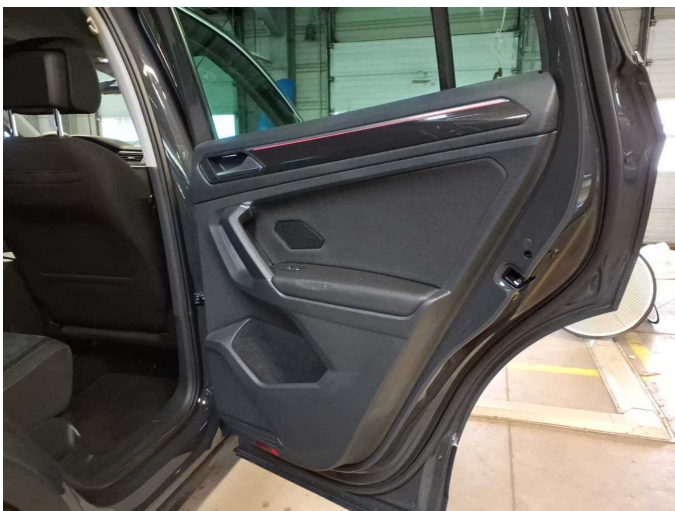
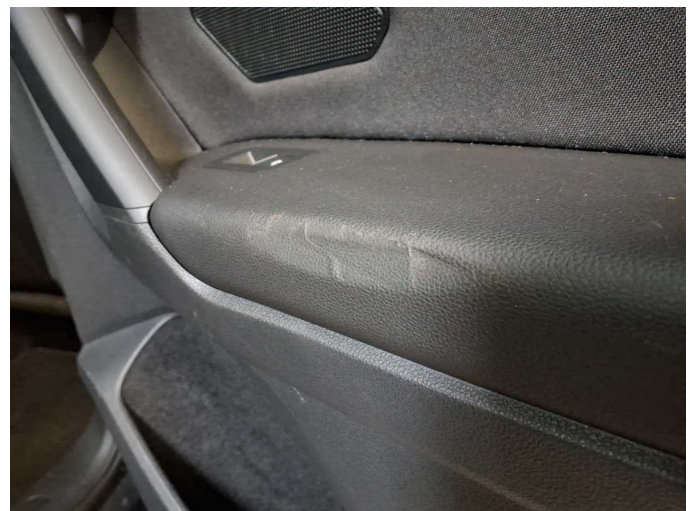
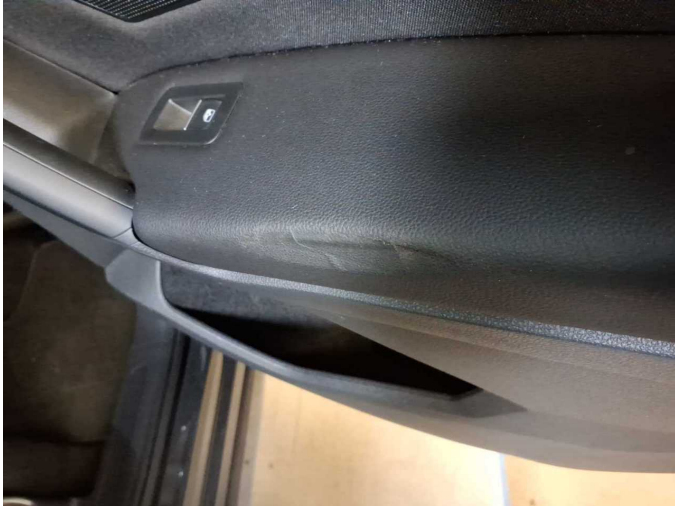
Damage 2: Door - rear right side: Door handle - inside - Deformed -
Replace

Damage 2: Door - rear right side: Door handle - inside - Deformed - Replace

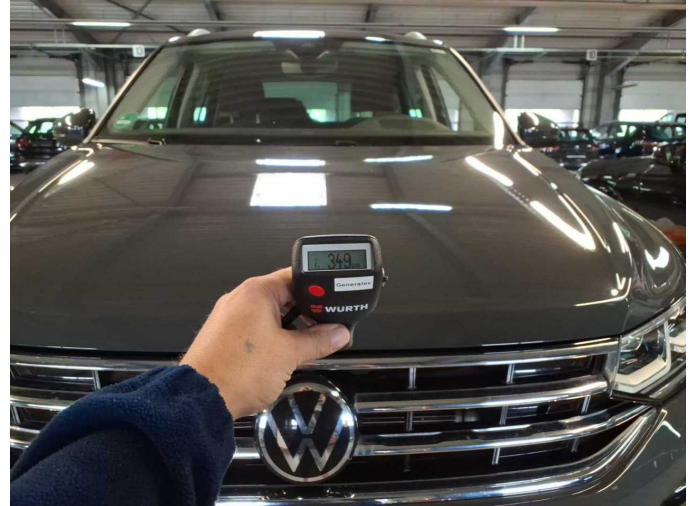
Bonnet	349 µm	Side panel - rear right side	211 µm
Door - rear right side	170 µm

Repainting 1: Bonnet

- 1 Bonnet, Professionally carried out, Invoice of repair done Non-existent
- 2 Side panel - rear right side, Professionally carried out, Invoice of repair done Non-existent
- 3 Door - rear right side, Professionally carried out, Invoice of repair done Non-existent

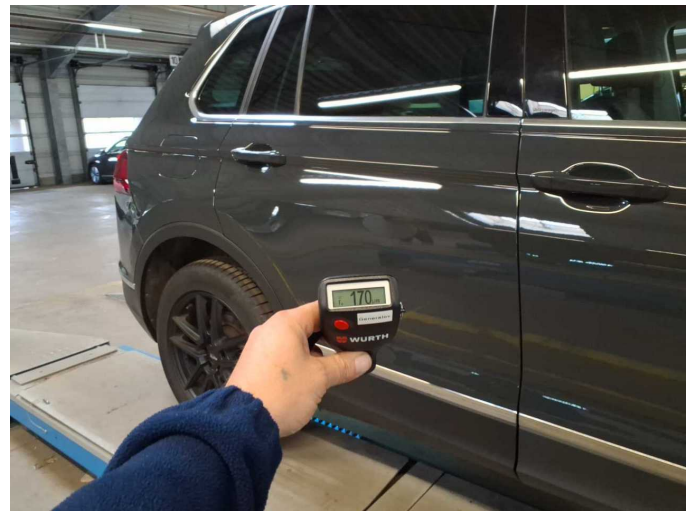
Repainting 3: Door - rear right side
