Expertise

Protocol number: 46234255  
Order No. / Reference: 26631490  
Inspection date: 30 Jun 2026

Manufacturer: Volkswagen

Model: Passat Variant 2.0 TDI SCR DSG Business

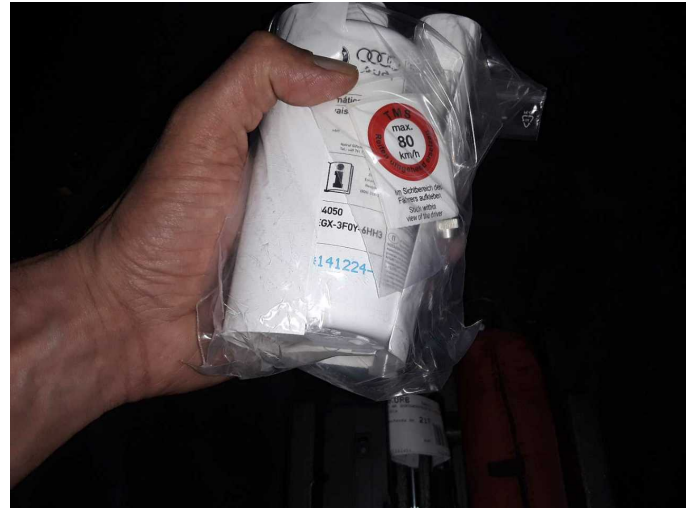
| No. | Component group | Description |
|---|---|---|
| 2 | Equipment | Tirefit filler - Due - Replace |

**Damage 2:** Equipment: Tirefit filler - Due - Replace

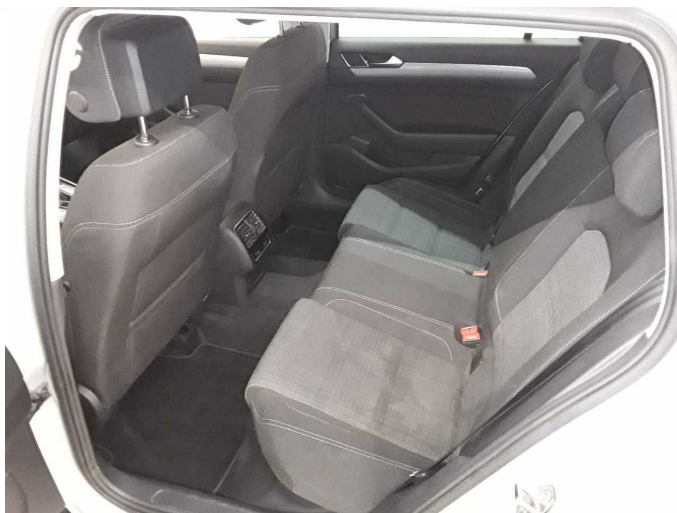
| No. | Component group | Description |
|---|---|---|
| 3 | Seat - rear | Back seat - Soiled - Clean |

**Damage 3:** Seat - rear: Back seat - Soiled - Clean

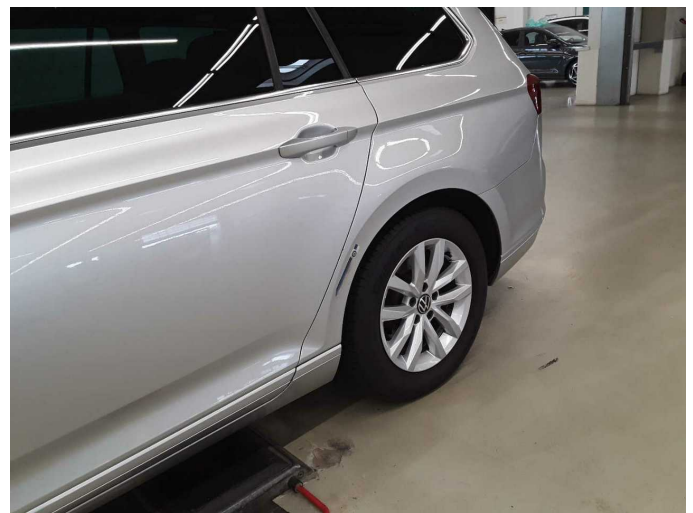
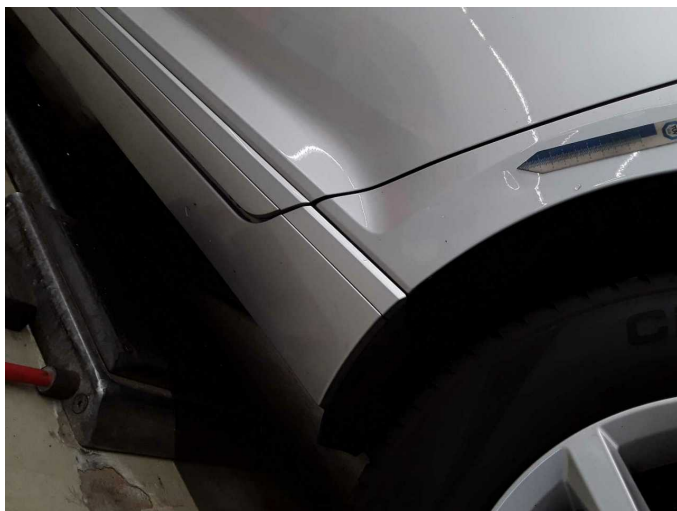
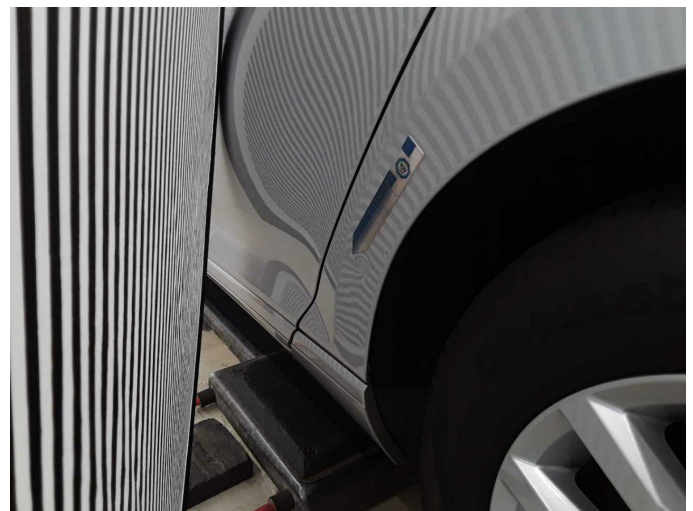
| No. | Component group | Description |
|---|---|---|
| 4 | Side panel - rear left side | Side panel - dent(s) - Smart repair |

**Damage 4:** Side panel - rear left side: Side panel - dent(s) - Smart repair

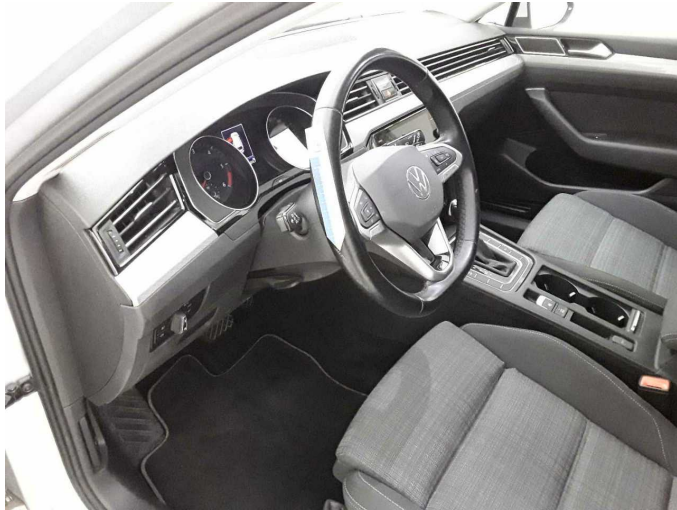
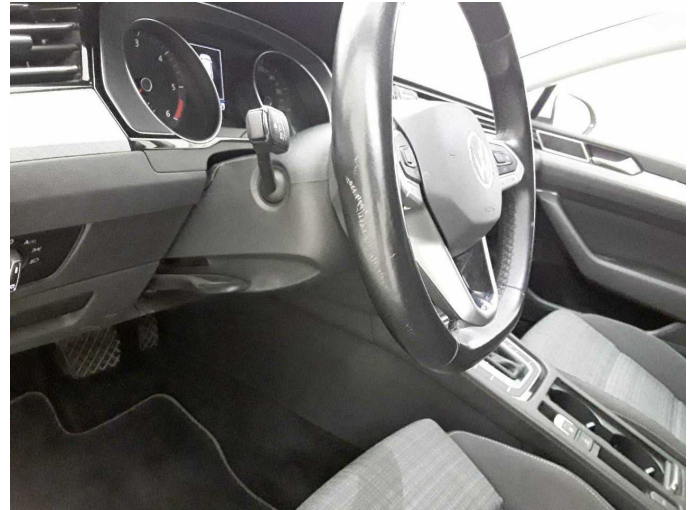
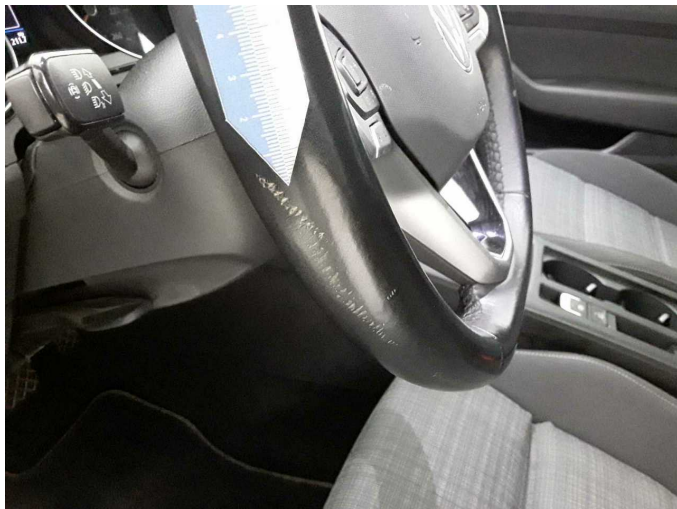
| No. | Component group | Description |
|---|---|---|
| 5 | Steering system | Steering wheel sheath - Scratched - Smart repair |

**Damage 5:** Steering system: Steering wheel sheath - Scratched - Smart repair

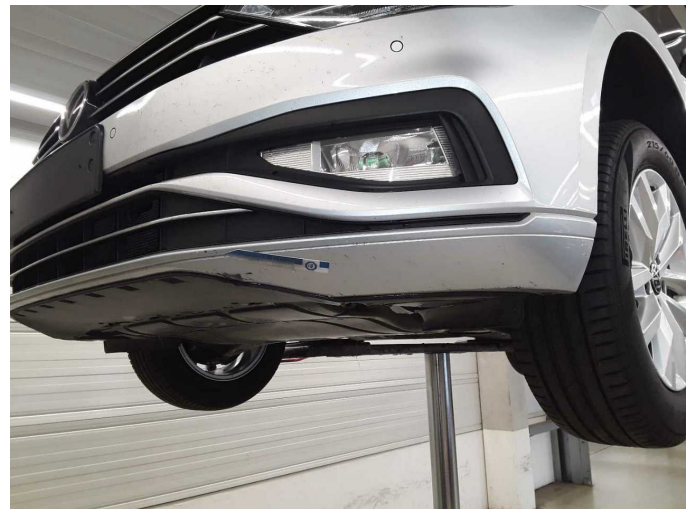
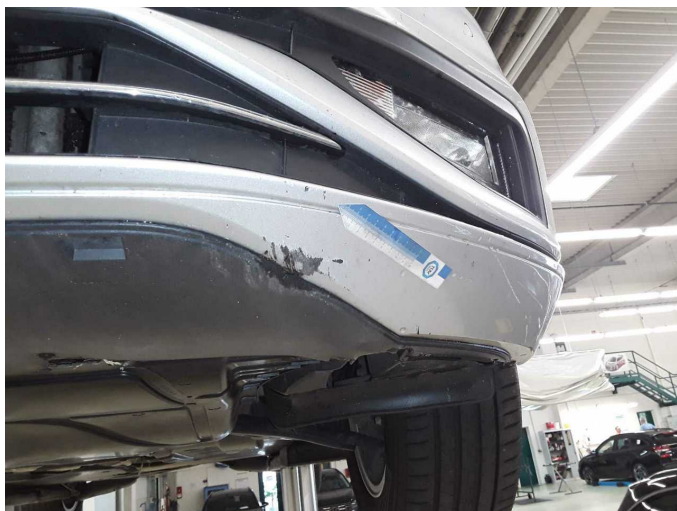
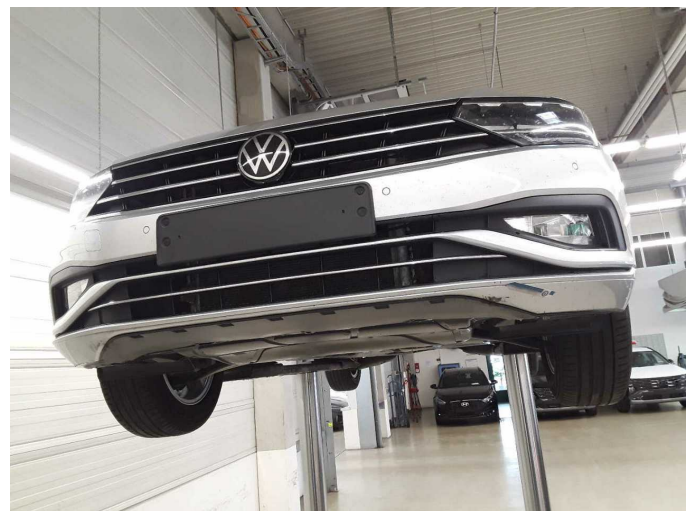
| No. | Component group | Description |
|---|---|---|
| 6 | Front bumper | Front bumper - Scratched - Smart repair |

**Damage 6:** Front bumper: Front bumper - Scratched - Smart repair

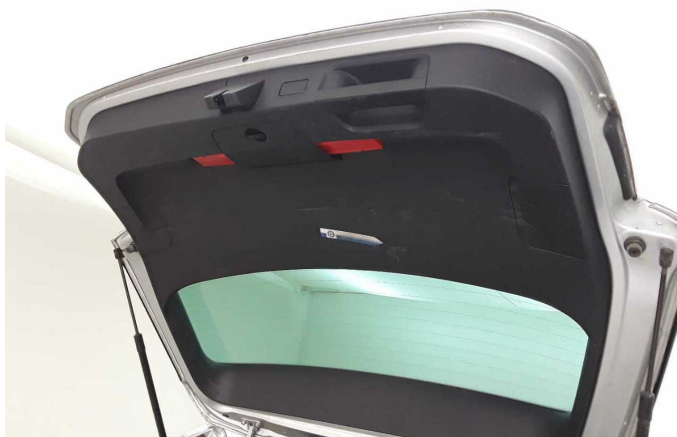
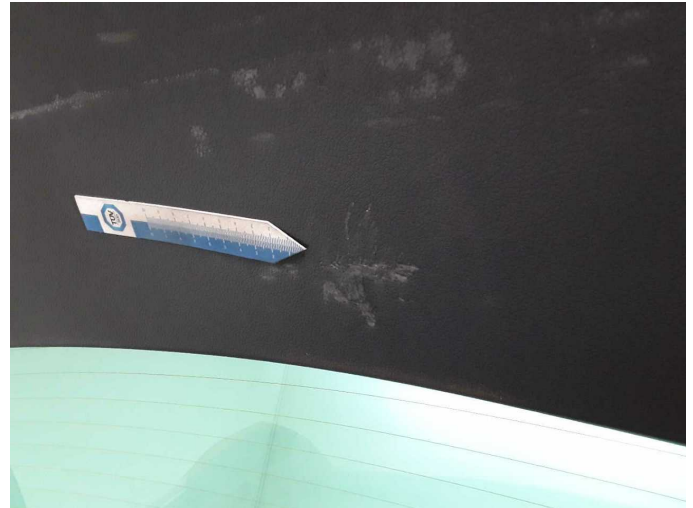
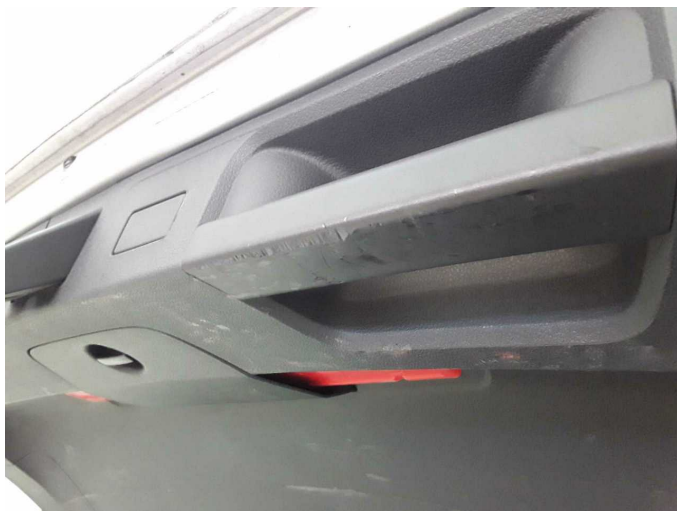
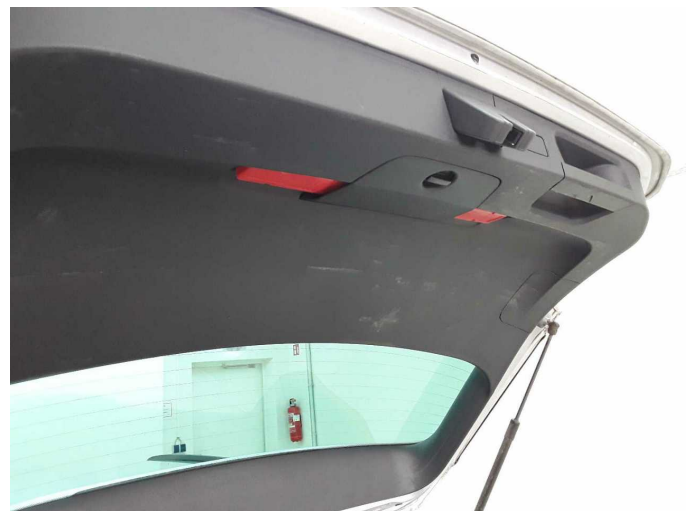
| No. | Component group | Description |
|---|---|---|
| 7 | Boot lid / rear door | Trim - standard - lower - Scratched - Replace |

**Damage 7:** Boot lid / rear door: Trim - standard - lower - Scratched - Replace

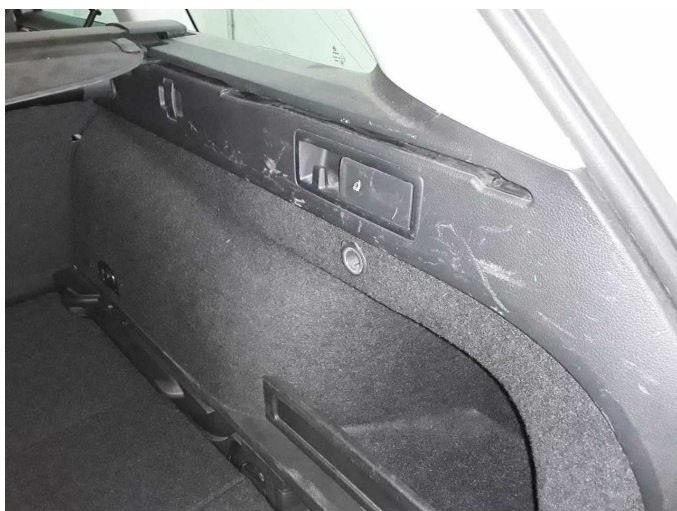
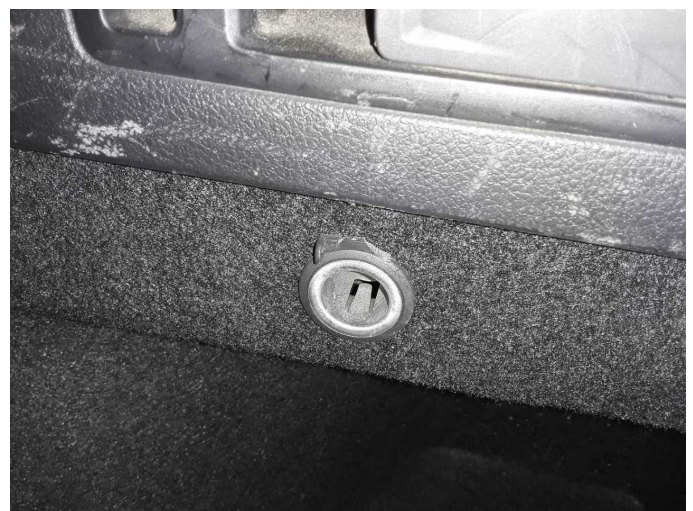
| No. | Component group | Description |
|---|---|---|
| 8 | Trim / covers | Cargo area - lining - right side (Steckdosendeckel) - Broken / torn - Replace |

**Damage 8:** Trim / covers: Cargo area - lining - right side (Steckdosendeckel) - Broken / torn - Replace

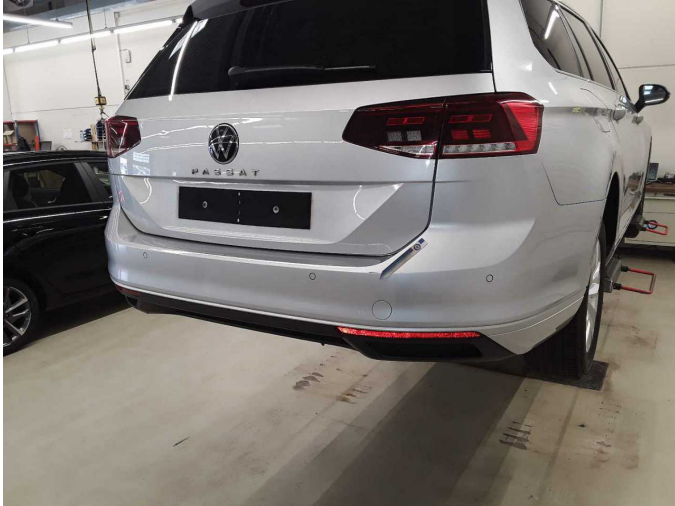
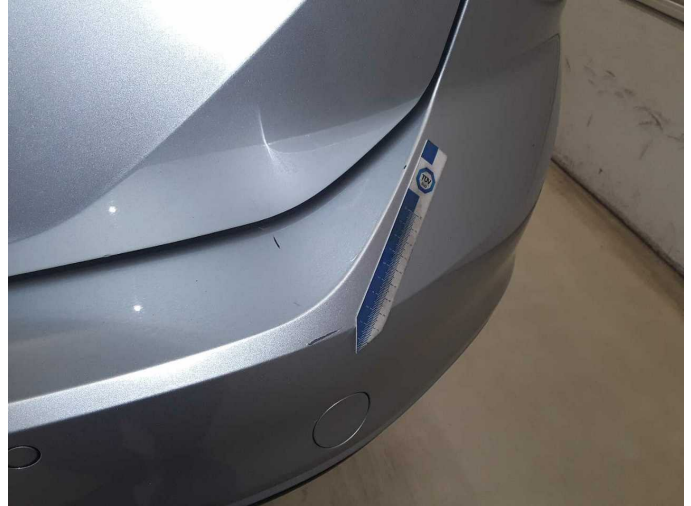
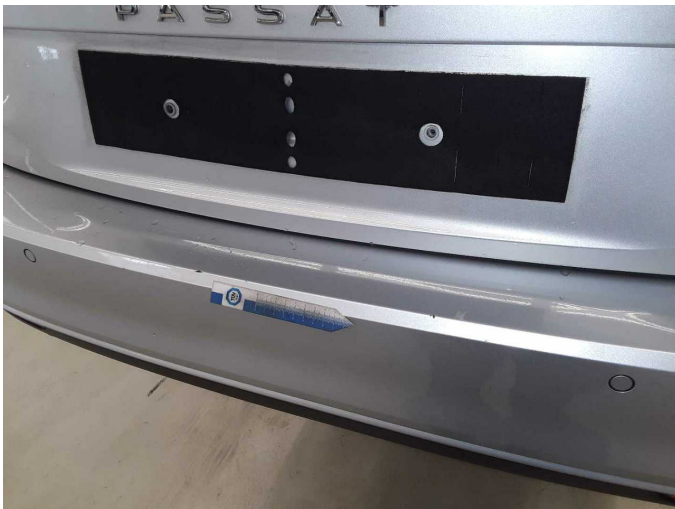
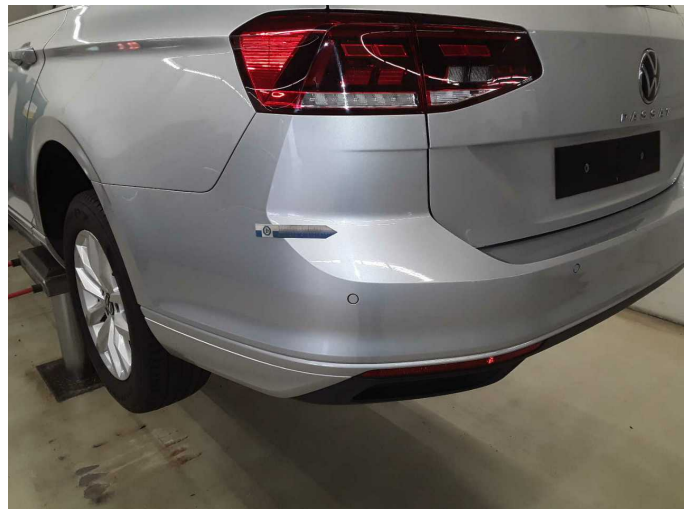
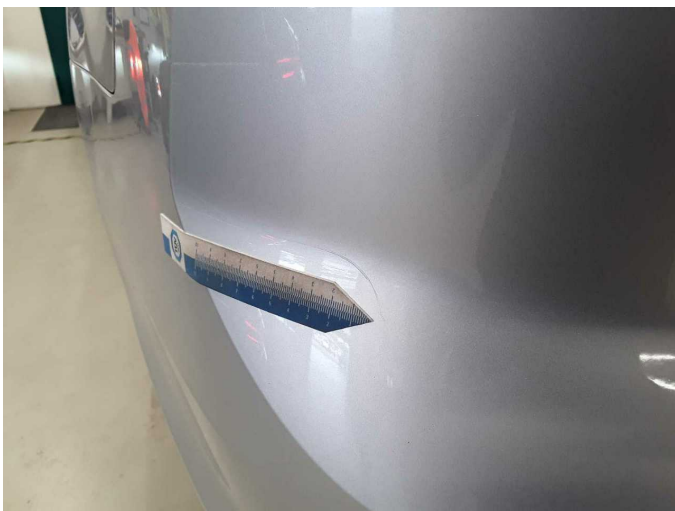
| No. | Component group | Description |
|---|---|---|
| 9 | Rear bumper | Rear bumper - Scratched - Paint |

**Damage 9:** Rear bumper: Rear bumper - Scratched - Paint
