Expertise

Protocol number: 46585070  
Order No. / Reference: 26631227  
Inspection date: 16 Jul 2026

Manufacturer: Skoda  
VIN: TMBJC7NY5PF050712

Model: Enyaq iV 80

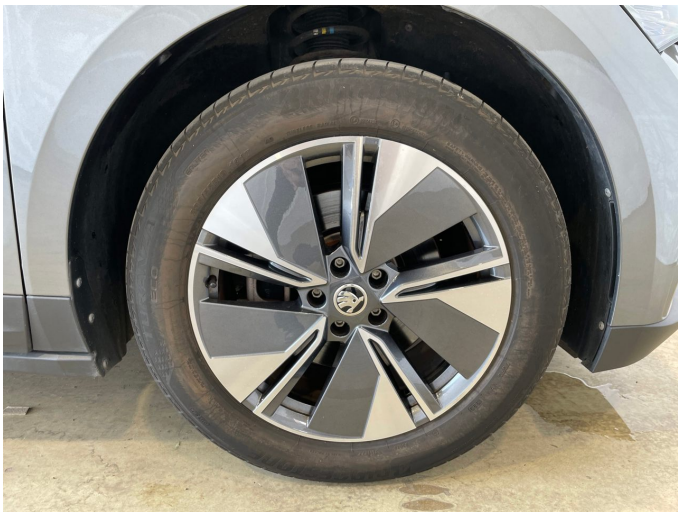
Figure 12: Mounted tyres

| # | Tyre size | Type of tyre | Manufacturer | Tread depth |
|---|---|---|---|---|
| 1) | 235/55 R19 101T | Summer tyres on Light alloy | Bridgestone | 4mm / 4mm |
| 2) | 255/50 R19 103T | Summer tyres on Light alloy | Bridgestone | 6mm / 6mm |

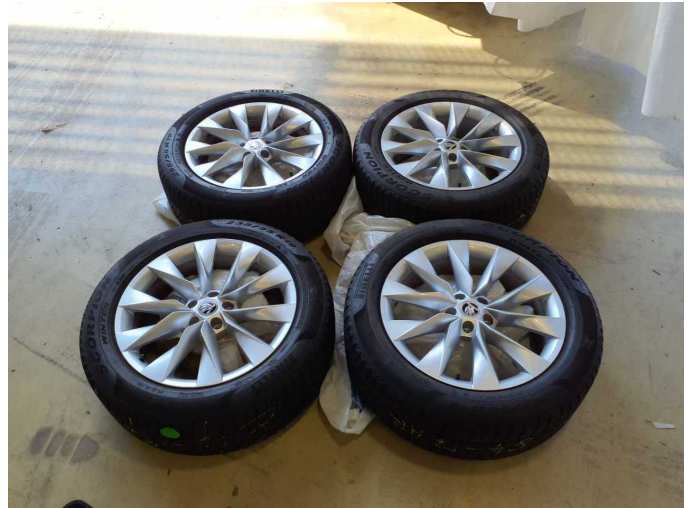
Figure 14: Additional tyres

| # | Tyre size | Type of tyre | Manufacturer | Tread depth |
|---|---|---|---|---|
| 1) | 235/55 R19 101T | Winter tires (with run-flat tires) on Light alloy | Pirelli | 5mm / 5mm |
| 2) | 255/50 R19 103T | Winter tires (with run-flat tires) on Light alloy | Pirelli | 6mm / 6mm |

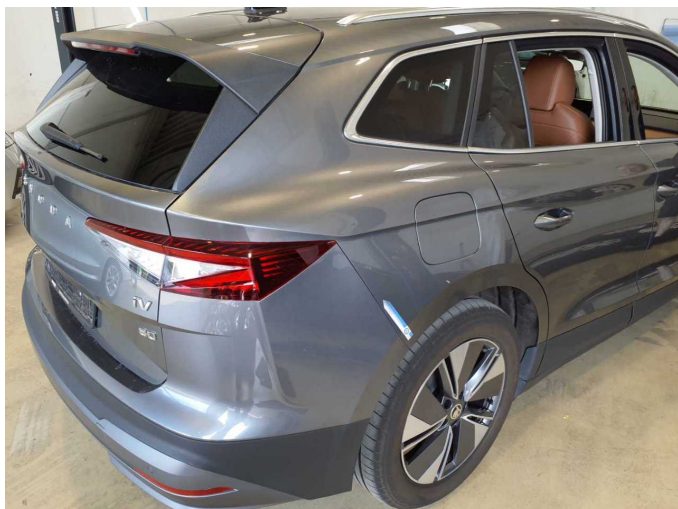
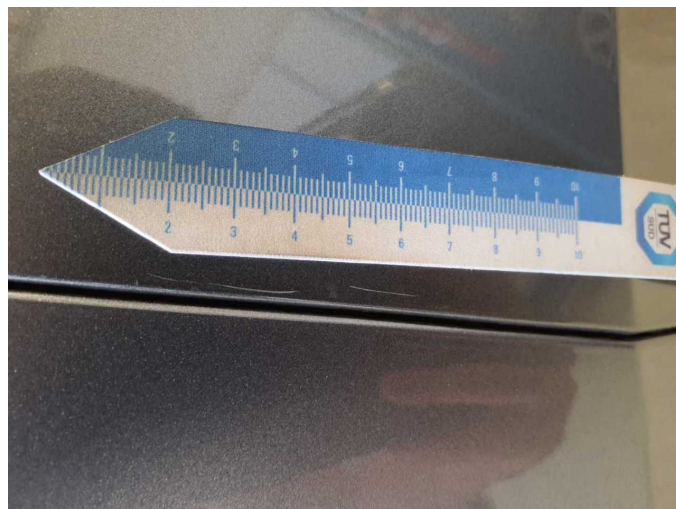
| No. | Component group | Description |
|---|---|---|
| 2 | Side panel - rear right side | Side panel - Scratch(es) - Paint |

**Damage 2:** Side panel - rear right side: Side panel - Scratch(es) - Paint
