Expertise

Protocol number: 46104707  
Order No. / Reference: 26457139  
Inspection date: 23 Jun 2026

Manufacturer: Ford

Model: S-Max 2.0 EcoBlue Aut. TITANIUM

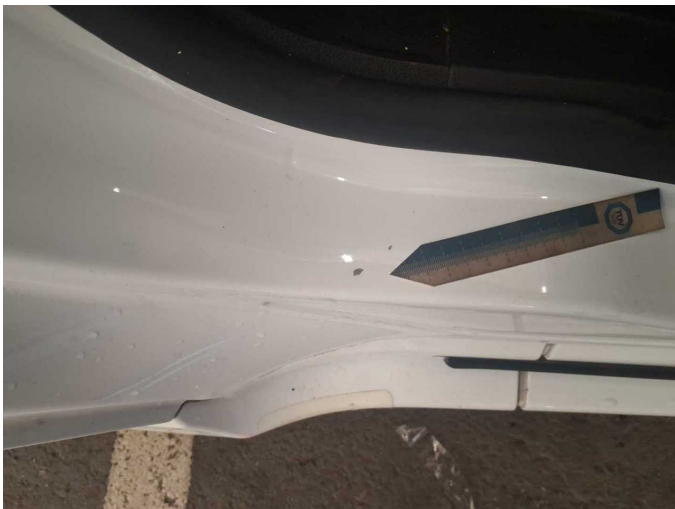
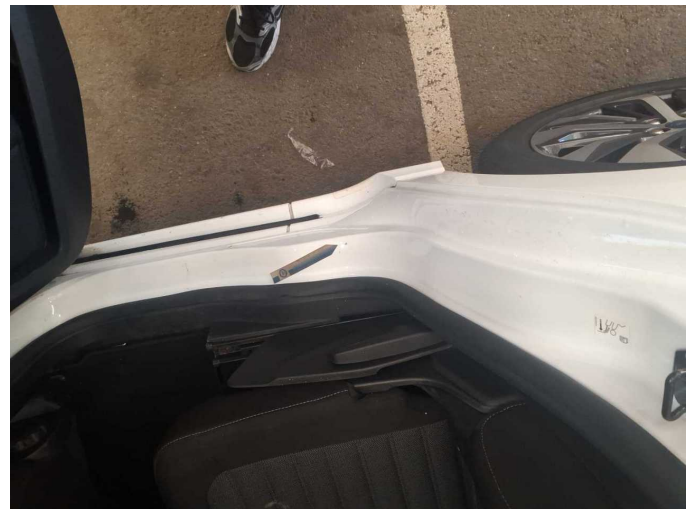
Damage 2: Side panel - rear right side: Sill - Scratch(es) - Smart repair

| No. | Component group | Description |
|---|---|---|
| 2 | Side panel - rear right side | Sill - Scratch(es) - Smart repair |

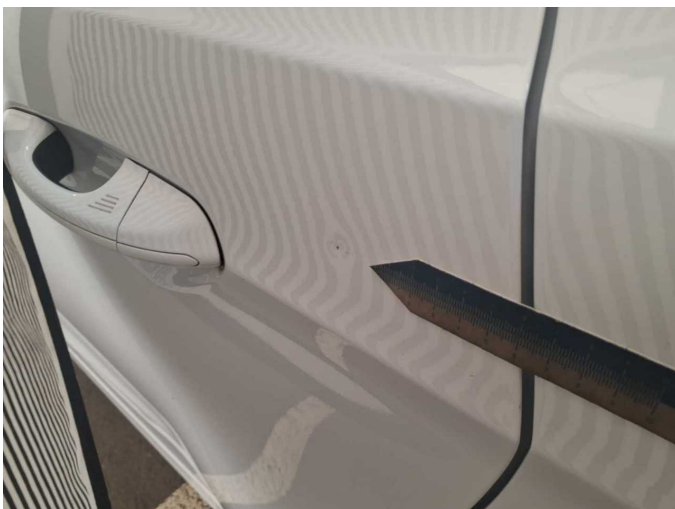
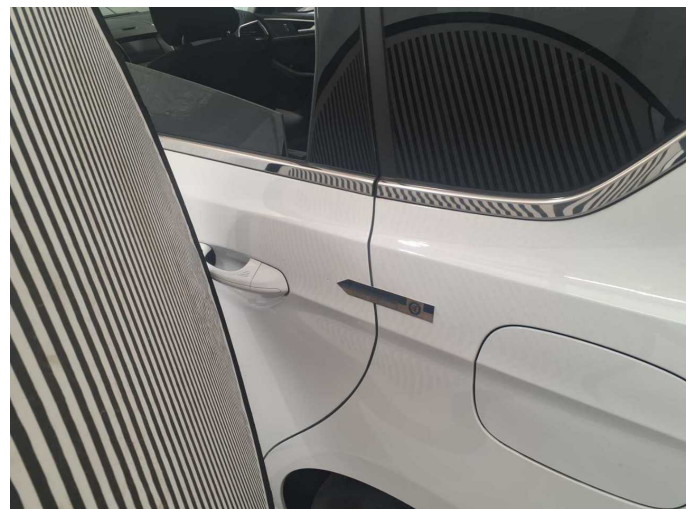
Damage 3: Door - rear left side: Door - Dent / paintcoat damage - Smart repair

| No. | Component group | Description |
|---|---|---|
| 3 | Door - rear left side | Door - Dent / paintcoat damage - Smart repair |

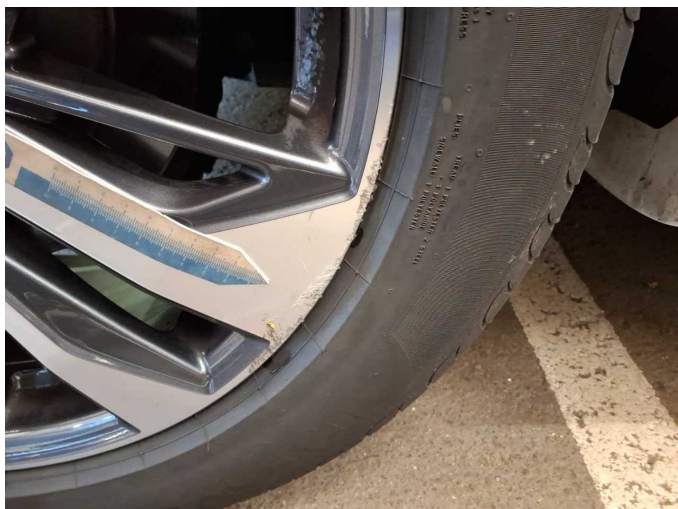
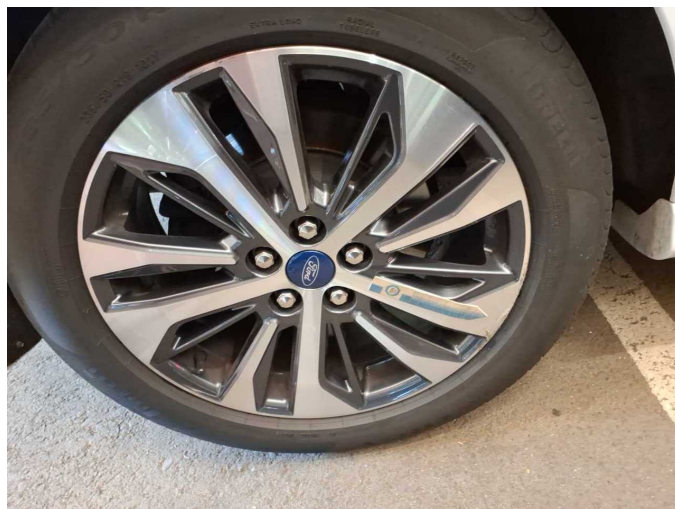
**Damage 4:** Wheel / tyres: Alloy rim - rear right side (Materialabtrag) - Scratch(es) - Replace

| No. | Component group | Description |
|---|---|---|
| 4 | Wheel / tyres | Alloy rim - rear right side (Materialabtrag) - Scratch(es) - Replace |

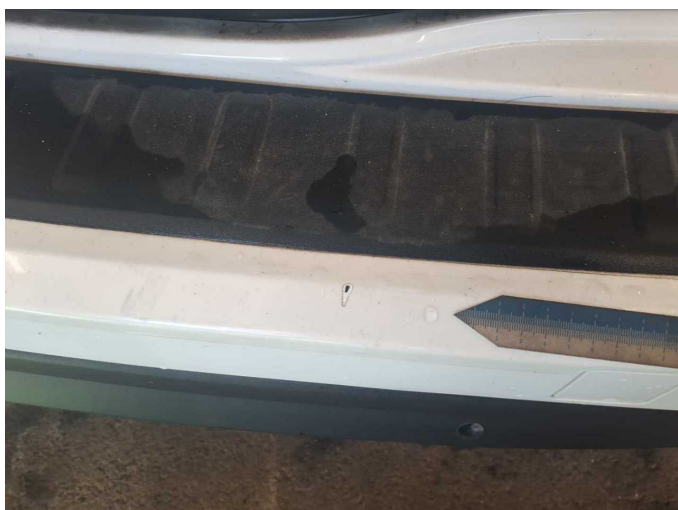
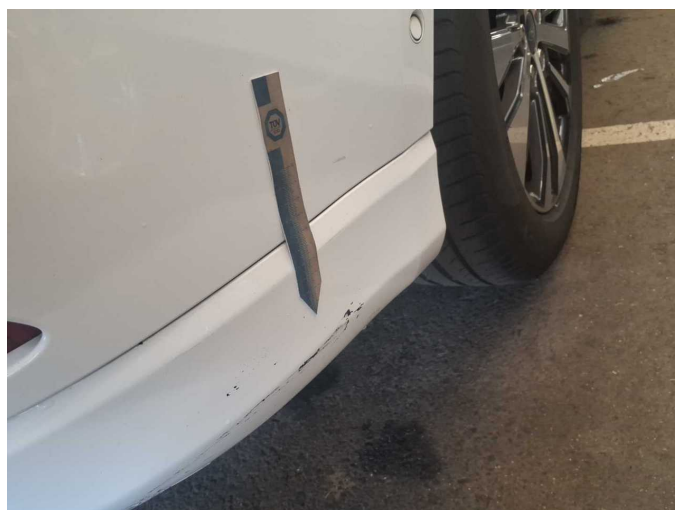
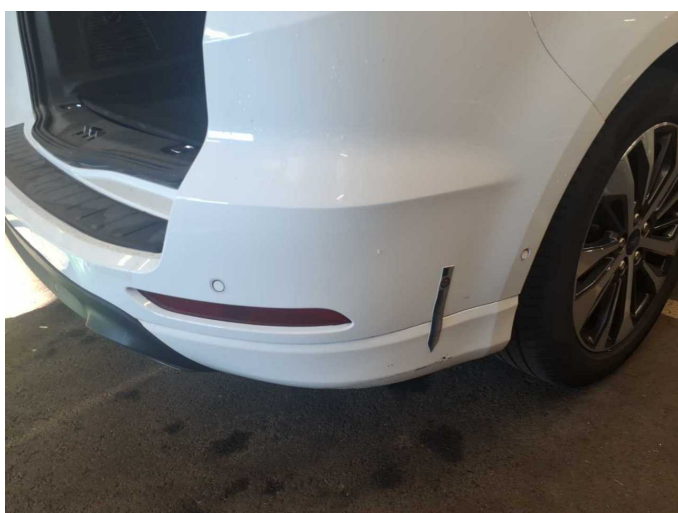
**Damage 5:** Rear bumper: Rear bumper - Scratch(es) - Paint

| No. | Component group | Description |
|---|---|---|
| 5 | Rear bumper | Rear bumper - Scratch(es) - Paint |

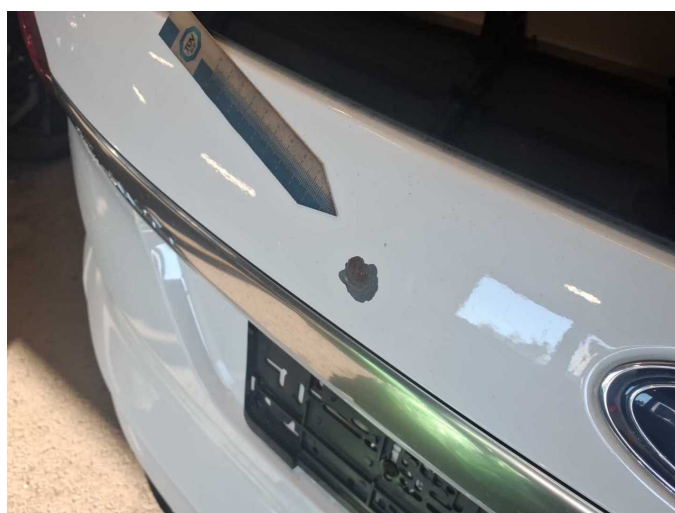
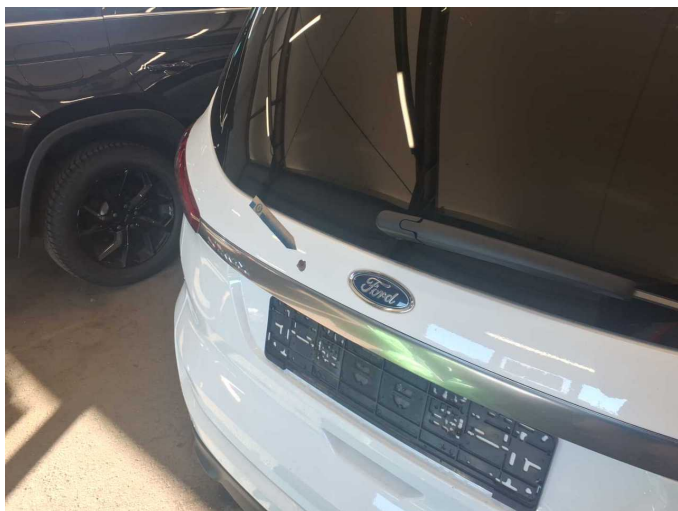
**Damage 6:** Boot lid / rear door: Boot lid - Corrosion - Repair and paint

| No. | Component group | Description |
|---|---|---|
| 6 | Boot lid / rear door | Boot lid - Corrosion - Repair and paint |

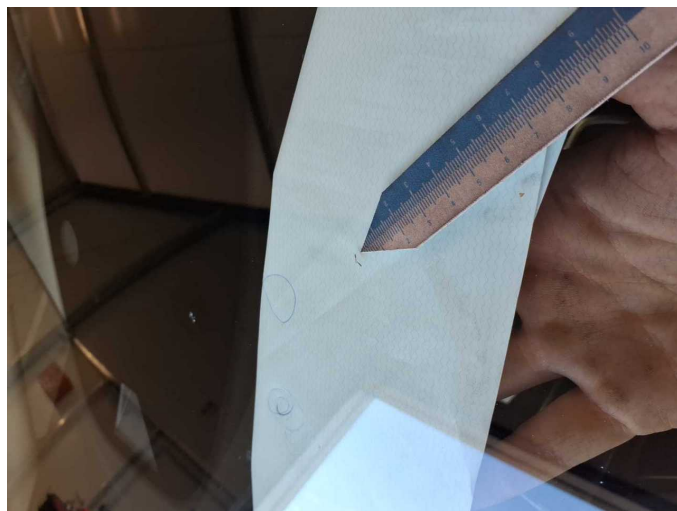
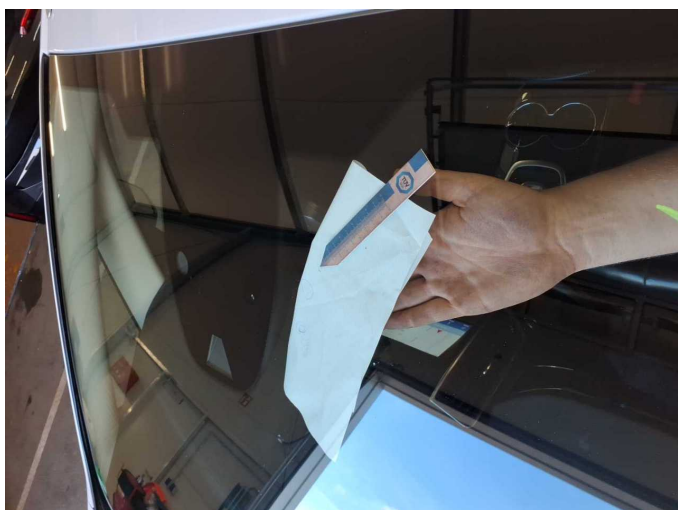
**Damage 7:** Vehicle glazing: Windscreen (Beheizbare Frontscheibe) - Stone chips - Replace

| No. | Component group | Description |
|---|---|---|
| 7 | Vehicle glazing | Windscreen (Beheizbare Frontscheibe) - Stone chips - Replace |

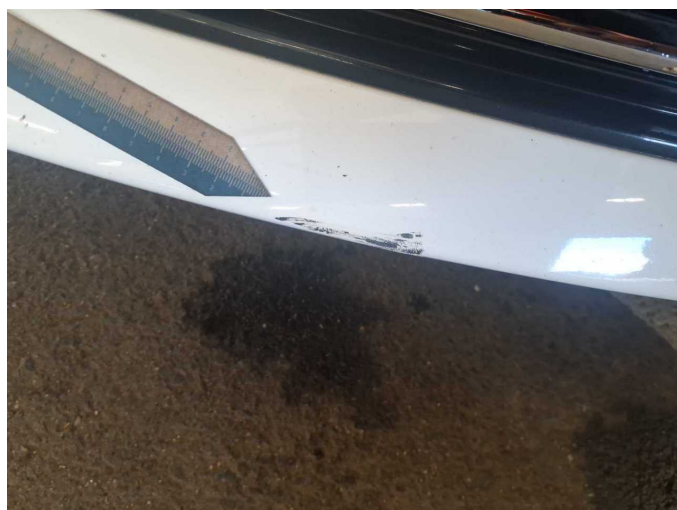
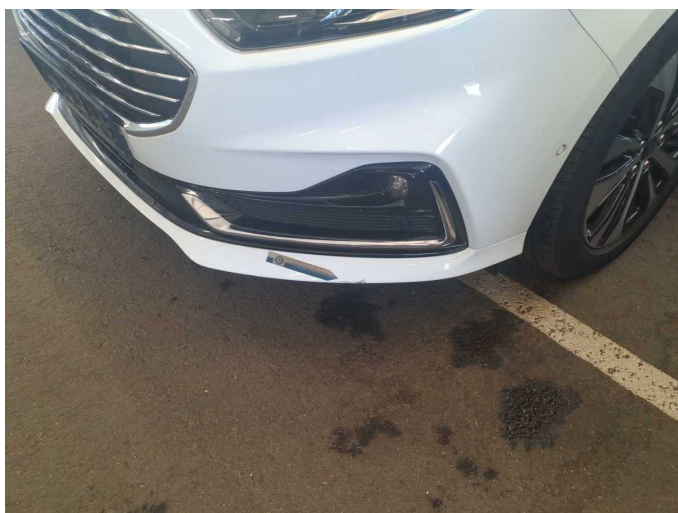
**Wear and tear 4:** Front bumper: Front bumper - Scratched - Paint

| No. | Component group | Description |
|---|---|---|
| 4 | Front bumper | Front bumper - Scratched - Paint |

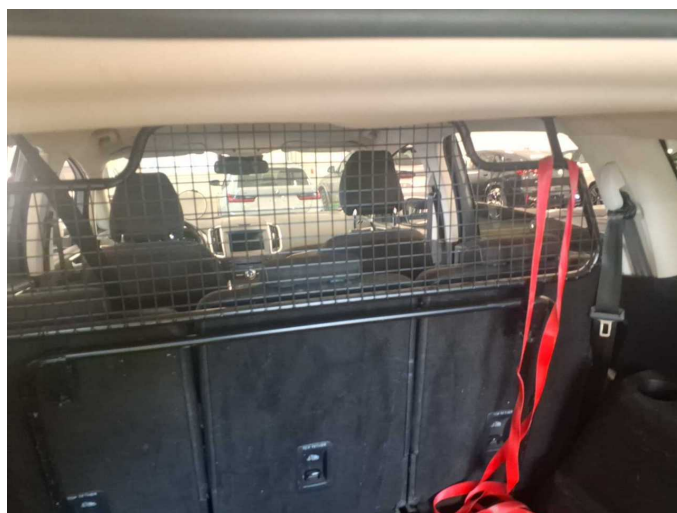
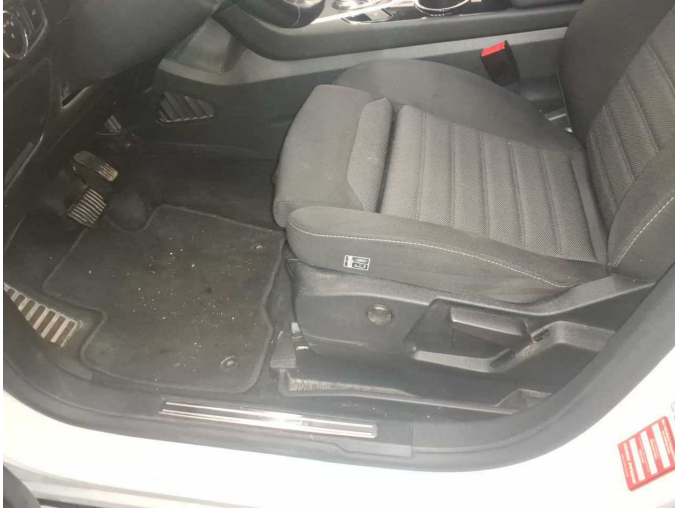
**Missing part 1:** Equipment: Fire extinguisher - Missing - Replace

Equipment - Fire extinguisher

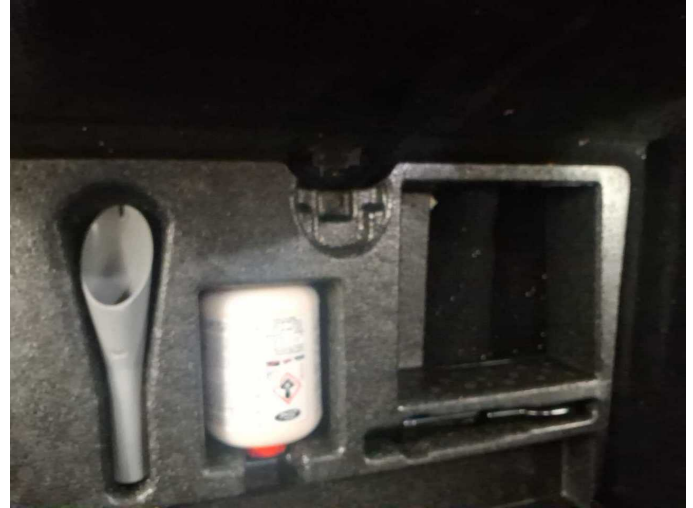
**Missing part 2:** Equipment: Tirefit compressor - Missing - Replace

Equipment - Tirefit compressor
