Expertise

Protocol number: 46493624  
Order No. / Reference: 26504664  
Inspection date: 13 Jul 2026

Manufacturer: Opel

Model: Grandland 1.5 D Automatik Elegance

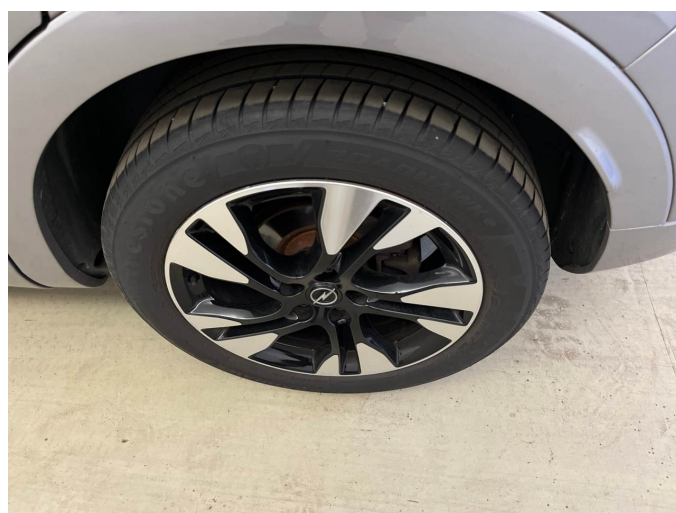
Figure 12: Mounted tyres

| Tyres | | | | |
|---|---|---|---|---|
| 1) | 225/55 R18 98V | Summer tyres on Light alloy | Firestone | 5mm / 5mm |
| 2) | 225/55 R18 98V | Summer tyres on Light alloy | Firestone | 5mm / 5mm |

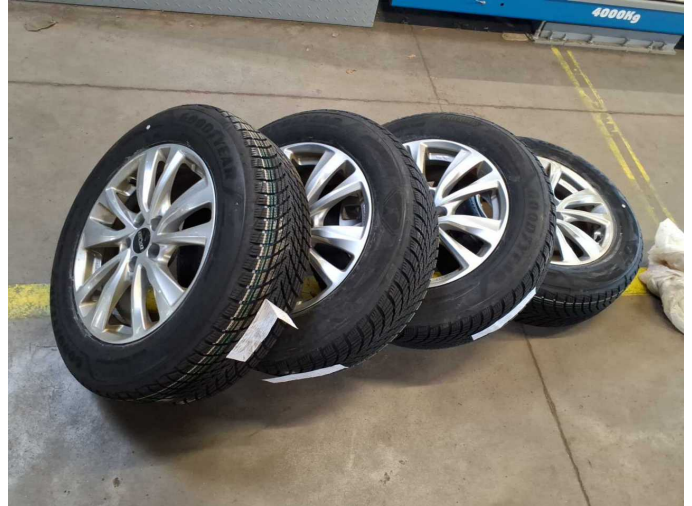
Figure 14: Additional tyres

| Tyres | | | | |
|---|---|---|---|---|
| 1) | 215/65 R17 98H | Winter tyres on Light alloy | Goodyear | 9mm / 9mm |
| 2) | 215/65 R17 98H | Winter tyres on Light alloy | Goodyear | 9mm / 9mm |

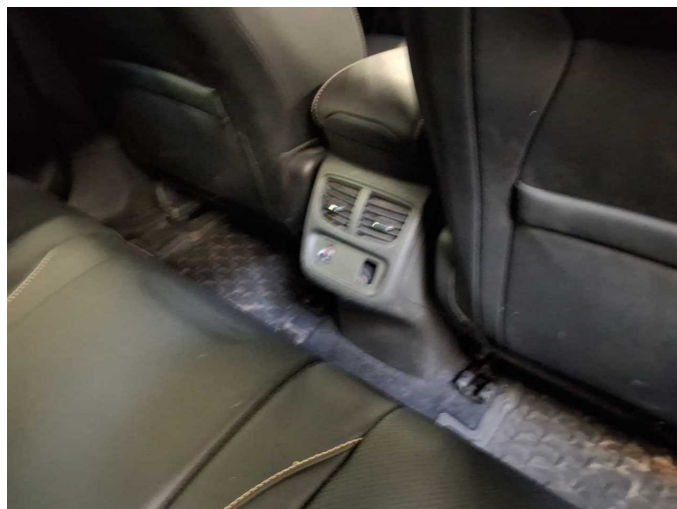
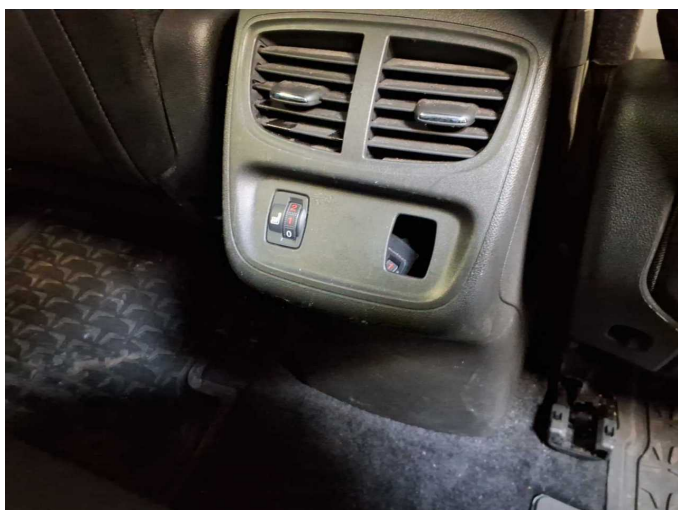
| No. | Component group | Description |
|---|---|---|
| 1 | Electrical system | Switch (Sitz Heizung hinten) - Damaged - Replace |

**Damage 1:** Electrical system: Switch (Sitz Heizung hinten) - Damaged - Replace

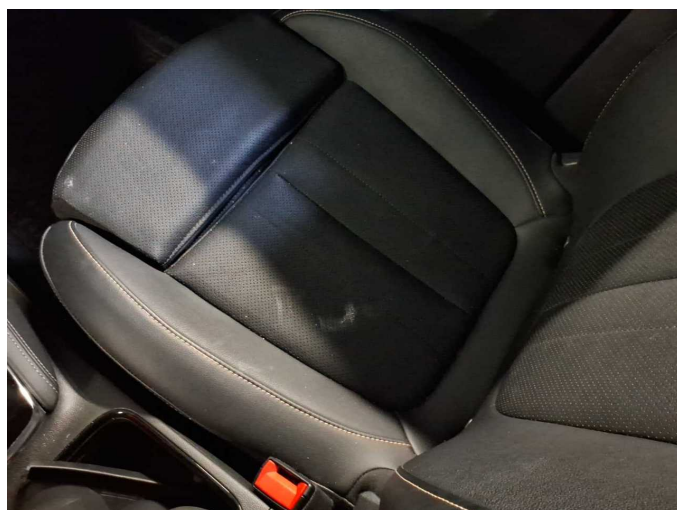
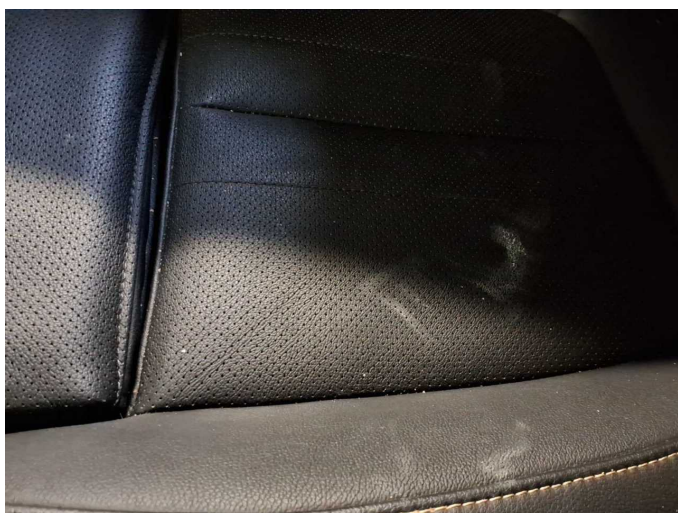
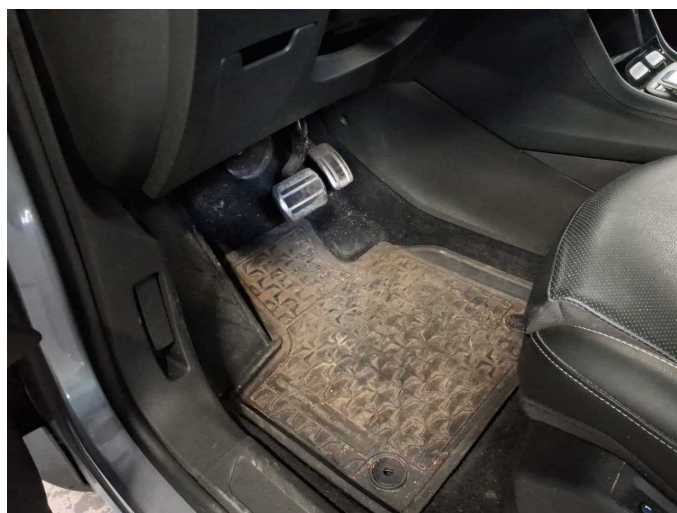
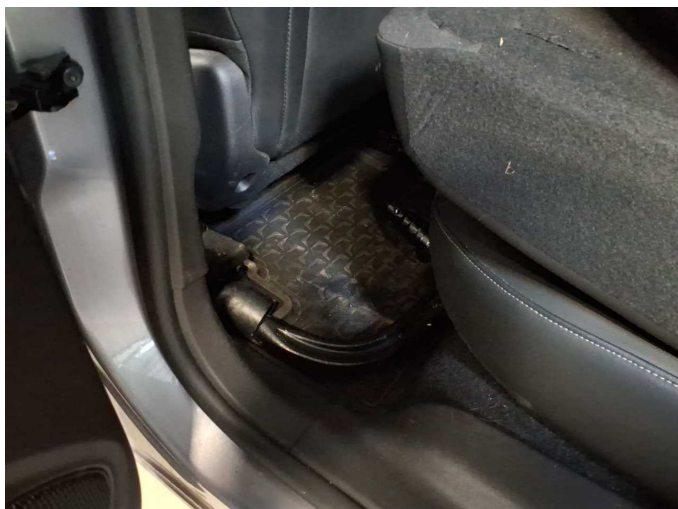
| No. | Component group | Description |
|---|---|---|
| 2 | Interior | Interior - Soiled - Clean |

**Damage 2:** Interior: Interior - Soiled - Clean

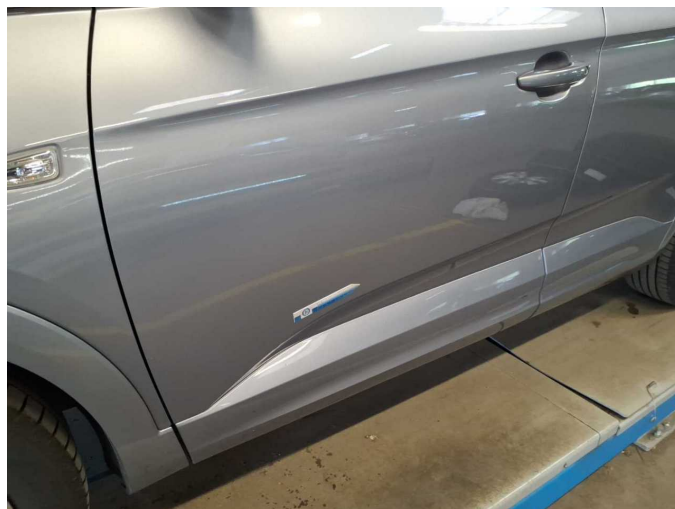
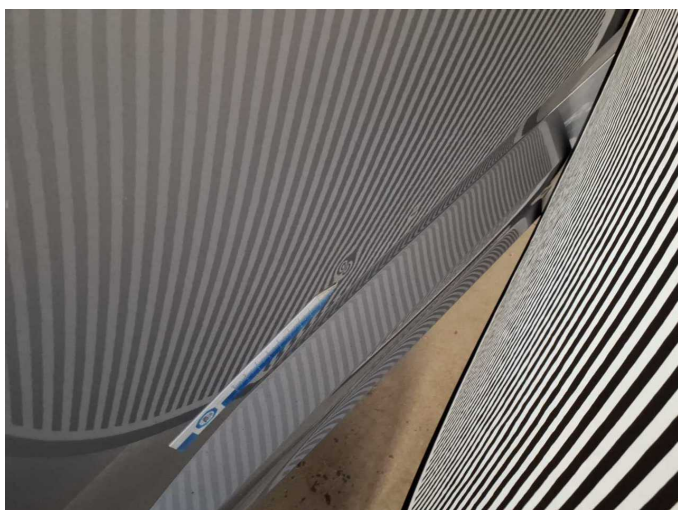
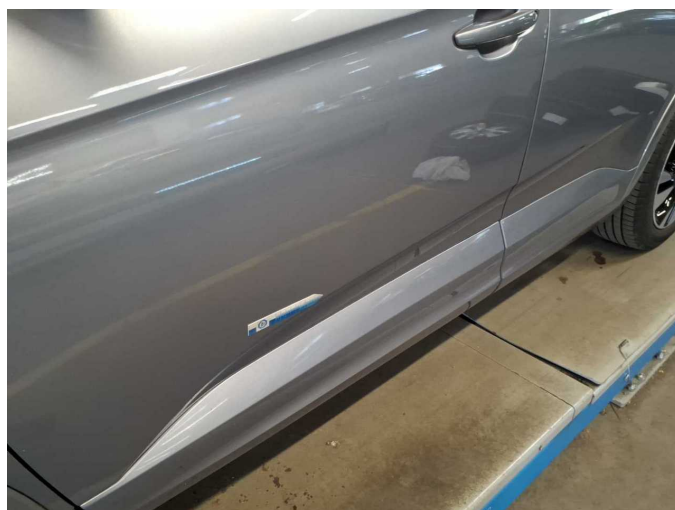
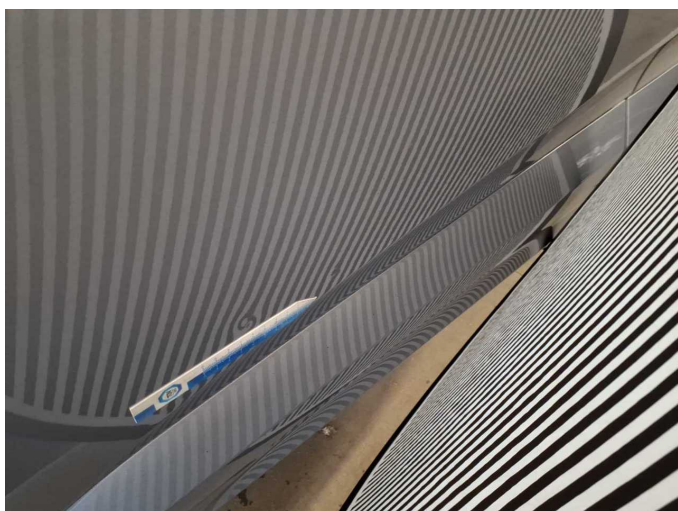
| No. | Component group | Description |
|---|---|---|
| 3 | Door - front left side | Door - dent(s) - Smooth repair work |

**Damage 3:** Door - front left side: Door - dent(s) - Smooth repair work

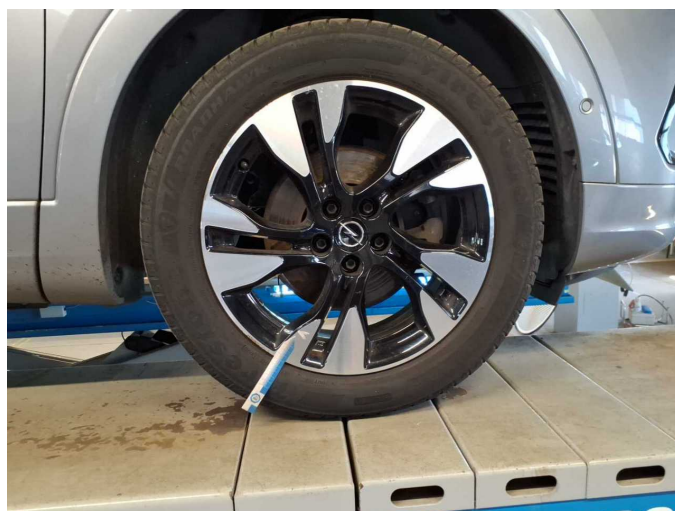
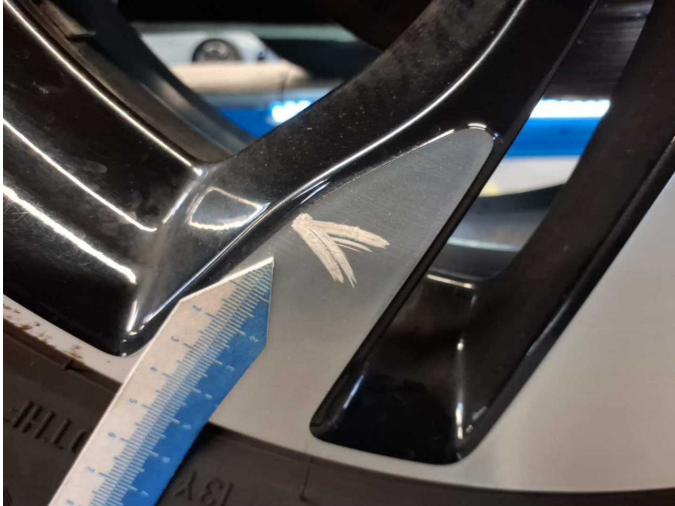
| No. | Component group | Description |
|---|---|---|
| 4 | Wheel / tyres | Alloy rim - front right side - Scratched - Loss in value |

**Damage 4:** Wheel / tyres: Alloy rim - front right side - Scratched - Loss in value

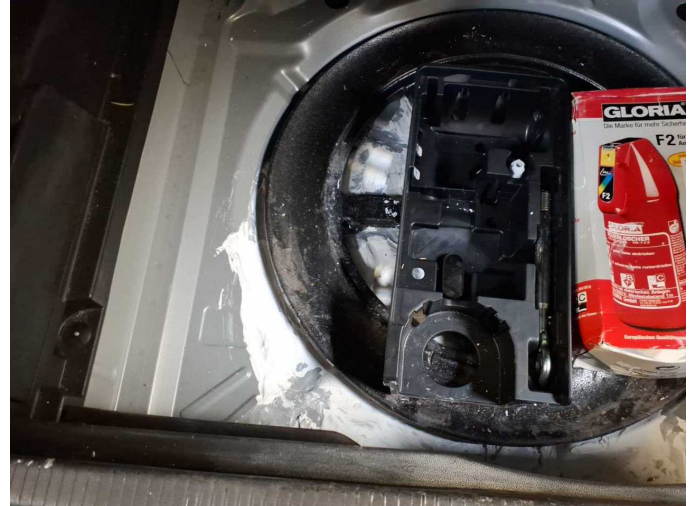
| No. | Component group | Description |
|---|---|---|
| 5 | Rear of vehicle | Boot floor - Soiled - Clean |

**Damage 5:** Rear of vehicle: Boot floor - Soiled - Clean

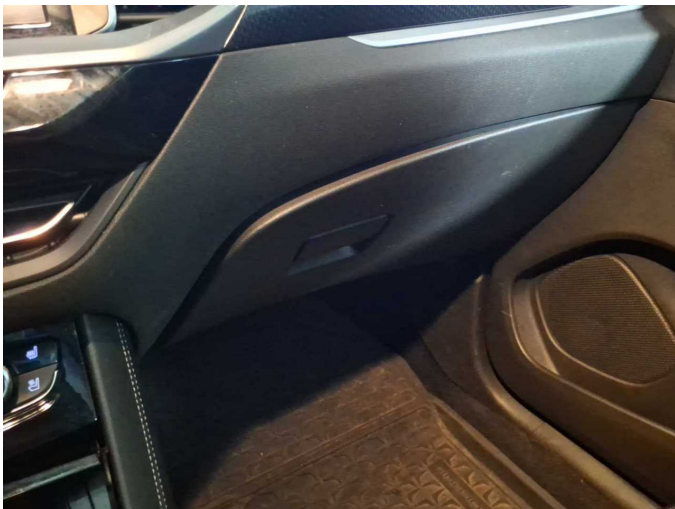
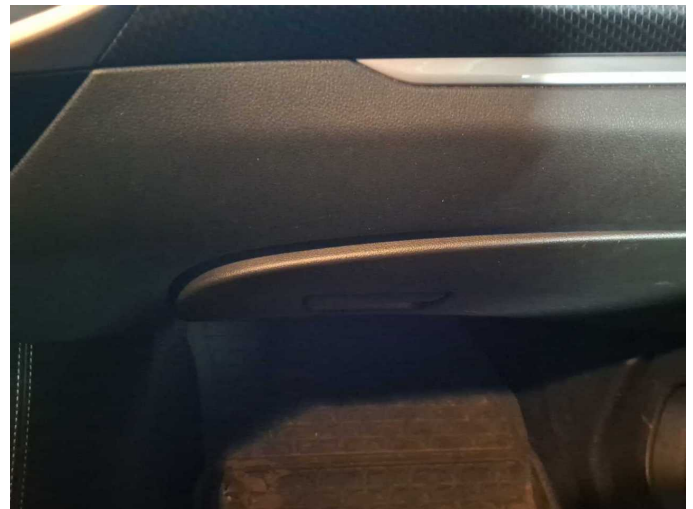
| No. | Component group | Description |
|---|---|---|
| 6 | Instrument panel | Glove box lid (Schließt nicht richtig) - Sub-function - Replace |

**Damage 6:** Instrument panel: Glove box lid (Schließt nicht richtig) - Sub-function - Replace

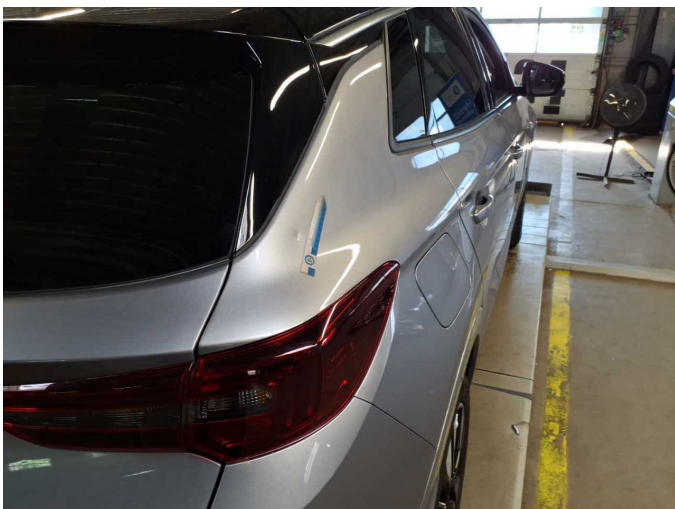
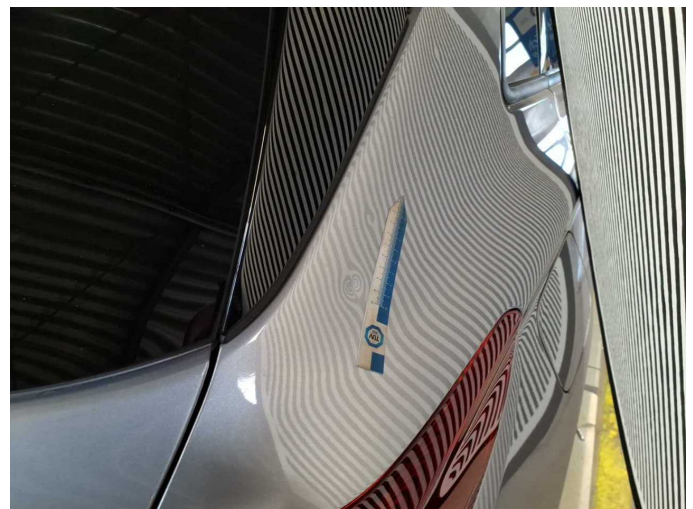
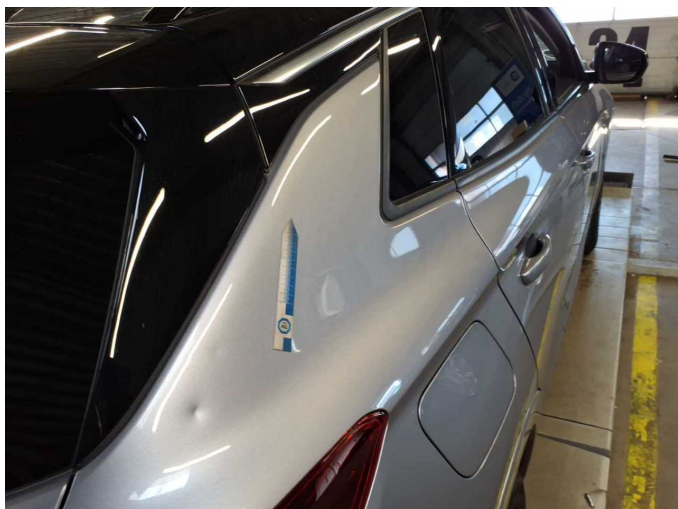
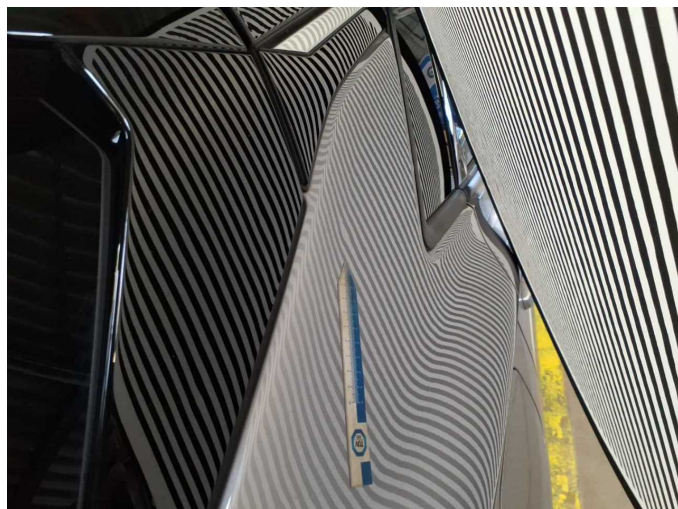
| No. | Component group | Description |
|---|---|---|
| 7 | Side panel - rear right side | Side panel - dent(s) - Smooth repair work |

**Damage 7:** Side panel - rear right side: Side panel - dent(s) - Smooth repair work

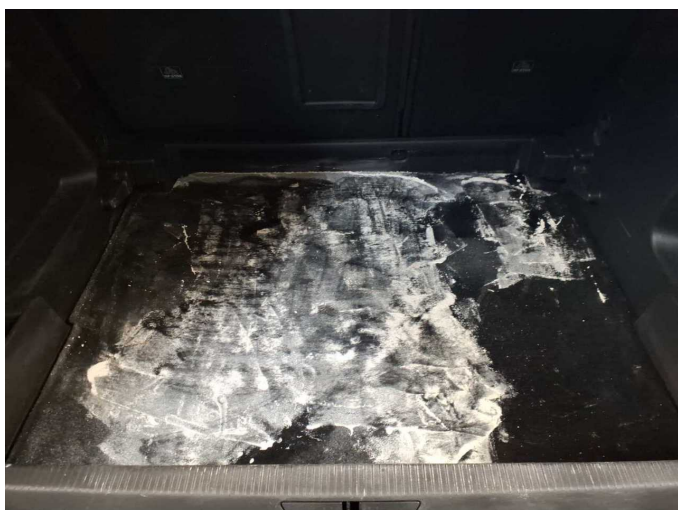
| No. | Component group | Description |
|---|---|---|
| 8 | Rear of vehicle | Boot floor - Soiled - Replace |

**Damage 8:** Rear of vehicle: Boot floor - Soiled - Replace

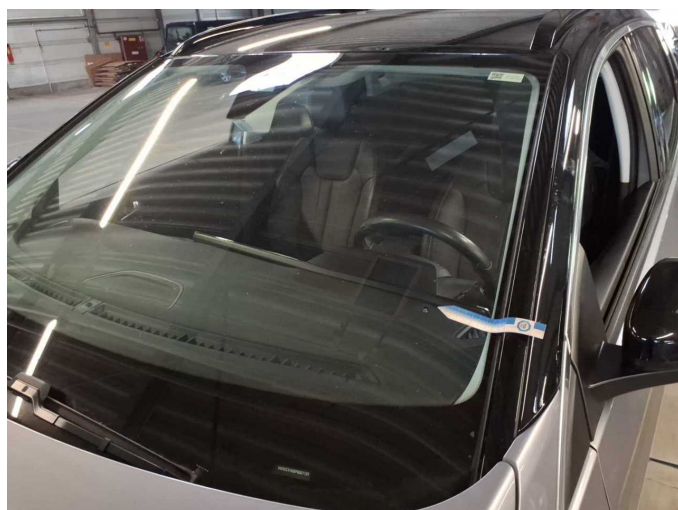
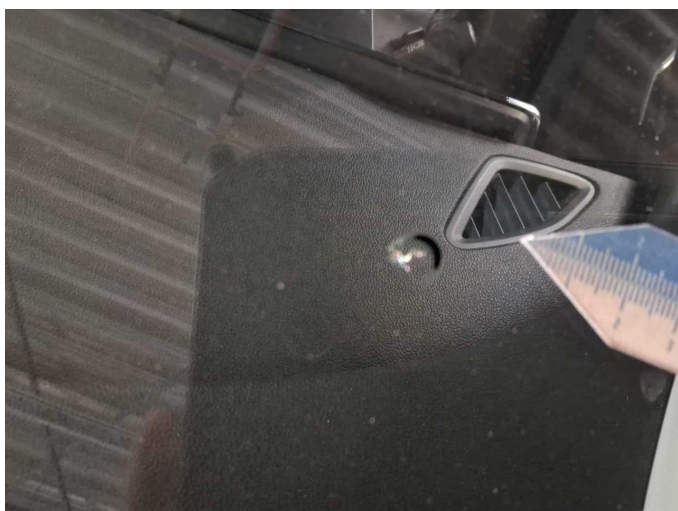
| No. | Component group | Description |
|---|---|---|
| 9 | Vehicle glazing | Windscreen - Stone chips - Replace |

**Damage 9:** Vehicle glazing: Windscreen - Stone chips - Replace

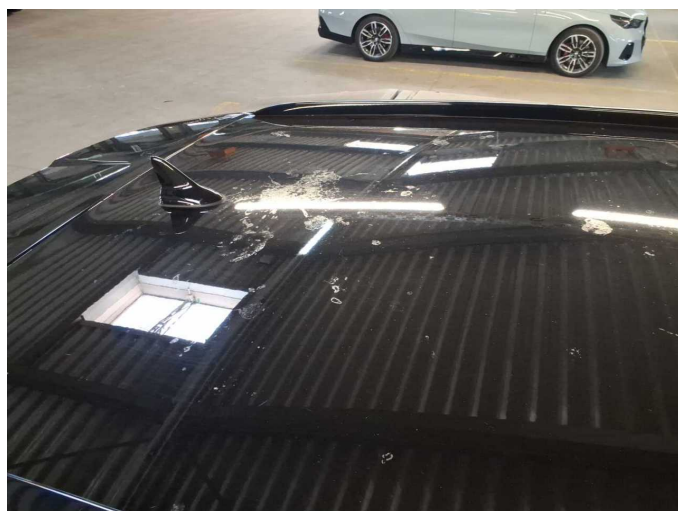
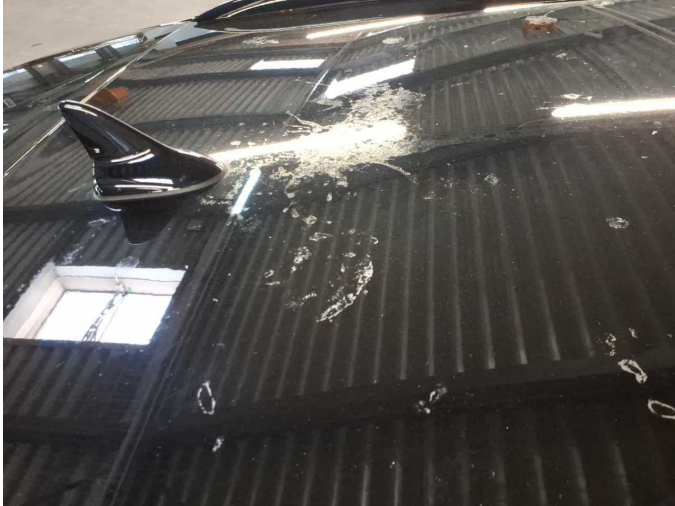
| No. | Component group | Description |
|---|---|---|
| 10 | Roof | Roof (Verätzungen) - Paint defect - Paint |

**Damage 10:** Roof: Roof (Verätzungen) - Paint defect - Paint

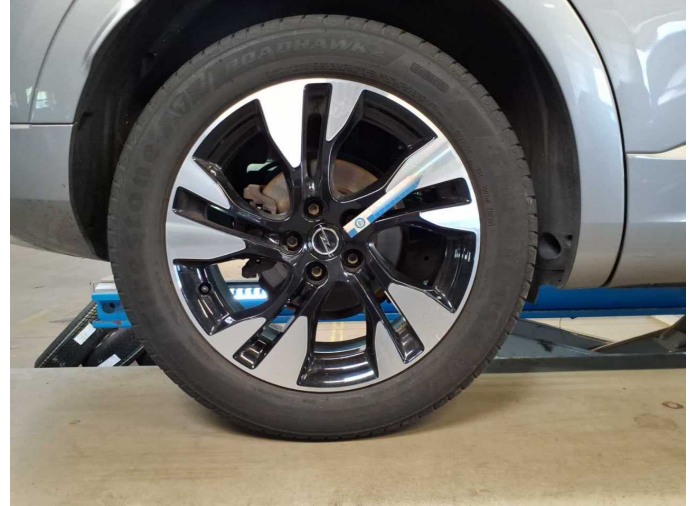
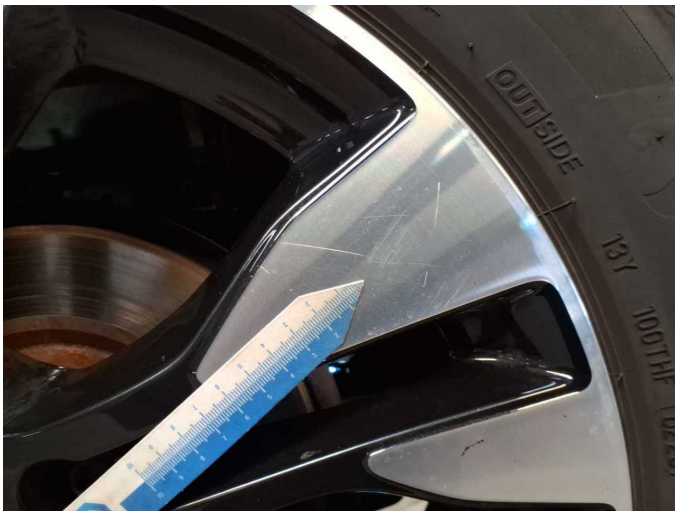
| No. | Component group | Description |
|---|---|---|
| 1 | Wheel / tyres | Alloy rim - rear right side - Scratched - No deduction |

**Wear and tear 1:** Wheel / tyres: Alloy rim - rear right side - Scratched - No deduction
