Expertise

Protocol number: 46122349  
Order No. / Reference: 26550458  
Inspection date: 24 Jun 2026

Manufacturer: Ford

Model: Transit Custom 320 L1H1 LKW VA Basis

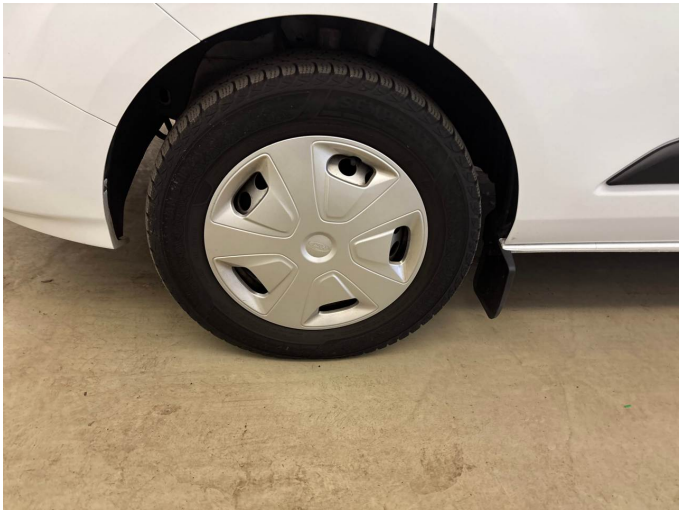
Figure 12: Mounted tyres

| # | Tyre size | Type of tyre | Manufacturer | Tread depth |
|---|---|---|---|---|
| 1) | 215/65 R16 107R | All-season tyres on Steel rim with wheel cover | Uniroyal | 5mm / 5mm |
| 2) | 215/65 R16 107R | All-season tyres on Steel rim with wheel cover | Uniroyal | 5mm / 5mm |

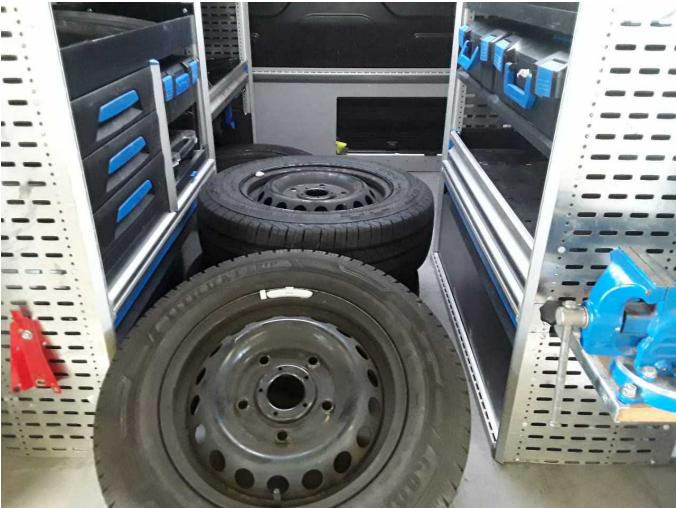
Figure 15: Additional tyres

| # | Tyre size | Type of tyre | Manufacturer | Tread depth |
|---|---|---|---|---|
| 1) | 215/65 R16 107T | Summer tyres on Steel | Goodyear | 6mm / 6mm |
| 2) | 215/65 R16 107T | Summer tyres on Steel | Goodyear | 6mm / 6mm |

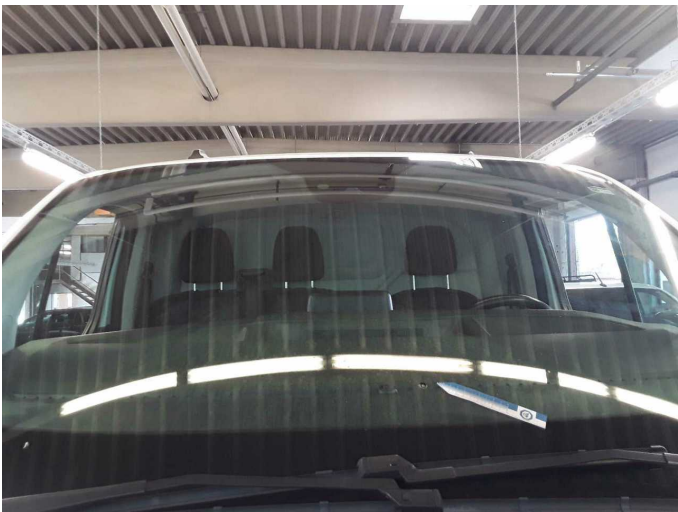
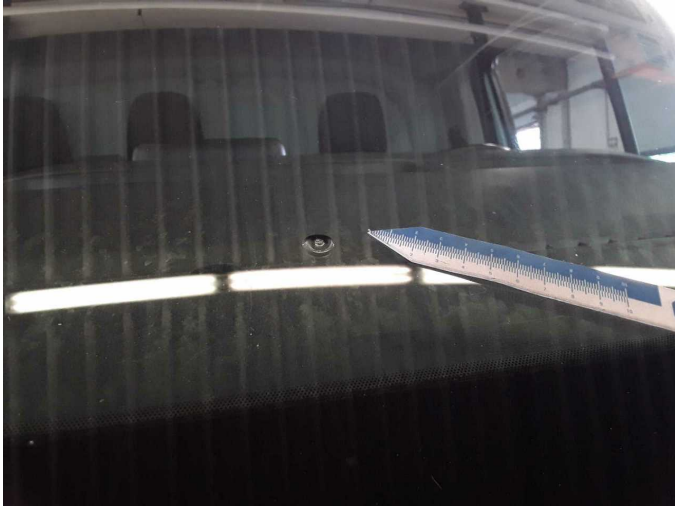
Damage 1: Vehicle glazing: Windscreen (Rissbildung) - Stone chips - Replace

**Damage 1:** Vehicle glazing: Windscreen (Rissbildung) - Stone chips - Replace

| No. | Component group | Description |
|---|---|---|
| 1 | Vehicle glazing | Windscreen (Rissbildung) - Stone chips - Replace |

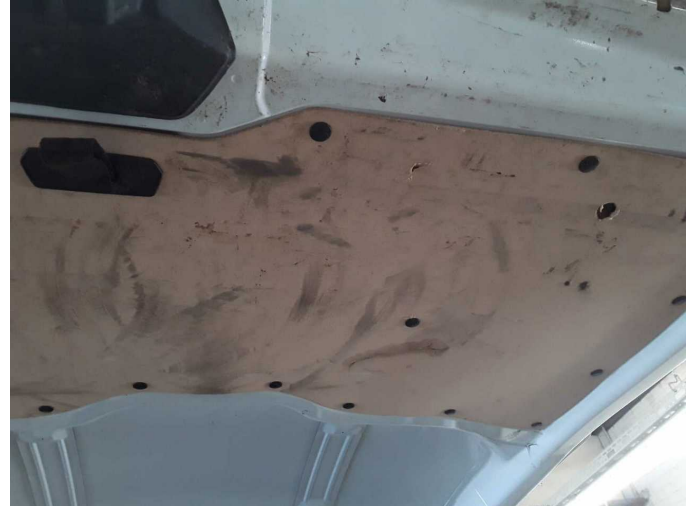
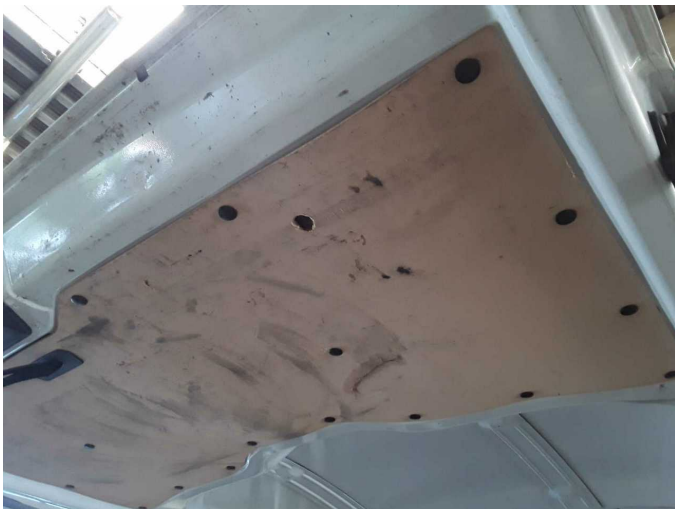
**Damage 2:** Trim / covers: Boot lid - interior trim - Damaged - Replace

| No. | Component group | Description |
|---|---|---|
| 2 | Trim / covers | Boot lid - interior trim - Damaged - Replace |

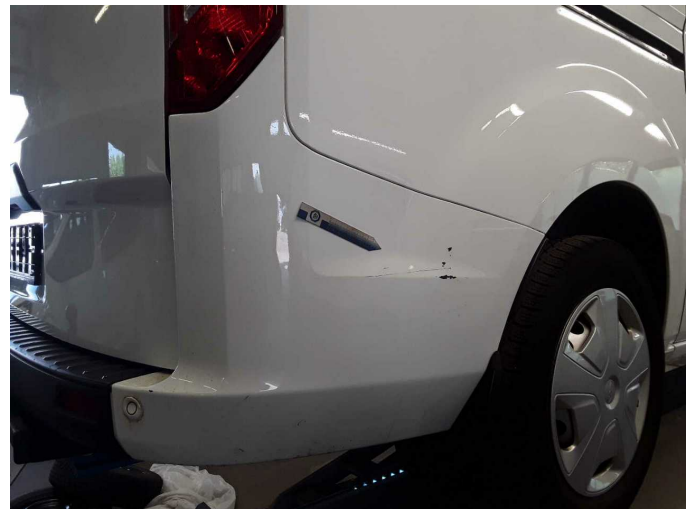
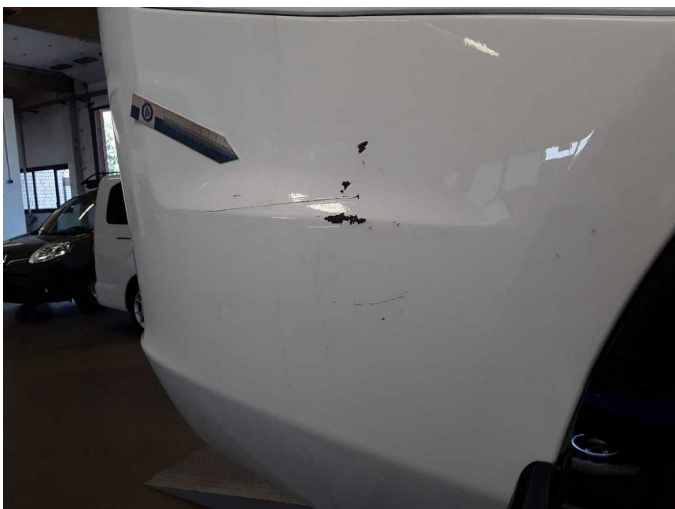
**Damage 4:** Rear bumper: Rear bumper - Scratch(es) - Paint

| No. | Component group | Description |
|---|---|---|
| 4 | Rear bumper | Rear bumper - Scratch(es) - Paint |

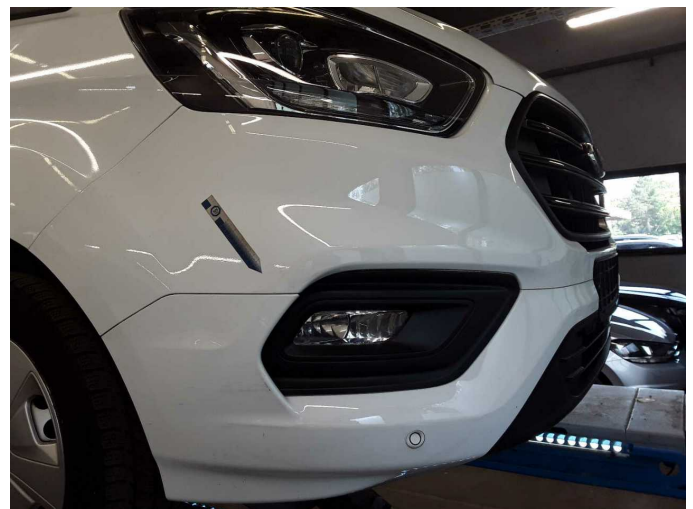
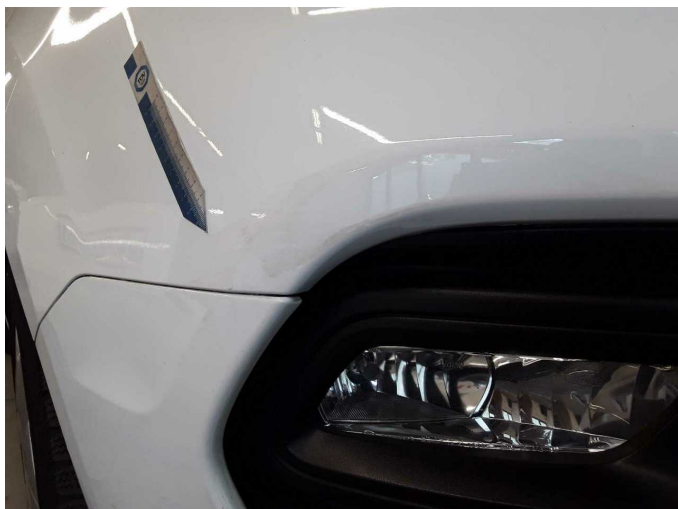
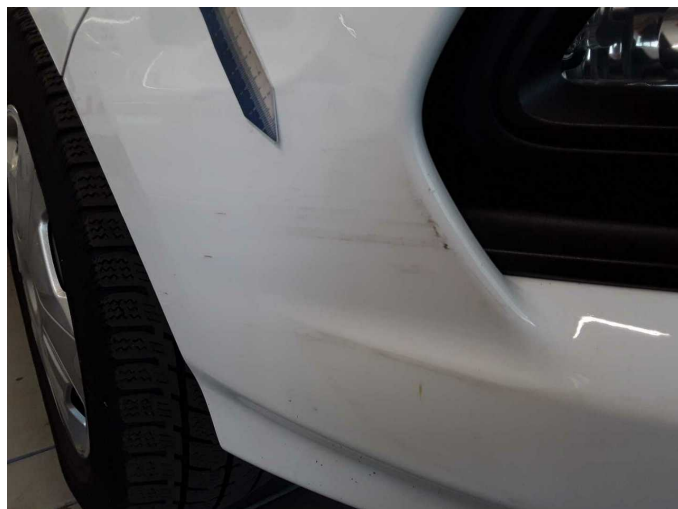
**Damage 5:** Front bumper: Front bumper - Scratched - Paint

| No. | Component group | Description |
|---|---|---|
| 5 | Front bumper | Front bumper - Scratched - Paint |

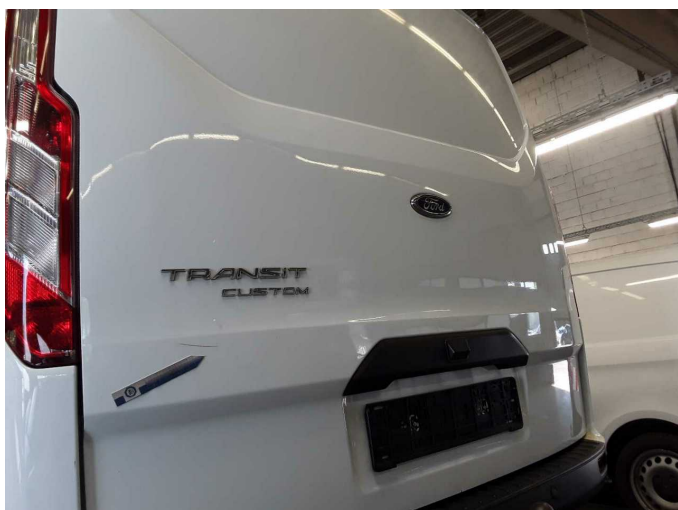
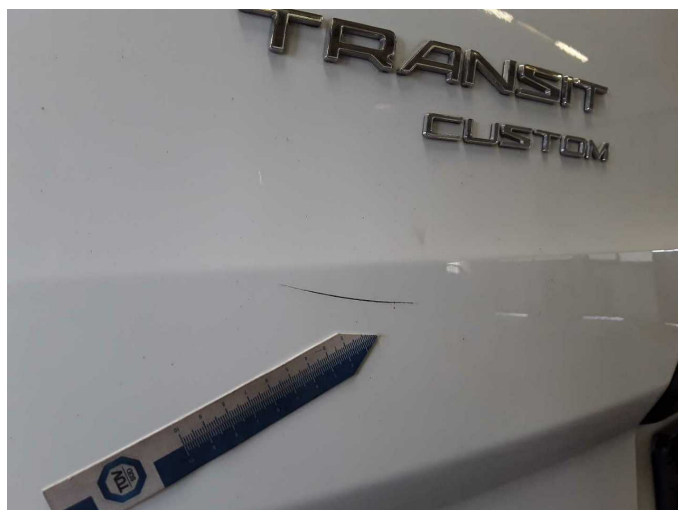
**Damage 6:** Boot lid / rear door: Boot lid - Scratch(es) - Paint

| No. | Component group | Description |
|---|---|---|
| 6 | Boot lid / rear door | Boot lid - Scratch(es) - Paint |

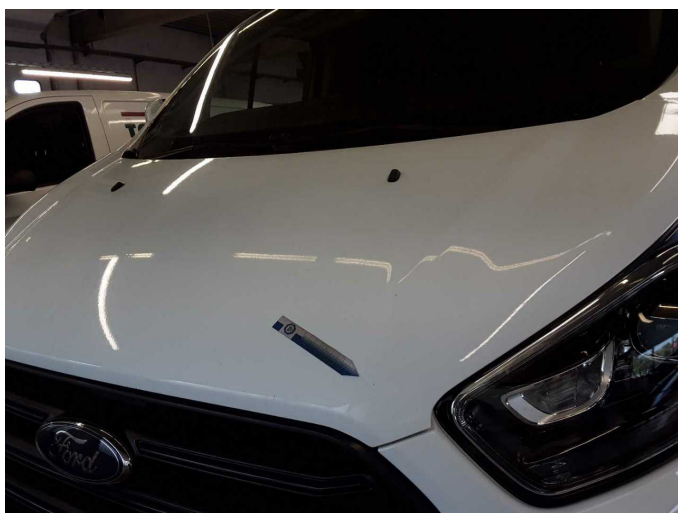
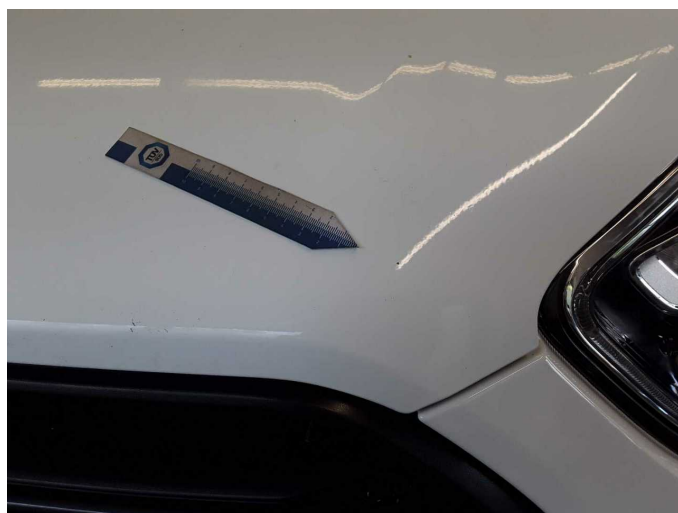
| No. | Component group | Description |
|---|---|---|
| 2 | Bonnet | Bonnet - Stone chips - No deduction |

**Wear and tear 2:** Bonnet: Bonnet - Stone chips - No deduction

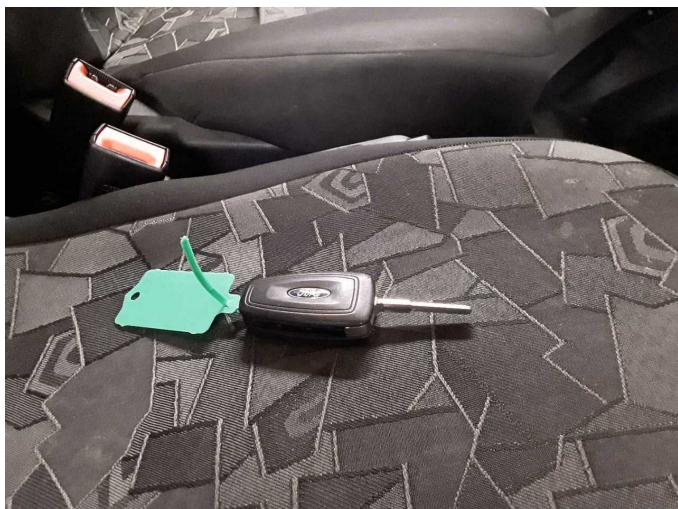
Equipment - Vehicle key with remote control

**Missing part 1:** Equipment: Vehicle key with remote control - Missing - Replace

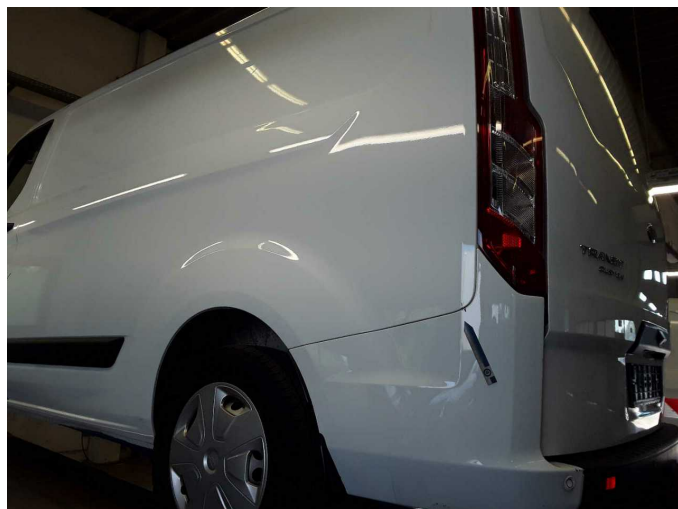
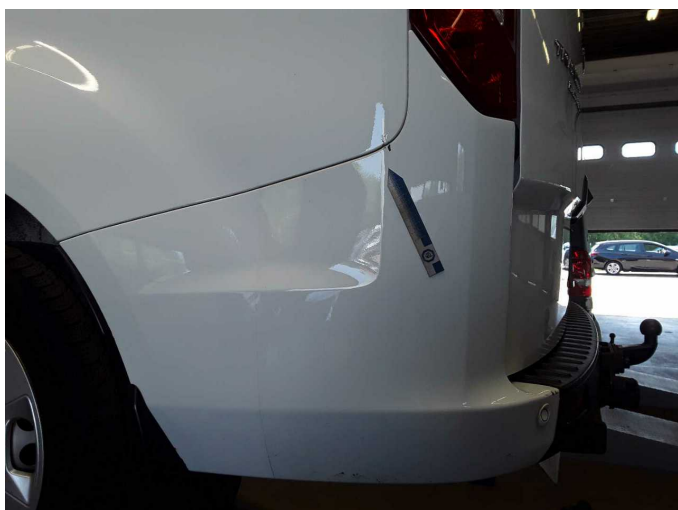
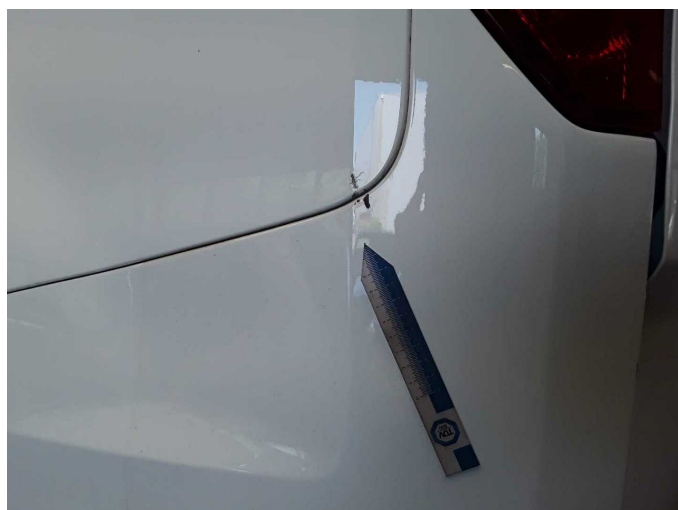
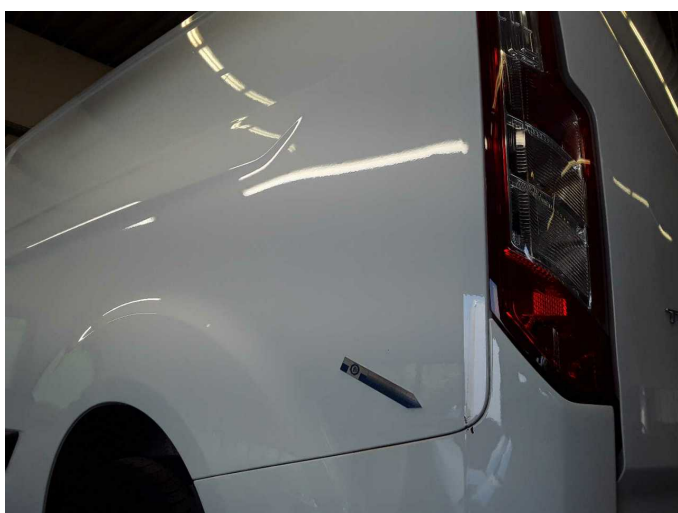
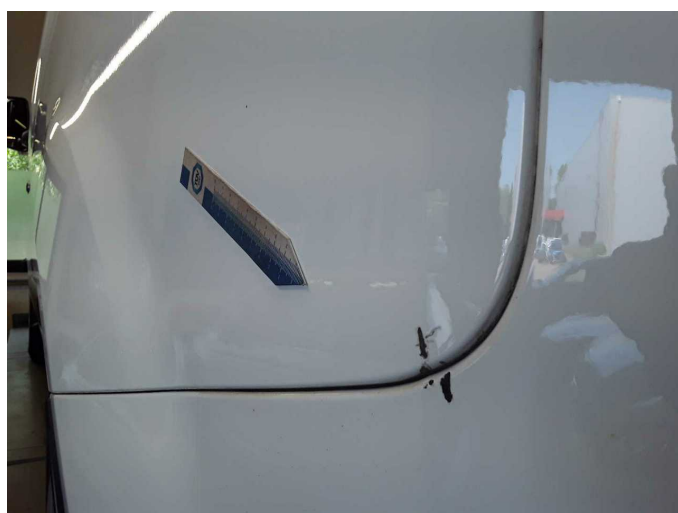
| No. | Previous damage | Extent of damage (Net) |
|---|---|---|
| 1 | Side - left, Provided by user / customer, from 19 Jan 2026 | 3.898,59 € |
| 2 | Side - left, Provided by user / customer | 5.001,65 € |

1 Side - left

**Accident 1:** Side - left

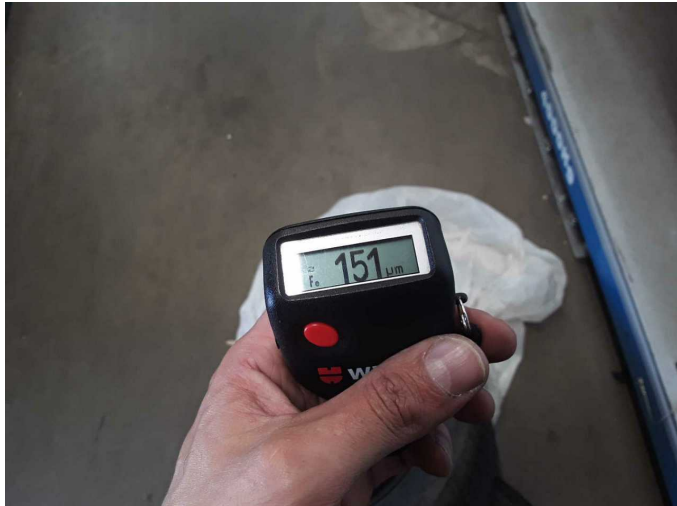
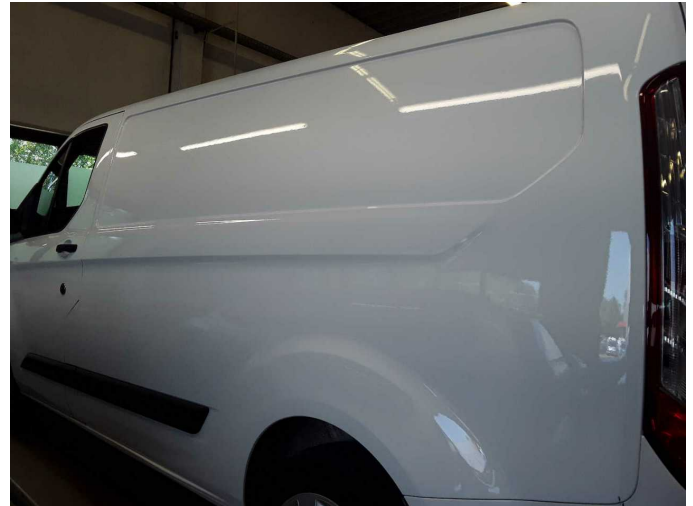
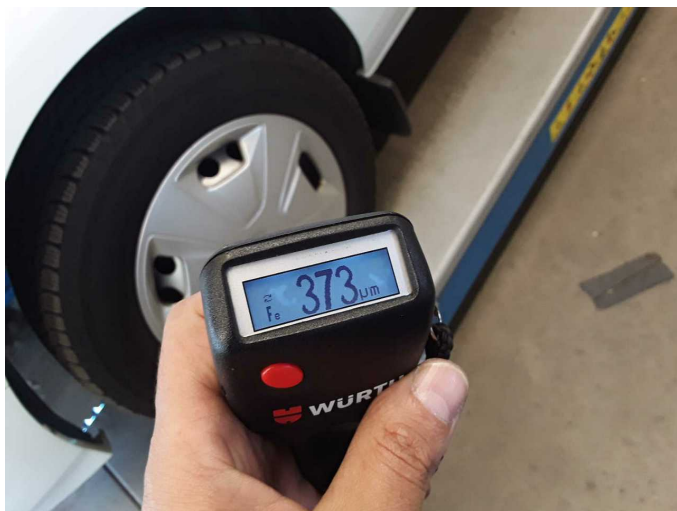
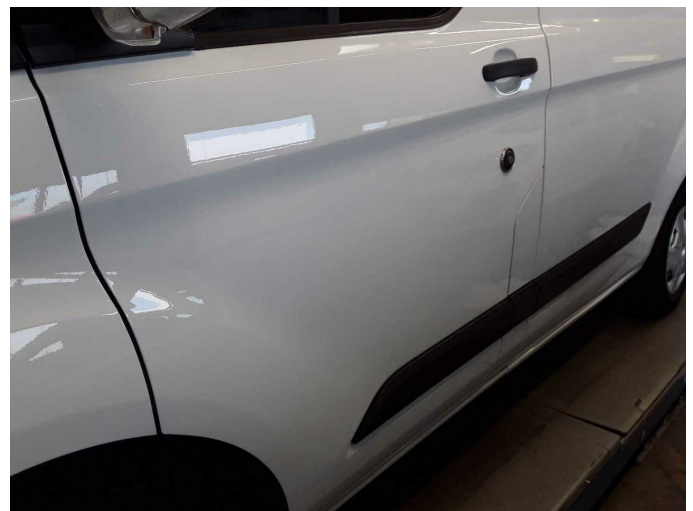
1 Side panel - rear left side, Professionally carried out, Invoice of repair done Non-existent

**Repainting 1:** Side panel - rear left side
