Expertise

Protocol number: 46583110  
Order No. / Reference: 26664519  
Inspection date: 16 Jul 2026

Manufacturer: Mercedes-Benz

Model: E 220 d T 9G-TRONIC Avantgarde

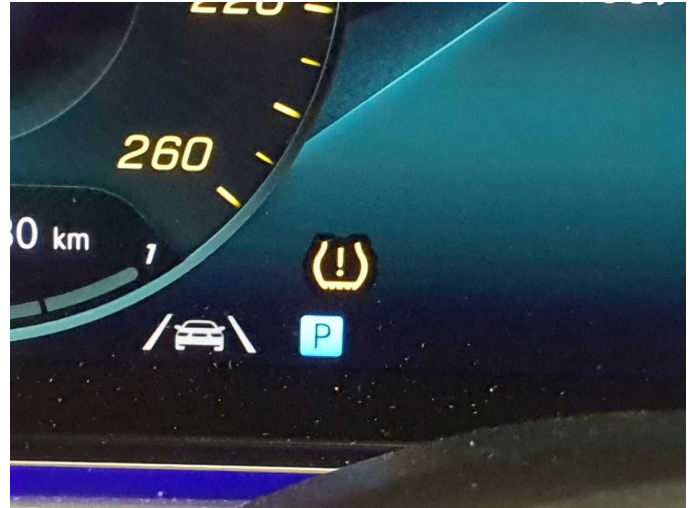
| No. | Component group | Description |
|---|---|---|
| 1 | Instrument panel | Indicator light (Reifendruck) - on - Perform diagnosis |

**Damage 1:** Instrument panel: Indicator light (Reifendruck) - on - Perform diagnosis

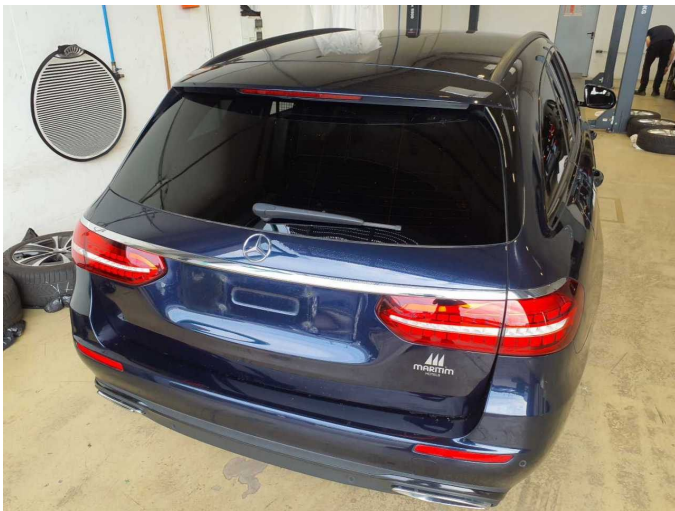
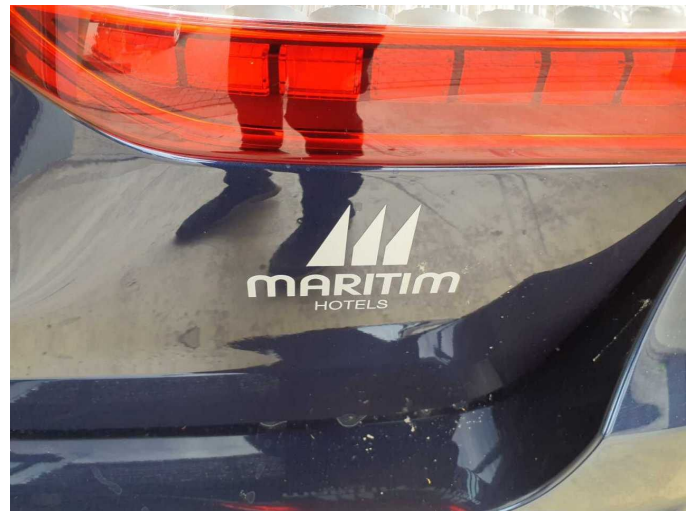
| No. | Component group | Description |
|---|---|---|
| 2 | Boot lid / rear door | Boot lid - Glued / labelled - De-glue / neutralise |

**Damage 2:** Boot lid / rear door: Boot lid - Glued / labelled - De-glue / neutralise

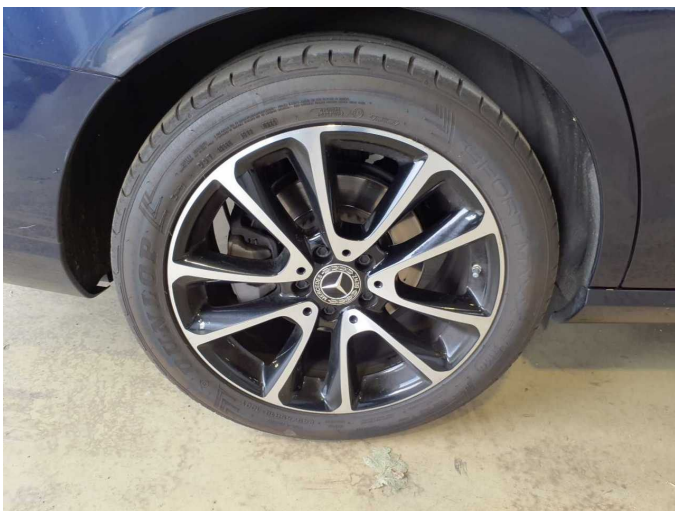
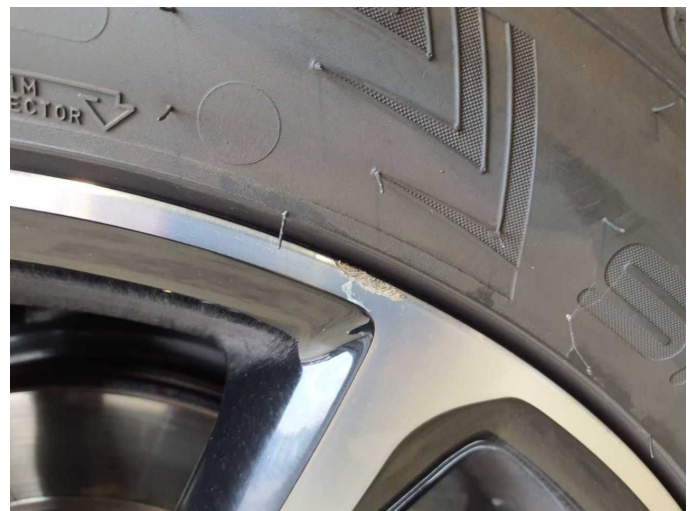
| No. | Component group | Description |
|---|---|---|
| 3 | Wheel / tyres | Alloy rim - rear right side - Scratch(es) - Loss in value |

**Damage 3:** Wheel / tyres: Alloy rim - rear right side - Scratch(es) - Loss in value

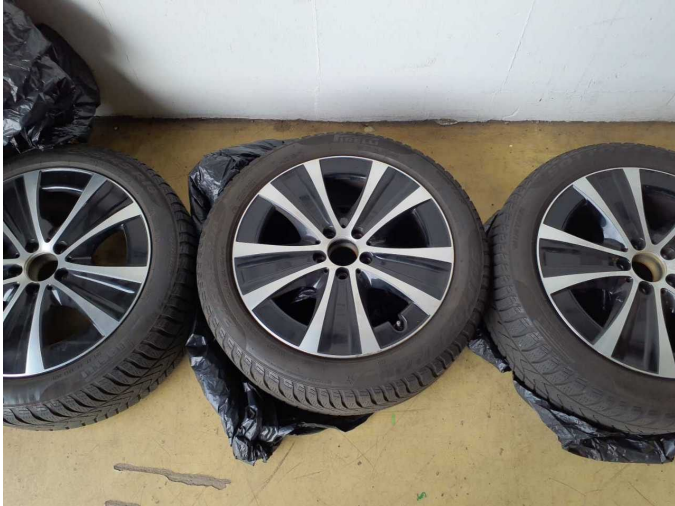
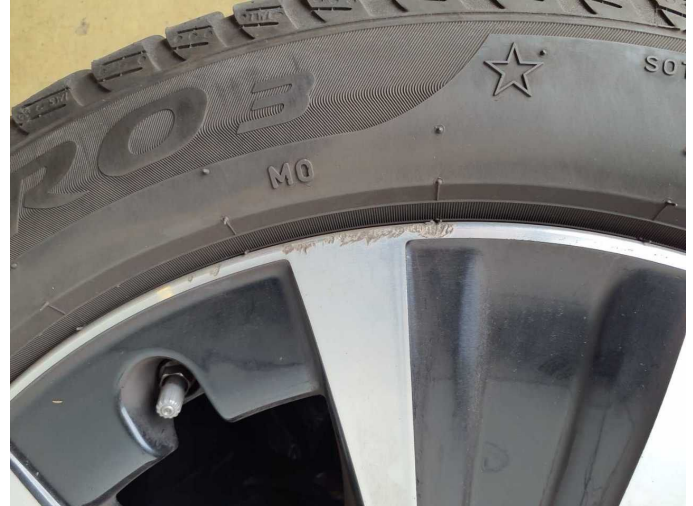
| No. | Component group | Description |
|---|---|---|
| 4 | 2nd wheel set | 1 alloy rim - Scratch(es) - Loss in value |

**Damage 4:** 2nd wheel set: 1 alloy rim - Scratch(es) - Loss in value

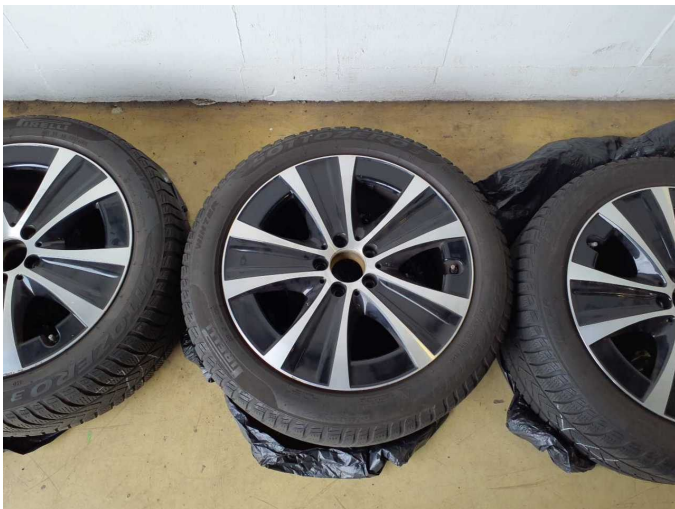
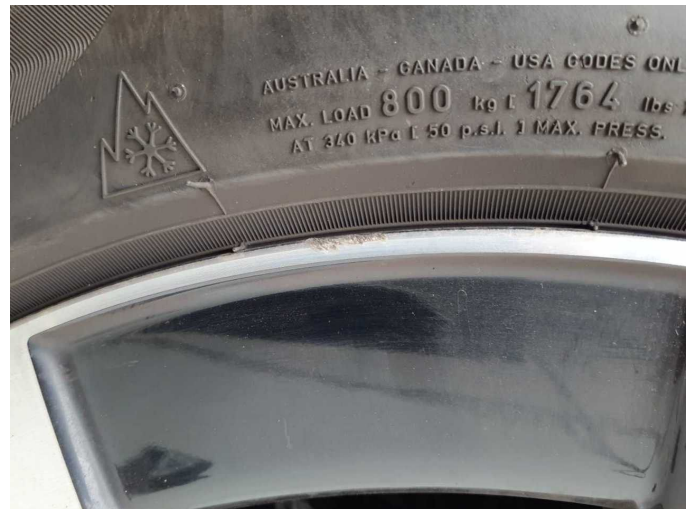
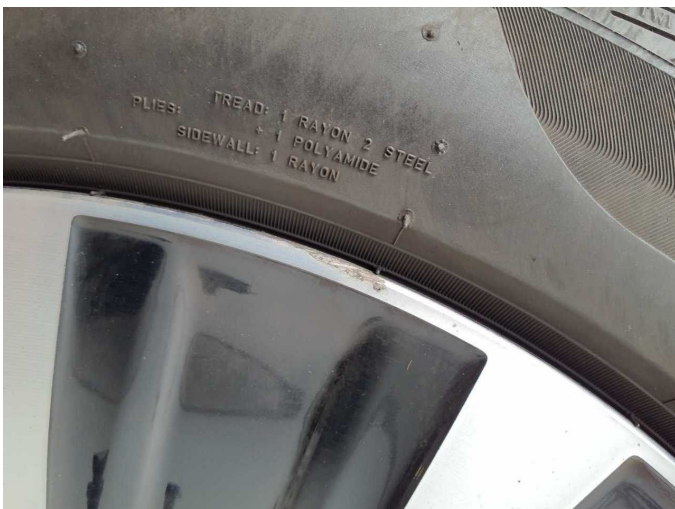
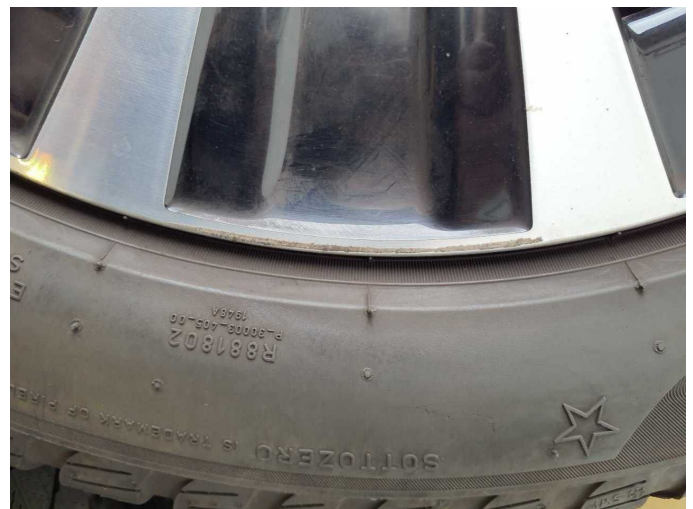
| No. | Component group | Description |
|---|---|---|
| 5 | 2nd wheel set | 1 alloy rim - Scratch(es) - Loss in value |

**Damage 5:** 2nd wheel set: 1 alloy rim - Scratch(es) - Loss in value

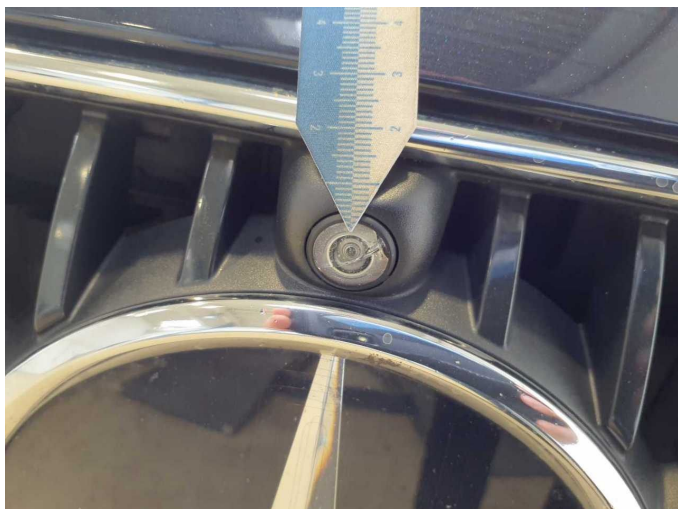
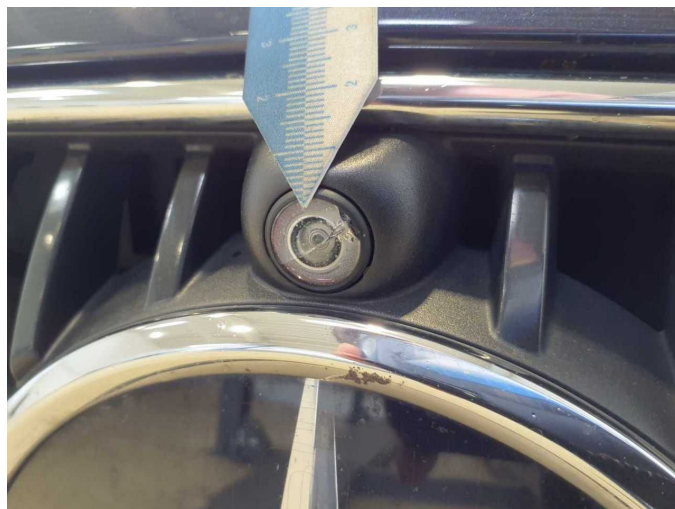
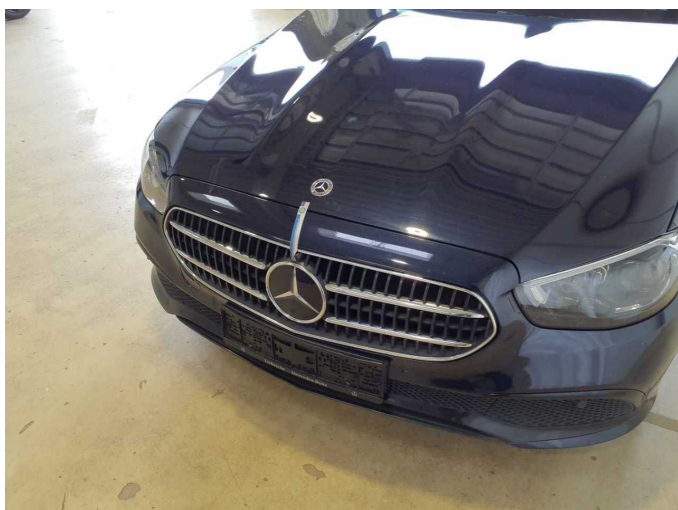
| No. | Component group | Description |
|---|---|---|
| 6 | Electronic systems | Front camera - Broken / torn - Replace |

**Damage 6:** Electronic systems: Front camera - Broken / torn - Replace

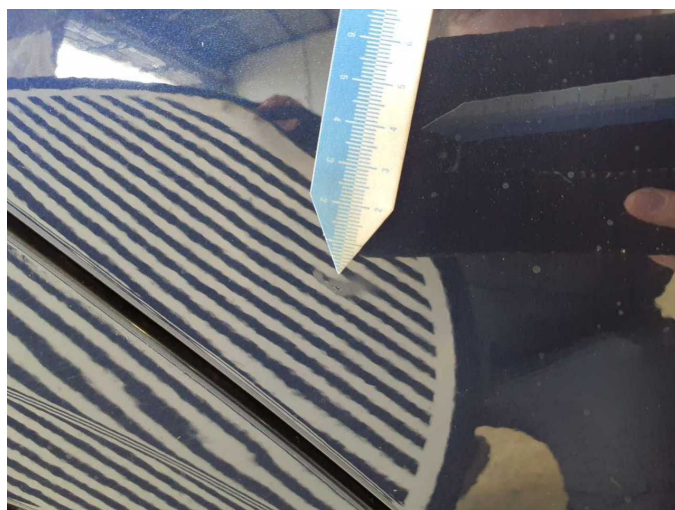
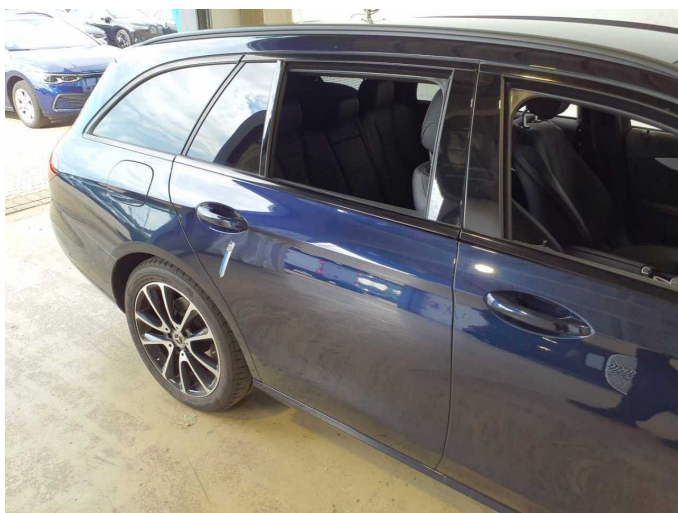
| No. | Component group | Description |
|---|---|---|
| 7 | Door - rear right side | Door (Sprühnebel) - Paint defect - Repair and paint |

**Damage 7:** Door - rear right side: Door (Sprühnebel) - Paint defect - Repair and paint

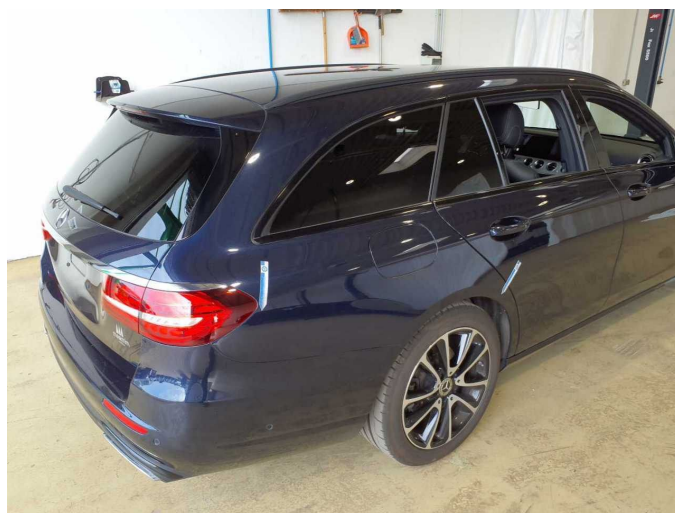
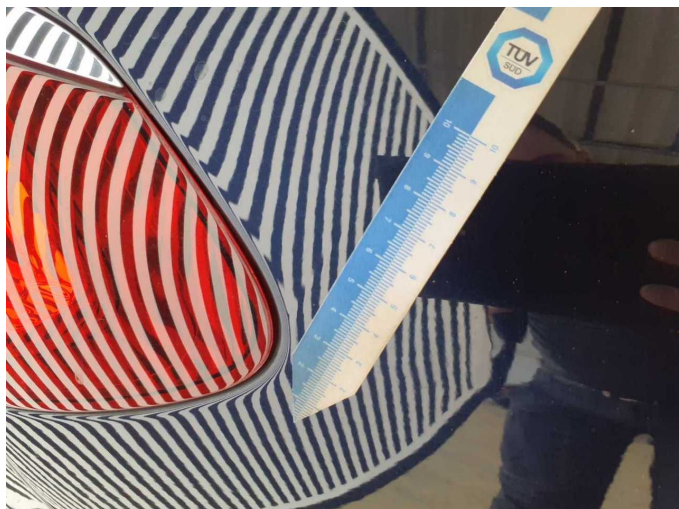
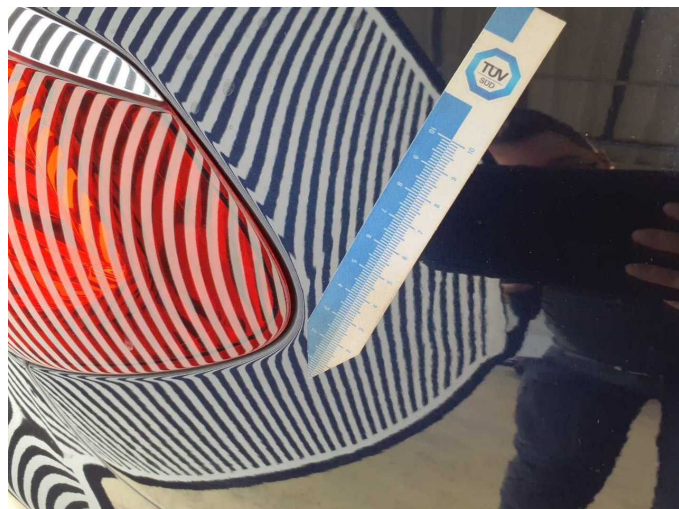
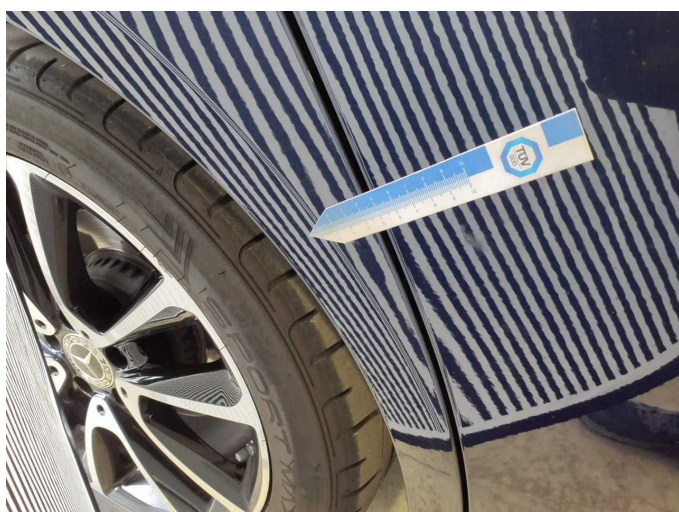
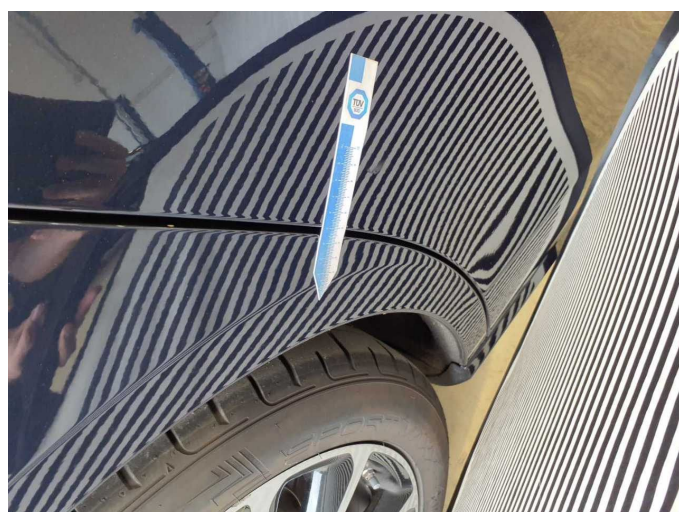
| No. | Component group | Description |
|---|---|---|
| 8 | Side panel - rear right side | Side panel - dent(s) - Repair and paint |

**Damage 8:** Side panel - rear right side: Side panel - dent(s) - Repair and paint

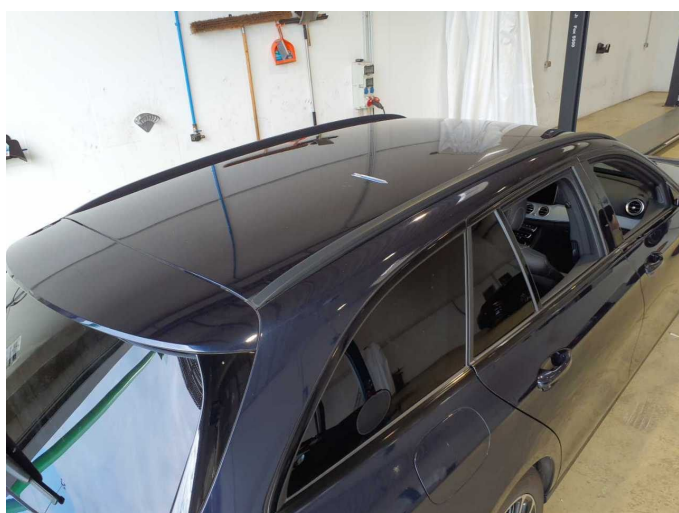
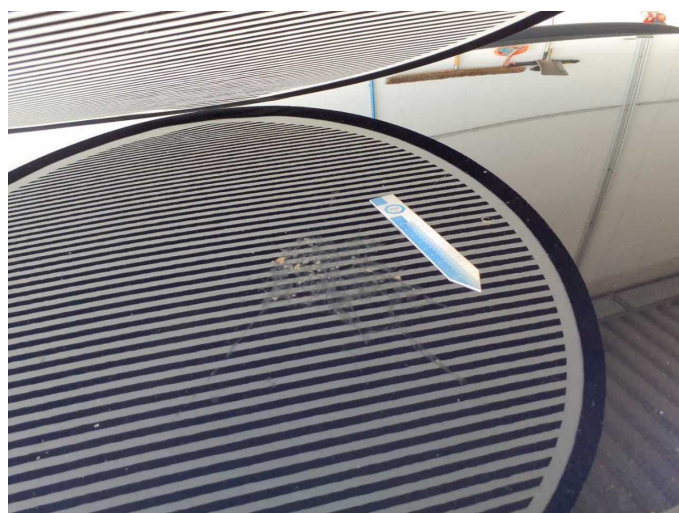
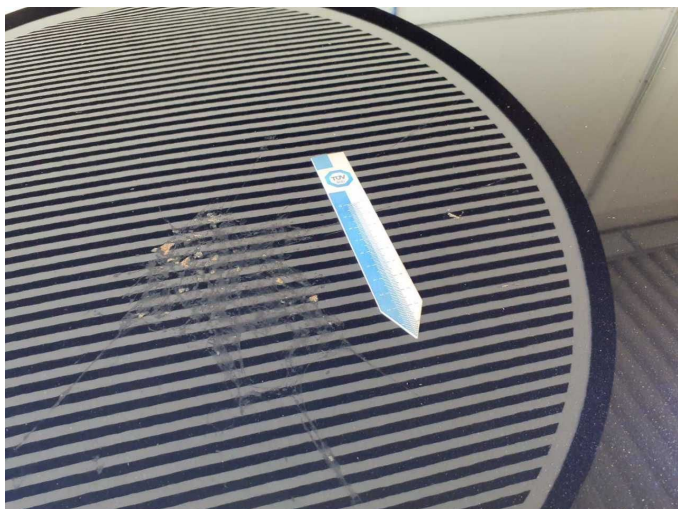
| No. | Component group | Description |
|---|---|---|
| 9 | Roof | Roof (Anätzung) - Paint defect - Repair and paint |

**Damage 9:** Roof: Roof (Anätzung) - Paint defect - Repair and paint

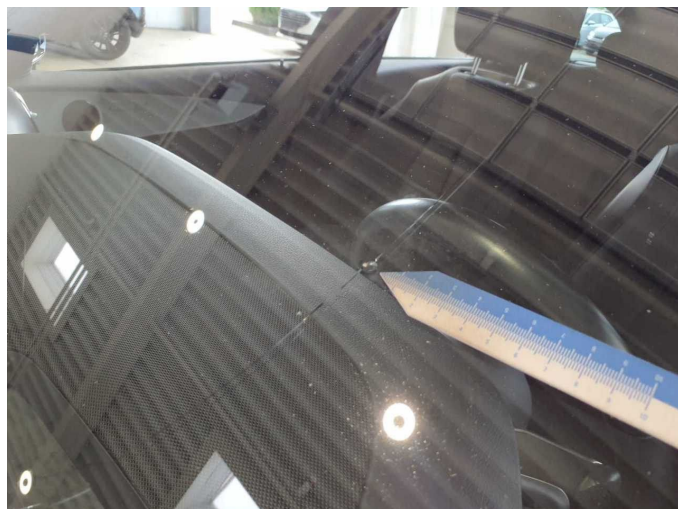
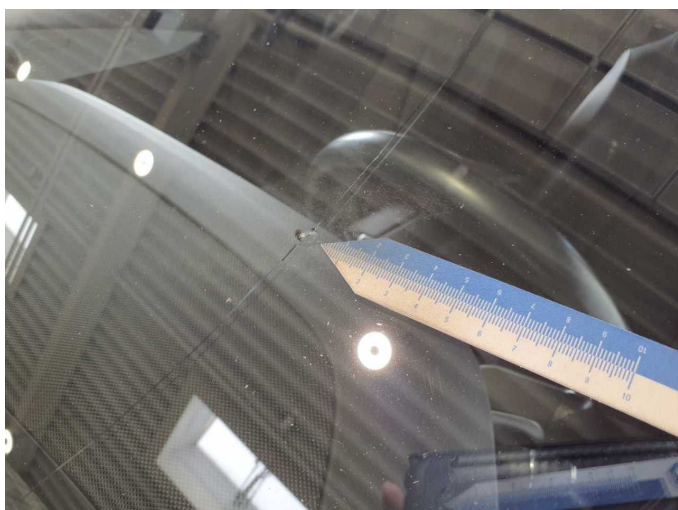
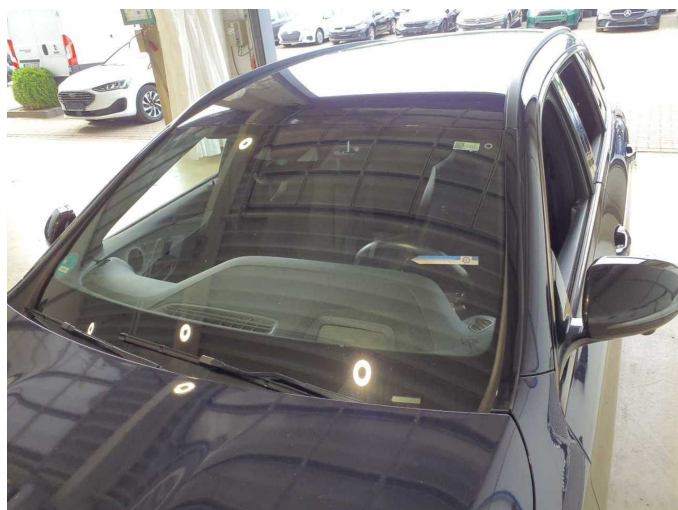
| No. | Component group | Description |
|---|---|---|
| 10 | Vehicle glazing | Windscreen - Broken / torn - Replace |

**Damage 10:** Vehicle glazing: Windscreen - Broken / torn - Replace

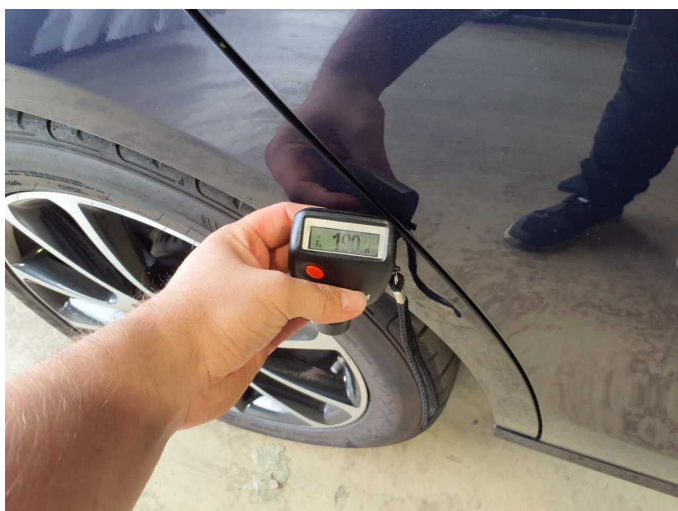
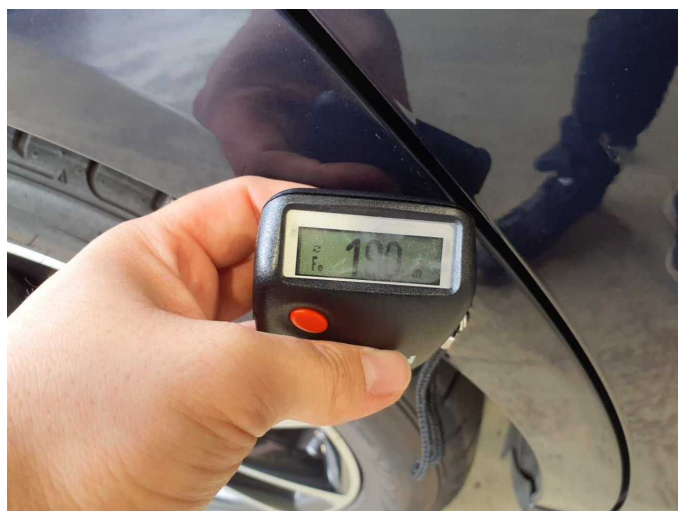
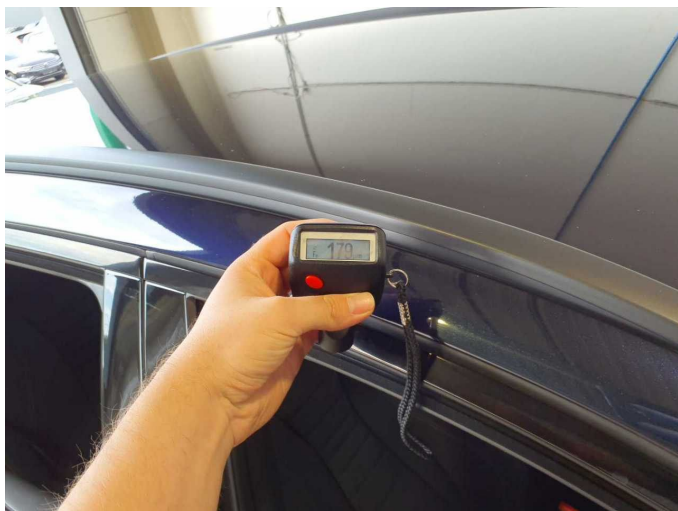
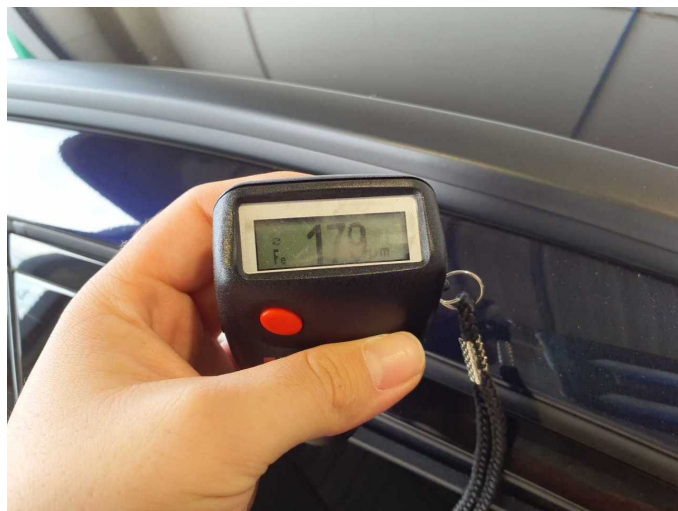
| No. | Repainting |
|---|---|
| 1 | Roof rail - right side, Side panel - rear right side, Professionally carried out |

| Roof rail - right side | 179 µm | Side panel - rear right side | 190 µm |

**Repainting 1:** Roof rail - right side, Side panel - rear right side
