Expertise

Protocol number: 46508055  
Order No. / Reference: 26574425  
Inspection date: 10 Jul 2026

Manufacturer: Ford

Model: Mondeo Turnier 2.0 EcoBlue Aut. Titanium

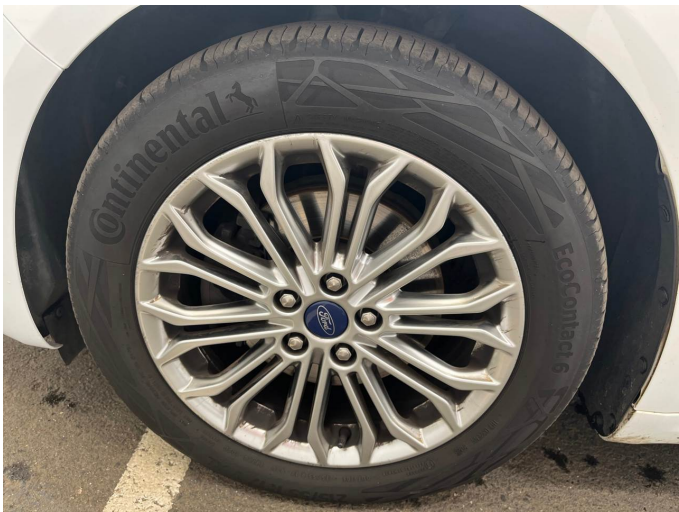
Figure 12: Mounted tyres

| Tyres | | | | |
|---|---|---|---|---|
| 1) | 215/55 R17 98V | Summer tyres on Light alloy | Continental | 5mm / 5mm |
| 2) | 215/55 R17 98W | Summer tyres on Light alloy | Goodyear | 5mm / 5mm |

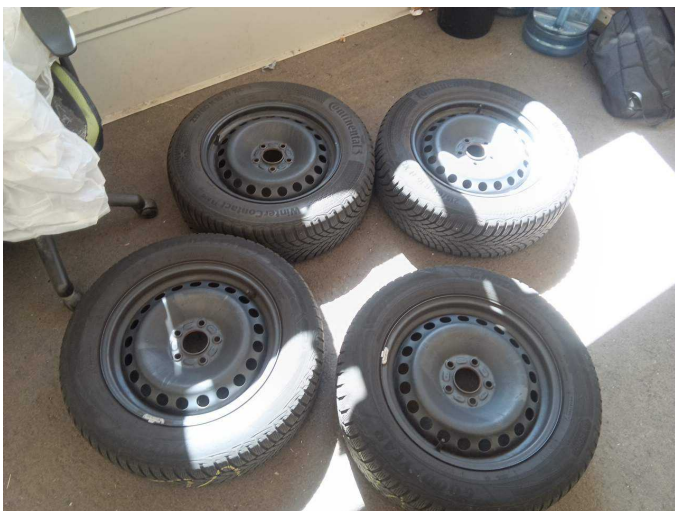
Figure 17: Additional tyres

| Tyres | | | | |
|---|---|---|---|---|
| 1) | 215/60 R16 99H | Winter tyres on Steel | Goodyear | 5mm / 5mm |
| 2) | 215/60 R16 99H | Winter tyres on Steel | Continental | 7mm / 7mm |

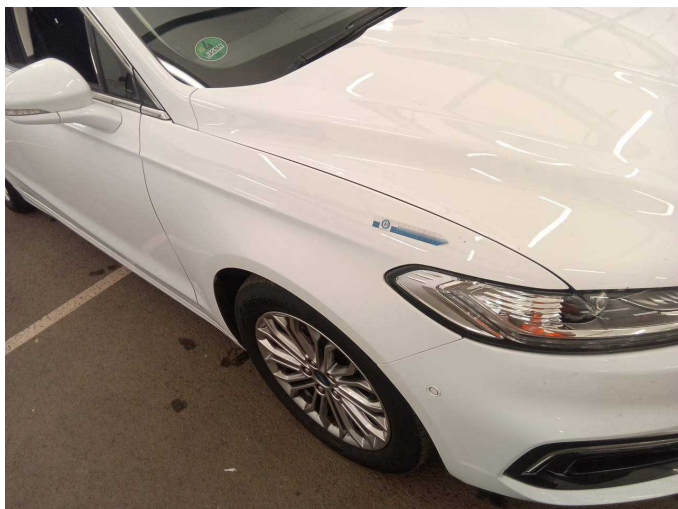
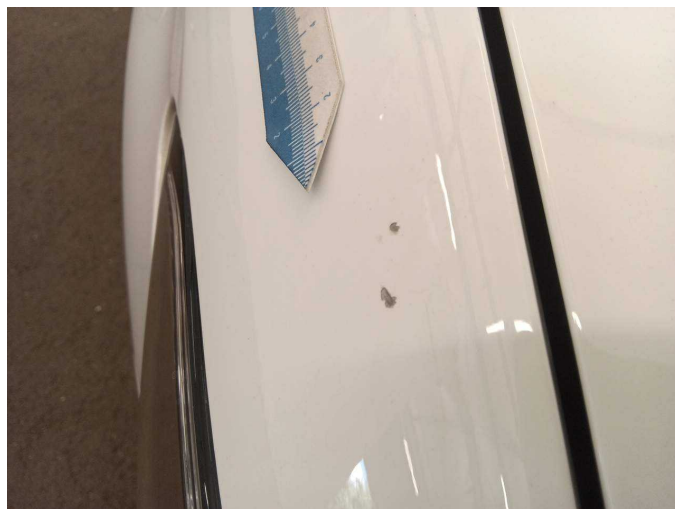
| No. | Component group | Description |
|---|---|---|
| 1 | Mudguard - right side | Mudguard - right side - Scratched - Paint |

**Damage 1:** Mudguard - right side: Mudguard - right side - Scratched - Paint

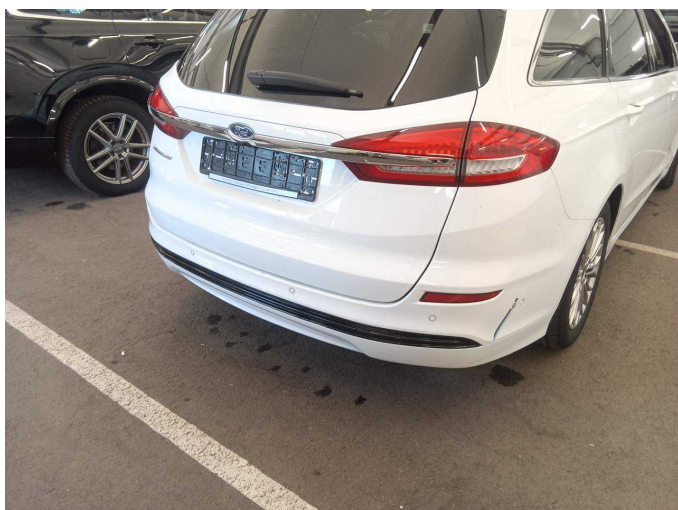
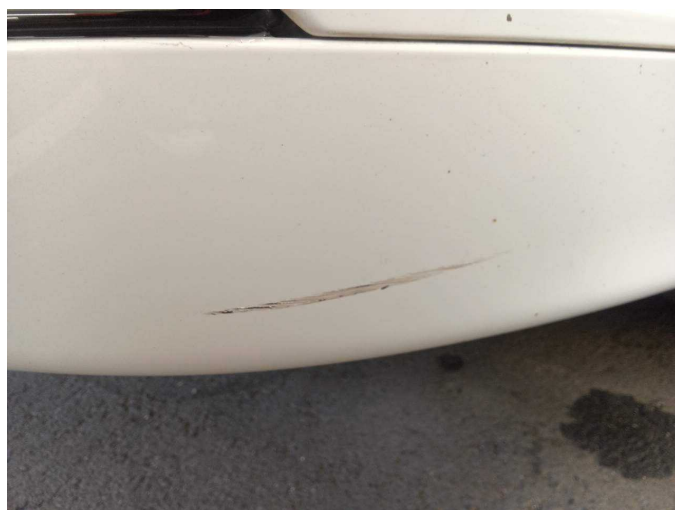
| No. | Component group | Description |
|---|---|---|
| 2 | Rear bumper | Spoiler - Scratch(es) - Paint |

**Damage 2:** Rear bumper: Spoiler - Scratch(es) - Paint

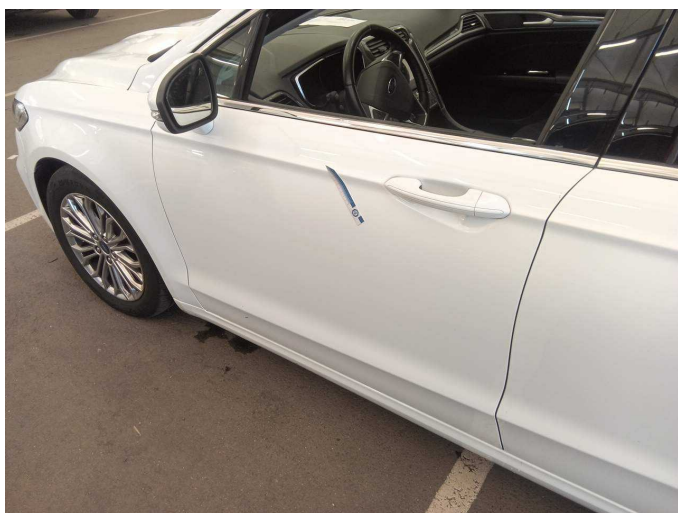
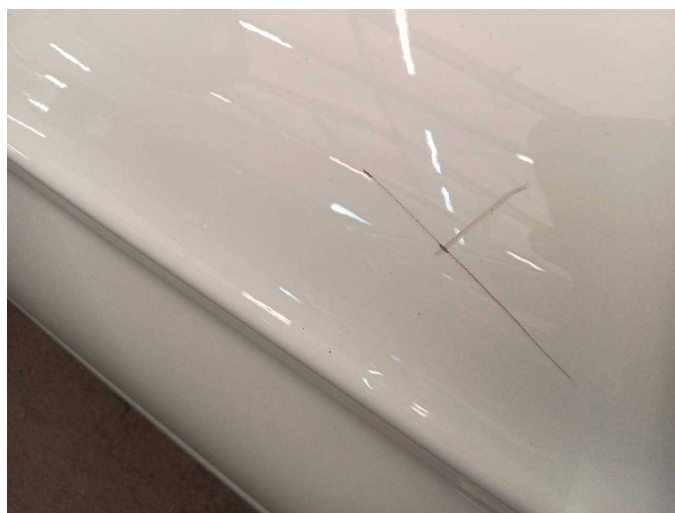
| No. | Component group | Description |
|---|---|---|
| 3 | Door - front left side | Door - Scratch(es) - Paint |

**Damage 3:** Door - front left side: Door - Scratch(es) - Paint

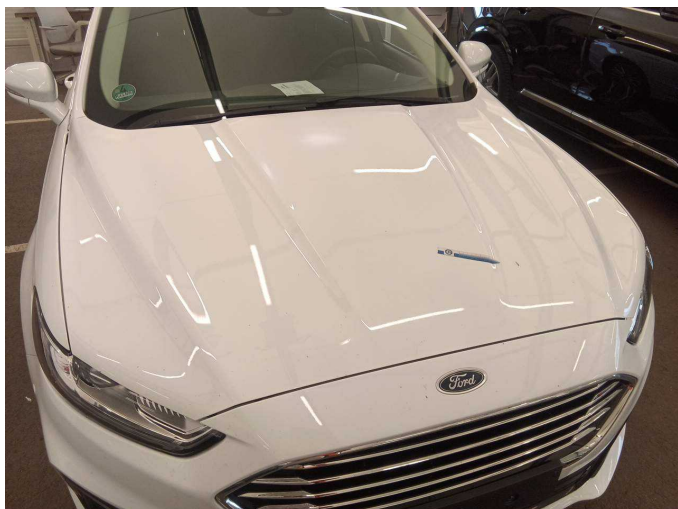
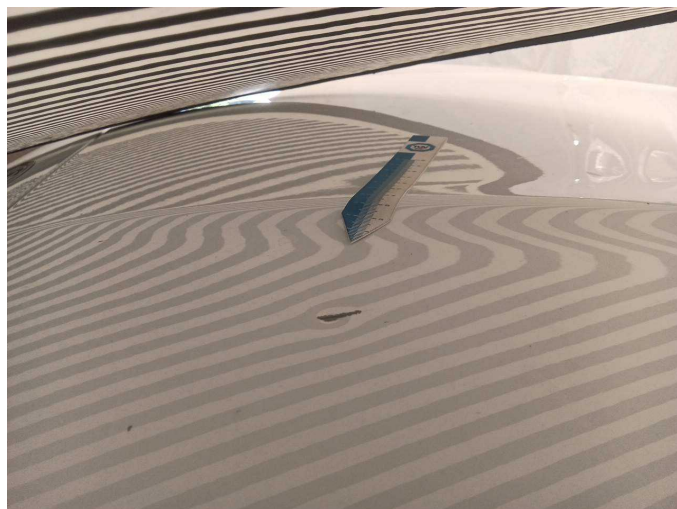
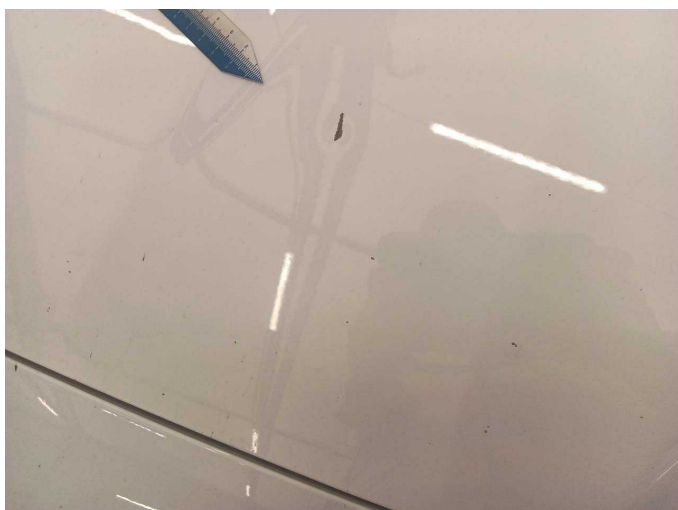
| No. | Component group | Description |
|---|---|---|
| 4 | Bonnet | Bonnet - Dent / paintcoat damage - Paint |

**Damage 4:** Bonnet: Bonnet - Dent / paintcoat damage - Paint

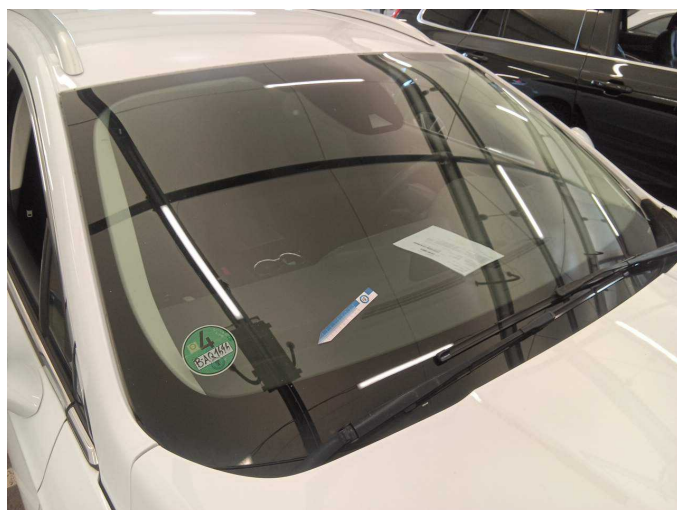
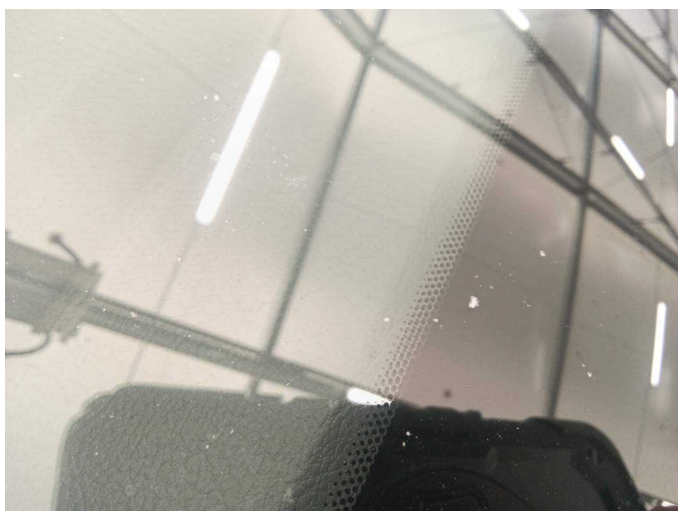
| No. | Component group | Description |
|---|---|---|
| 1 | Vehicle glazing | Windscreen - Stone chips - No deduction |

**Wear and tear 1:** Vehicle glazing: Windscreen - Stone chips - No deduction

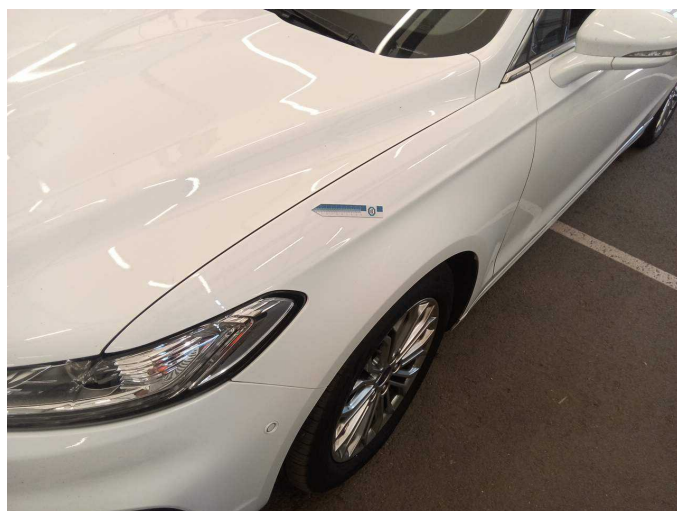
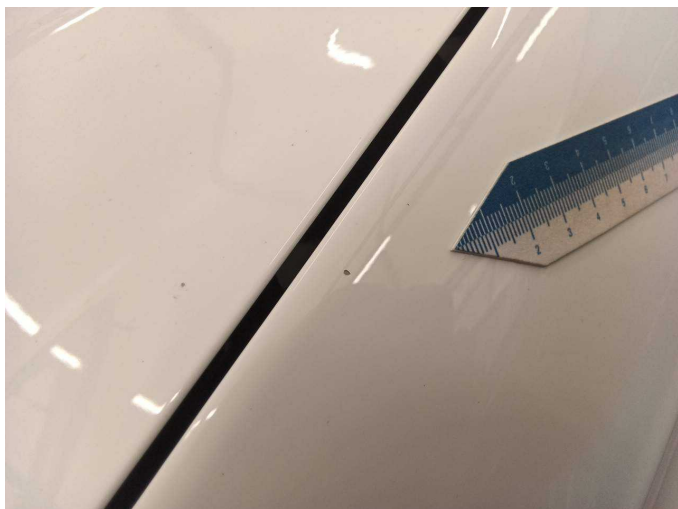
| No. | Component group | Description |
|---|---|---|
| 2 | Mudguard - left side | Mudguard - left side - Stone chips - No deduction |

**Wear and tear 2:** Mudguard - left side: Mudguard - left side - Stone chips - No deduction

**Wear and tear 2:** Mudguard - left side: Mudguard - left side - Stone chips  
- No deduction

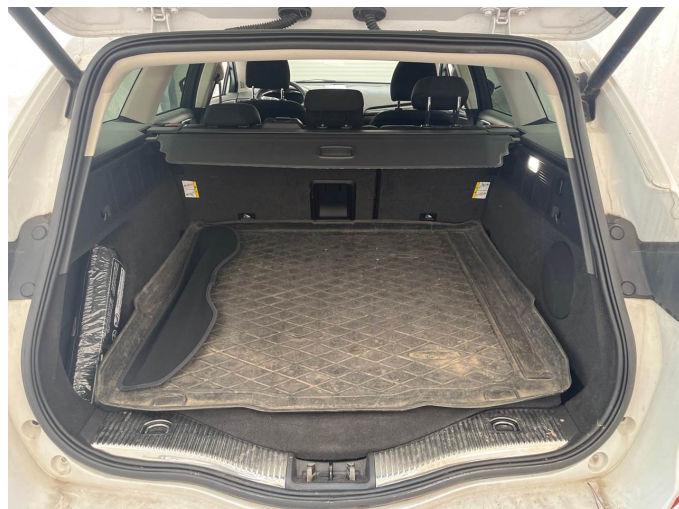
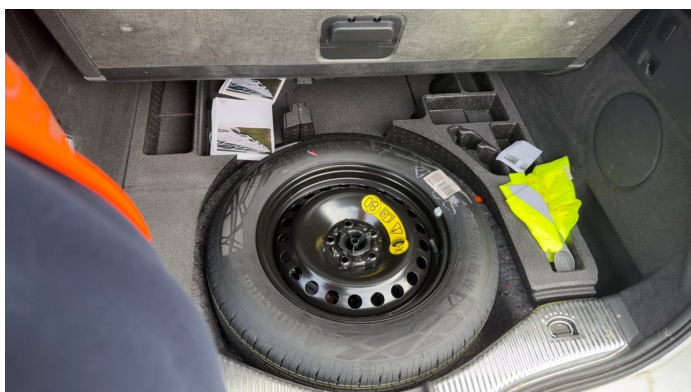
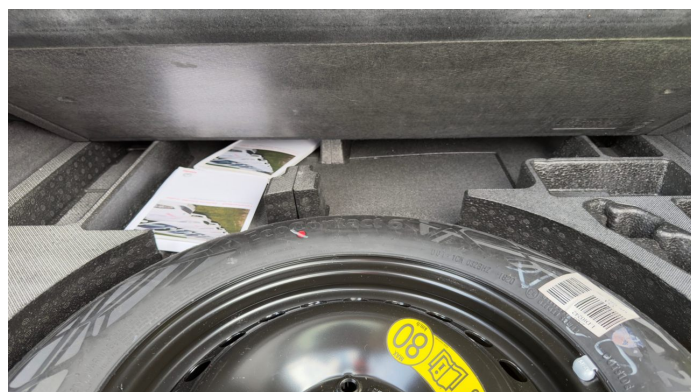
Interior - Separation net

**Missing part 1:** Interior: Separation net - Missing - Replace

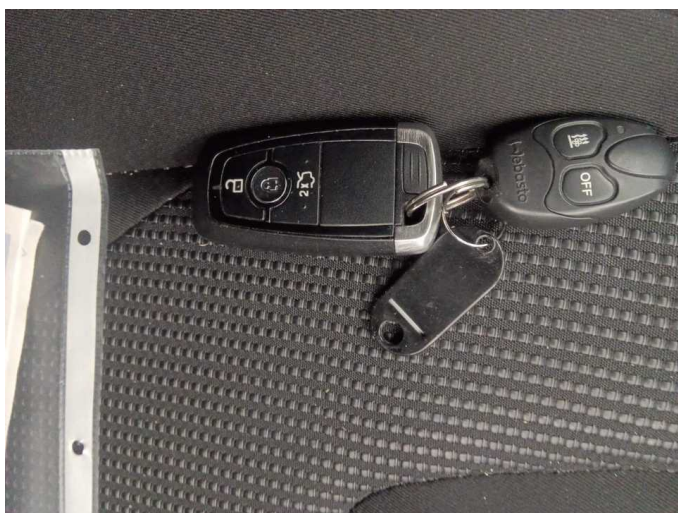
Equipment - Vehicle key

**Missing part 2:** Equipment: Vehicle key - Missing - Replace
