Expertise

Protocol number: 46200980
Order No. / Reference: 26578019
Inspection date: 26 Jun 2026

Model: Transit Custom 340 L2H1 LKW VA Trend

VIN: WF0ZXXTTGZLA22230

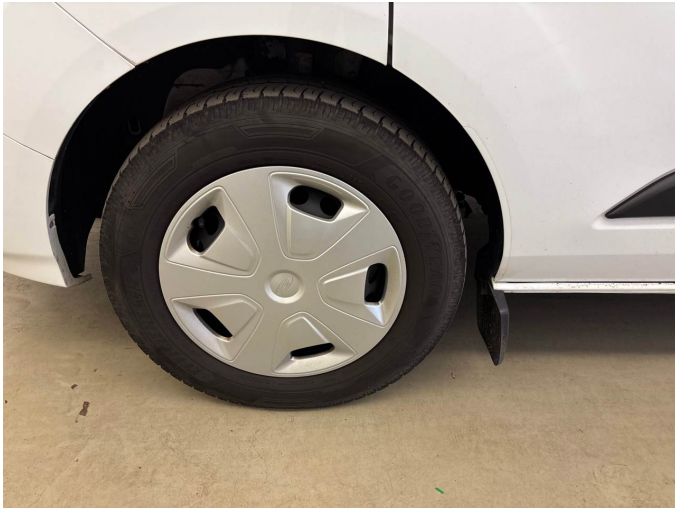
Figure 13: Mounted tyres

#	Tyre size	Type of tyre	Manufacturer	Tread depth
1)	215/65 R16 107T	Summer tyres on Steel rim with wheel cover	Goodyear	4mm / 4mm
2)	215/65 R16 107T	Summer tyres on Steel rim with wheel cover	Goodyear	4mm / 4mm

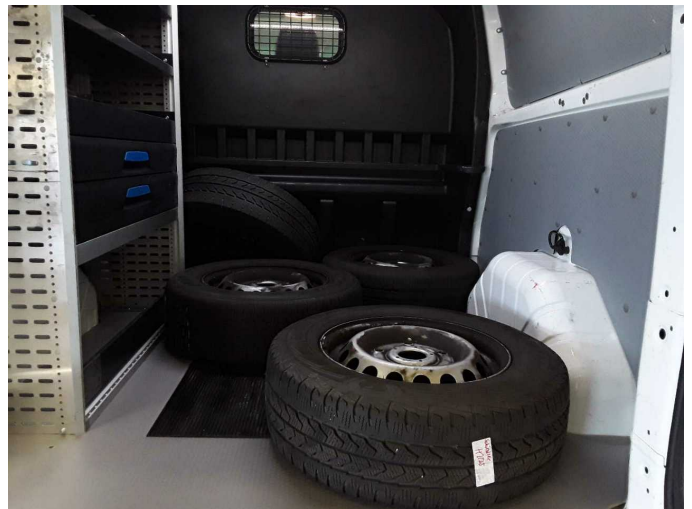
Figure 16: Additional tyres

#	Tyre size	Type of tyre	Manufacturer	Tread depth
1)	215/55 R16 107T	Winter tyres on Steel	Sonstige	5mm / 5mm
2)	215/55 R16 107T	Winter tyres on Steel	Goodyear	5mm / 5mm

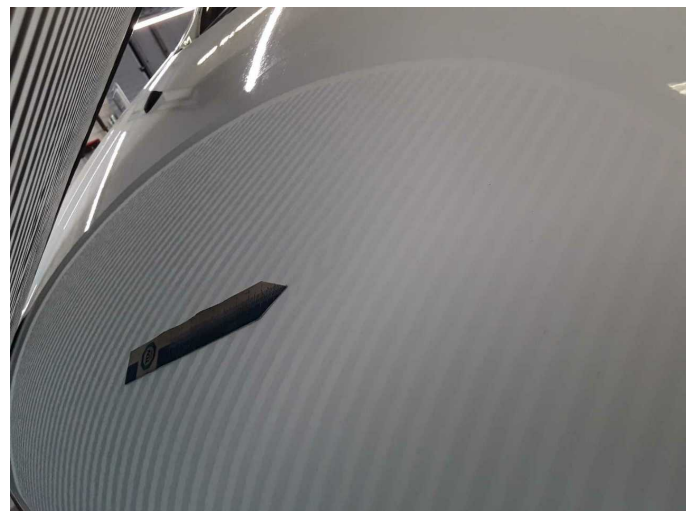
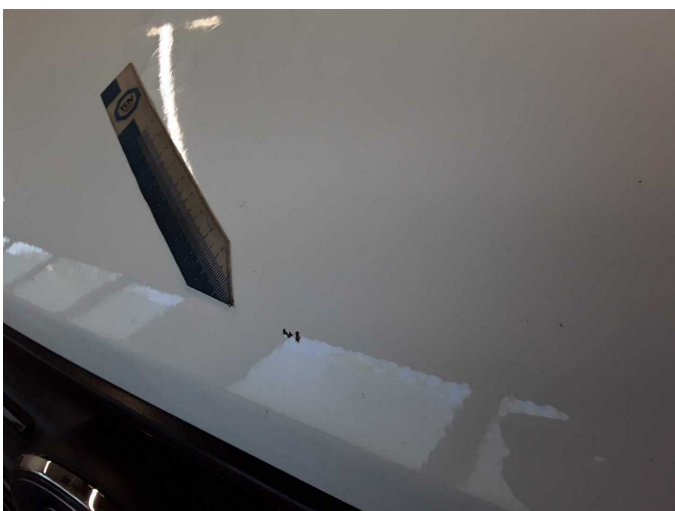
Damage 2: Bonnet: Bonnet - Dent / paintcoat damage - Repair and paint

No.	Component group	Description
1	Braking system	Brake pads - front - Worn - Replace
2	Bonnet	Bonnet - Dent / paintcoat damage - Repair and paint

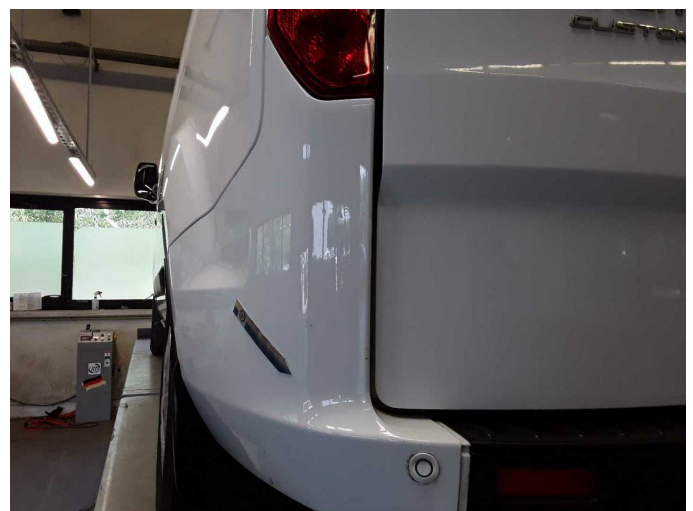
Wear and tear 1: Rear bumper: Rear bumper - Scratch(es) - No deduction

No.	Component group	Description
1	Rear bumper	Rear bumper - Scratch(es) - No deduction
2	Front bumper	Front bumper - Scratch(es) - No deduction
3	Vehicle glazing	Windscreen - Stone chips - No deduction
4	Interior	Interior - Scratch(es) - No deduction

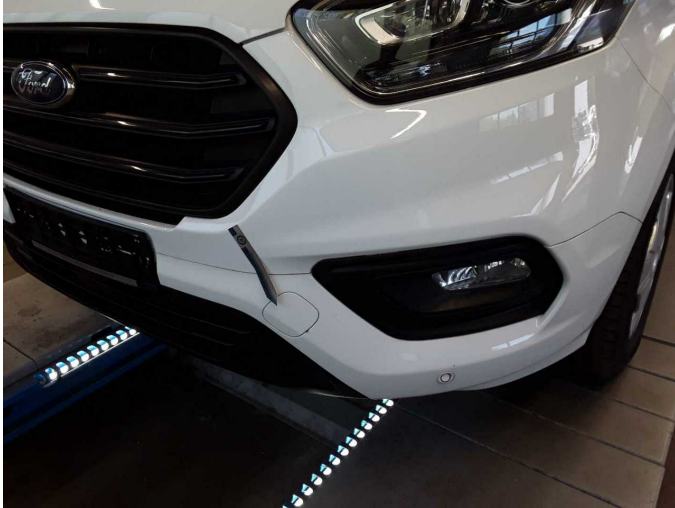
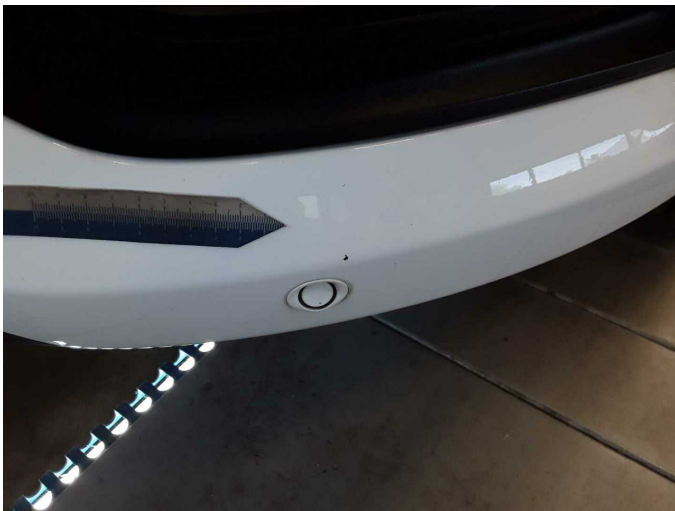
Wear and tear 2: Front bumper: Front bumper - Scratch(es) - No deduction

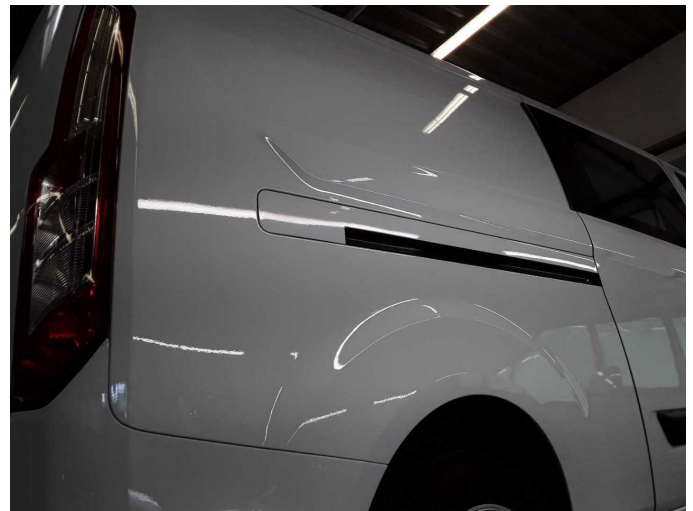
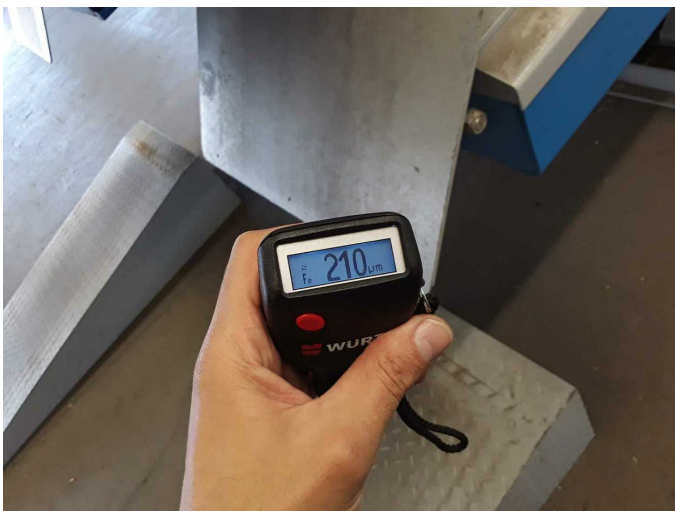
1 Side panel - rear right side, Professionally carried out, Invoice of repair done Non-existent

Side panel - rear right side 210 µm |

Repainting 1: Side panel - rear right side
