Expertise

Manufacturer: Volkswagen

Model: Passat Variant 2.0 TDI SCR DSG Business

VIN: WVGZZZ3CZPE038772

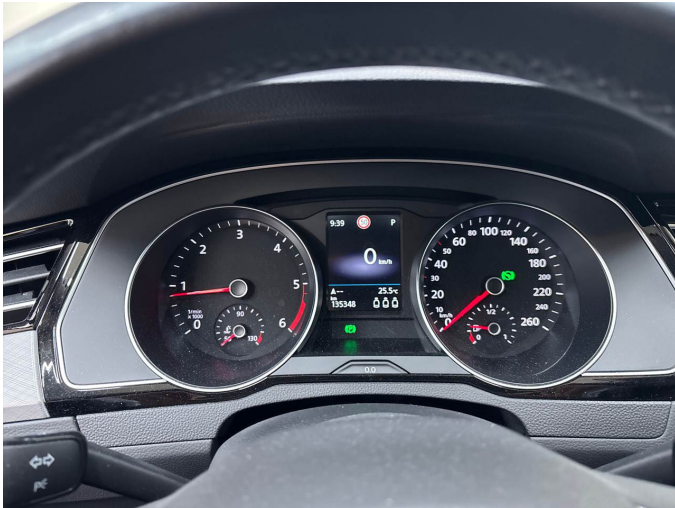
| Vehicle details | |
|---|---|
| Mileage (Read) | 135,348 km |

Figure 7: Instrument cluster

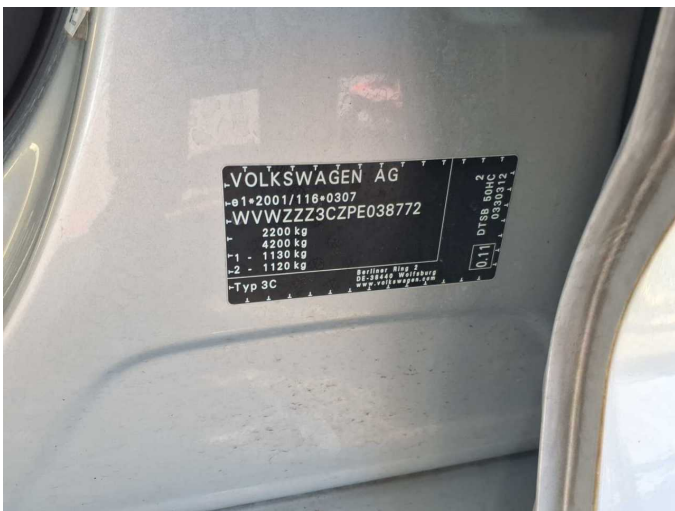
Figure 11: VIN

| VIN comparison | The vehicle identification number (VIN) was read from the vehicle and its conformity with the submitted documents was confirmed by the undersigned during the inspection. |

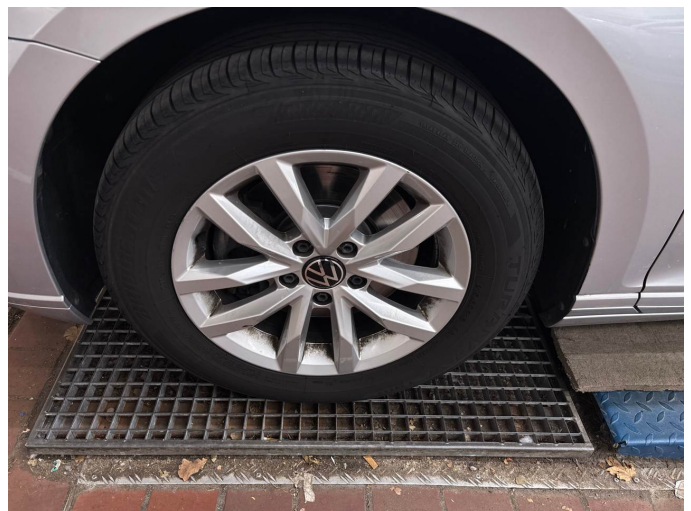
| # | Tyre size | Type of tyre | Manufacturer | Tread depth |
|---|---|---|---|---|
| 1) | 215/60 R16 95V | Summer tyres on Light alloy | Bridgestone | 4mm / 4mm |
| 2) | 215/60 R16 95V | Summer tyres on Light alloy | Bridgestone | 4mm / 4mm |

Figure 12: Mounted tyres

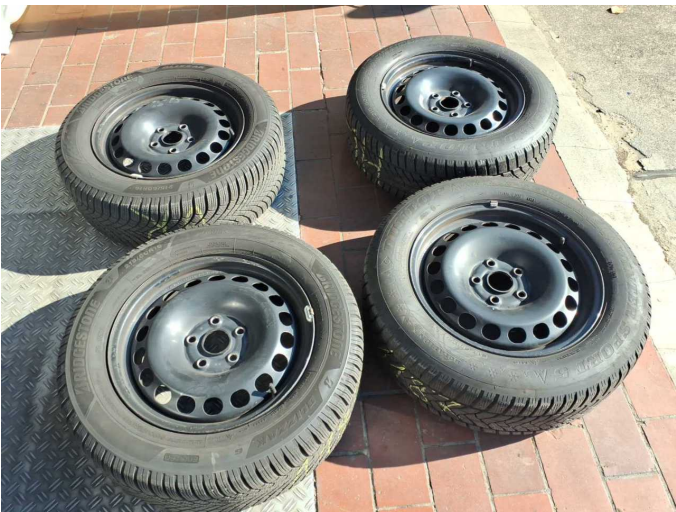
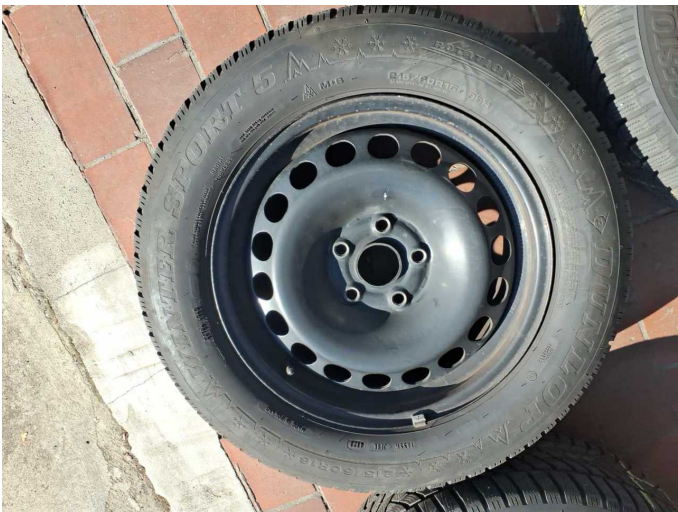
| # | Tyre size | Type of tyre | Manufacturer | Tread depth |
|---|---|---|---|---|
| 1) | 215/60 R16 99H | Winter tyres on Steel | Dunlop | 5mm / 5mm |
| 2) | 215/60 R16 99H | Winter tyres on Steel | Dunlop | 5mm / 5mm |

Figure 17: Additional tyres

Figure 18: Additional tyres

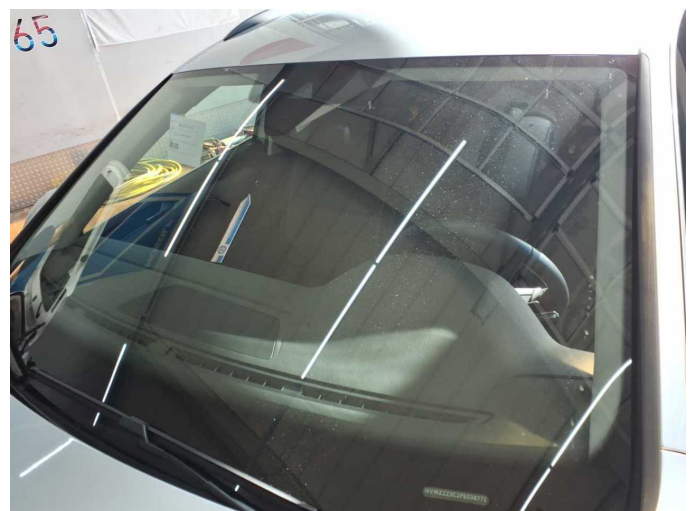
| No. | Component group | Description |
|---|---|---|
| 1 | Vehicle glazing | Windscreen - Stone chips - Replace |

Damage 1: Vehicle glazing: Windscreen - Stone chips - Replace

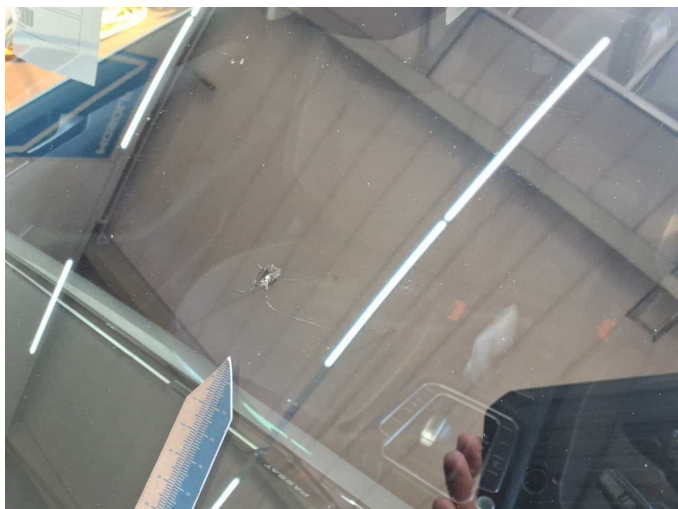
**Damage 1:** Vehicle glazing: Windscreen - Stone chips - Replace
