Expertise

Protocol number: 46077851  
Order No. / Reference: 26434587  
Inspection date: 20 Jun 2026

Manufacturer: Volvo

Model: XC90 T8 AWD Recharge Plus Bright

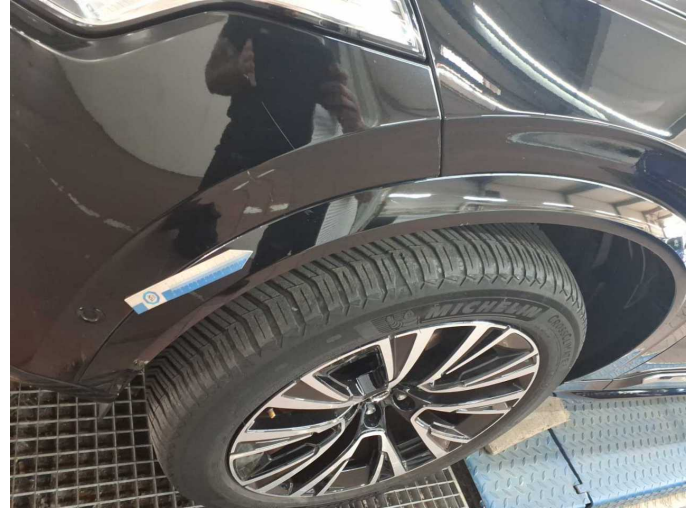
**Damage 1:** Side panel - rear left side: Wheel well extension - Scratch(es)  
- Smart repair

| No. | Component group | Description |
|---|---|---|
| 1 | Side panel - rear left side | Wheel well extension - Scratch(es) - Smart repair |

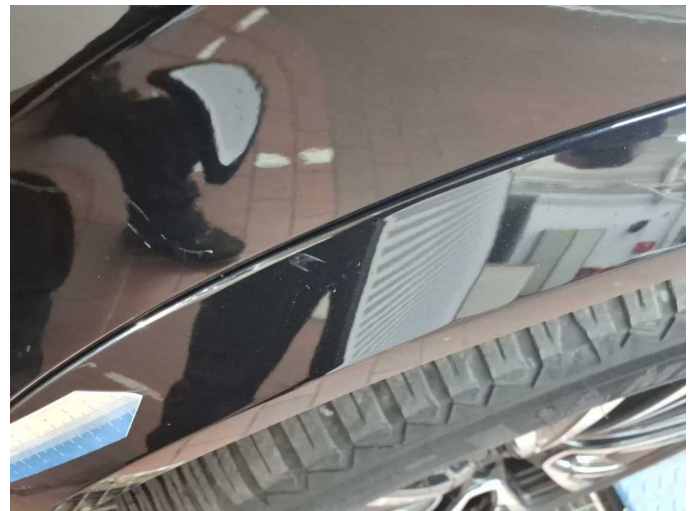
**Damage 1:** Side panel - rear left side: Wheel well extension - Scratch(es)  
- Smart repair

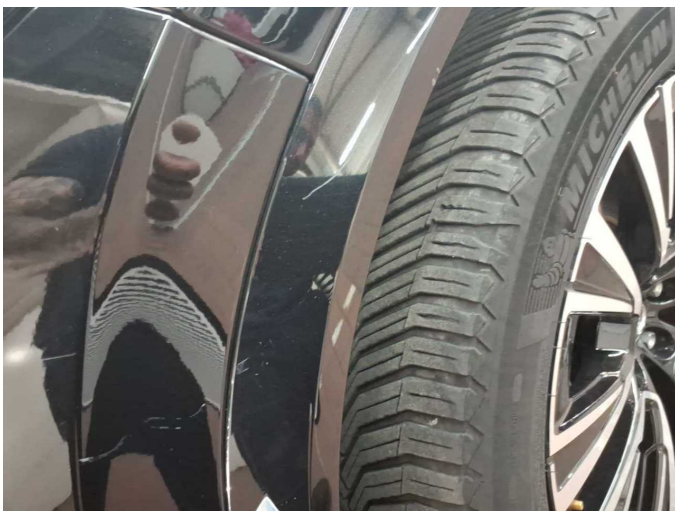
**Damage 1:** Side panel - rear left side: Wheel well extension - Scratch(es)  
- Smart repair

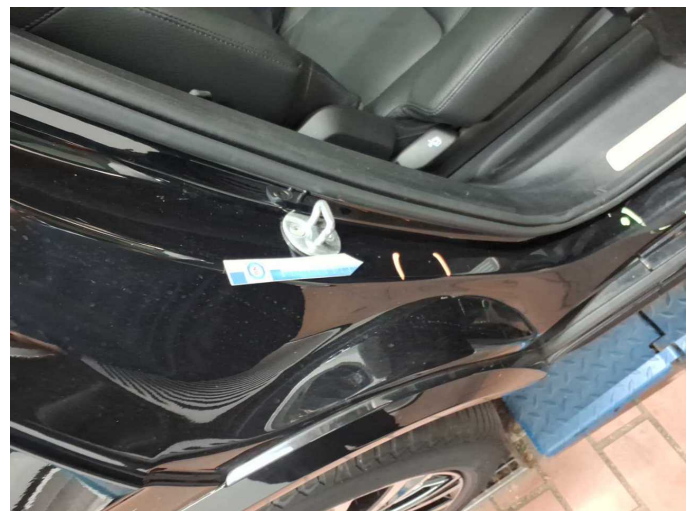
**Damage 1:** Side panel - rear left side: Wheel well extension - Scratch(es)  
- Smart repair

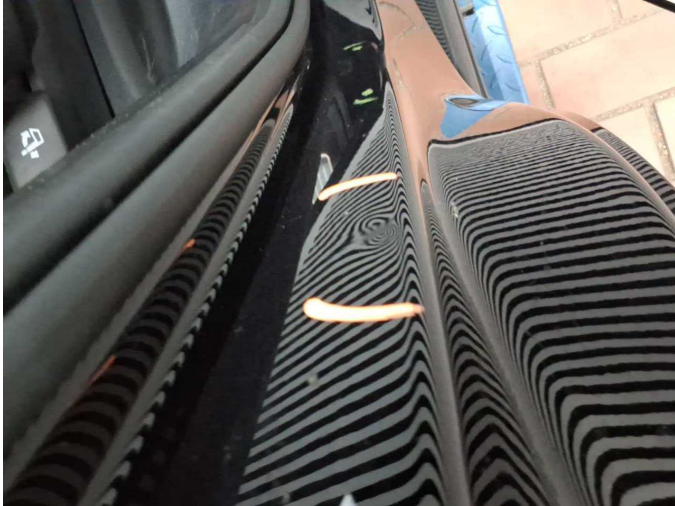
| No. | Component group | Description |
|---|---|---|
| 2 | Side panel - rear right side | Sill - dent(s) - Smooth repair work |

**Damage 2:** Side panel - rear right side: Sill - dent(s) - Smooth repair work

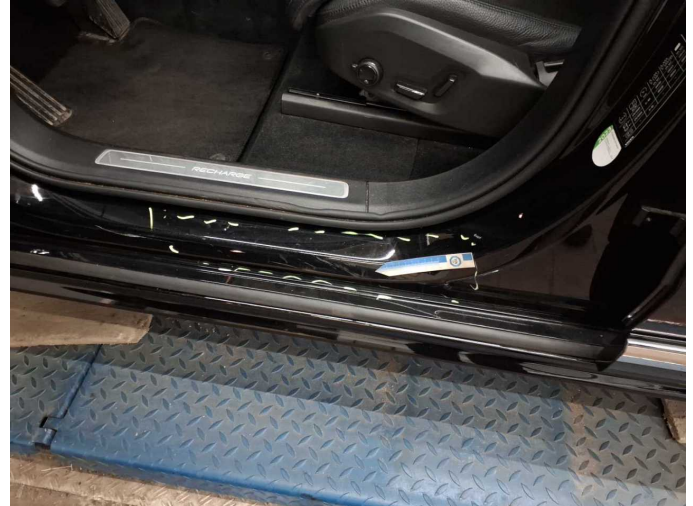
**Damage 2:** Side panel - rear right side: Sill - dent(s) - Smooth repair work

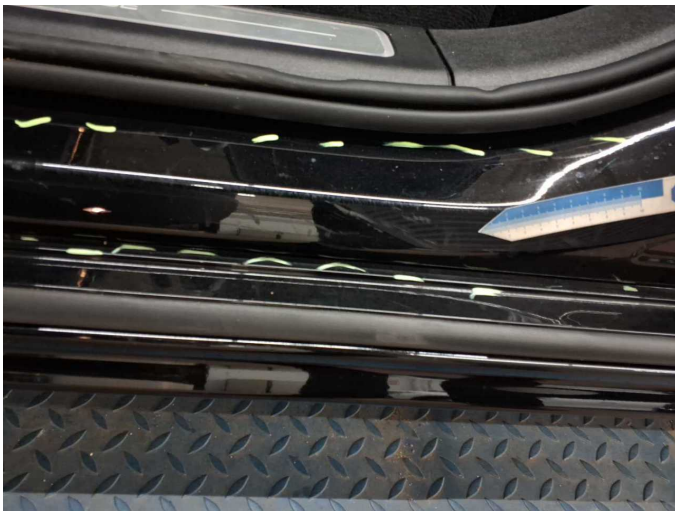
| No. | Component group | Description |
|---|---|---|
| 3 | Sill - left side | Sill - Scratch(es) - Smart repair |

**Damage 3:** Sill - left side: Sill - Scratch(es) - Smart repair

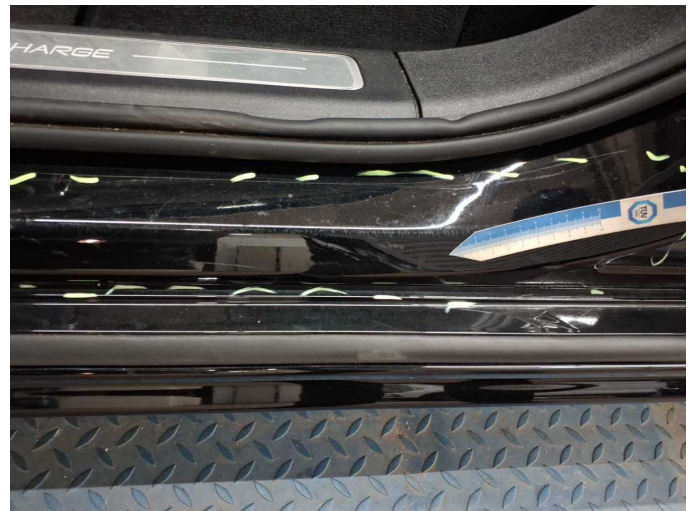
**Damage 3:** Sill - left side: Sill - Scratch(es) - Smart repair

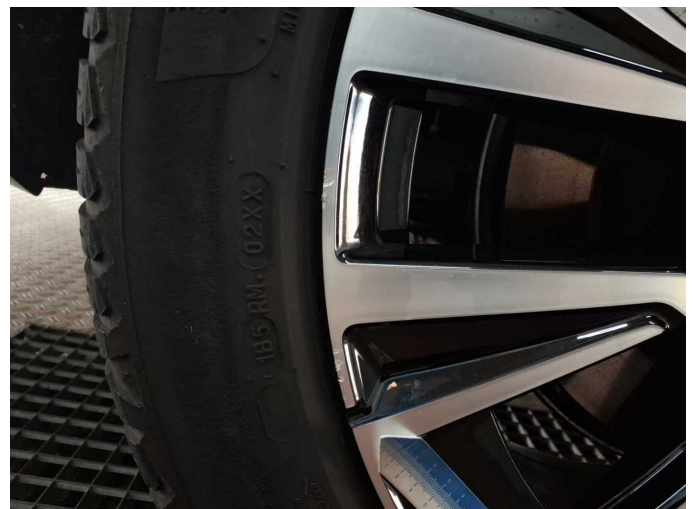
| No. | Component group | Description |
|---|---|---|
| 4 | Wheel / tyres | Alloy rim - rear right side - Scratched - Loss in value |

**Damage 4:** Wheel / tyres: Alloy rim - rear right side - Scratched - Loss in value

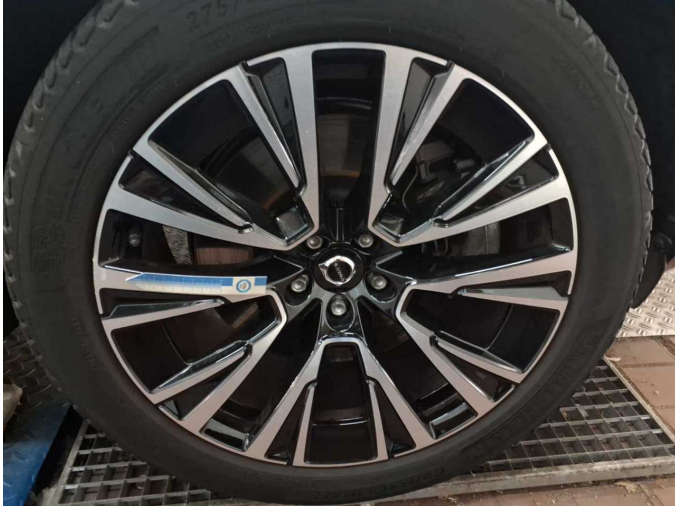
**Damage 4:** Wheel / tyres: Alloy rim - rear right side - Scratched - Loss in value

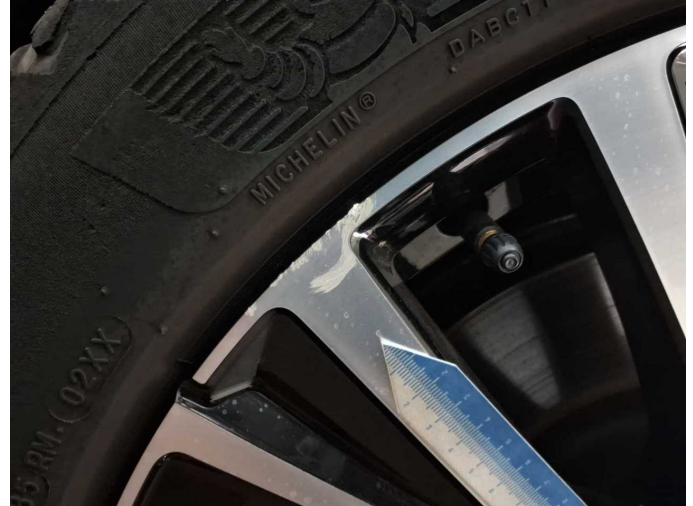
| No. | Component group | Description |
|---|---|---|
| 5 | Wheel / tyres | Alloy rim - front right side - Scratched - Loss in value |

**Damage 5:** Wheel / tyres: Alloy rim - front right side - Scratched - Loss in value

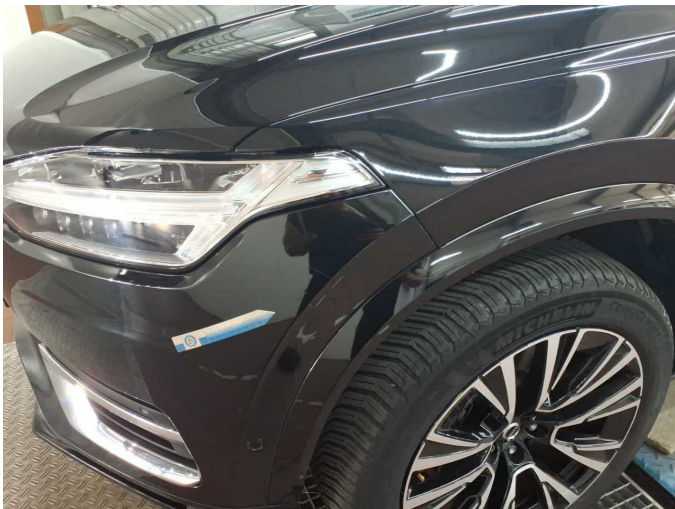
**Damage 5:** Wheel / tyres: Alloy rim - front right side - Scratched - Loss in value

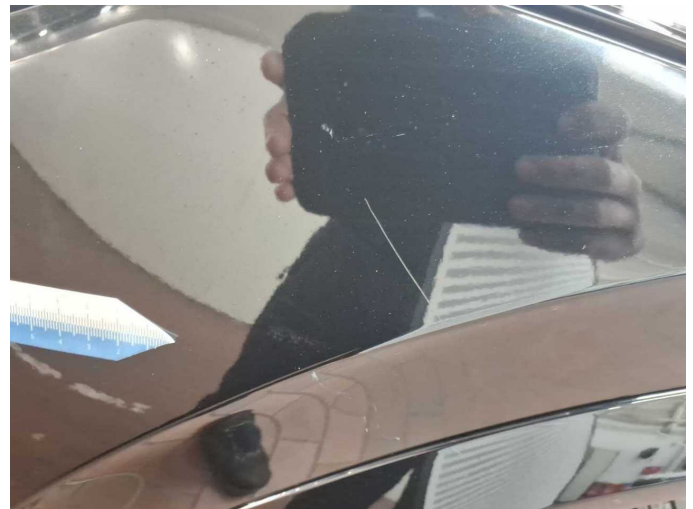
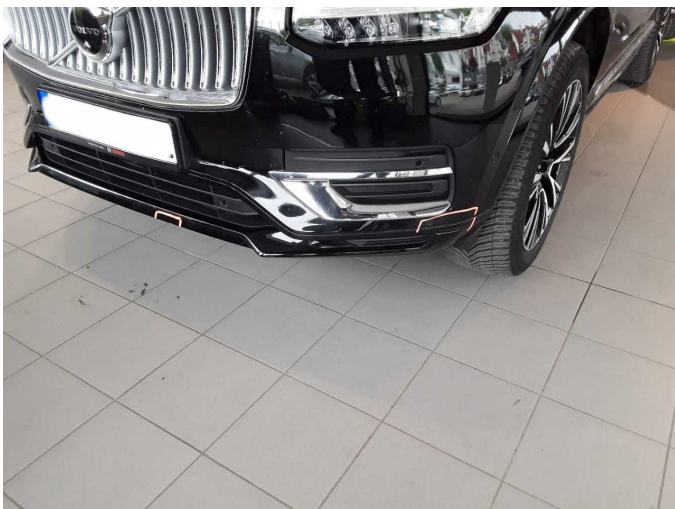
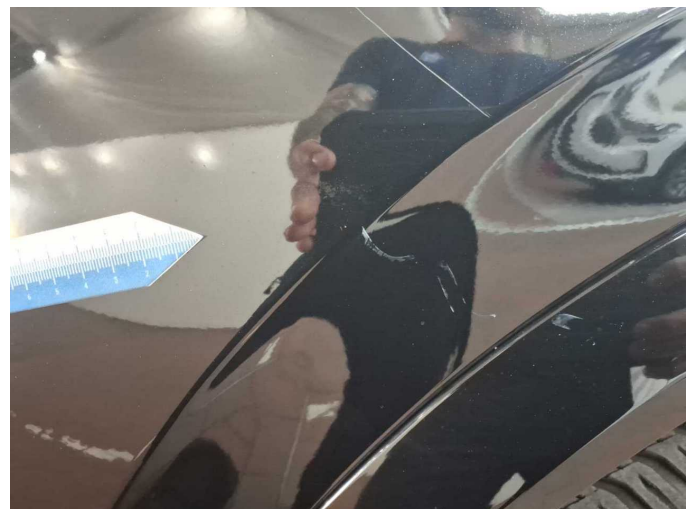
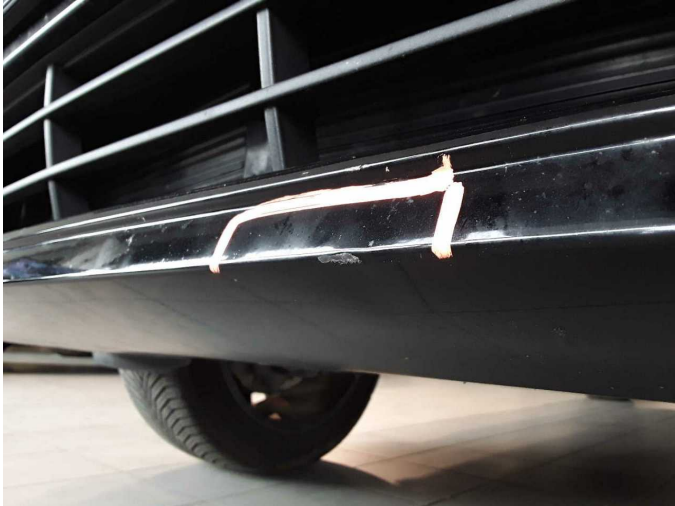
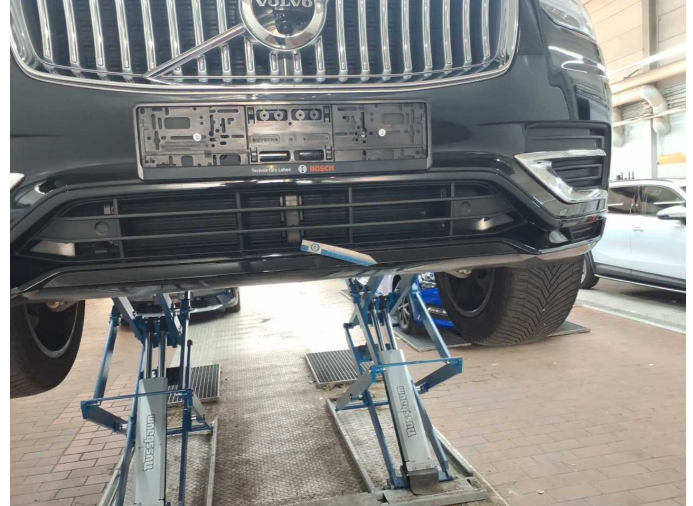
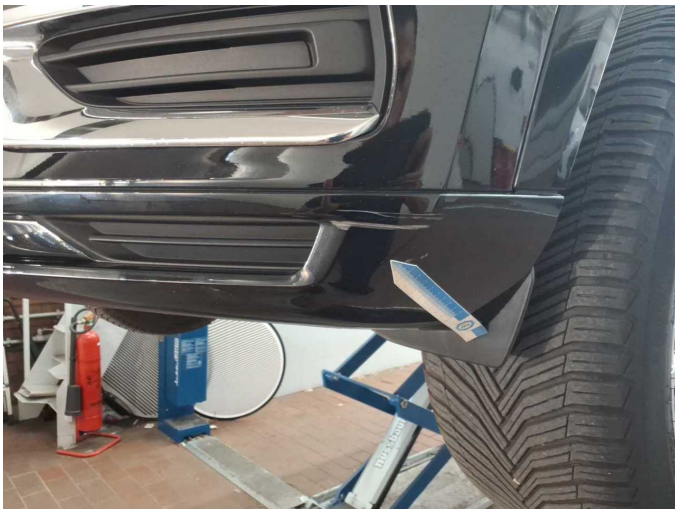
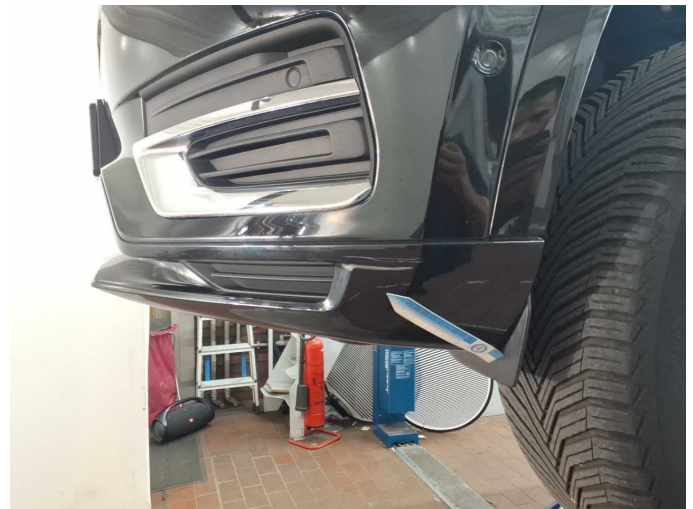
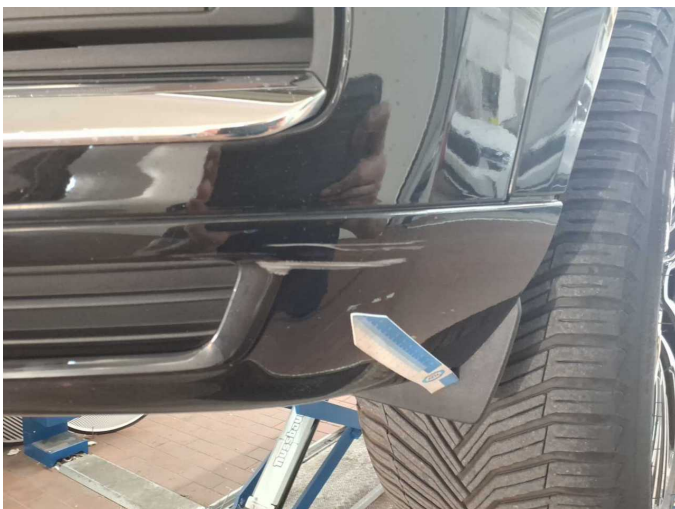
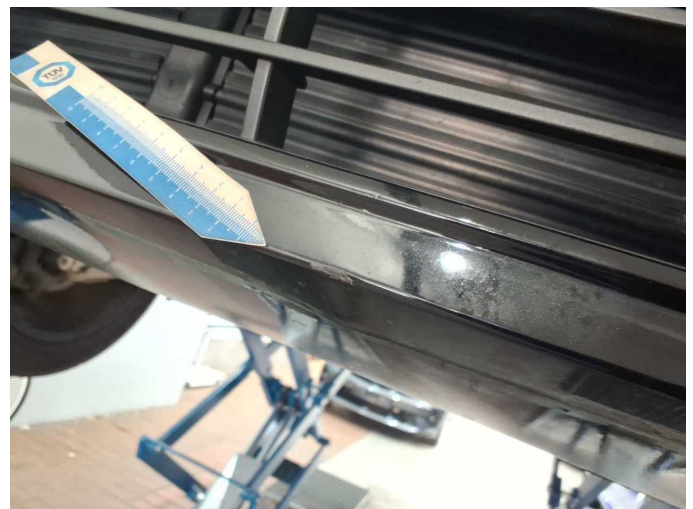
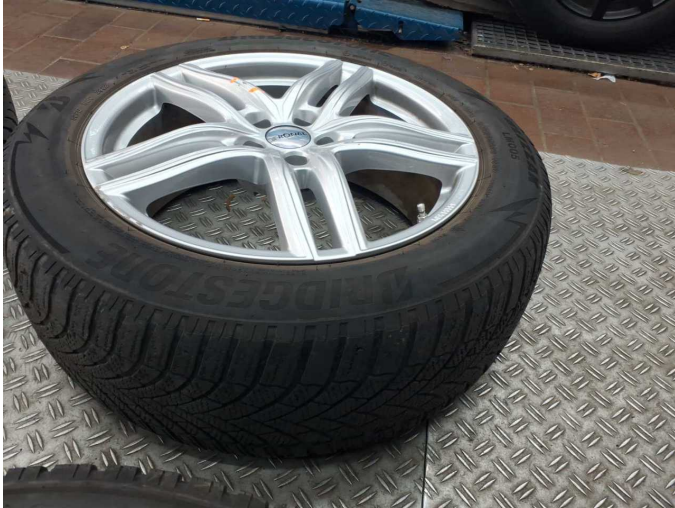
| No. | Component group | Description |
|---|---|---|
| 6 | Front bumper | Front bumper (+ Blende links lackieren) - Scratch(es) - Paint |

**Damage 6:** Front bumper: Front bumper (+ Blende links lackieren) - Scratch(es) - Paint

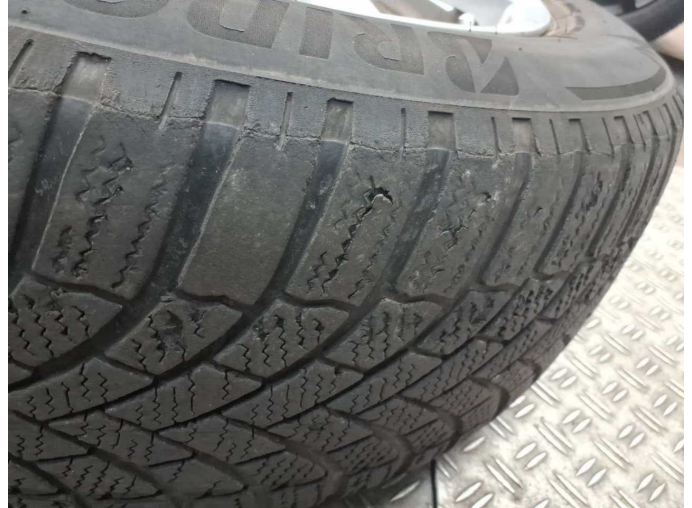
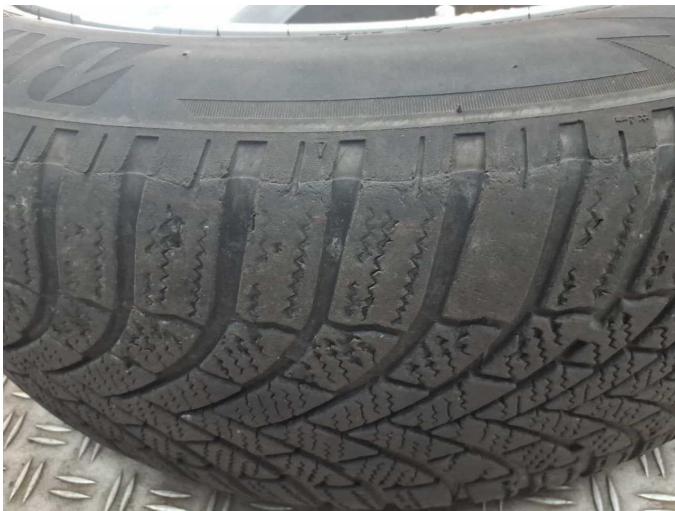
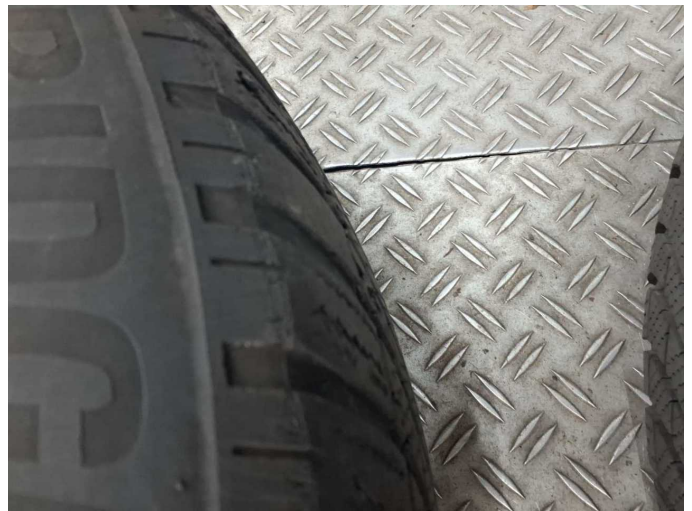
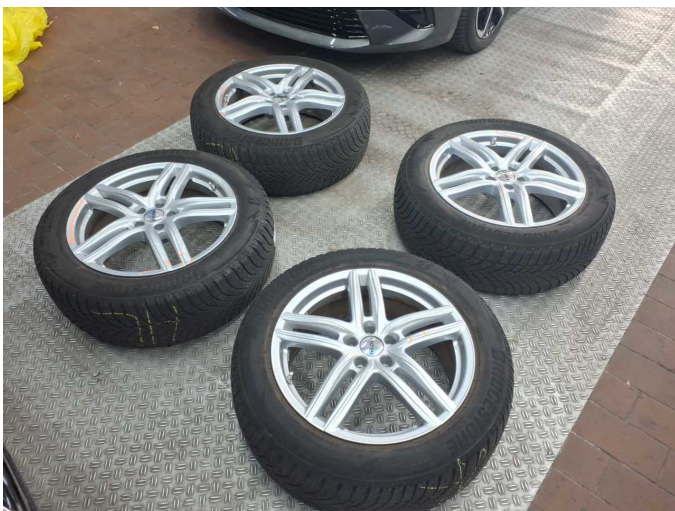
| No. | Component group | Description |
|---|---|---|
| 2 | 2nd wheel set | 1 tyre (Kein Teil der Ausstattung) - Worn - Replace |

**Wear and tear 2:** 2nd wheel set: 1 tyre (Kein Teil der Ausstattung) - Worn  
- Replace

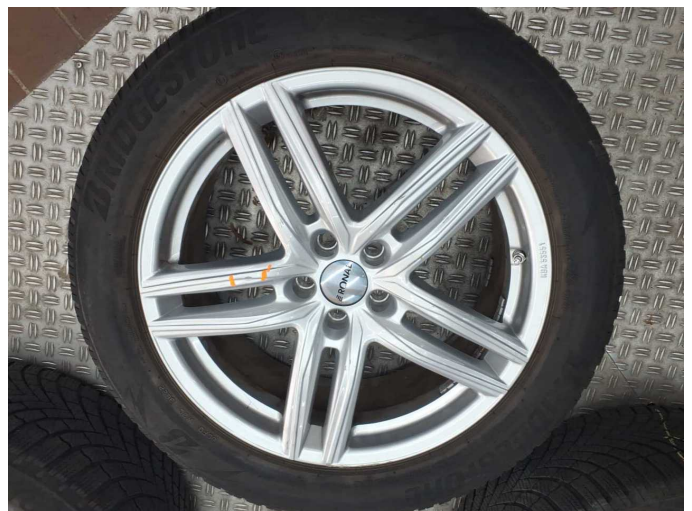
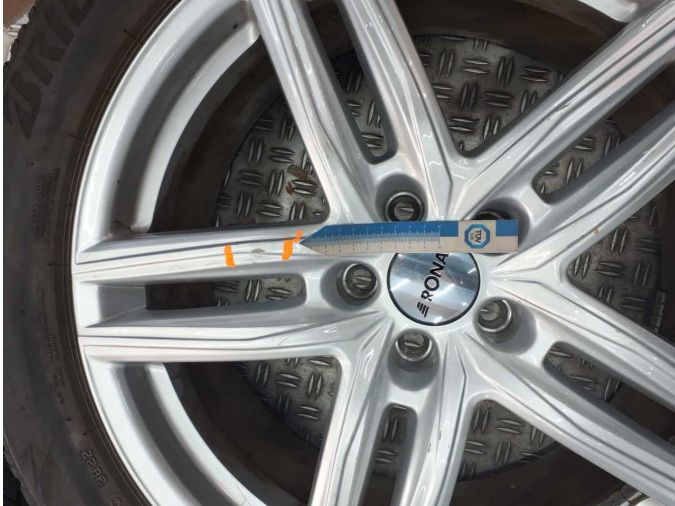
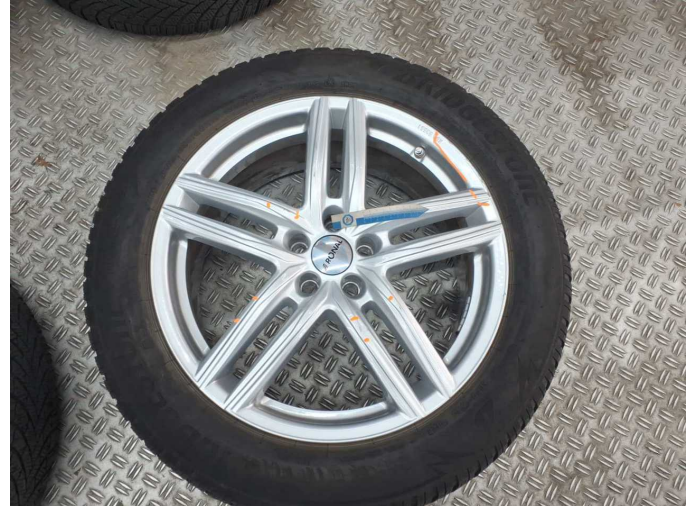
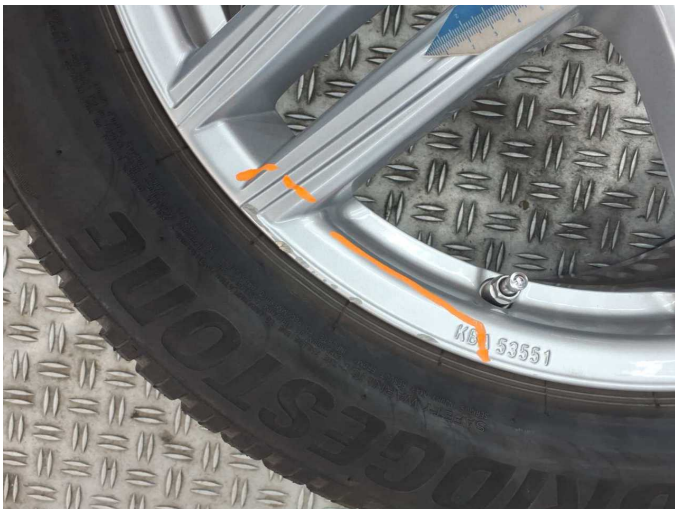
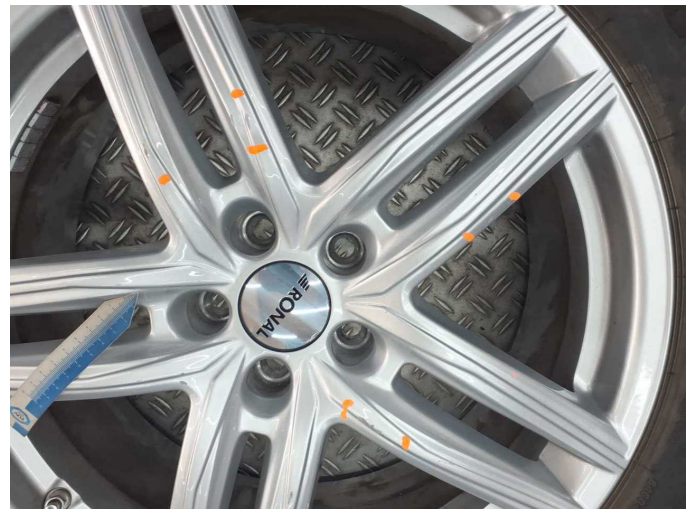
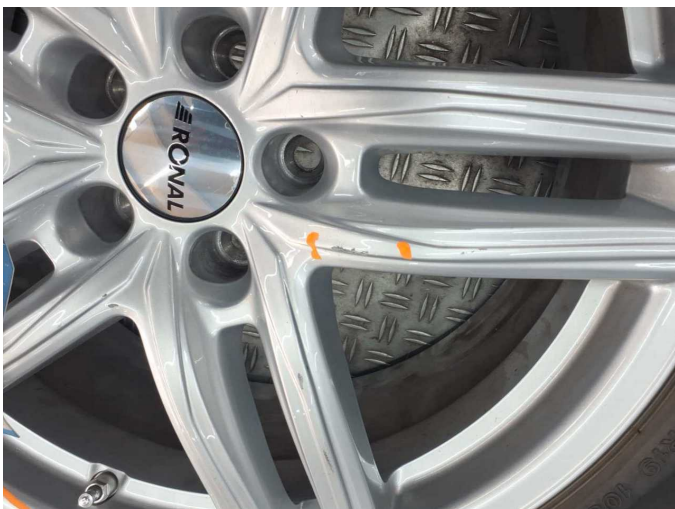
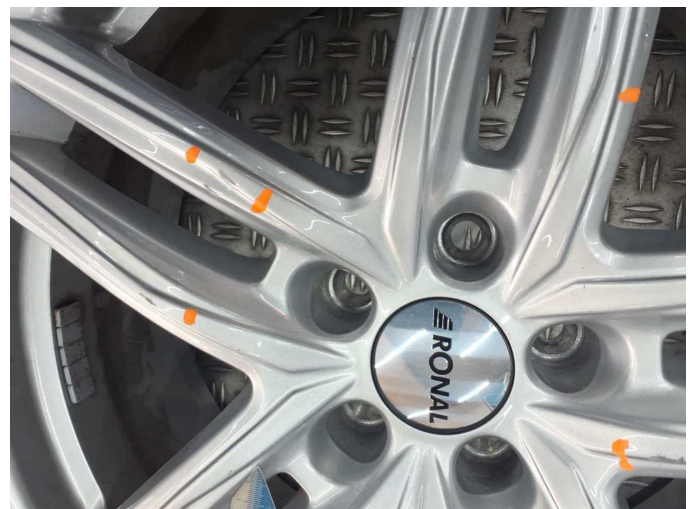
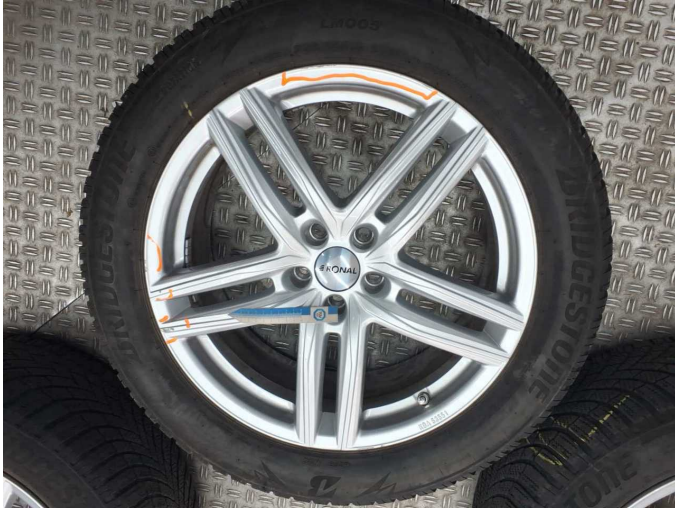
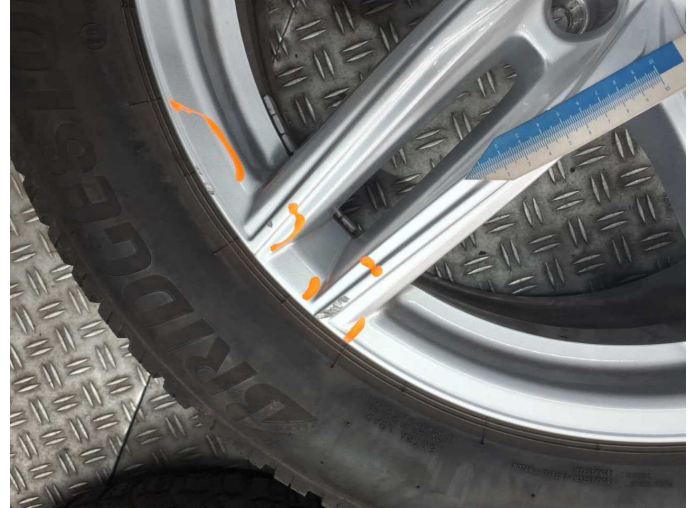
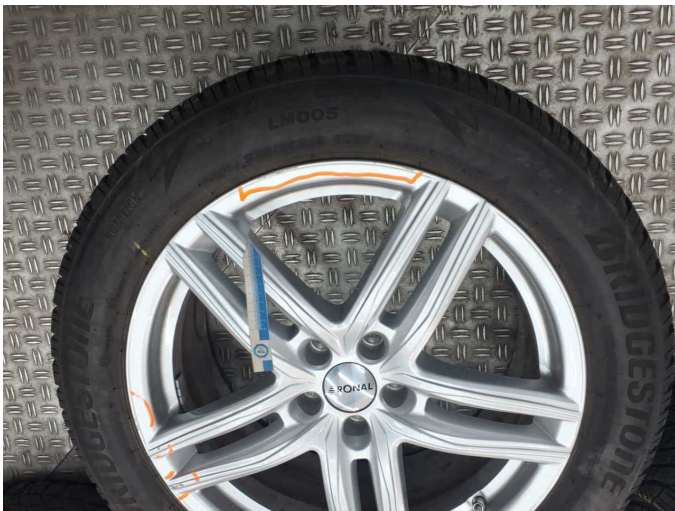
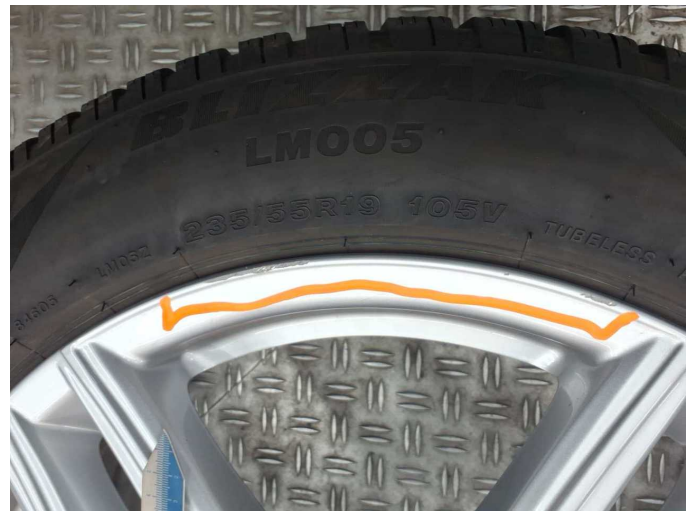
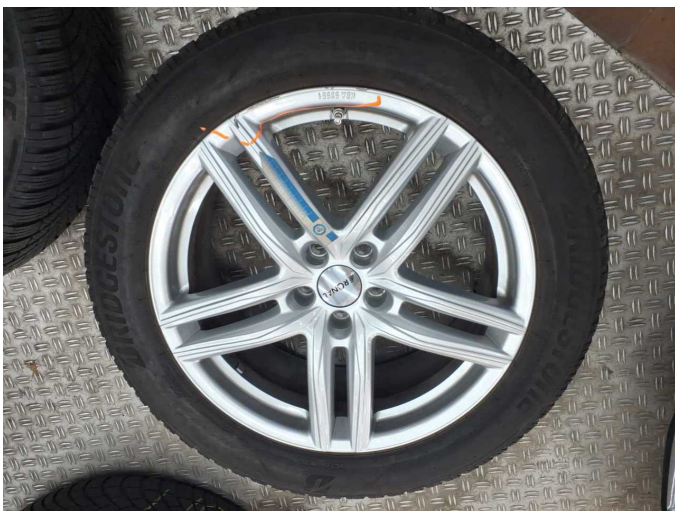
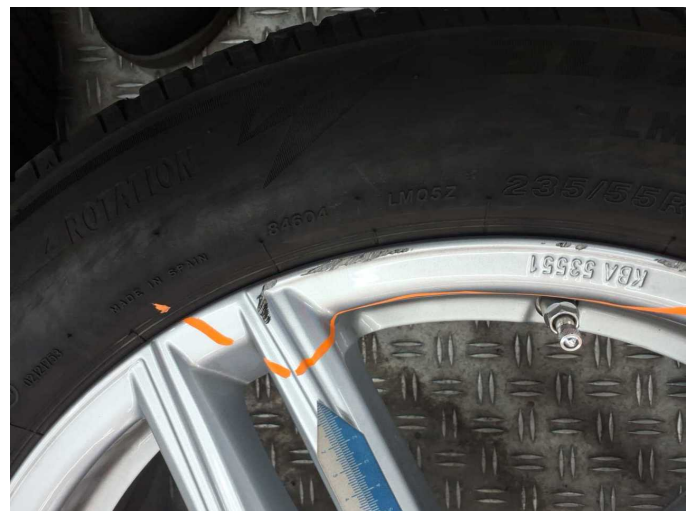
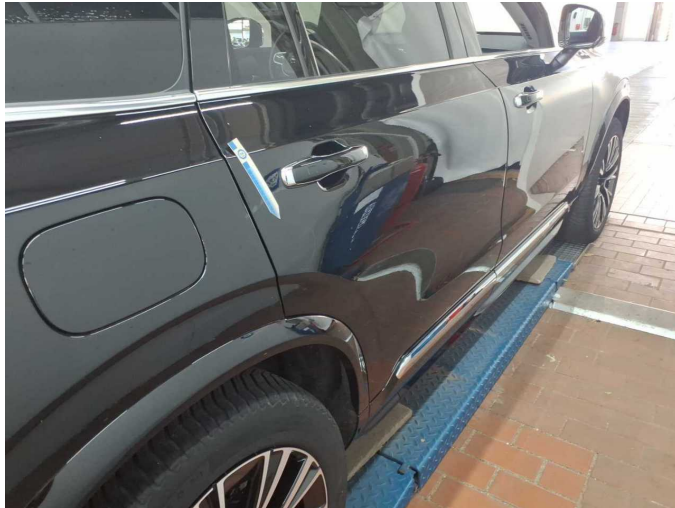
| No. | Component group | Description |
|---|---|---|
| 3 | 2nd wheel set | Alloy rim set - complete (Kein Teil der Ausstattung) - Scratched - No deduction |

**Wear and tear 3:** 2nd wheel set: Alloy rim set - complete (Kein Teil der Ausstattung) - Scratched - No deduction

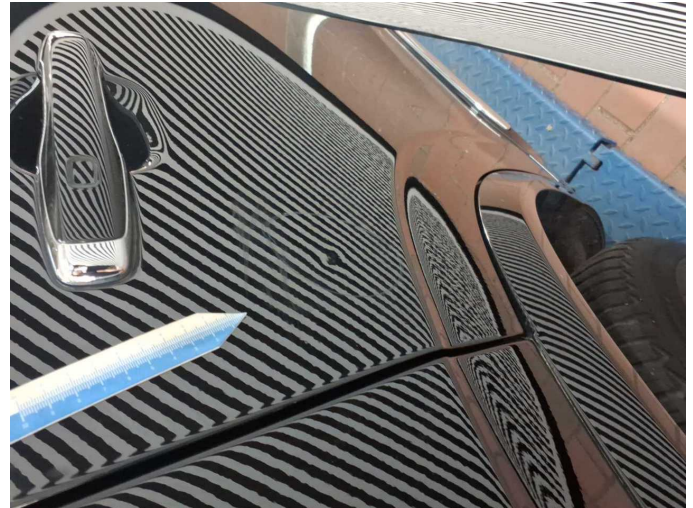
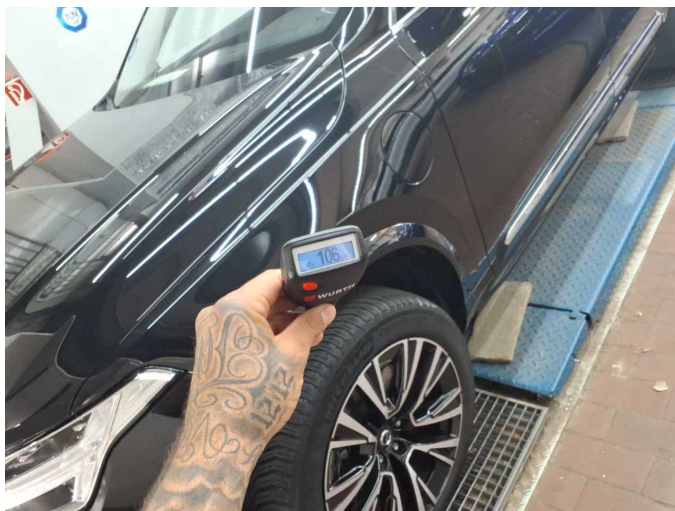
| No. | Component group | Description |
|---|---|---|
| 4 | Door - rear right side | Door - dent(s) - No deduction |

**Wear and tear 4:** Door - rear right side: Door - dent(s) - No deduction

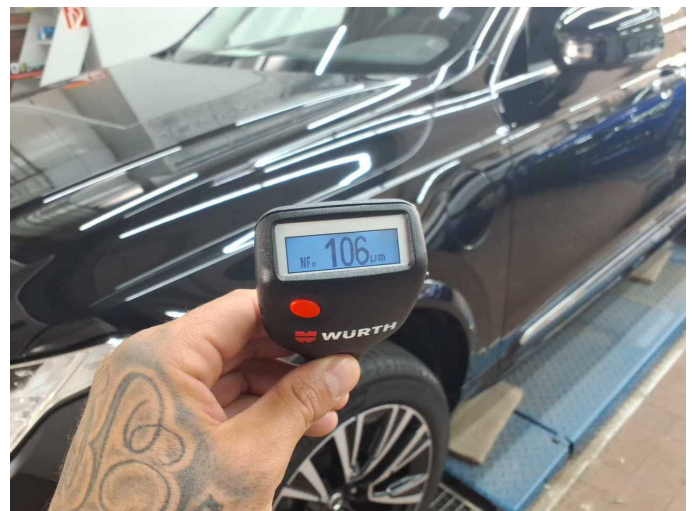
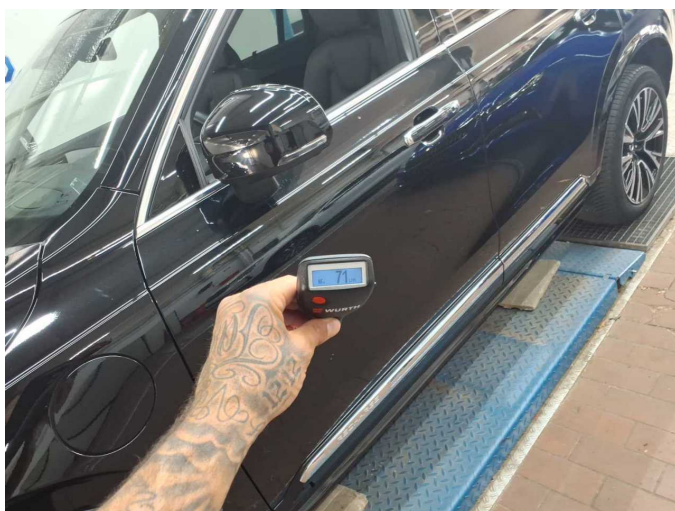
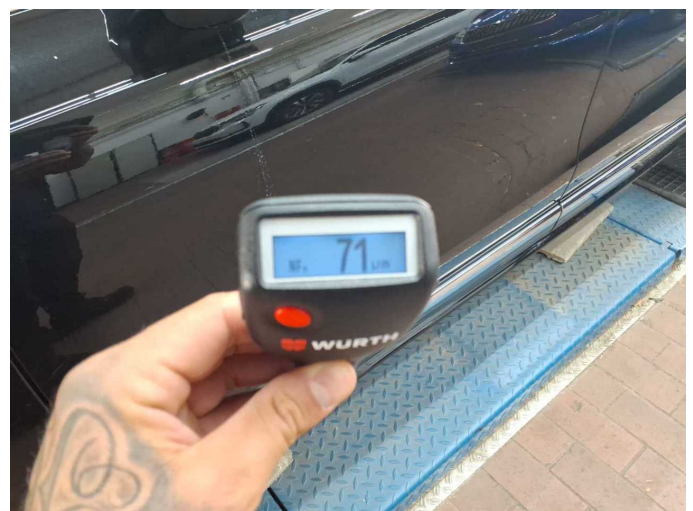
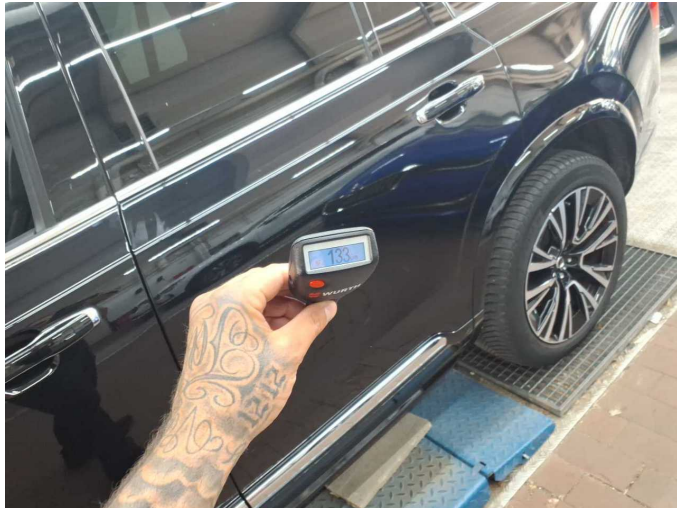
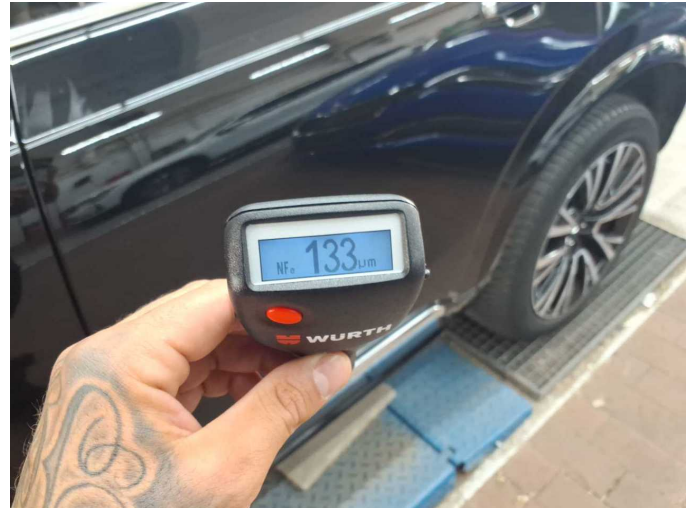
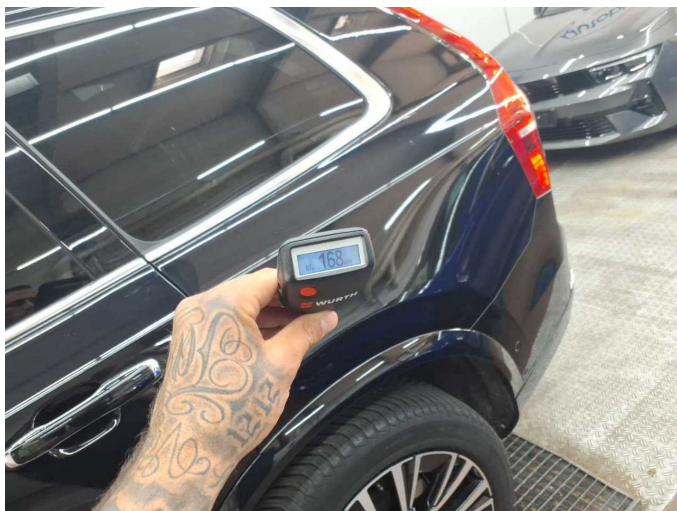
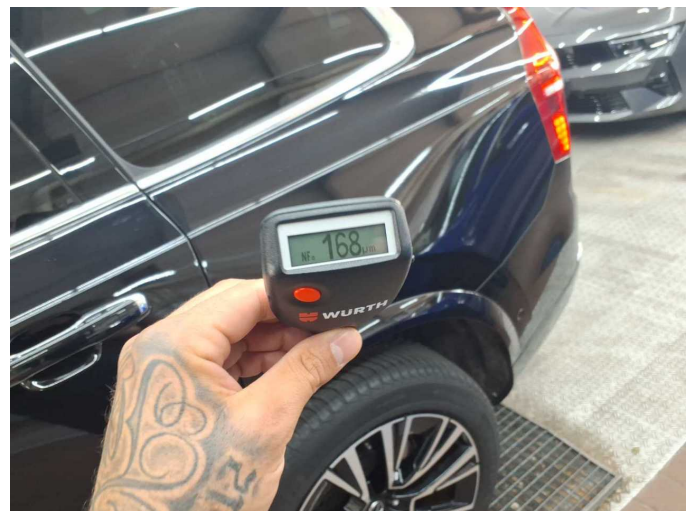
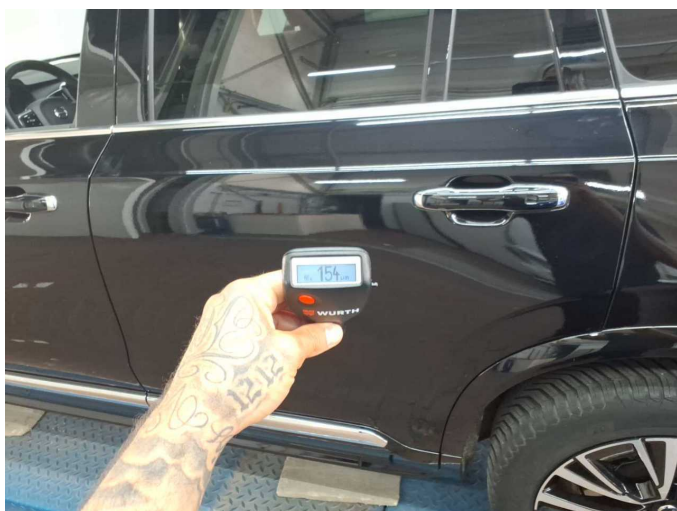
| No. | Previous damage | Extent of damage (Net) |
|---|---|---|
| 1 | Side - left, Professionally repaired, Invoice of repair done Non-existent, from 24 May 2025 | 1.124,20 € |

Professionally repaired previous damages were found at the vehicle.

**Previous damage 1:** Side - left

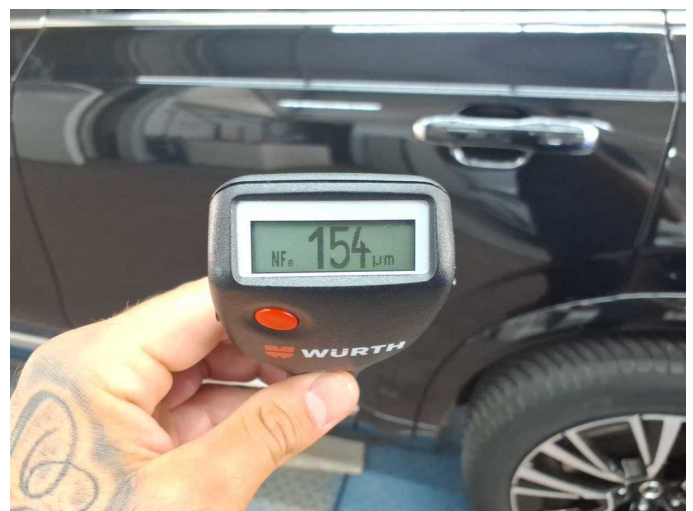
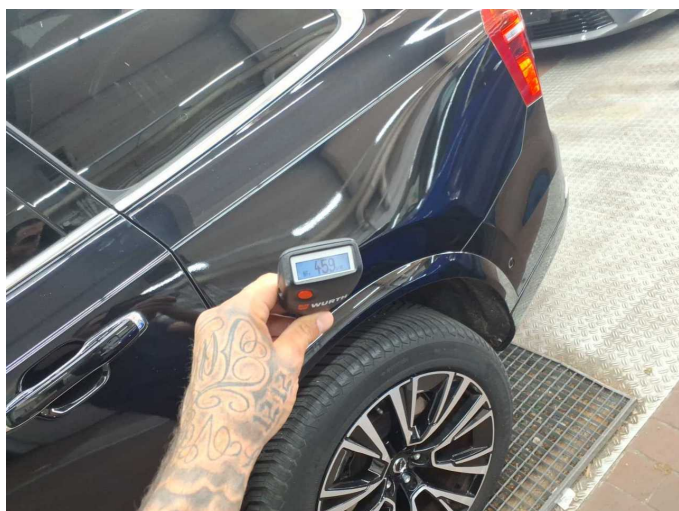
| No. | Repainting |
|---|---|
| 1 | Side panel - rear left side, Door - rear left side, Professionally carried out, Invoice of repair done Non-existent |

| Side panel - rear left side | 459 µm | Door - rear left side | 154 µm |

**Repainting 1: Side panel - rear left side, Door - rear left side**

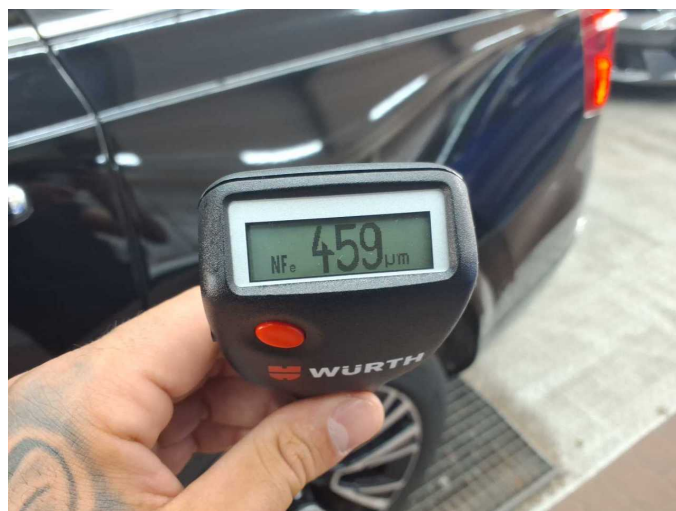
**Repainting 1:** Side panel - rear left side, Door - rear left side
