Expertise

Protocol number: 46192763  
Order No. / Reference: 26528098  
Inspection date: 23 Jun 2026

| Manufacturer: Ford | Model: Focus 1.5 EcoBlue Start-Stopp-System Aut. TITANIUM X |
| VIN: WF0NXXGCHNPD64093 | |

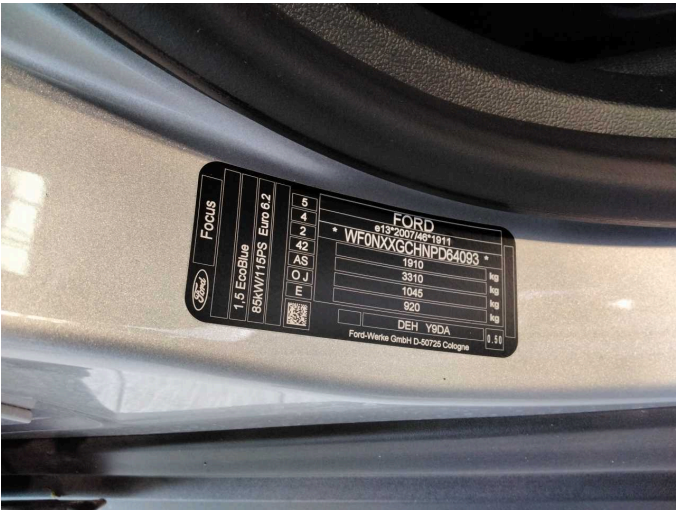
Figure 11: VIN

| VIN comparison | The vehicle identification number (VIN) was read from the vehicle and its conformity with the submitted documents was confirmed by the undersigned during the inspection. |

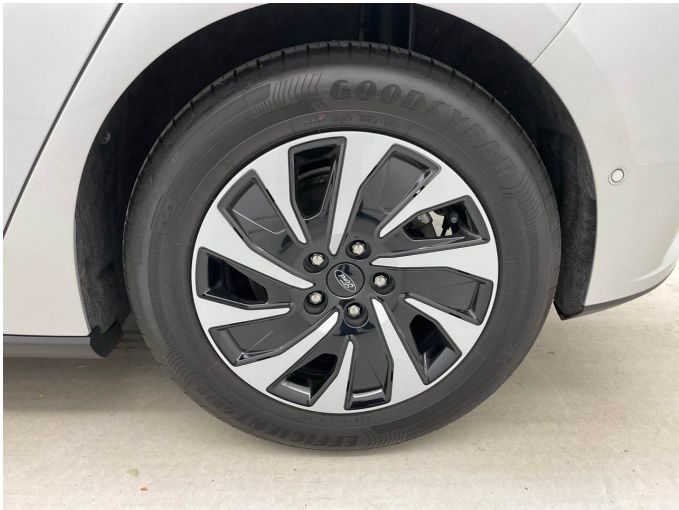
Figure 12: Mounted tyres

| Tyres | | | | |
|---|---|---|---|---|
| 1) | 205/60 R16 92V | Summer tyres on Light alloy | Goodyear | 5mm / 5mm |
| 2) | 205/60 R16 92V | Summer tyres on Light alloy | Goodyear | 6mm / 6mm |

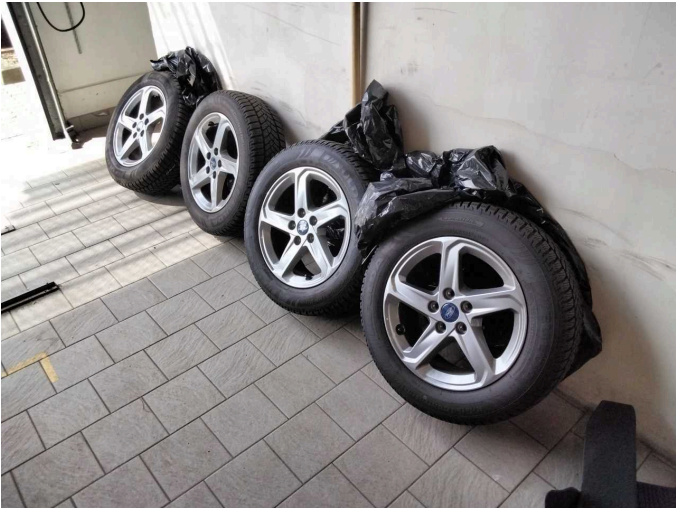
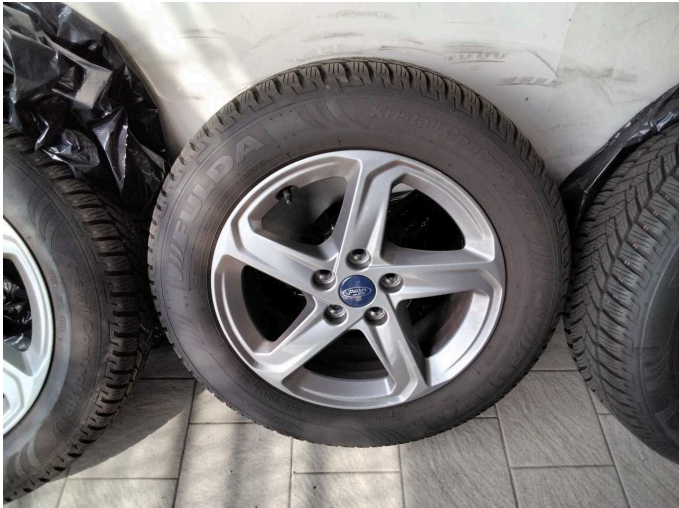
Figure 15: Additional tyres

| Tyres | | | | |
|---|---|---|---|---|
| 1) | 205/60 R16 92H | Winter tyres on Light alloy | Fulda | 9mm / 9mm |
| 2) | 205/60 R16 92H | Winter tyres on Light alloy | Fulda | 9mm / 9mm |

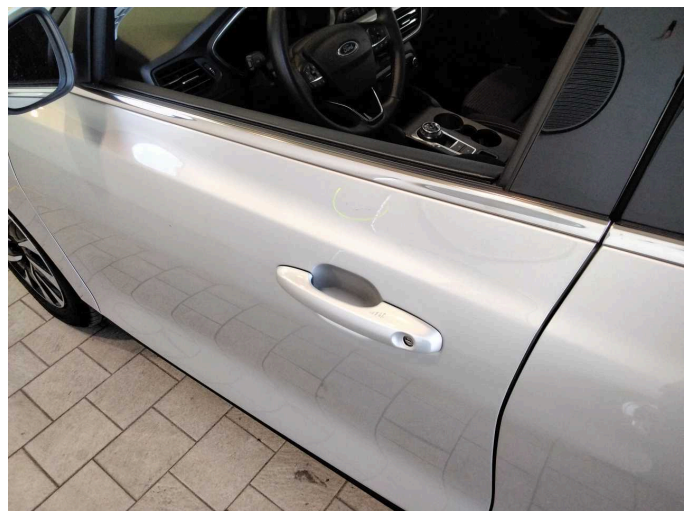
**Damage 1:** Door - front left side: Door - Scratch(es) - Smart repair

| No. | Component group | Description |
|---|---|---|
| 1 | Door - front left side | Door - Scratch(es) - Smart repair |

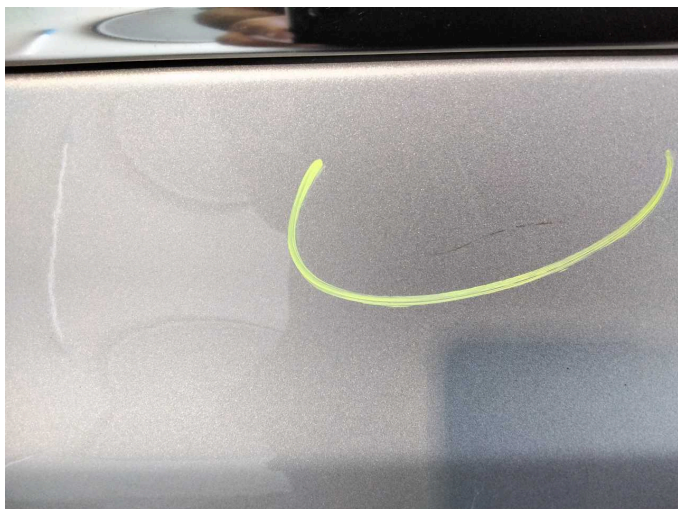
**Damage 1:** Door - front left side: Door - Scratch(es) - Smart repair

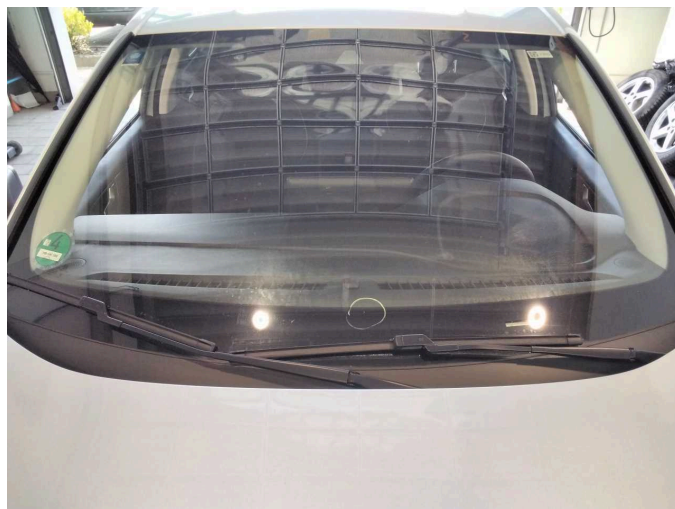
**Damage 2:** Vehicle glazing: Windscreen - Stone chips - Replace

| No. | Component group | Description |
|---|---|---|
| 2 | Vehicle glazing | Windscreen - Stone chips - Replace |

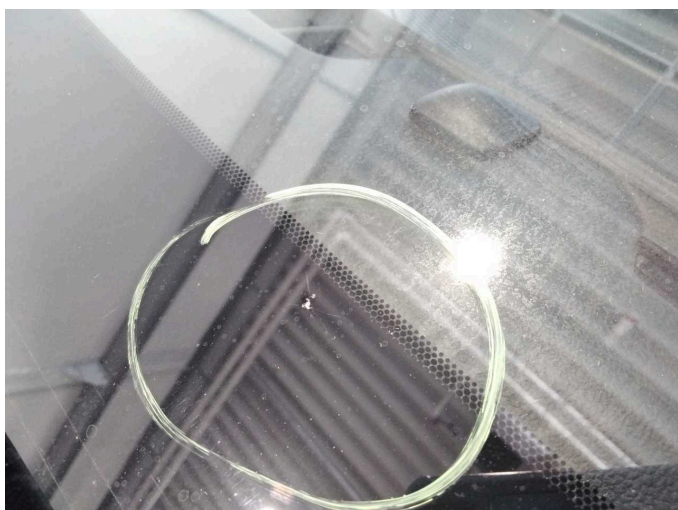
**Damage 2:** Vehicle glazing: Windscreen - Stone chips - Replace

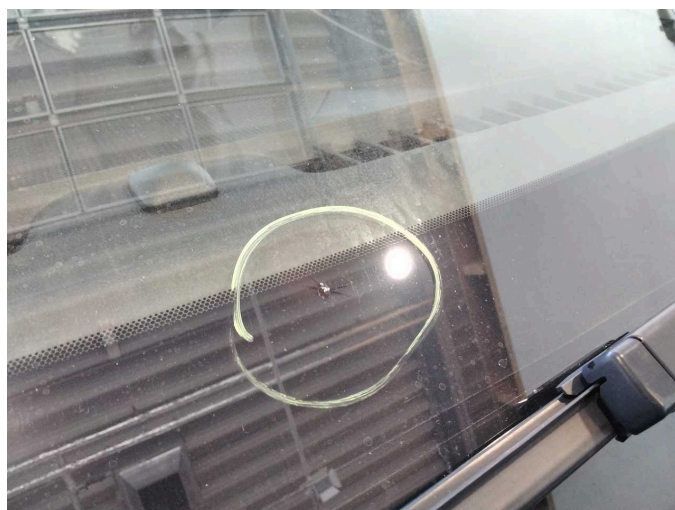
**Damage 2:** Vehicle glazing: Windscreen - Stone chips - Replace

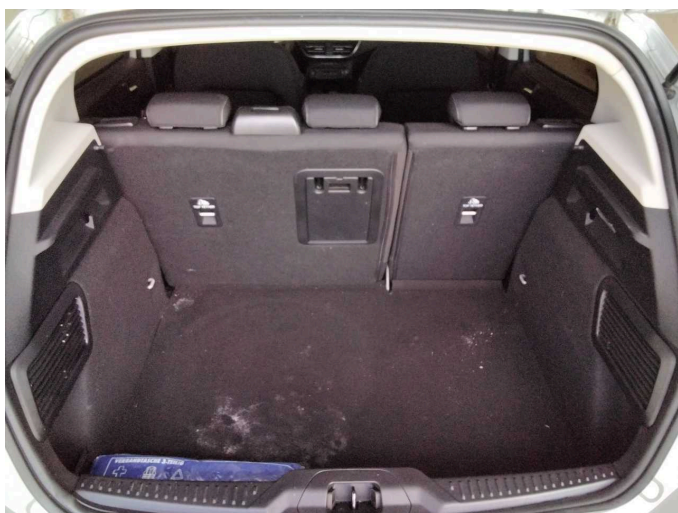
**Missing part 3:** Interior: Boot cover / roller cover - Missing - Replace

Trim / covers - Floor mats (Gummimatten vorne)  
Equipment - Fire extinguisher  
Interior - Boot cover / roller cover
