Expertise

Protocol number: 45607472
Order No. / Reference: 26424408
Inspection date: 22 May 2026

Manufacturer: Ford

Model: Kuga 2.0 EcoBlue 4x4 Aut. TITANIUM X

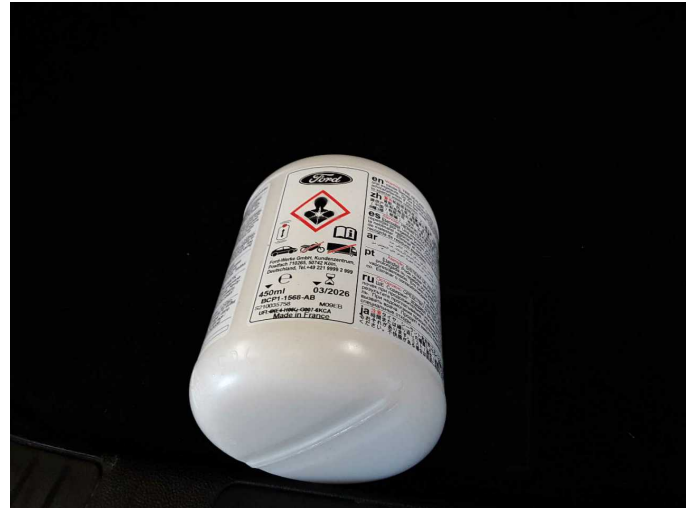
Damage 1: Equipment: Tirefit filler - Expired - Replace

| No. | Component group | Description |
|---|---|--|
| 1 | Equipment | Tirefit filler - Expired - Replace |

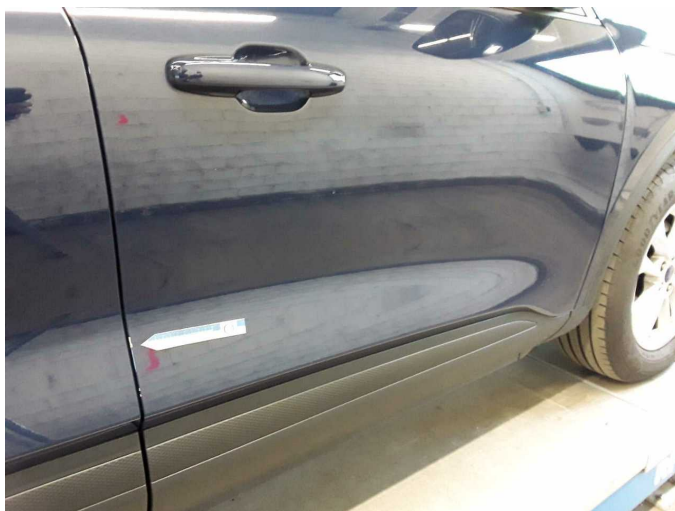
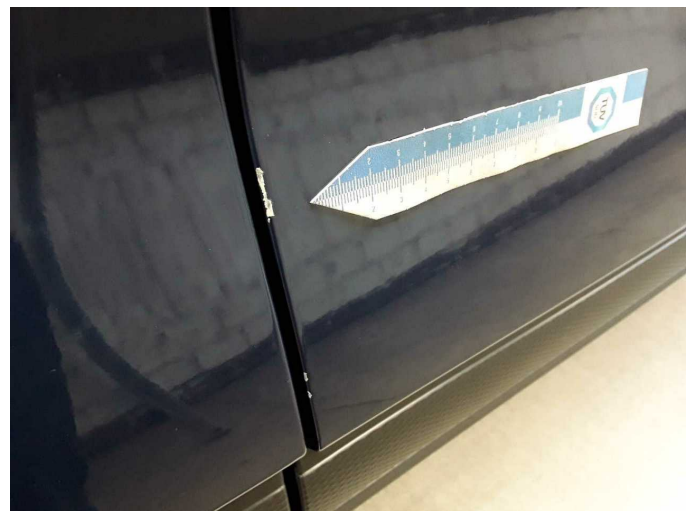
Damage 2: Door - front left side: Door - Scratch(es) - Smart repair

| No. | Component group | Description |
|---|---|--|
| 2 | Door - front left side | Door - Scratch(es) - Smart repair |

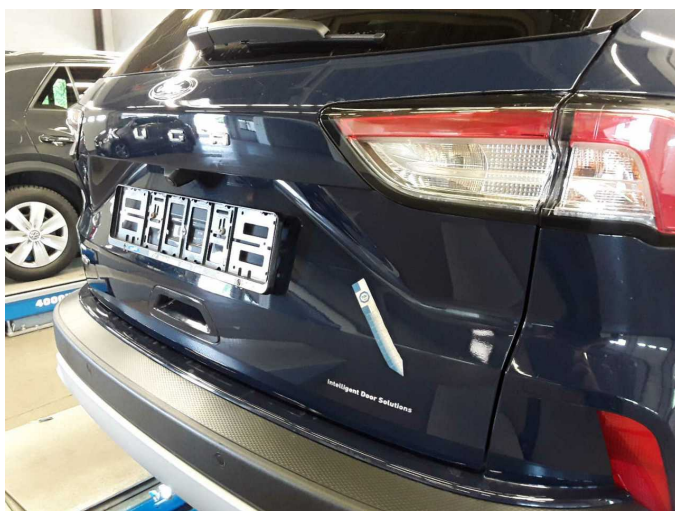
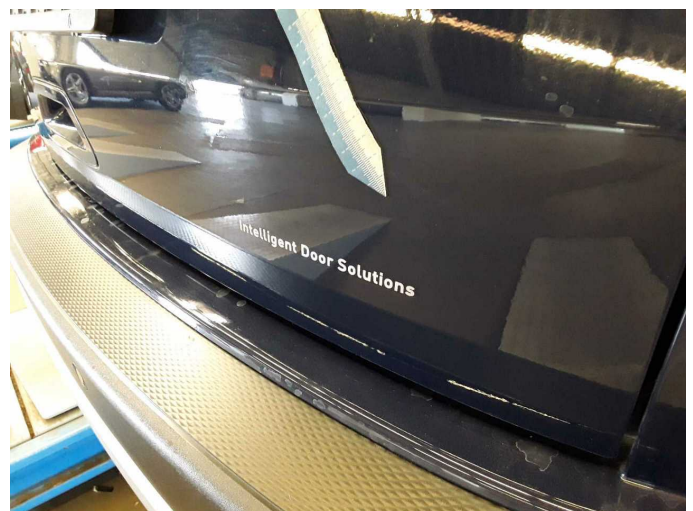
Damage 3: Boot lid / rear door: Boot lid - Glued / labelled - De-glue / neutralise

| No. | Component group | Description |
|---|---|--|
| 3 | Boot lid / rear door | Boot lid - Glued / labelled - De-glue / neutralise |

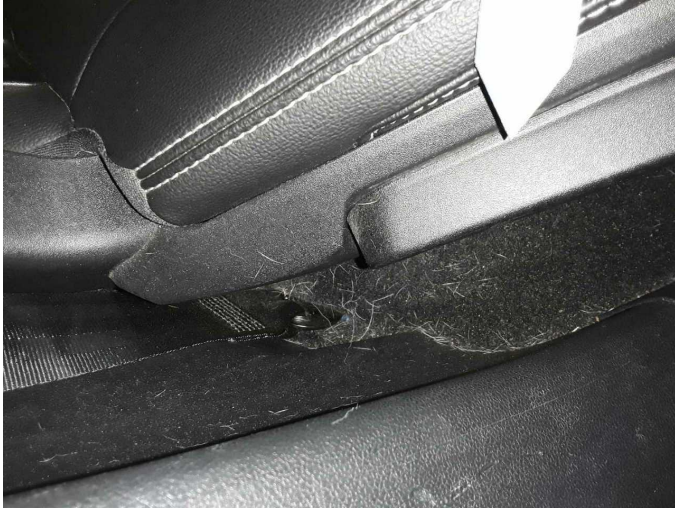
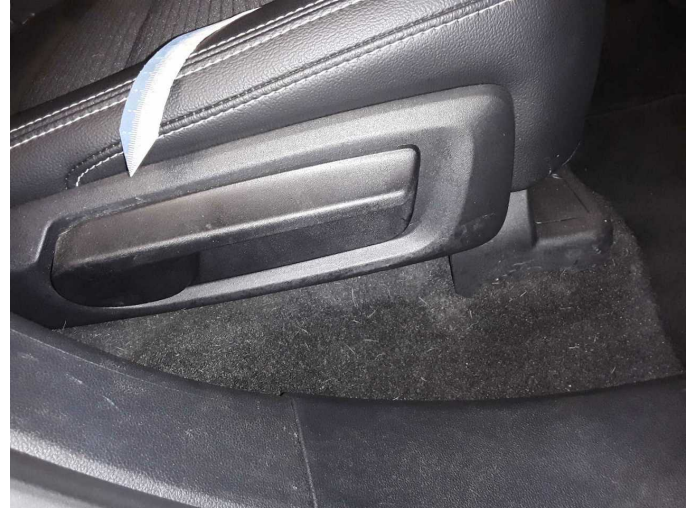
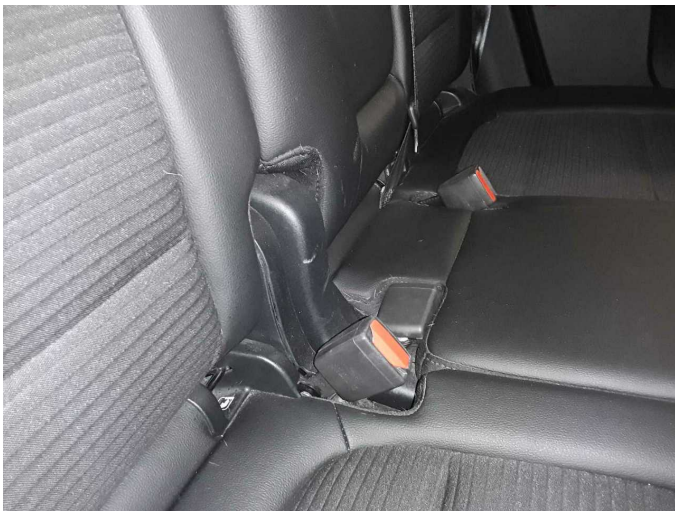
Damage 4: Interior: Interior (Hundehaare) - Soiled - Conditioning

| No. | Component group | Description |
|---|---|--|
| 4 | Interior | Interior (Hundehaare) - Soiled - Conditioning |

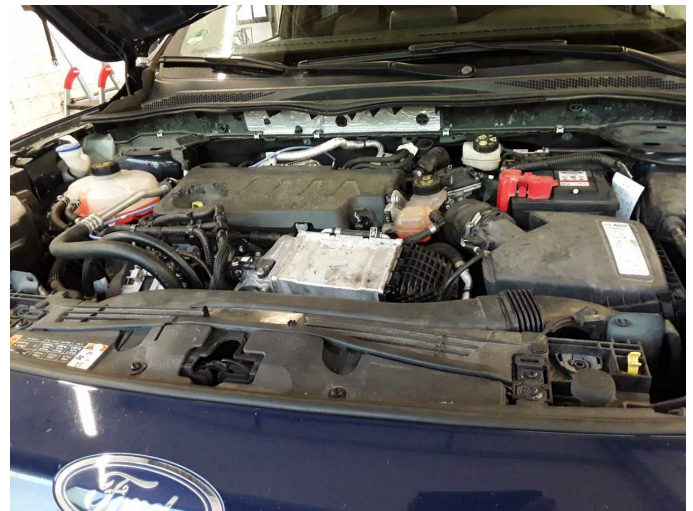
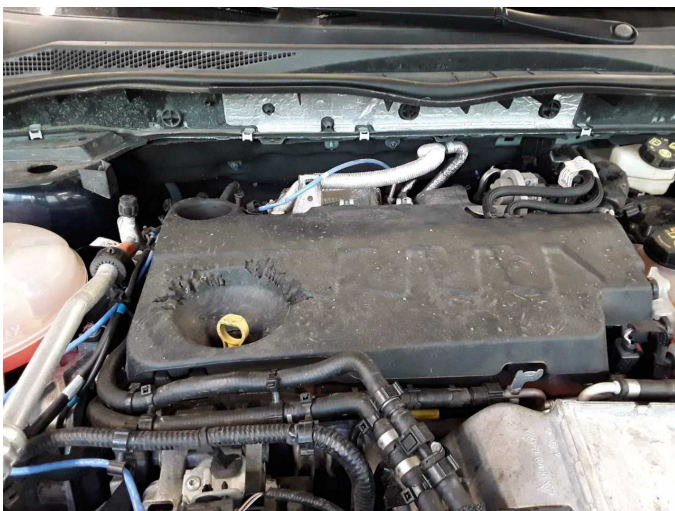
Damage 5: Engine: Engine cover - Damaged - Replace

| No. | Component group | Description |
|---|---|--|
| 5 | Engine | Engine cover - Damaged - Replace |

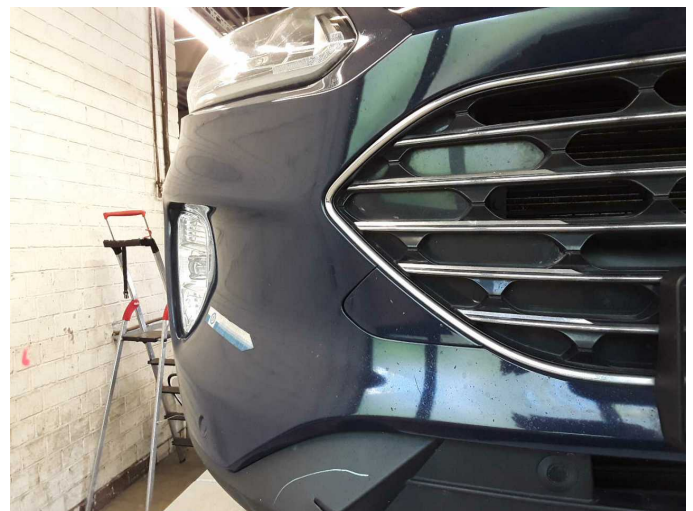
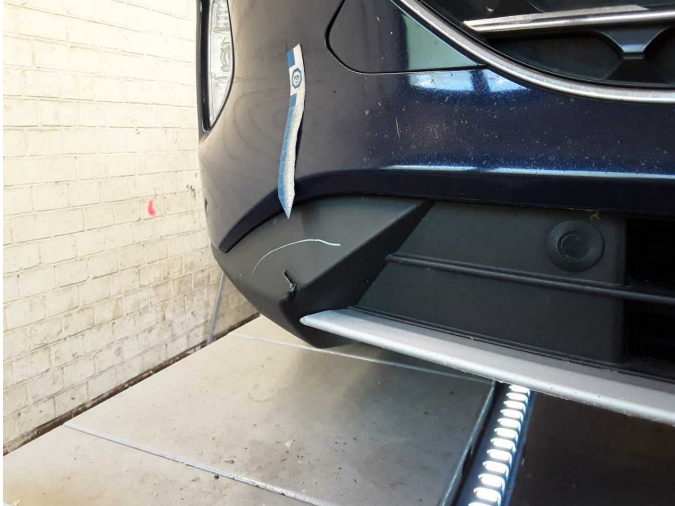
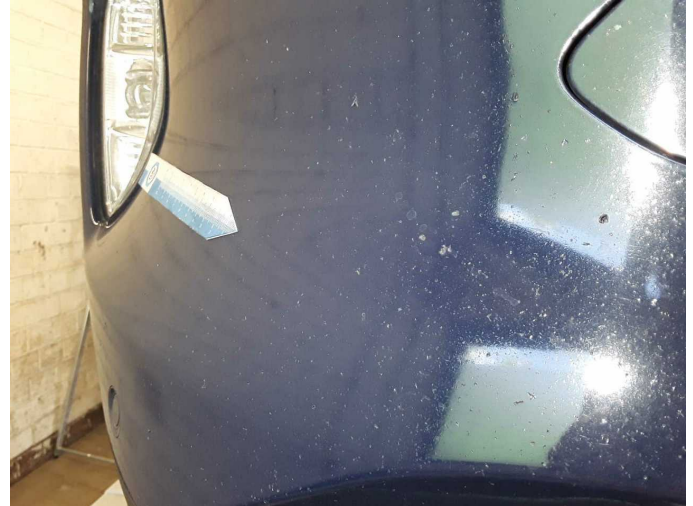
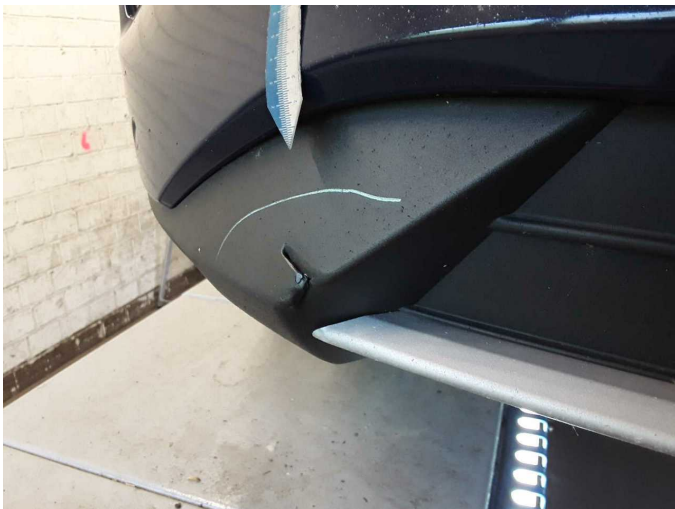
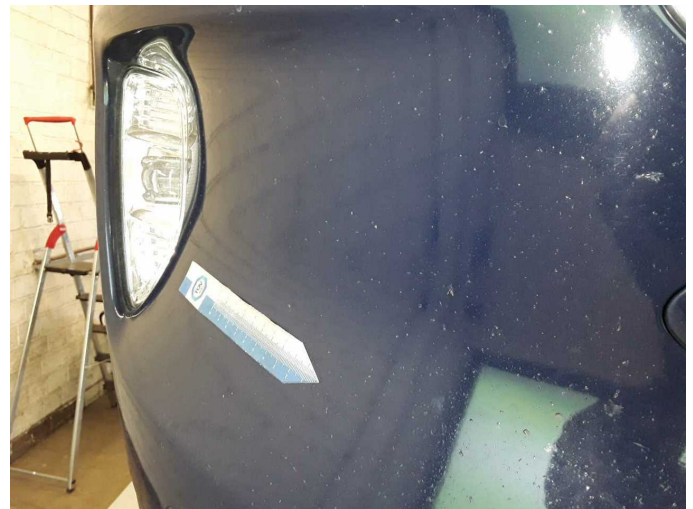
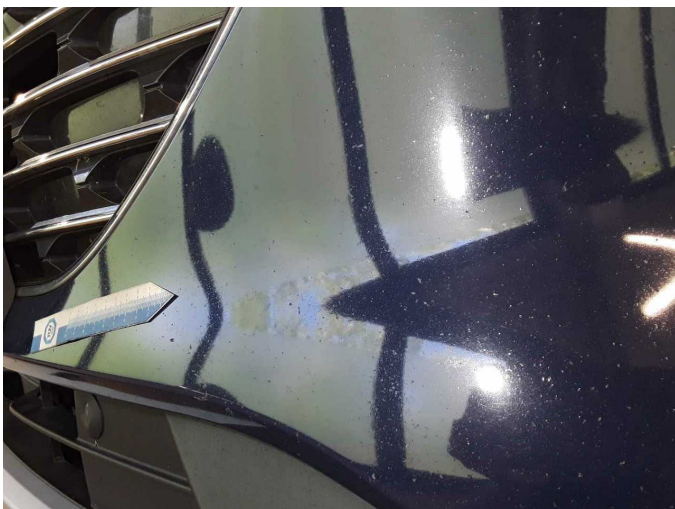
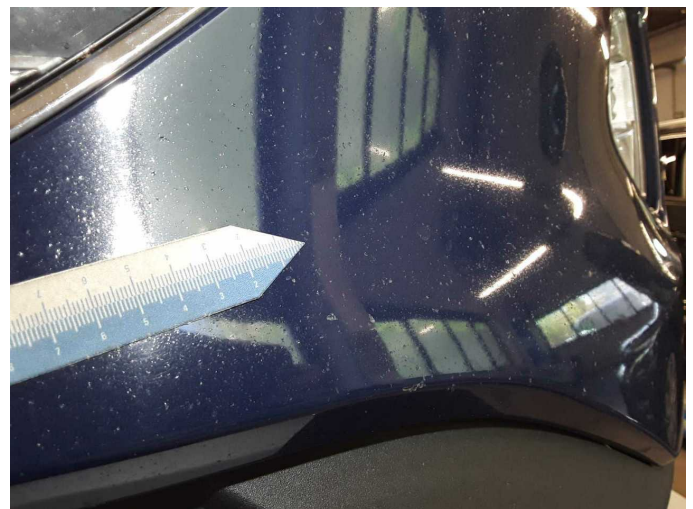
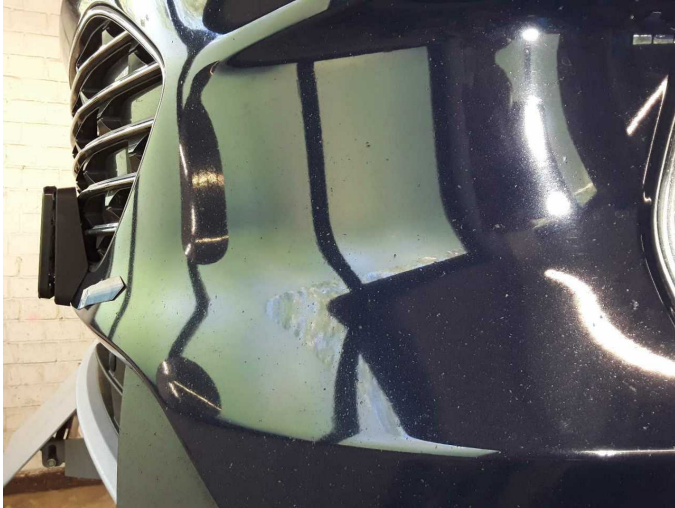
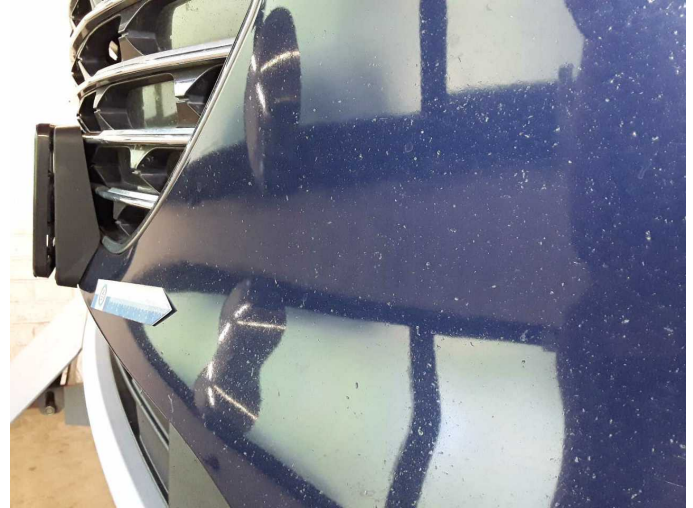
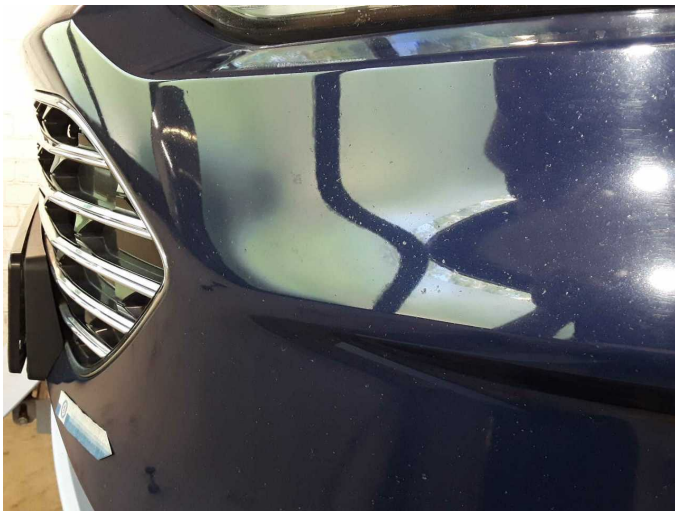
Damage 6: Front bumper: Front bumper (Sandstrahleffekt + Spoiler erneuern) - Stone chips - Paint

| No. | Component group | Description |
|---|---|--|
| 6 | Front bumper | Front bumper (Sandstrahleffekt + Spoiler erneuern) - Stone chips - Paint |

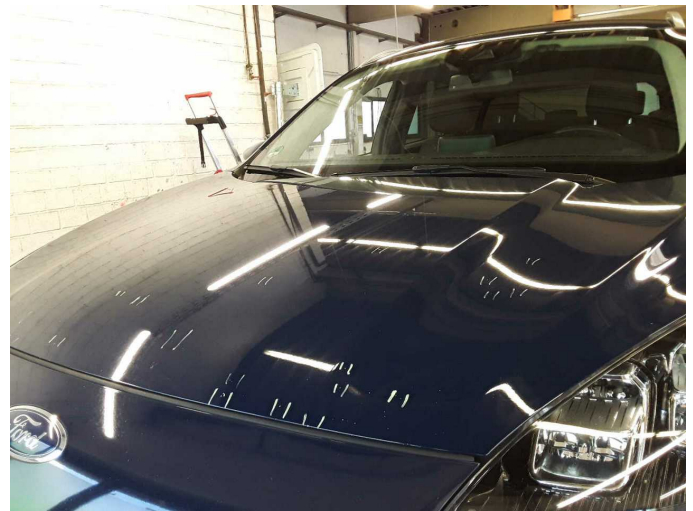
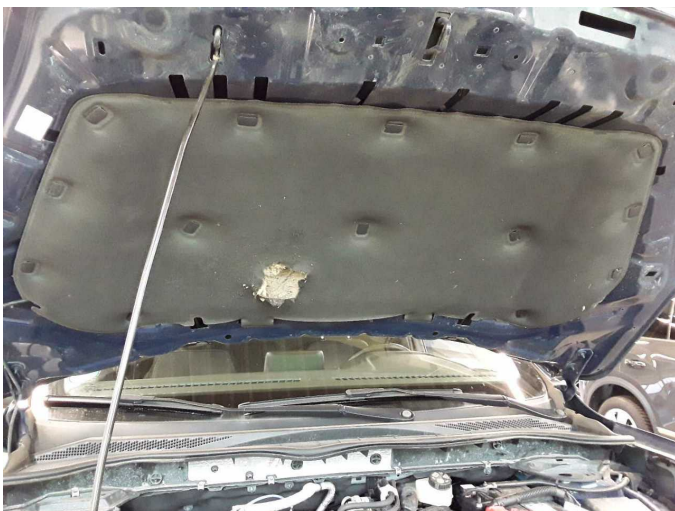
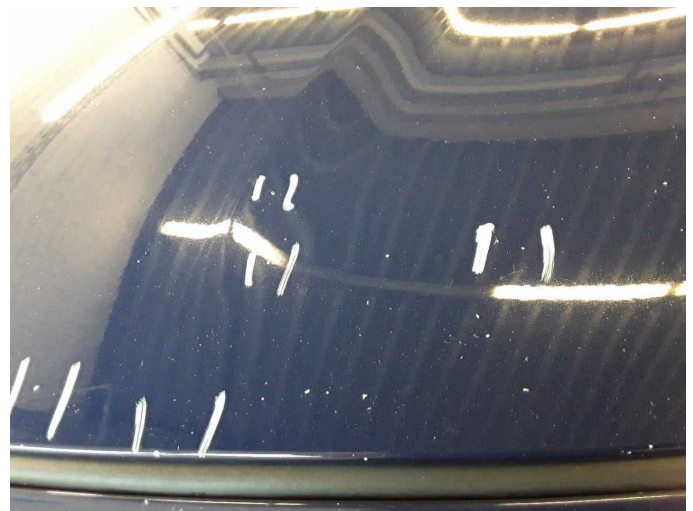
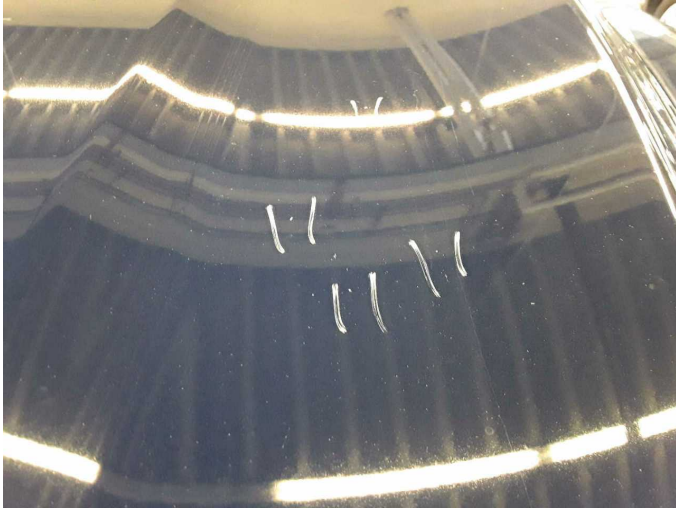
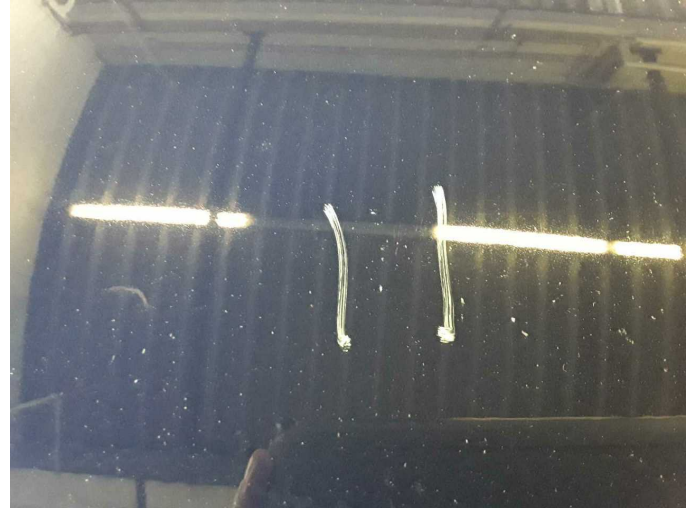
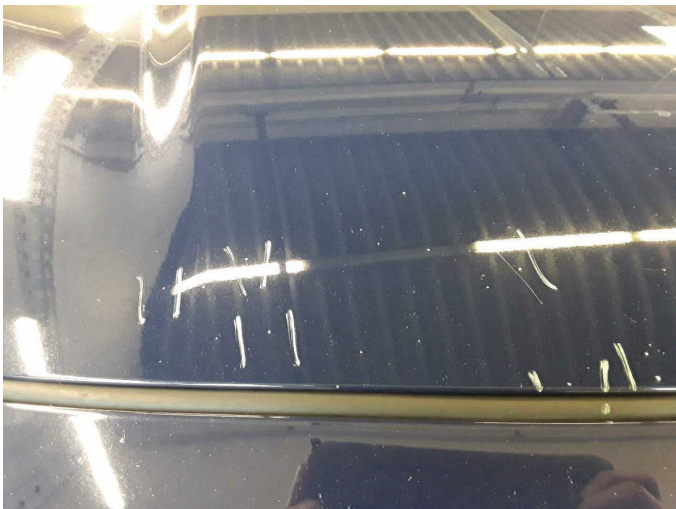
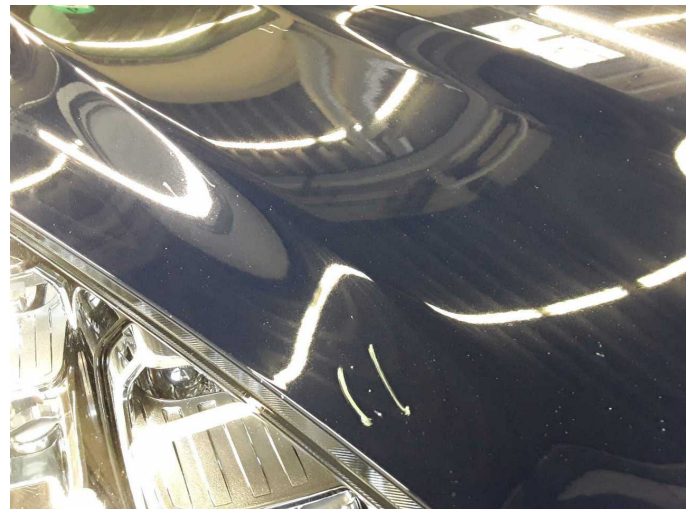
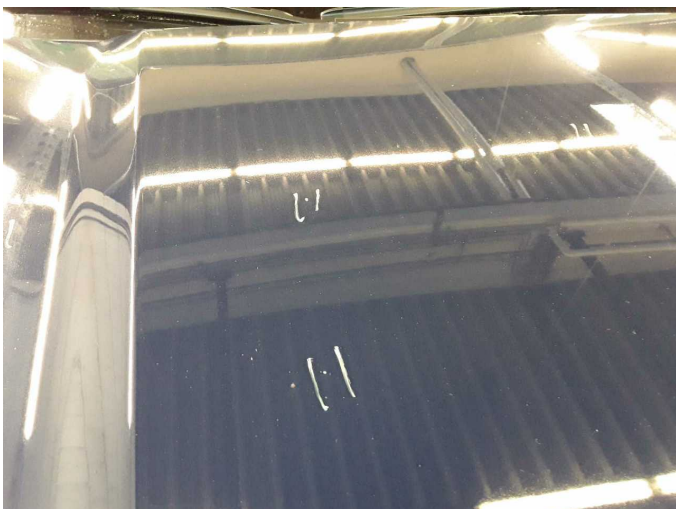
Damage 7: Bonnet: Bonnet (Sandstrahleffekt + Dämmmatte erneuern) - Stone chips - Paint

| No. | Component group | Description |
|---|---|--|
| 7 | Bonnet | Bonnet (Sandstrahleffekt + Dämmmatte erneuern) - Stone chips - Paint |

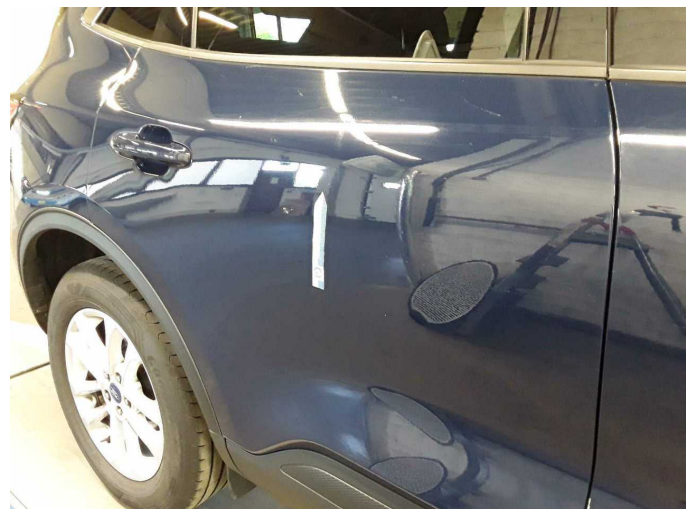
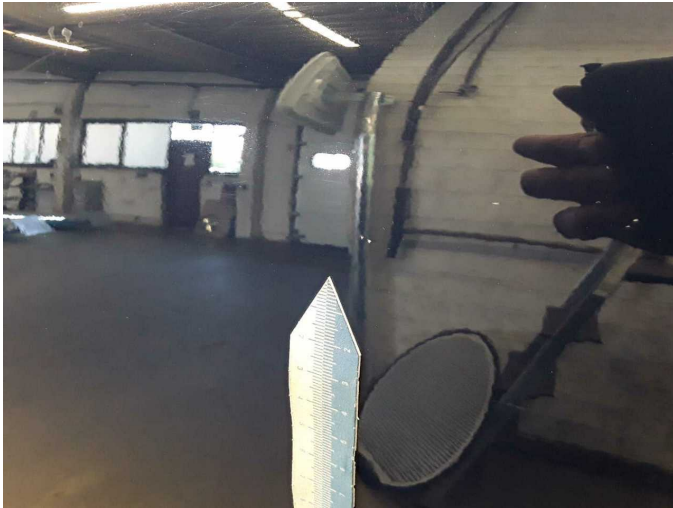
Wear and tear 1: Door - rear right side: Door - Stone chips - No deduction

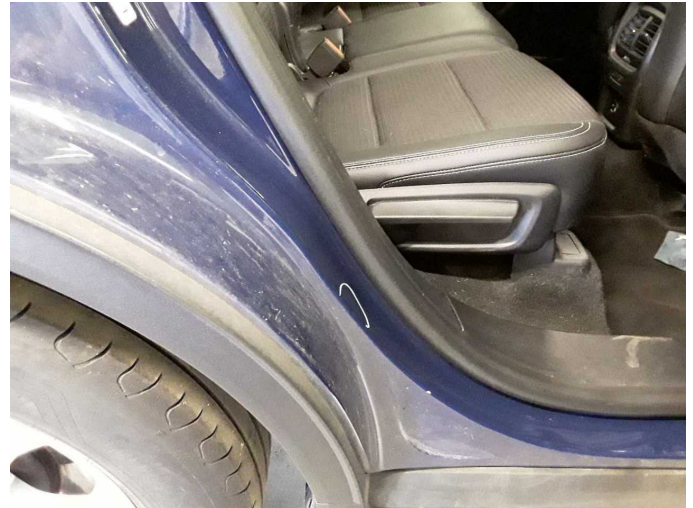
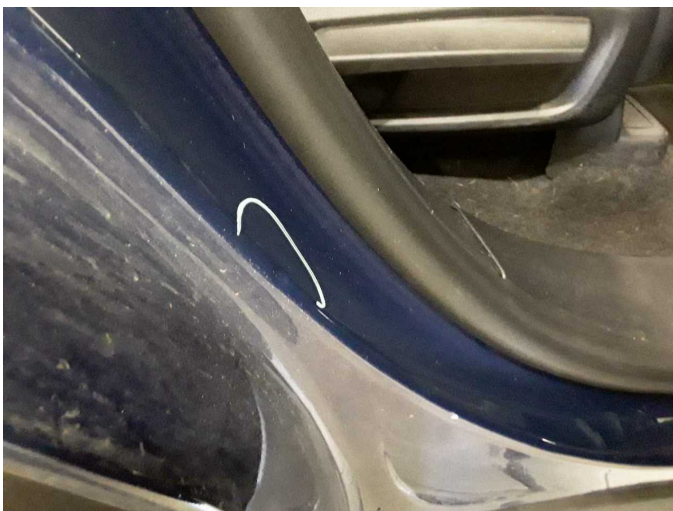
Wear and tear 3: Side panel - rear right side: Sill - dent(s) - No deduction

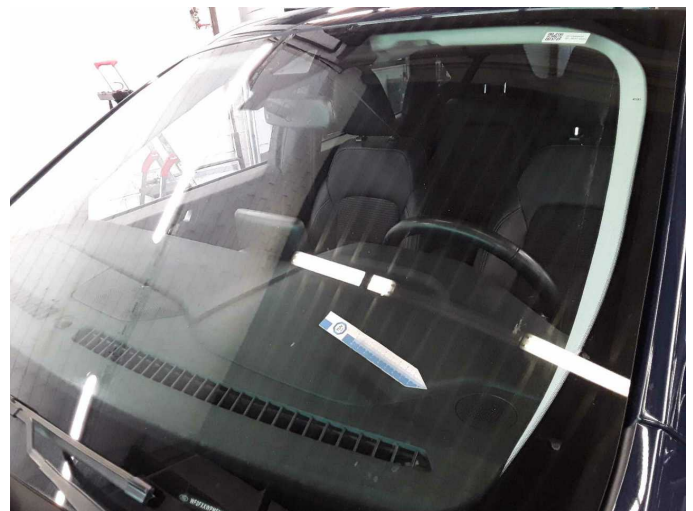
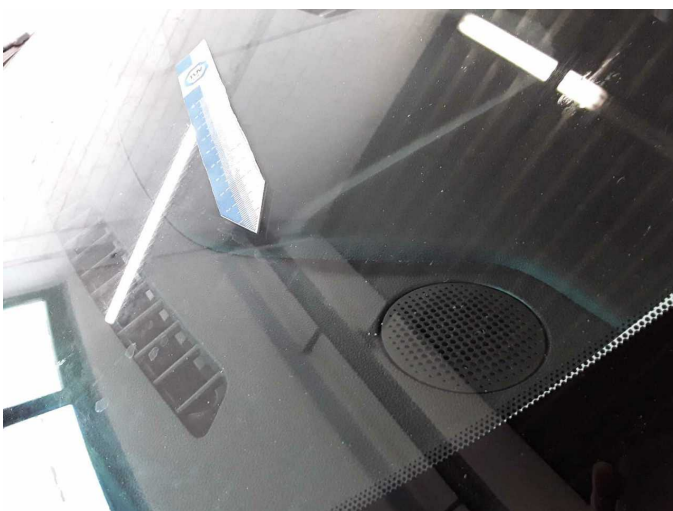
Wear and tear 4: Vehicle glazing: Windscreen - Stone chips - No deduction

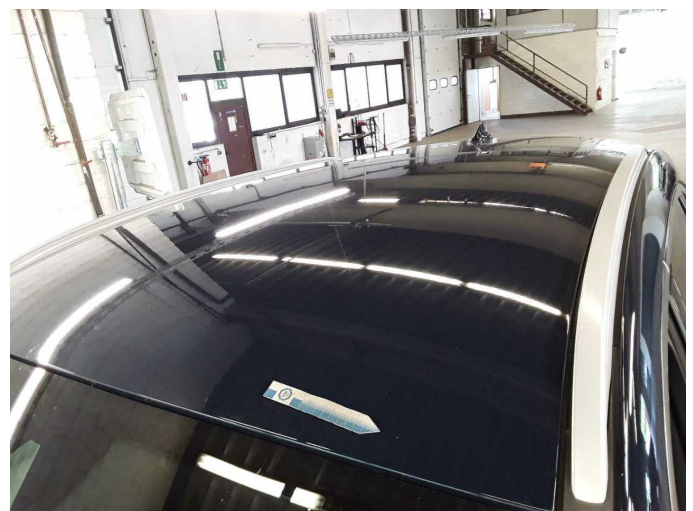
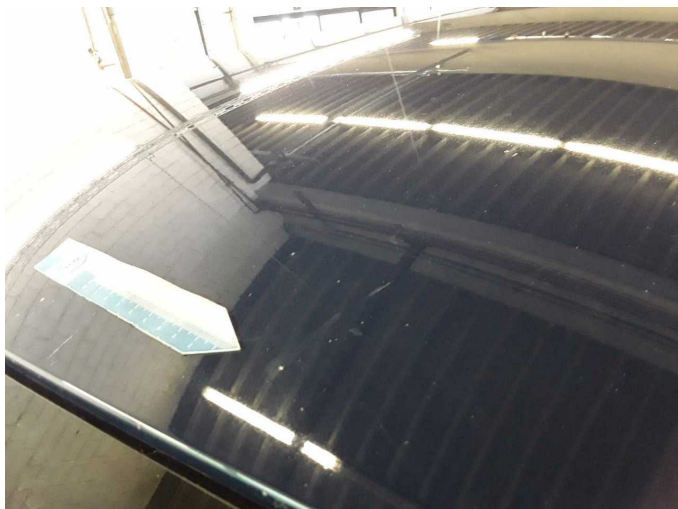
Wear and tear 5: Roof: Roof - Stone chips - No deduction

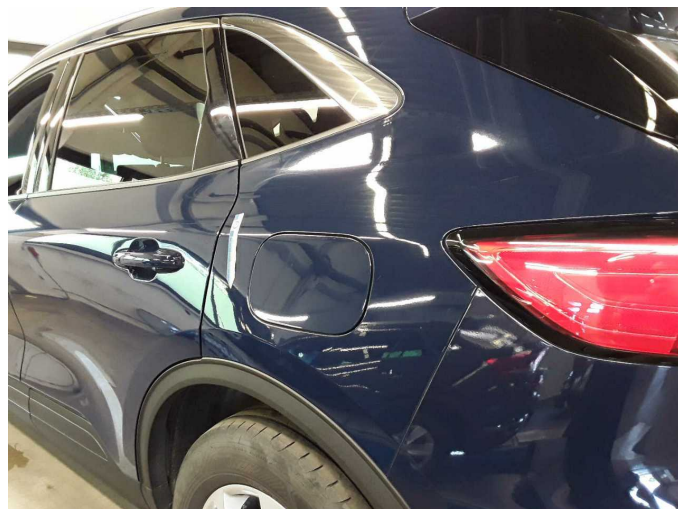
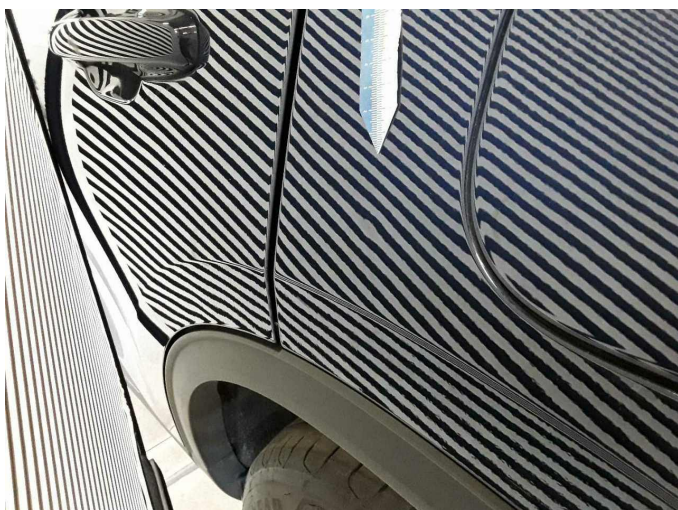
Wear and tear 6: Side panel - rear left side: Side panel - dent(s) - No deduction
