Expertise

Protocol number: 46500513  
Order No. / Reference: 26681096  
Inspection date: 13 Jul 2026

Manufacturer: Skoda  
VIN: TMBJJ7NSXP8532131

Model: Kodiaq 2.0 TDI DSG Ambition

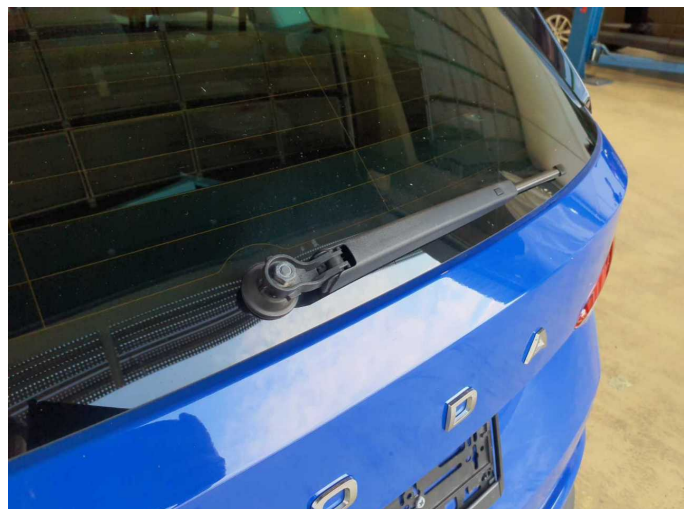
| No. | Component group | Description |
|---|---|---|
| 1 | Trim / covers | Trim / covers - Missing - Replace |

Damage 1: Trim / covers: Trim / covers - Missing - Replace

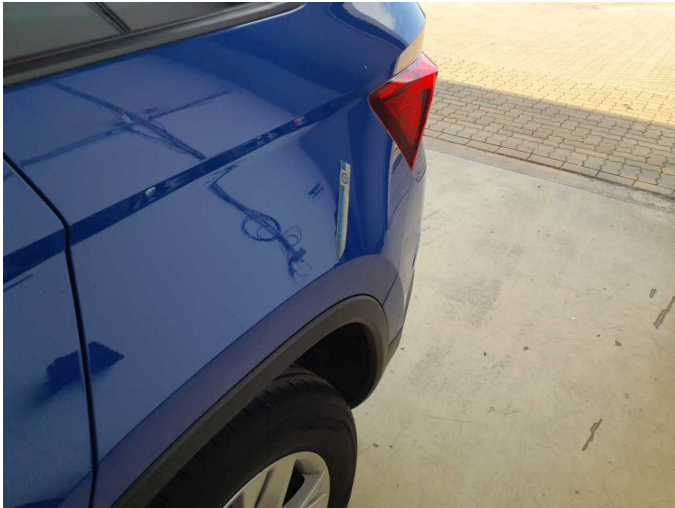
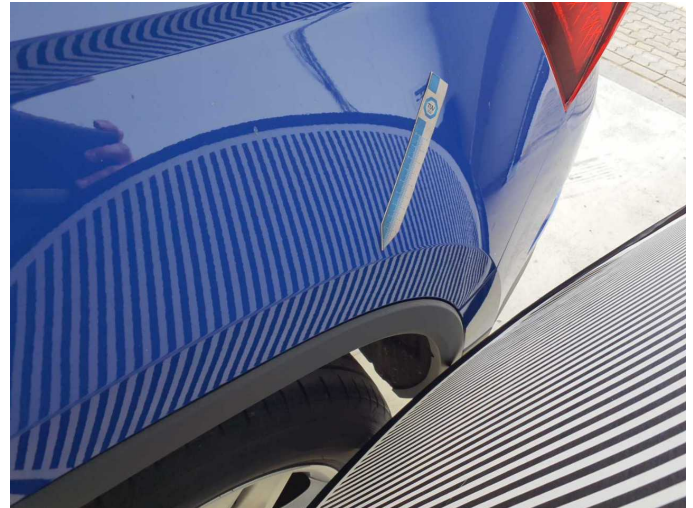
| No. | Component group | Description |
|---|---|---|
| 2 | Side panel - rear left side | Side panel - dent(s) - Smooth repair work |

**Damage 2:** Side panel - rear left side: Side panel - dent(s) - Smooth repair work

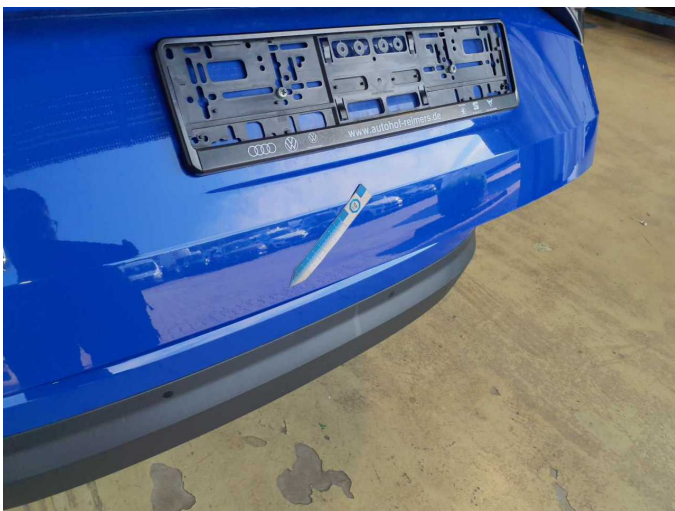
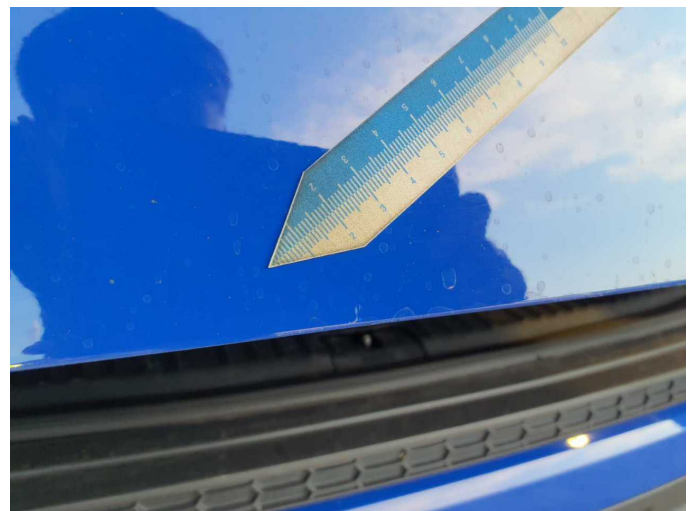
| No. | Component group | Description |
|---|---|---|
| 3 | Boot lid / rear door | Boot lid - Scratch(es) - Smart repair |

**Damage 3:** Boot lid / rear door: Boot lid - Scratch(es) - Smart repair

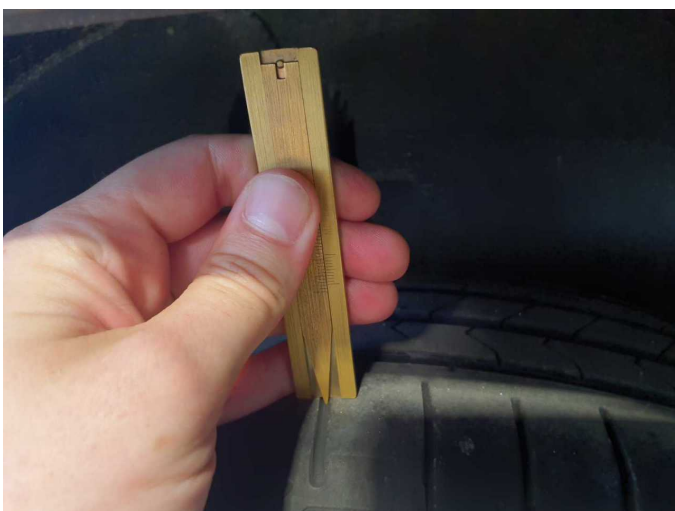
| # | Tyre size | Type of tyre | Manufacturer | Tread depth |
|---|---|---|---|---|
| 2) | 215/65 R17 99V | Summer tyres on Light alloy | Hankook | 3mm / 2mm |

| No. | Component group | Description |
|---|---|---|
| 5 | Wheel / tyres | Tyre - rear right side - Worn - Replace |

**Damage 5:** Wheel / tyres: Tyre - rear right side - Worn - Replace

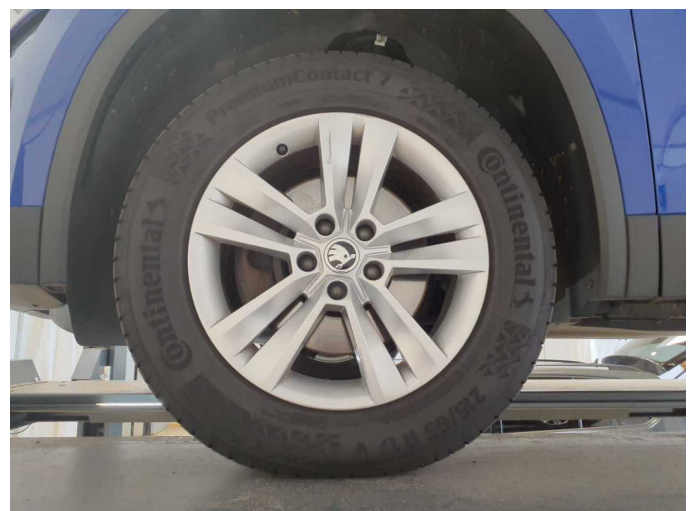
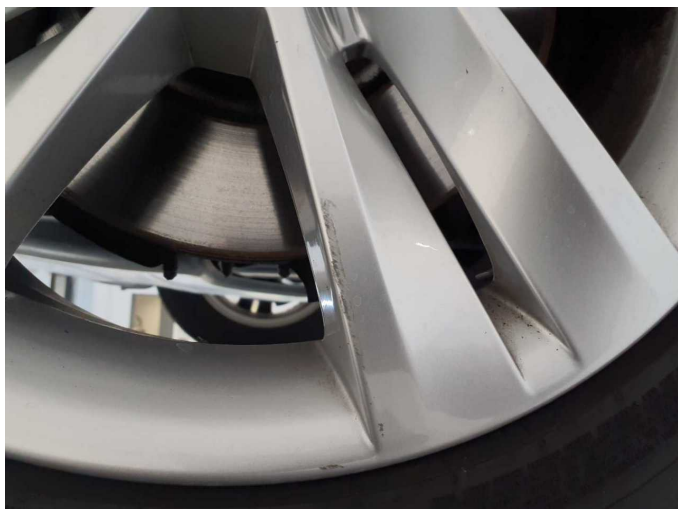
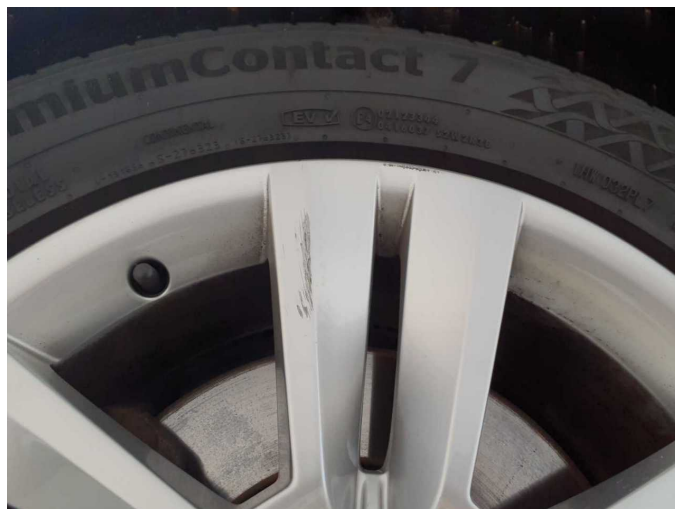
| No. | Component group | Description |
|---|---|---|
| 6 | Wheel / tyres | Alloy rim - front left side - Scratch(es) - Loss in value |

**Damage 6:** Wheel / tyres: Alloy rim - front left side - Scratch(es) - Loss in value

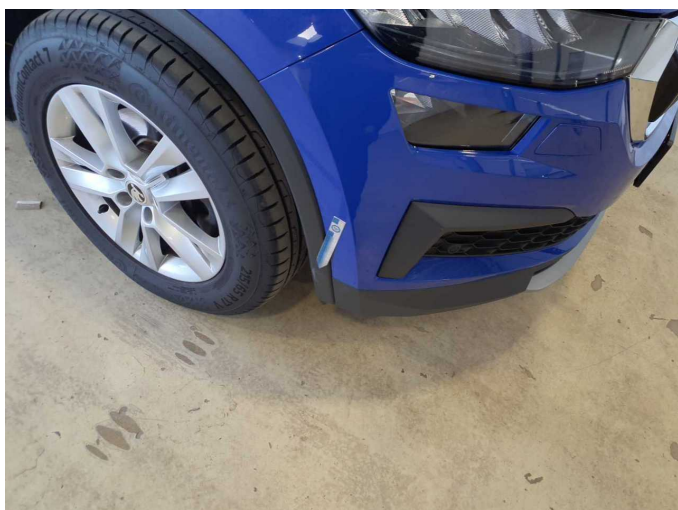
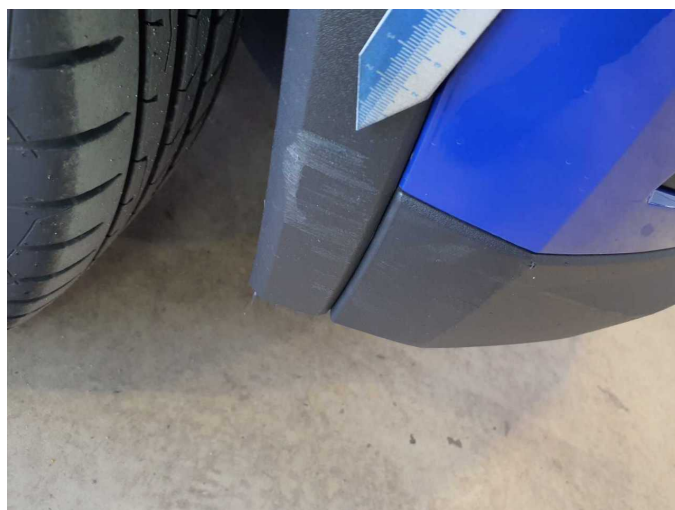
| No. | Component group | Description |
|---|---|---|
| 7 | Mudguard - right side | Wheel well extension - Scratch(es) - Replace |

**Damage 7:** Mudguard - right side: Wheel well extension - Scratch(es) - Replace

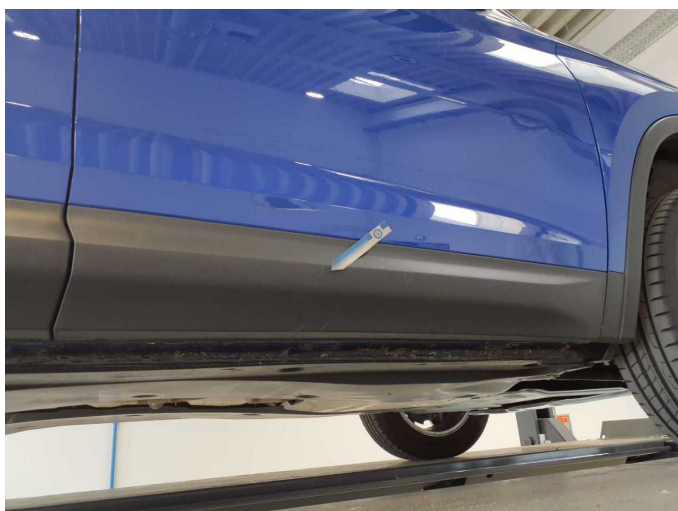
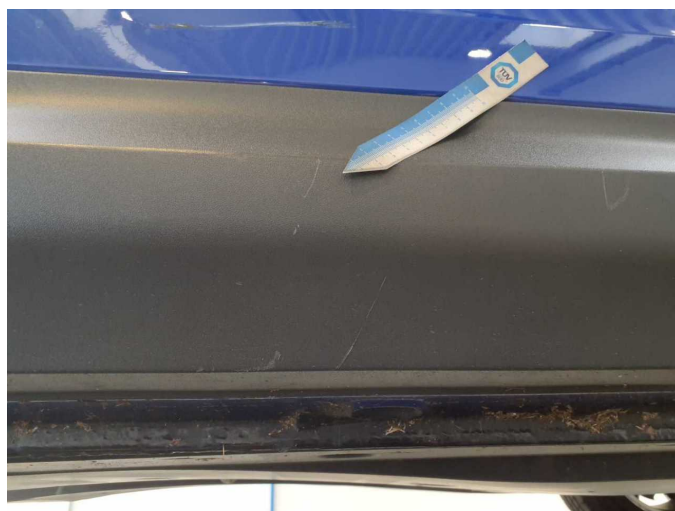
| No. | Component group | Description |
|---|---|---|
| 8 | Door - front right side | Brightware - lower - Scratch(es) - Replace |

**Damage 8:** Door - front right side: Brightware - lower - Scratch(es) - Replace

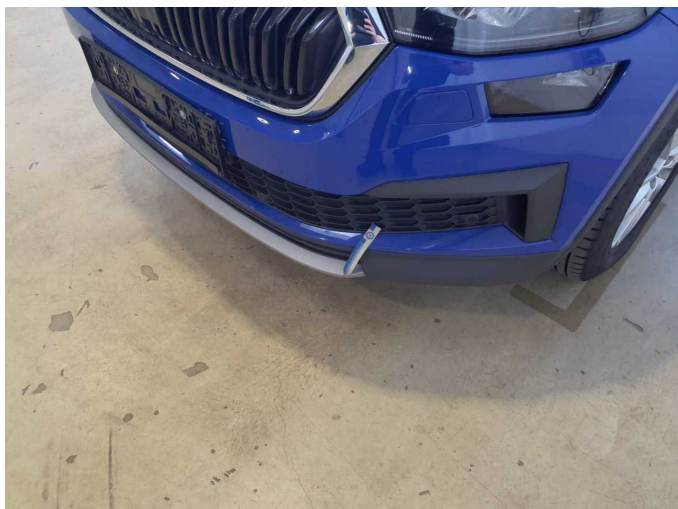
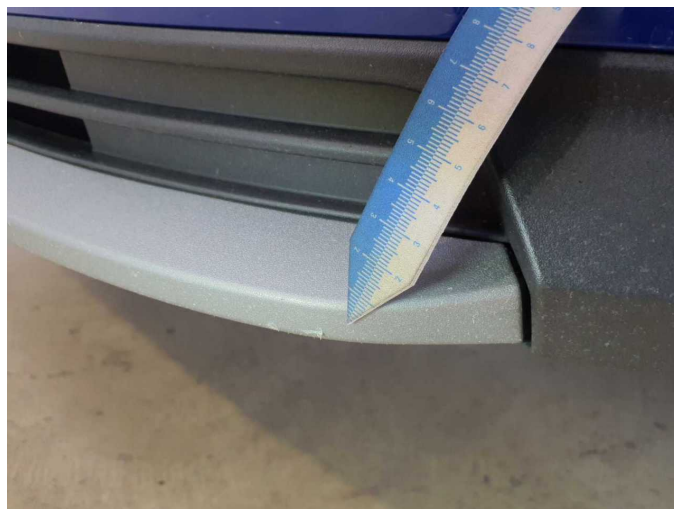
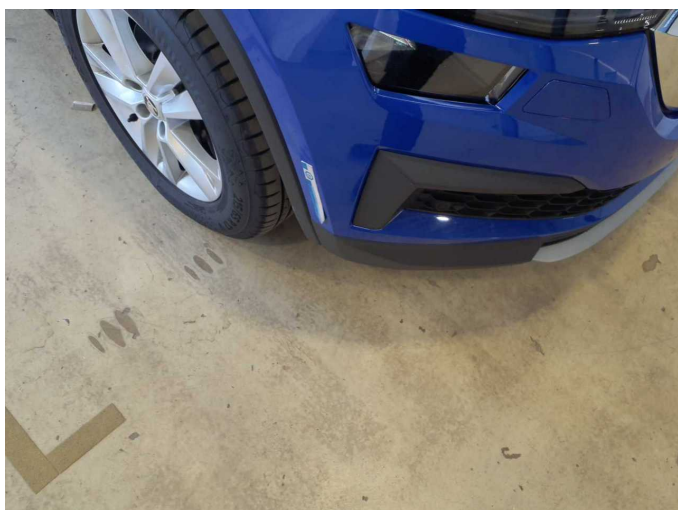
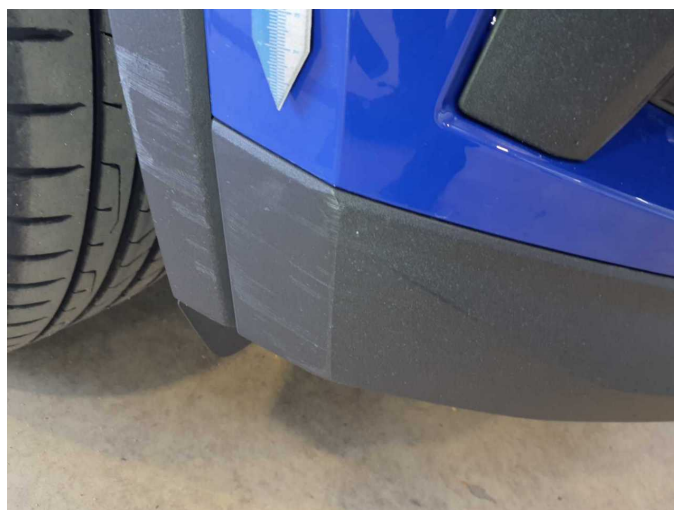
| No. | Component group | Description |
|---|---|---|
| 9 | Front bumper | Spoiler - Scratch(es) - Replace |

**Damage 9:** Front bumper: Spoiler - Scratch(es) - Replace

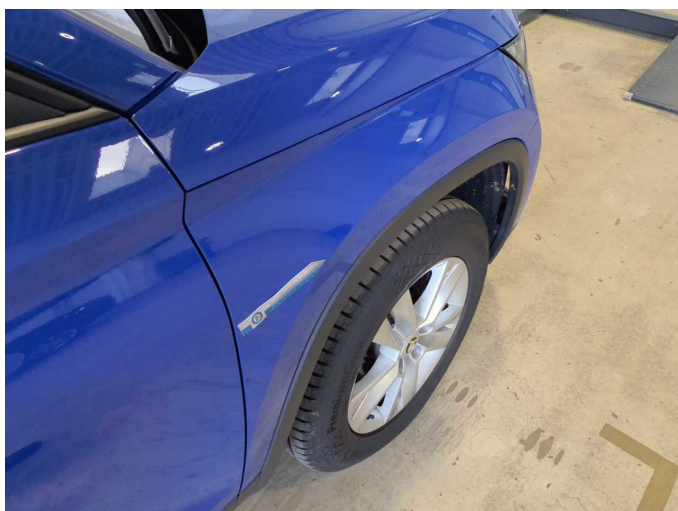
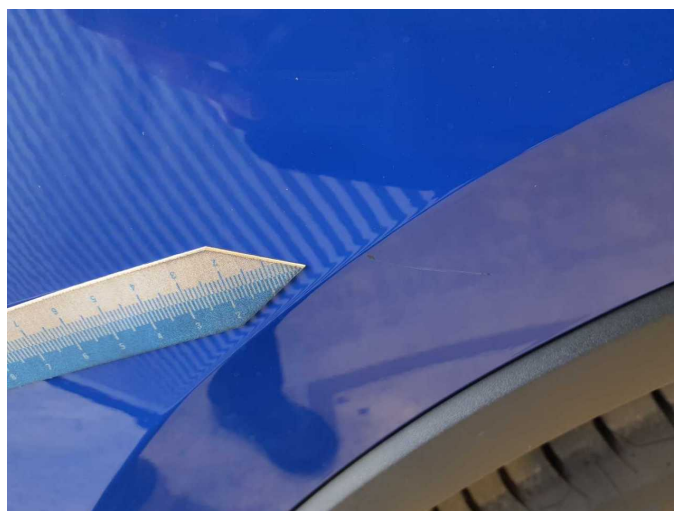
| No. | Component group | Description |
|---|---|---|
| 10 | Mudguard - right side | Mudguard - right side - Scratch(es) - Paint |

**Damage 10:** Mudguard - right side: Mudguard - right side - Scratch(es) - Paint

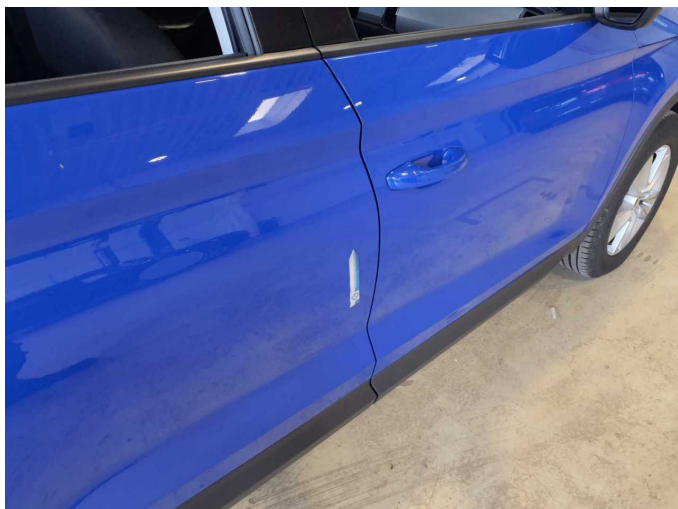
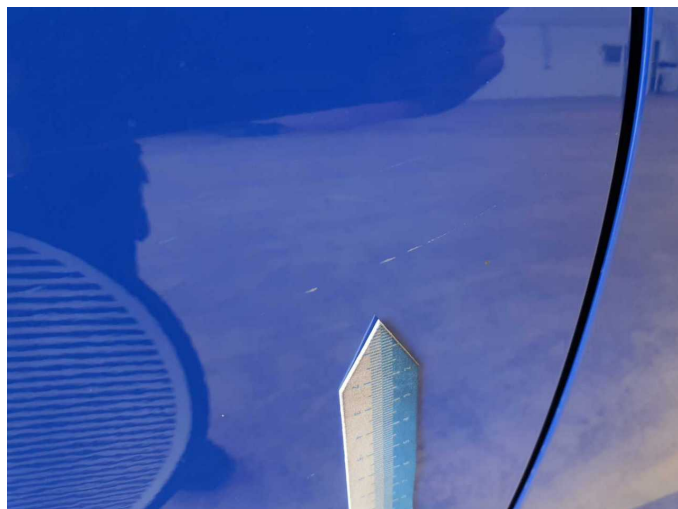
| No. | Component group | Description |
|---|---|---|
| 11 | Door - rear right side | Door - Scratch(es) - Paint |

**Damage 11:** Door - rear right side: Door - Scratch(es) - Paint

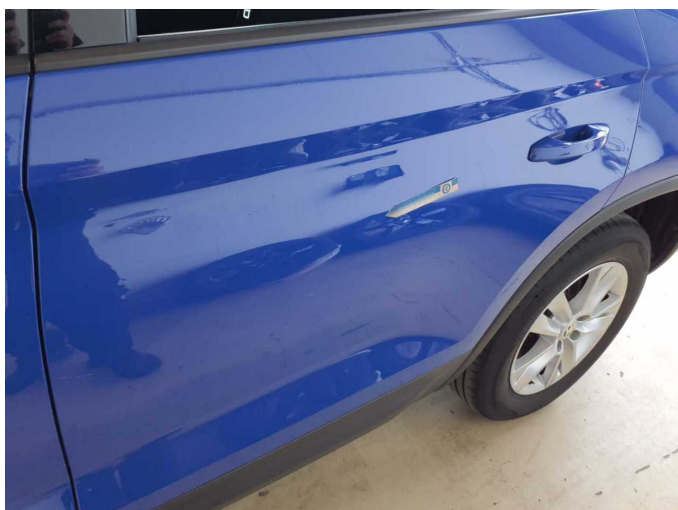
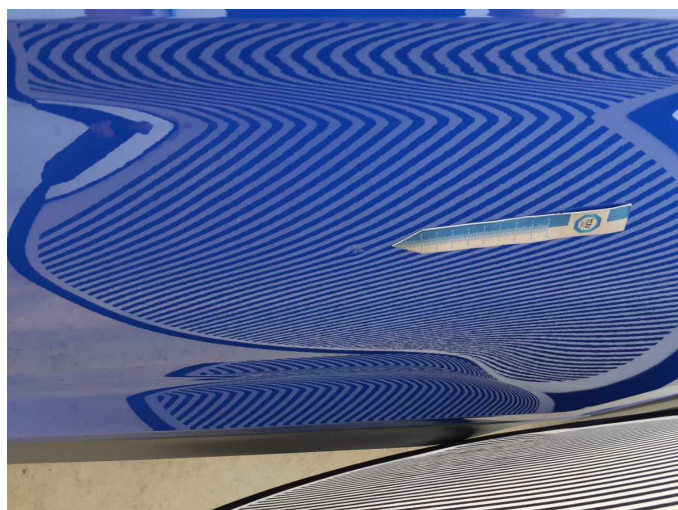
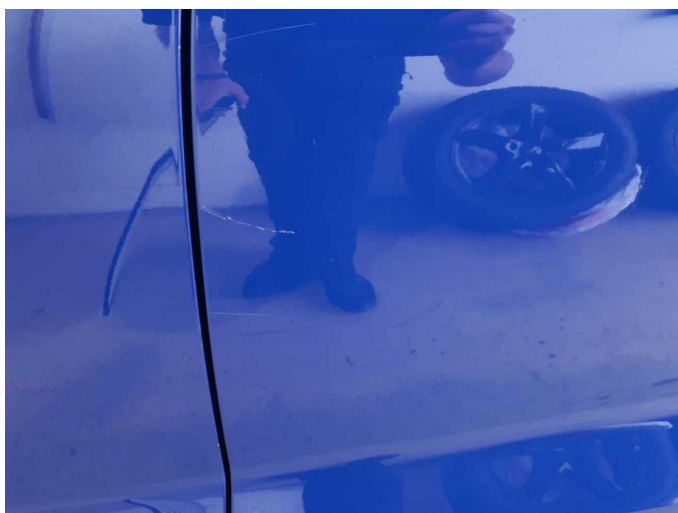
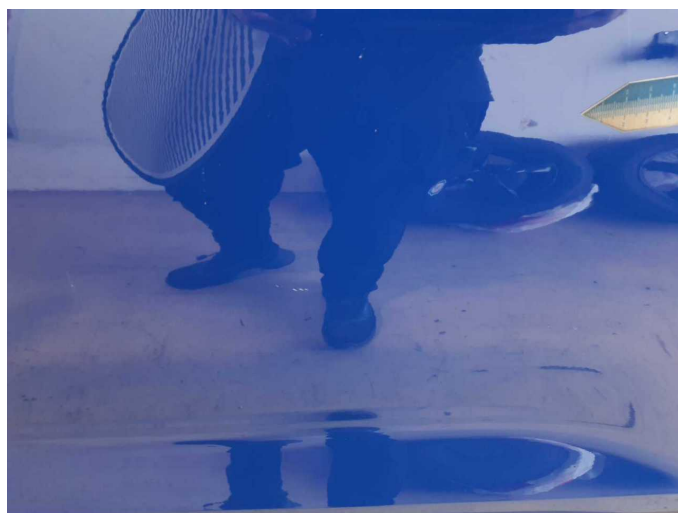
| No. | Component group | Description |
|---|---|---|
| 12 | Door - rear left side | Door - Dent / paintcoat damage - Repair and paint |

**Damage 12:** Door - rear left side: Door - Dent / paintcoat damage - Repair and paint

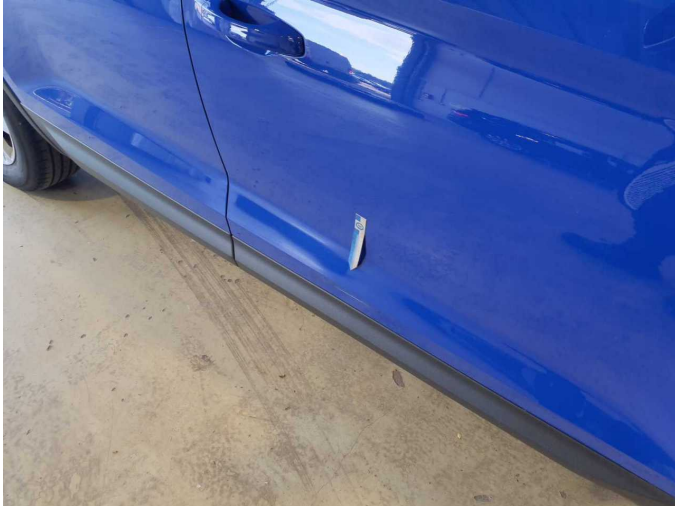
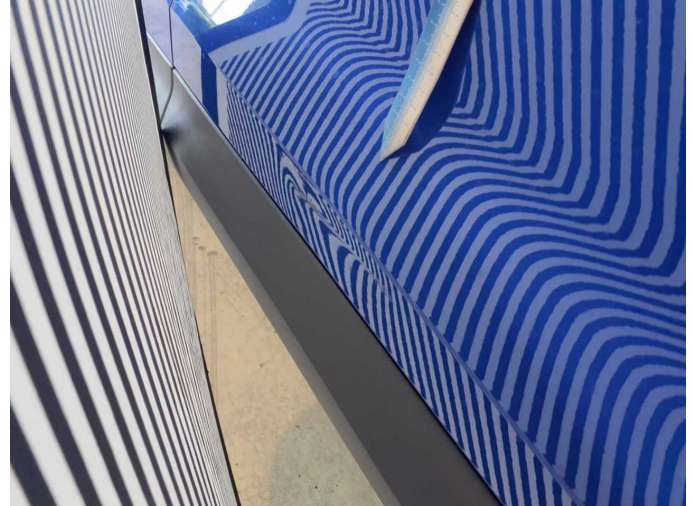
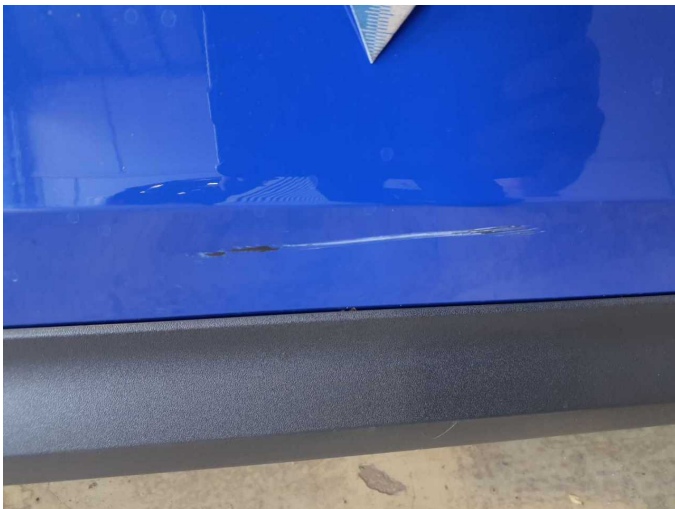
| No. | Component group | Description |
|---|---|---|
| 13 | Door - front right side | Door - Dent / paintcoat damage - Repair and paint |

**Damage 13:** Door - front right side: Door - Dent / paintcoat damage - Repair and paint

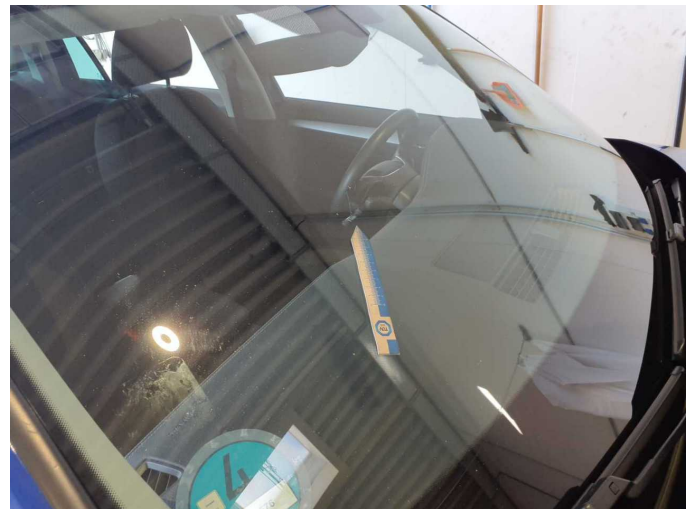
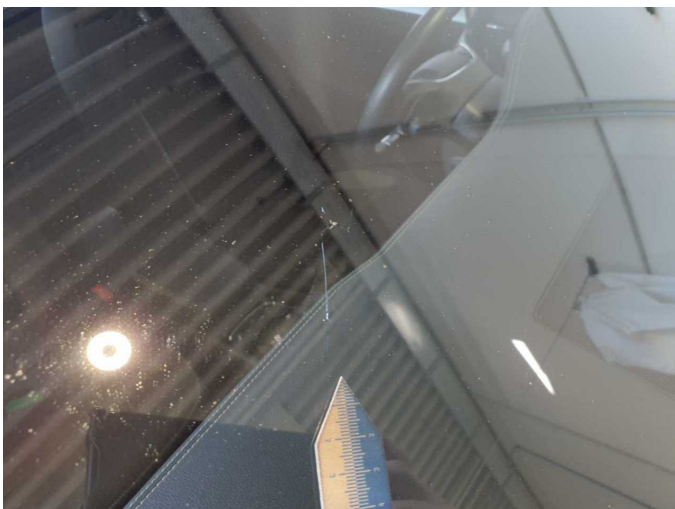
| No. | Component group | Description |
|---|---|---|
| 14 | Vehicle glazing | Windscreen - Broken / torn - Replace |

**Damage 14:** Vehicle glazing: Windscreen - Broken / torn - Replace

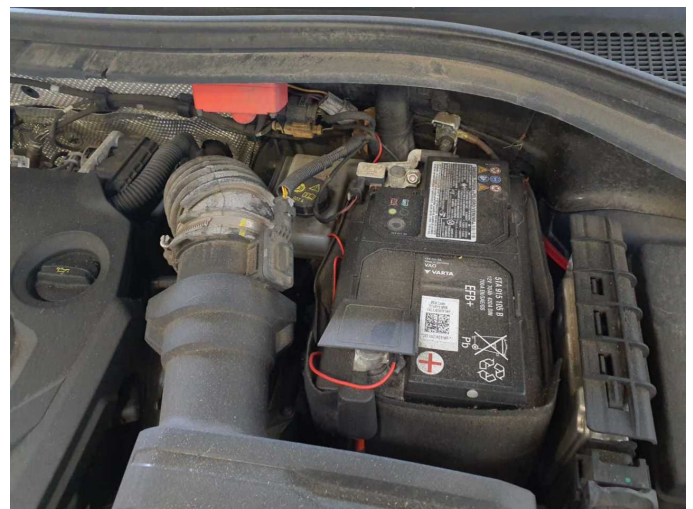
| No. | Component group | Description |
|---|---|---|
| 3 | Engine | Engine (Marderabwehr) - Differs from the original configuration - No deduction |

**Wear and tear 3:** Engine: Engine (Marderabwehr) - Differs from the original configuration - No deduction

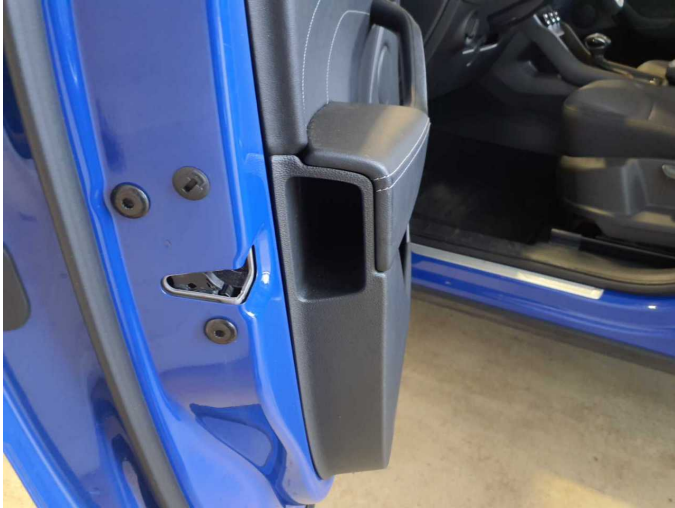
Equipment - Umbrella

**Missing part 1:** Equipment: Umbrella - Missing - Replace
