Expertise

Protocol number: 46524328  
Order No. / Reference: 26660732  
Inspection date: 1 Jul 2026

Manufacturer: Volkswagen

Model: Passat Variant 2.0 TDI SCR DSG Business

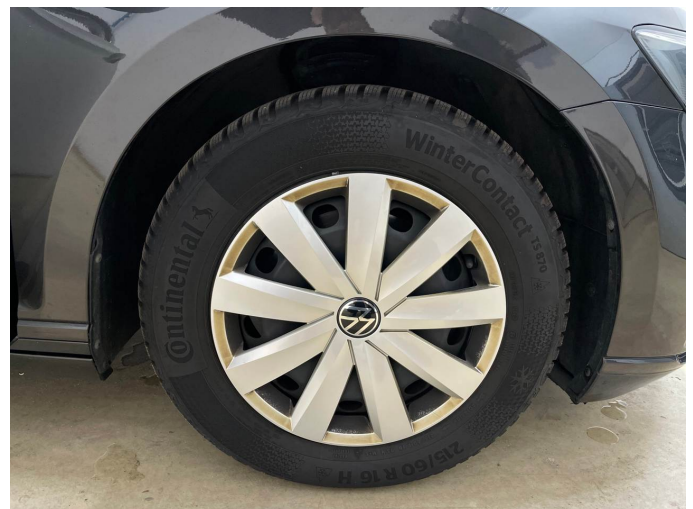
| Tyres | | | | |
|---|---|---|---|---|
| 1) | 215/60 R16 95H | Winter tyres on Steel rim with wheel cover | Continental | 8mm / 8mm |
| 2) | 215/60 R16 95H | Winter tyres on Steel rim with wheel cover | Dunlop | 7mm / 7mm |

Figure 12: Mounted tyres

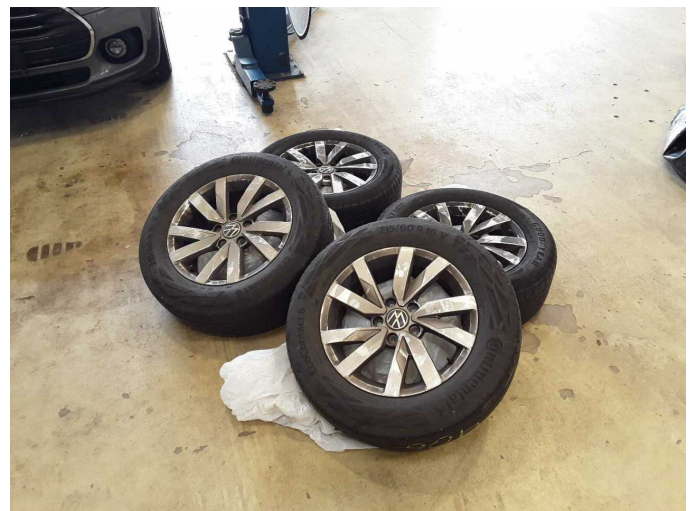
| Tyres | | | | |
|---|---|---|---|---|
| 1) | 215/60 R16 95V | Summer tyres on Light alloy | Continental | 0mm / 0mm |
| 2) | 215/60 R16 95V | Summer tyres on Light alloy | Goodyear | 2mm / 2mm |

Figure 16: Additional tyres

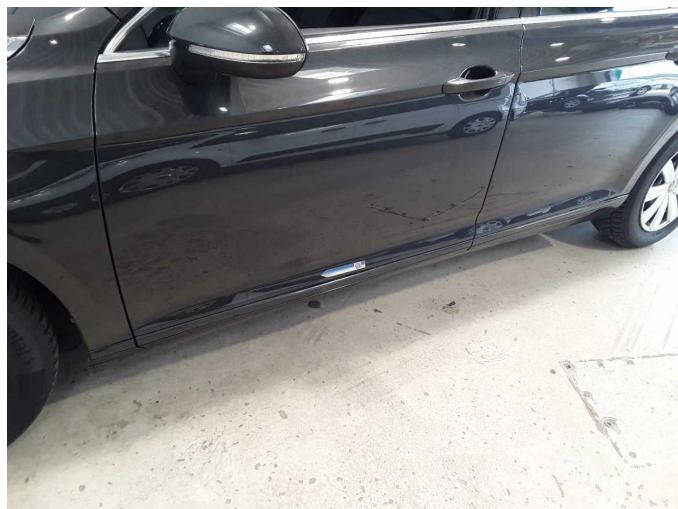
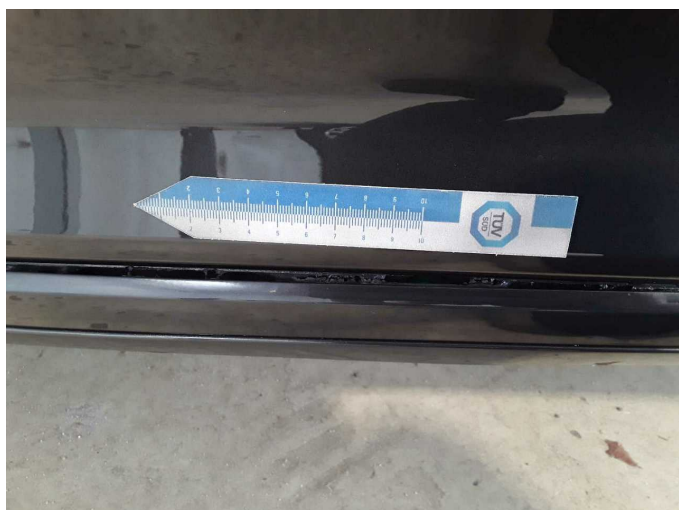
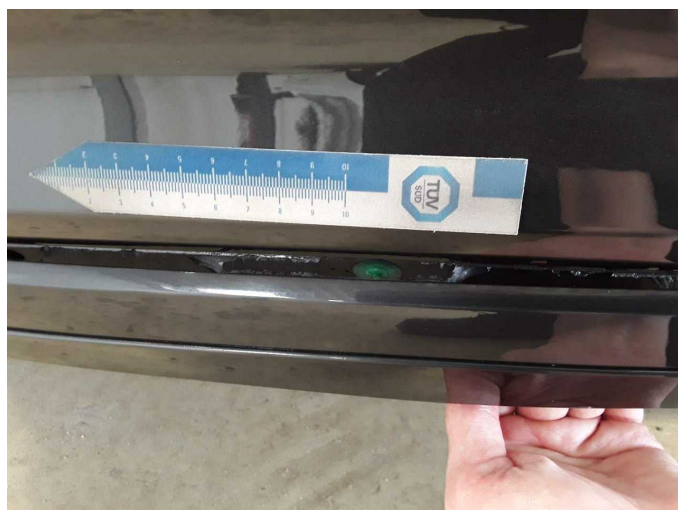
| No. | Component group | Description |
|---|---|---|
| 1 | Door - front left side | Brightware - lower - Loose - Un- / install |

**Damage 1:** Door - front left side: Brightware - lower - Loose - Un- / install

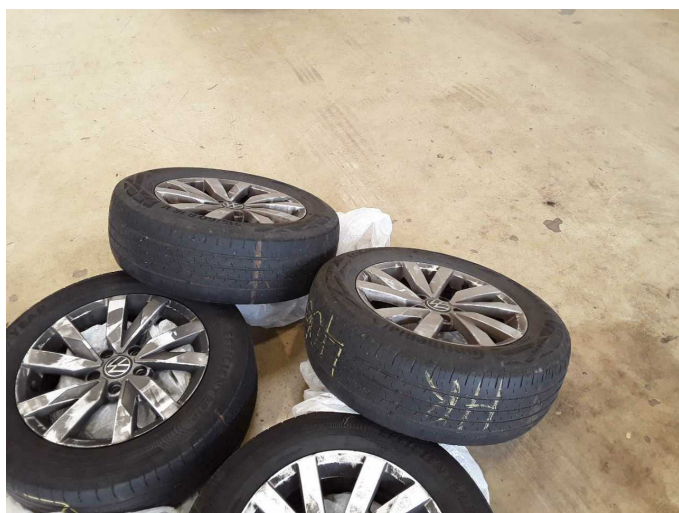
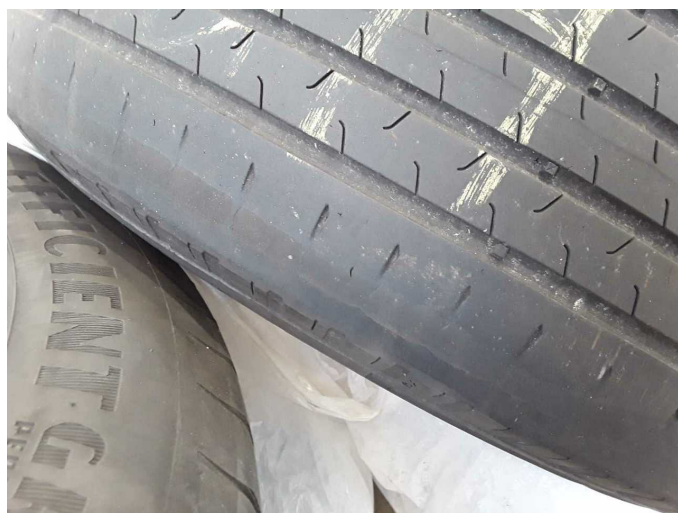
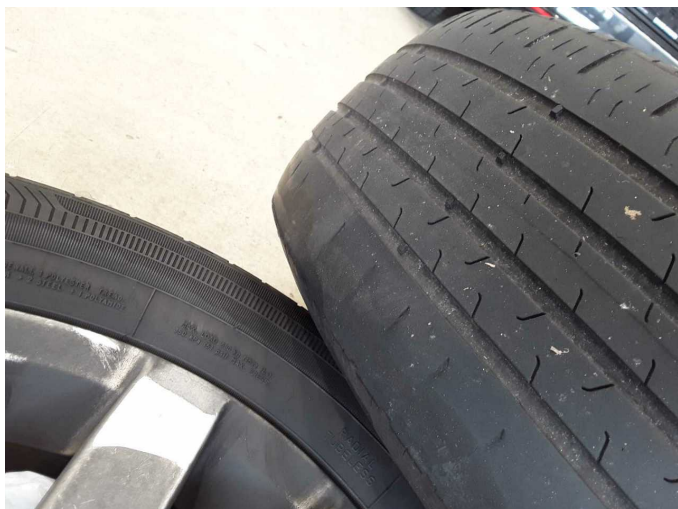
| No. | Component group | Description |
|---|---|---|
| 2 | 2nd wheel set | 2 tyres (Innen abgefahren) - Worn - Replace |

**Damage 2:** 2nd wheel set: 2 tyres (Innen abgefahren) - Worn - Replace

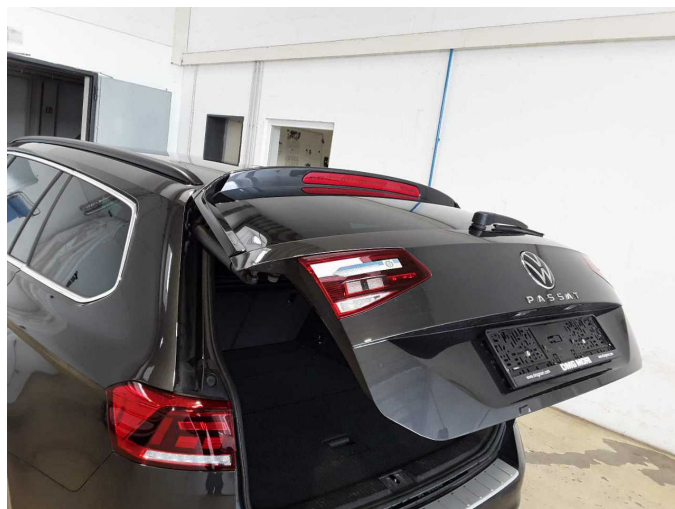
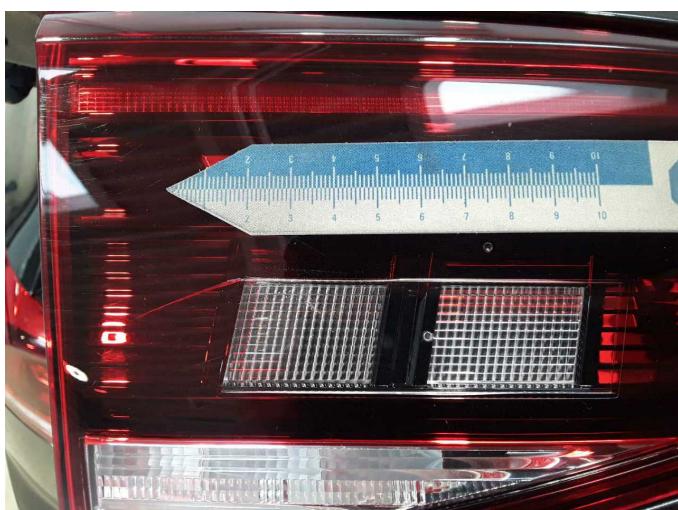
| No. | Component group | Description |
|---|---|---|
| 3 | Tail light | Tail lamp - left side (Innen) - Broken / torn - Replace |

**Damage 3:** Tail light: Tail lamp - left side (Innen) - Broken / torn - Replace

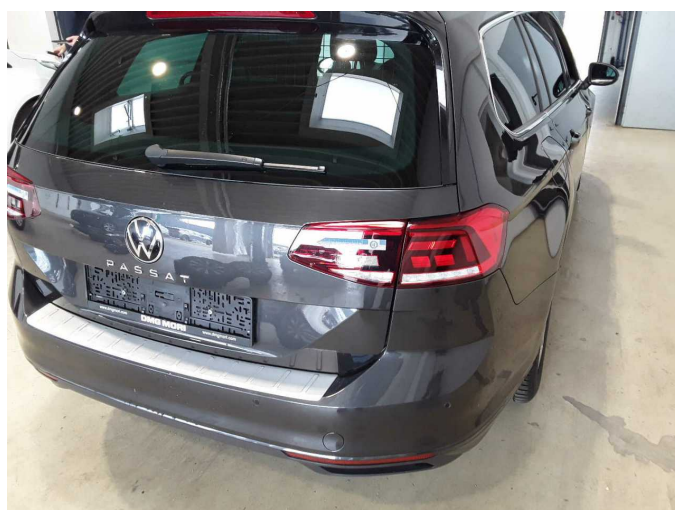
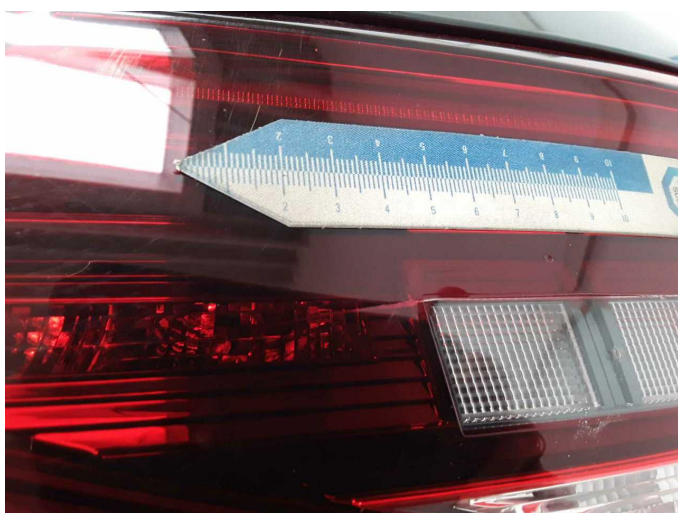
| No. | Component group | Description |
|---|---|---|
| 4 | Tail light | Tail lamp - right side (Innen) - Broken / torn - Replace |

**Damage 4:** Tail light: Tail lamp - right side (Innen) - Broken / torn - Replace

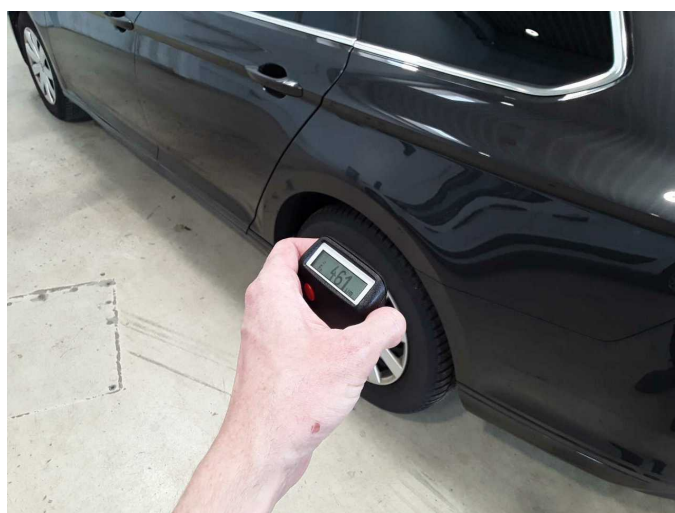
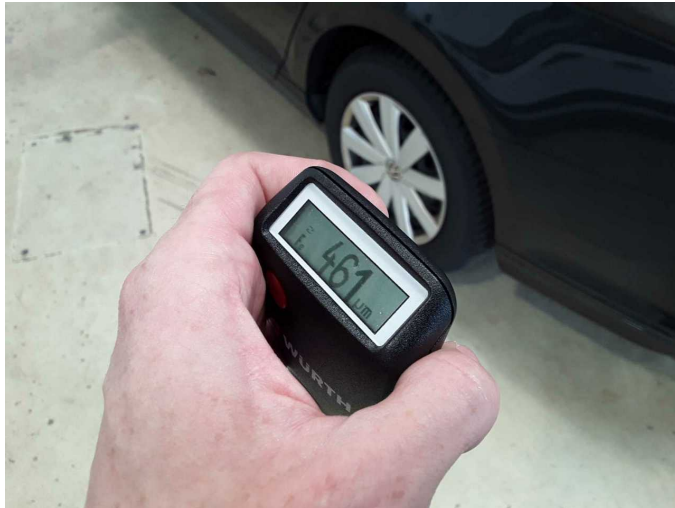
| No. | Repainting |
|---|---|
| 1 | Side panel - rear left side, Professionally carried out, Invoice of repair done Non-existent |

| Side panel - rear left side | 461 µm | Door - rear left side | 714 µm |

**Repainting 1:** Side panel - rear left side

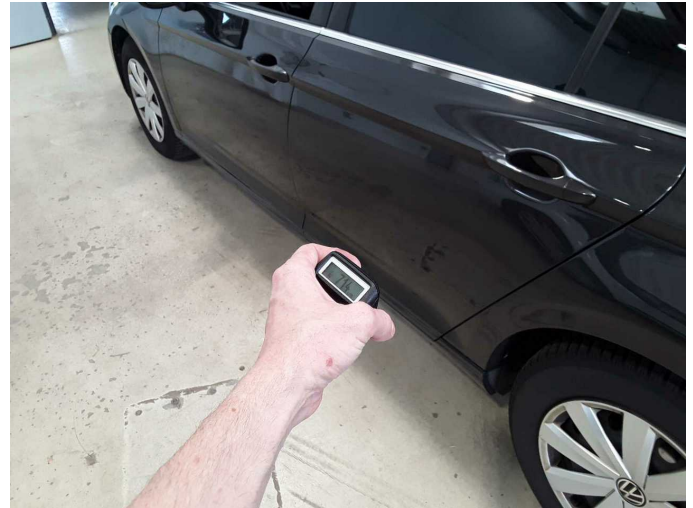
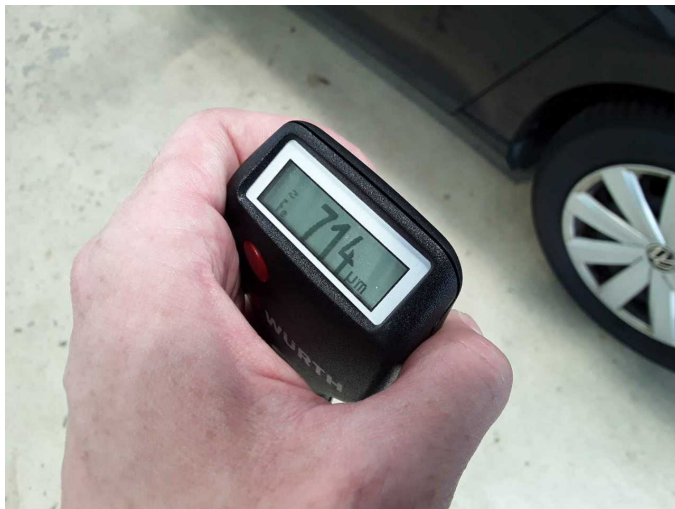
| No. | Repainting |
|---|---|
| 2 | Door - rear left side, Professionally carried out, Invoice of repair done Non-existent |

**Repainting 2:** Door - rear left side

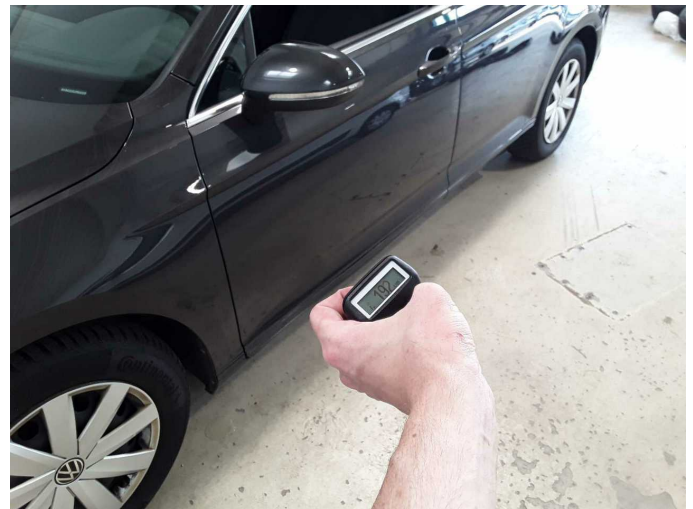
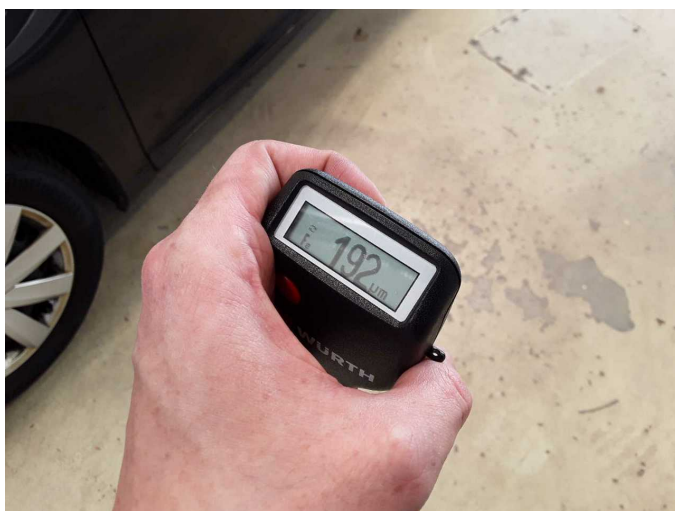
| No. | Repainting |
|---|---|
| 3 | Door - front left side, Professionally carried out, Invoice of repair done Non-existent |

| Door - front left side | 192 µm | | |

**Repainting 3:** Door - front left side
