Expertise

Protocol number: 46844838  
Order No. / Reference: 26737796  
Inspection date: 3 Aug 2026

Manufacturer: Skoda  
VIN: TMBJH9NY3SF022798

Model: ENYAQ 85

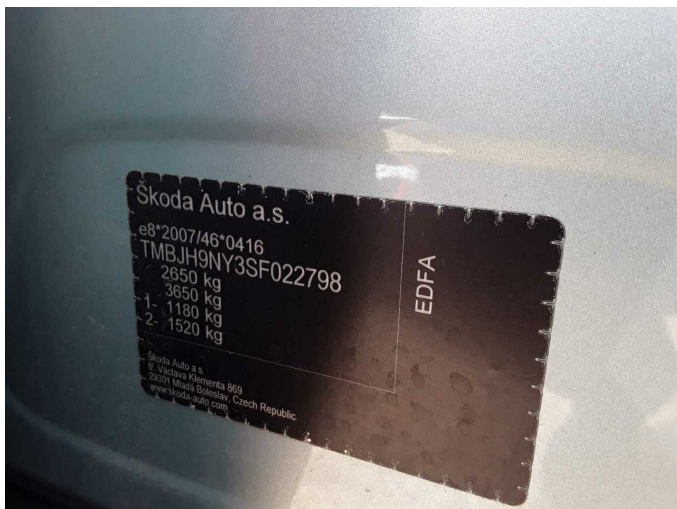
Figure 11: VIN

| VIN comparison | The vehicle identification number (VIN) was read from the vehicle and its conformity with the submitted documents was confirmed by the undersigned during the inspection. |

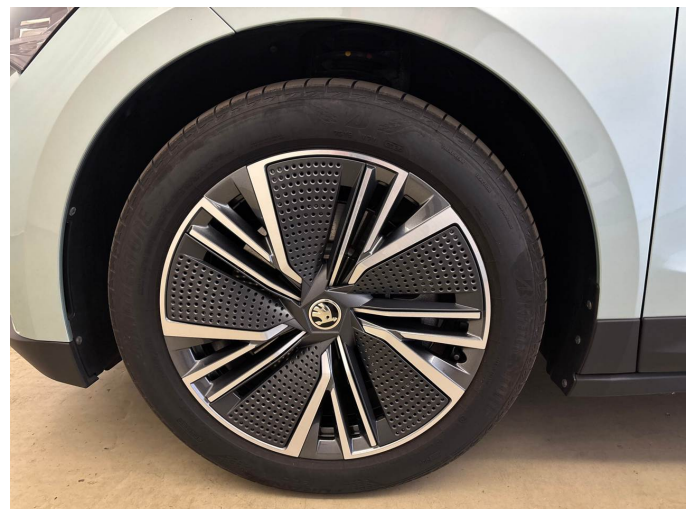
Figure 12: Mounted tyres

| # | Tyre size | Type of tyre | Manufacturer | Tread depth |
|---|---|---|---|---|
| 1) | 235/50 R20 100T | Summer tyres on Light alloy | Bridgestone | 5mm / 5mm |
| 2) | 255/45 R20 101T | Summer tyres on Light alloy | Bridgestone | 5mm / 5mm |

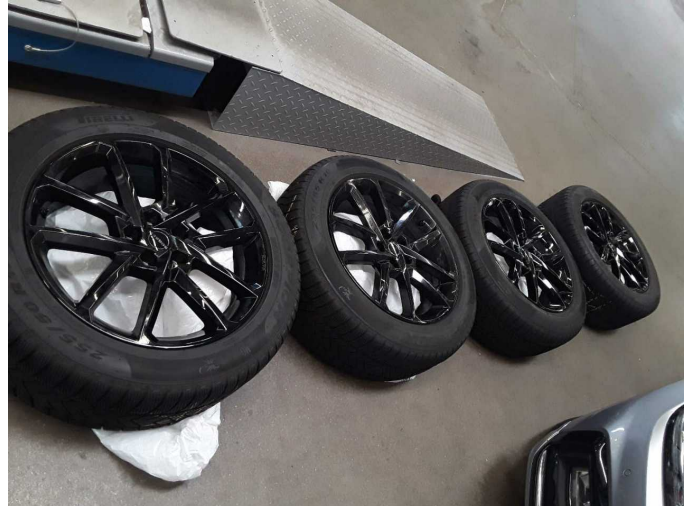
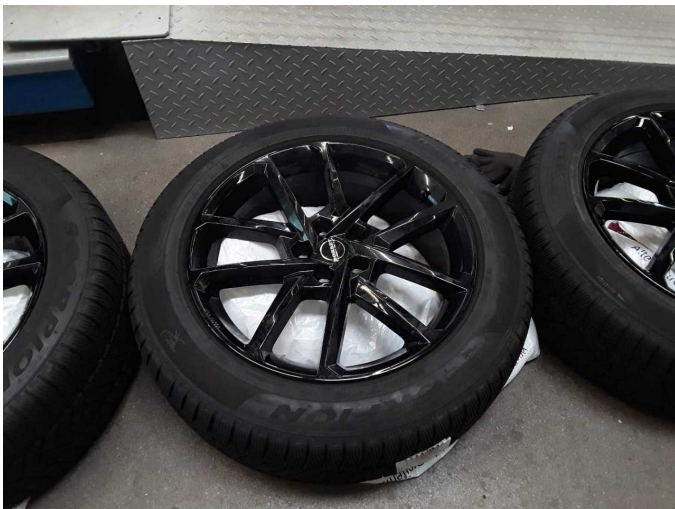
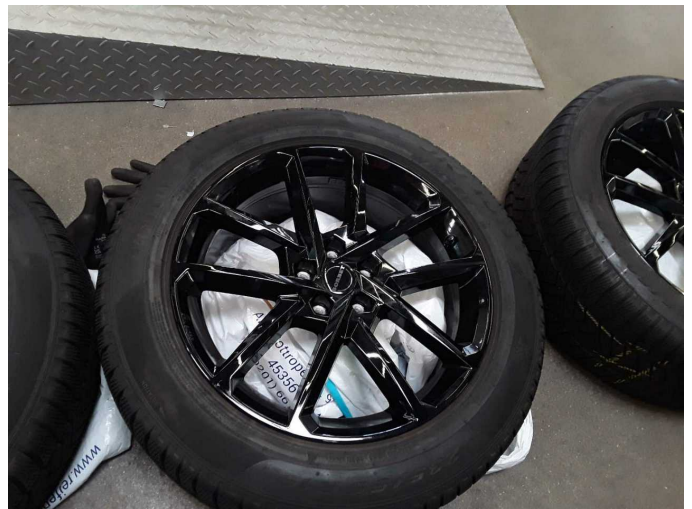
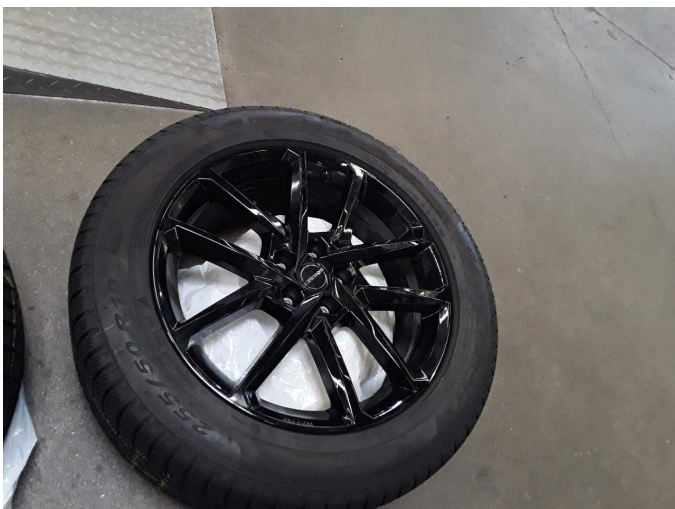
| # | Tyre size | Type of tyre | Manufacturer | Tread depth |
|---|---|---|---|---|
| 1) | 235/55 R19 101H | Winter tyres on Light alloy | Pirelli | 7mm / 7mm |
| 2) | 255/50 R19 103H | Winter tyres on Light alloy | Pirelli | 6mm / 6mm |

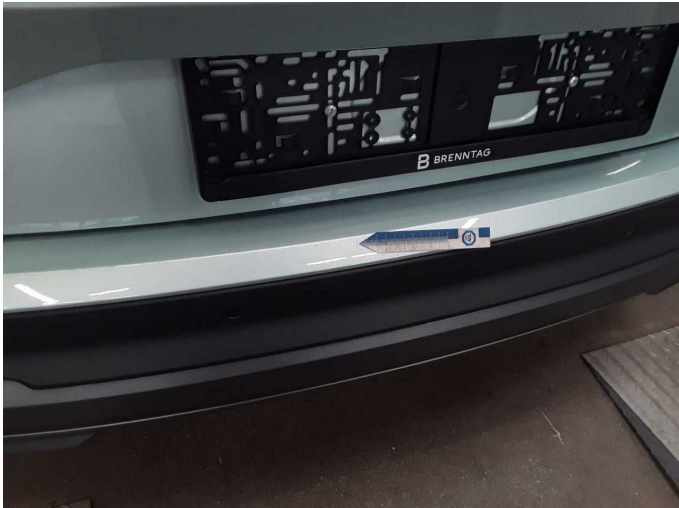
Damage 2: Rear bumper: Rear bumper - Scratch(es) - Smart repair

| No. | Component group | Description |
|---|---|---|
| 2 | Rear bumper | Rear bumper - Scratch(es) - Smart repair |

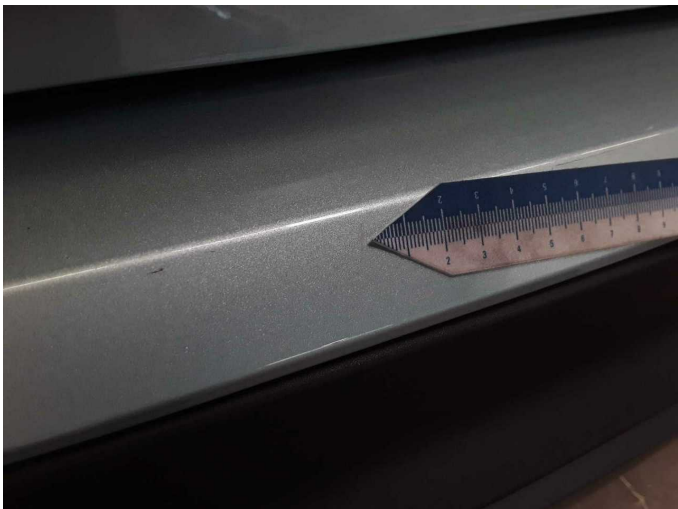
Damage 2: Rear bumper: Rear bumper - Scratch(es) - Smart repair

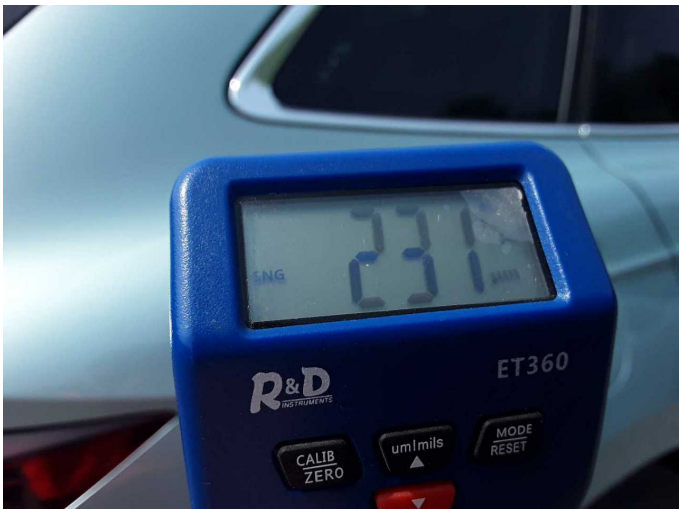
| No. | Repainting |
|---|---|
| 1 | Side panel - rear right side, Door - front right side, Professionally carried out |

Side panel - rear right side: 231 μm

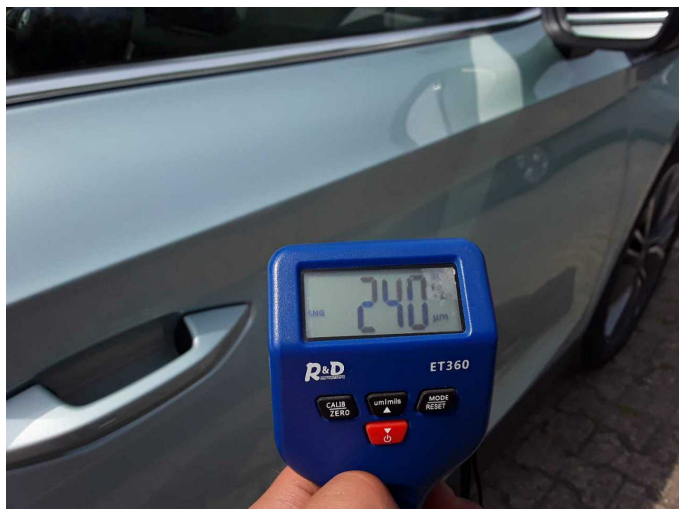
Door - front right side: 240 µm
