Expertise

Protocol number: 45918399
Order No. / Reference: 26373334
Inspection date: 12 Jun 2026

Manufacturer: Ford

Model: Kuga 2.5 Duratec FHEV ST-LINE X

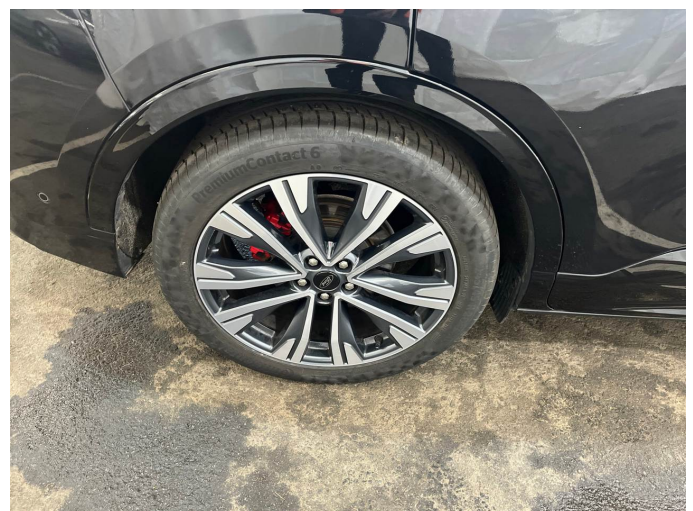
#	Tyre size	Type of tyre	Manufacturer	Tread depth
1)	245/45 R20 103V	Summer tyres on Light alloy	Continental	5mm / 5mm
2)	245/45 R20 103V	Summer tyres on Light alloy	Continental	6mm / 6mm

Figure 12: Mounted tyres

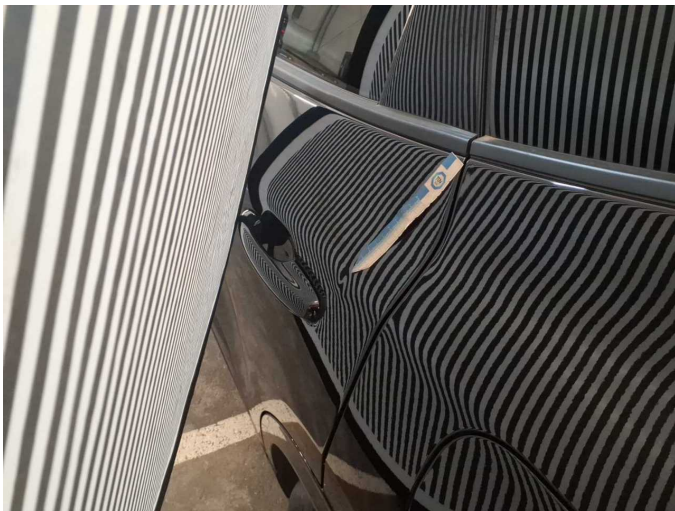
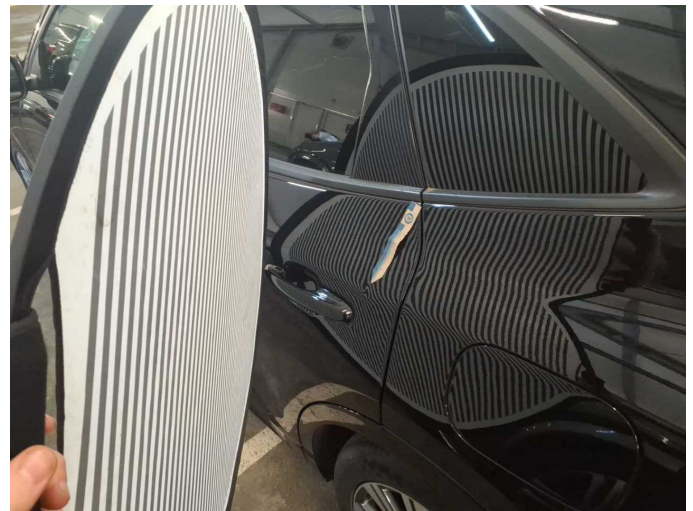
Damage 1: Door - rear left side: Door - dent(s) - Smart repair

No.	Component group	Description
1	Door - rear left side	Door - dent(s) - Smart repair
2	Side panel - rear right side	Side panel - Scratch(es) - Smart repair
3	Sill - right side	Sill - Scratch(es) - Smart repair
4	Misc.	Main inspection - Expired - Perform

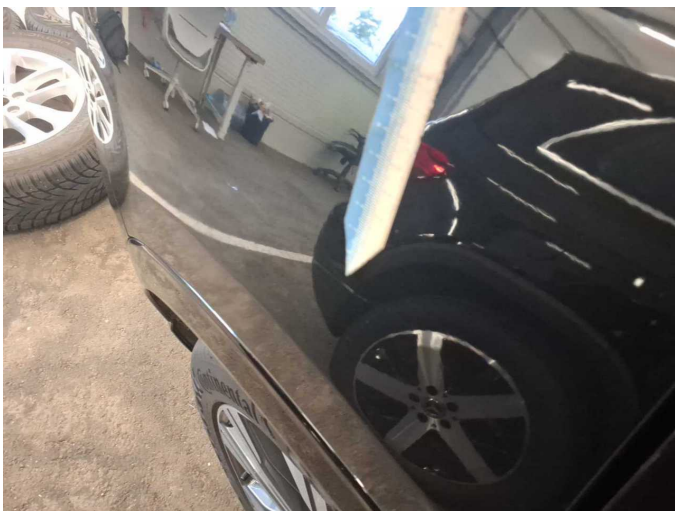
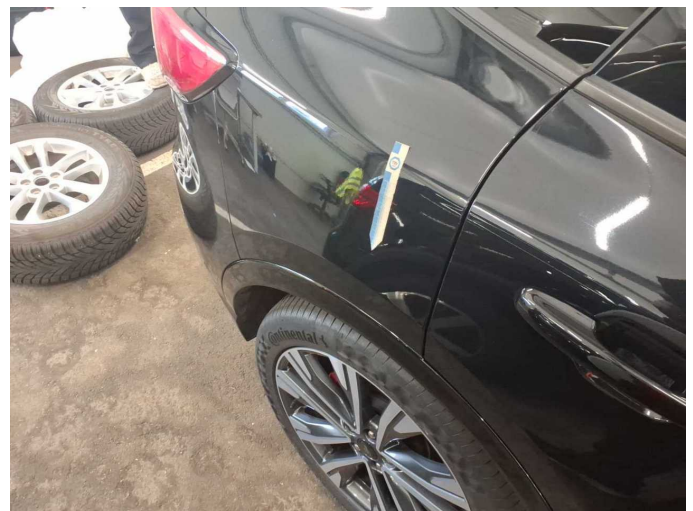
Damage 2: Side panel - rear right side: Side panel - Scratch(es) - Smart repair

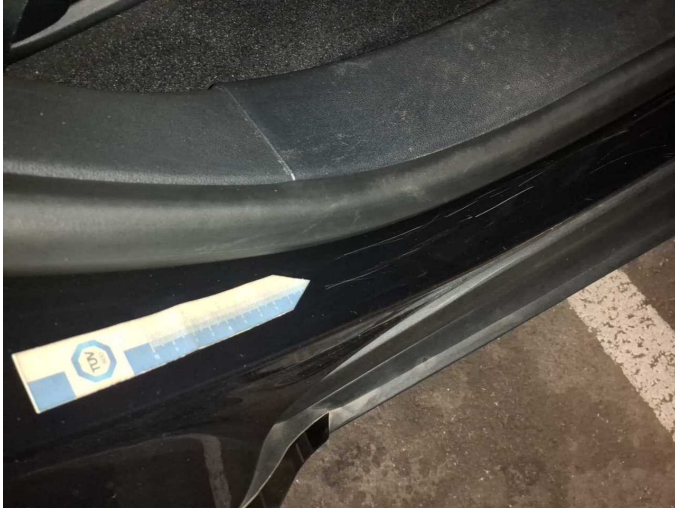
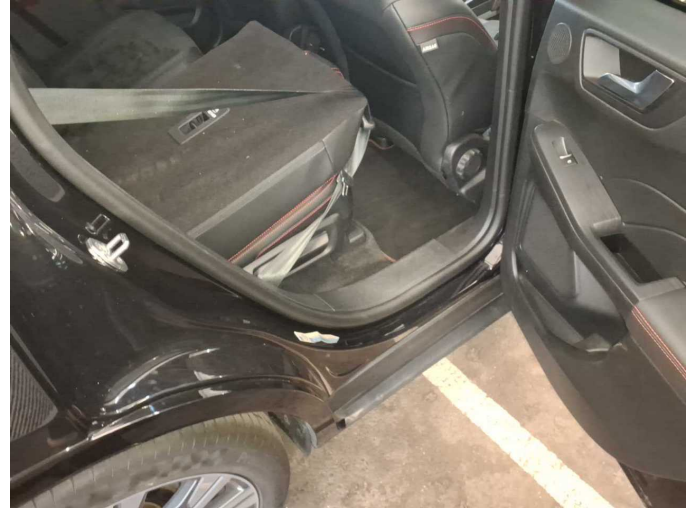
Damage 3: Sill - right side: Sill - Scratch(es) - Smart repair

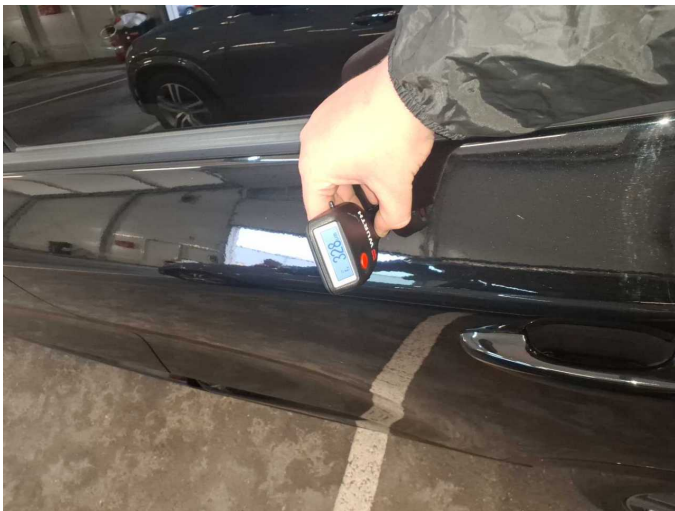
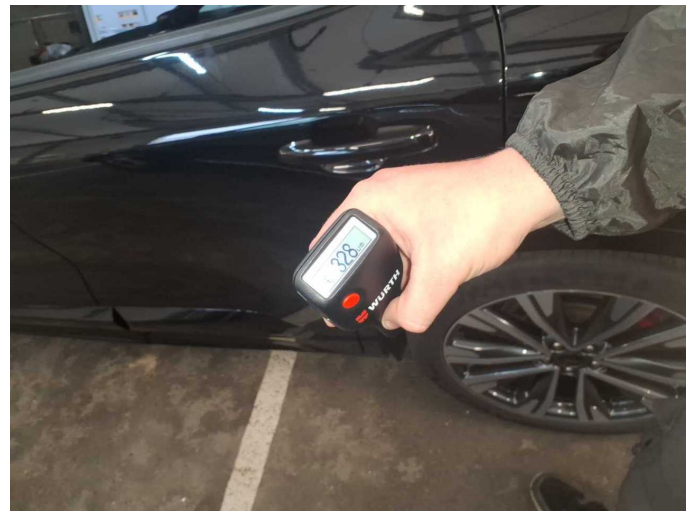
No.	Repainting
1	Door - rear left side, Professionally carried out, Invoice of repair done Non-existent

Repainting 1: Door - rear left side

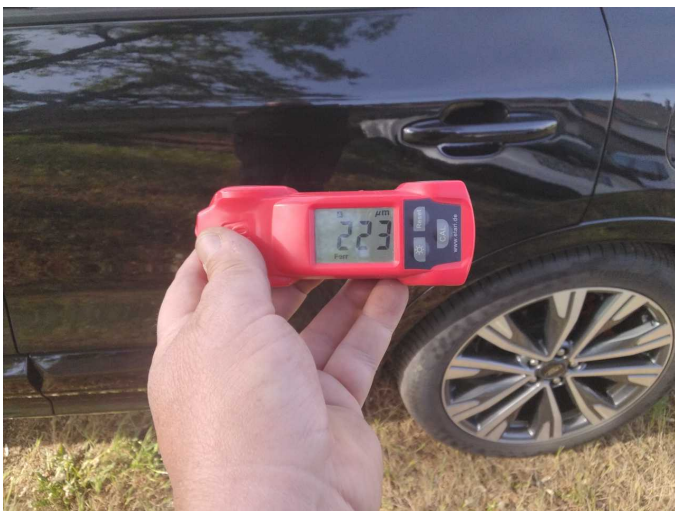
Door - rear left side 328 µm |

Door - rear left side: 328 μm
