Expertise

Protocol number: 46739680  
Order No. / Reference: 26795307  
Inspection date: 27 Jul 2026

Manufacturer: Opel

Model: Astra 1.5 D Start/Stop Sports Tourer Automatik Business  
Elegance

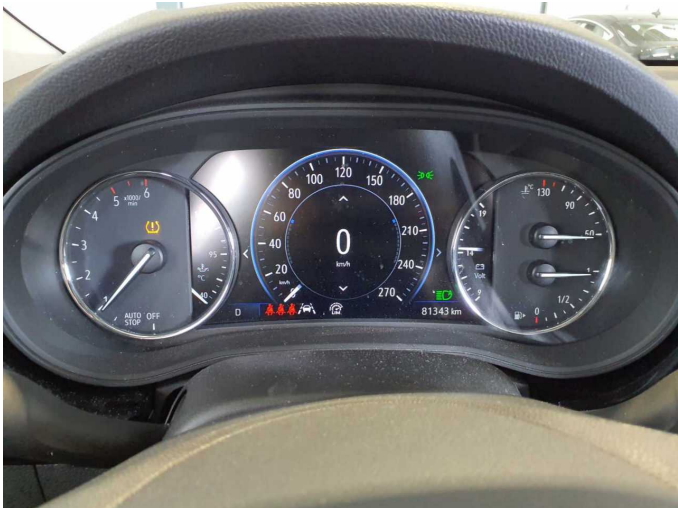
Figure 7: Instrument cluster

Damage 1: Instrument panel: Indicator light (Reifendruck) - on - Perform diagnosis

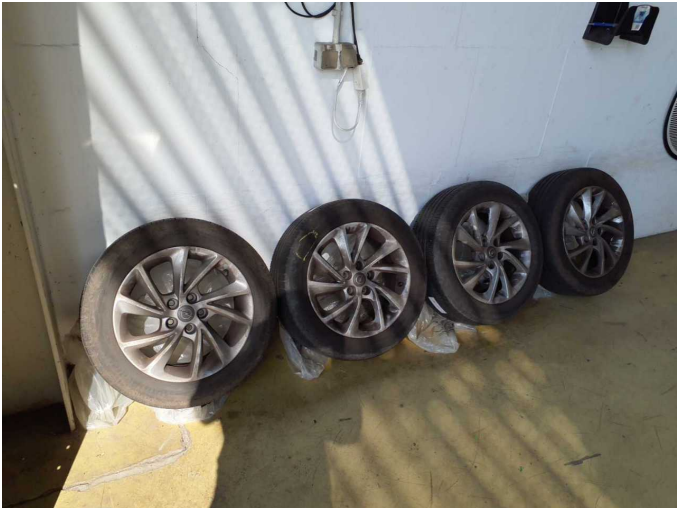
Figure 14: Additional tyres

| No. | Component group | Description |
|---|---|---|
| 5 | 2nd wheel set | 1 tyre - Porous / cracked - Replace |

**Damage 5:** 2nd wheel set: 1 tyre - Porous / cracked - Replace

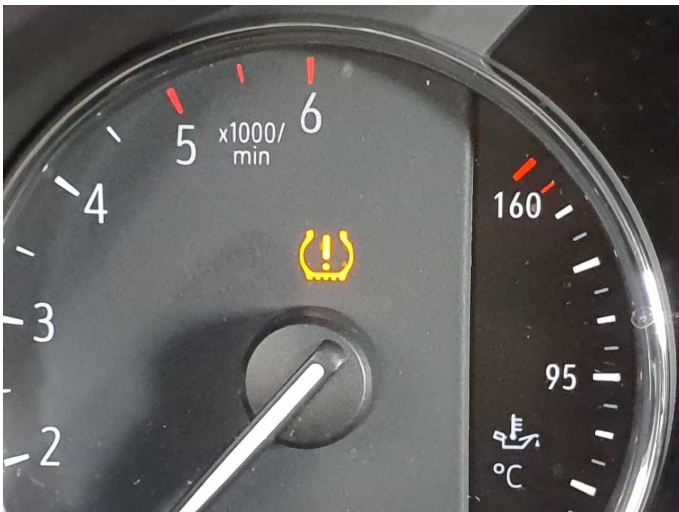
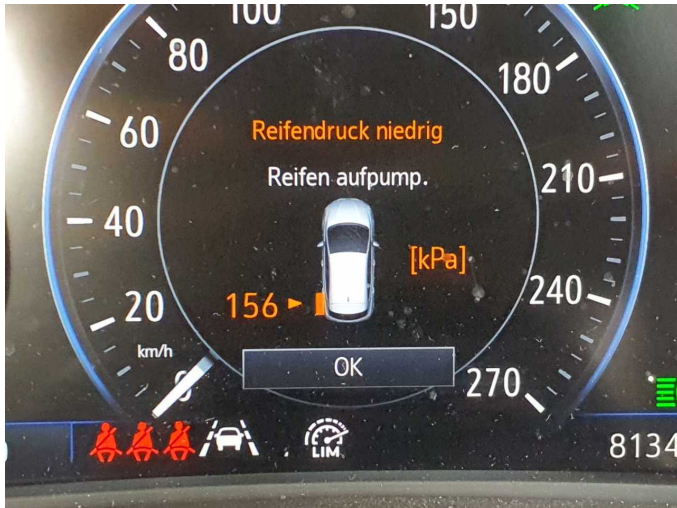
**Damage 1:** Instrument panel: Indicator light (Reifendruck) - on - Perform diagnosis

| No. | Component group | Description |
|---|---|---|
| 1 | Instrument panel | Indicator light (Reifendruck) - on - Perform diagnosis |

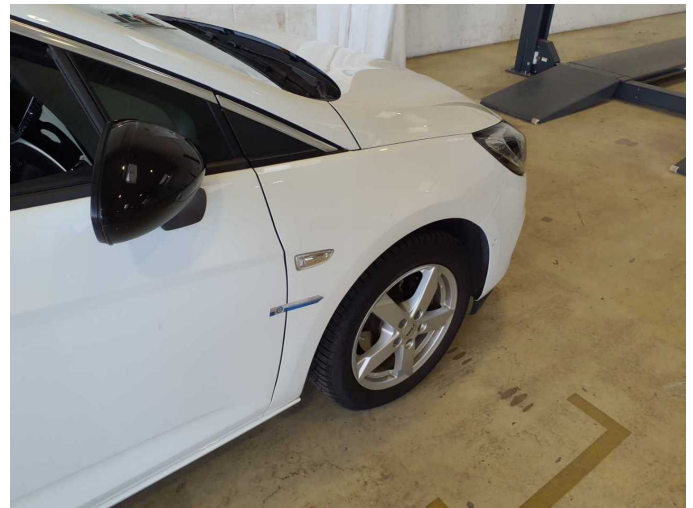
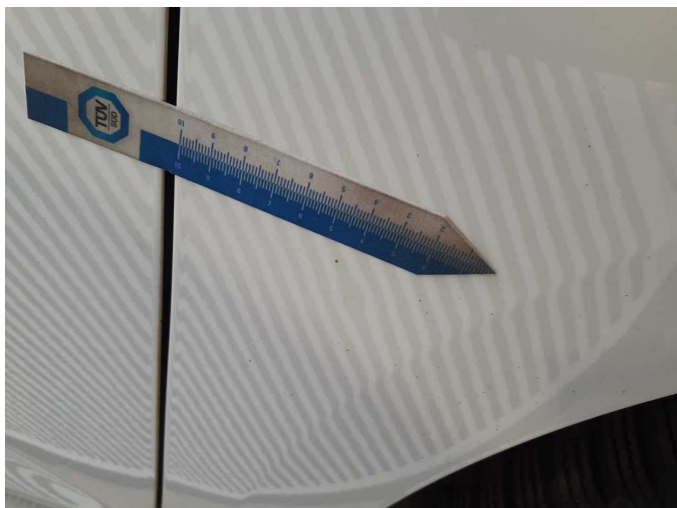
**Damage 2:** Mudguard - right side: Mudguard - right side - dent(s) - Smooth repair work

| No. | Component group | Description |
|---|---|---|
| 2 | Mudguard - right side | Mudguard - right side - dent(s) - Smooth repair work |

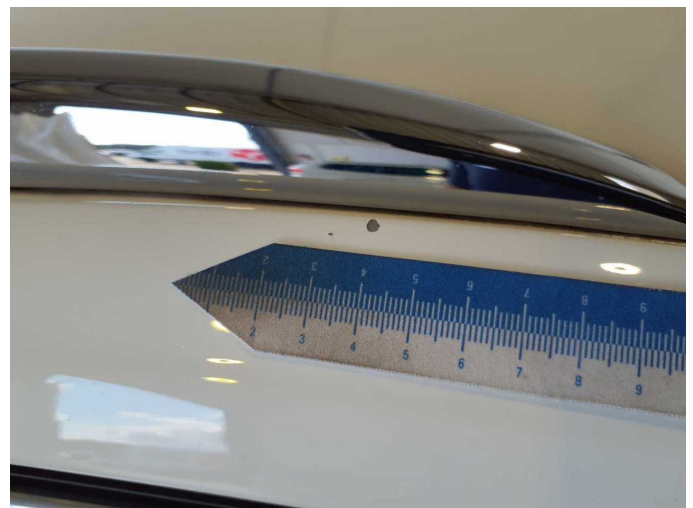
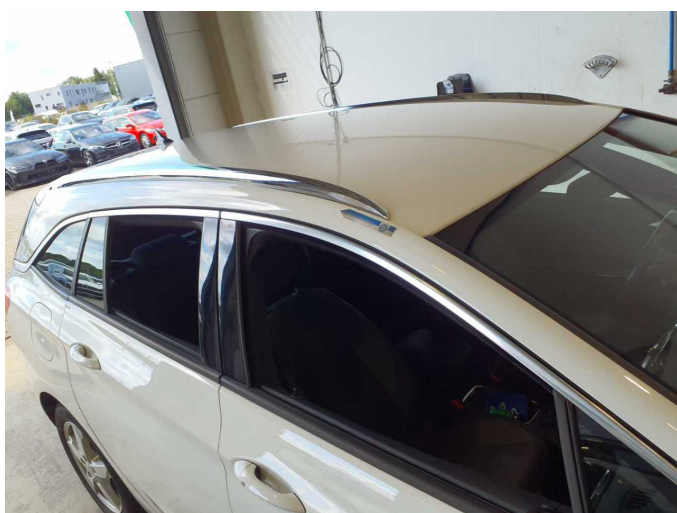
**Damage 3:** Roof: Roof rail - right side - Stone chips - Smart repair

| No. | Component group | Description |
|---|---|---|
| 3 | Roof | Roof rail - right side - Stone chips - Smart repair |

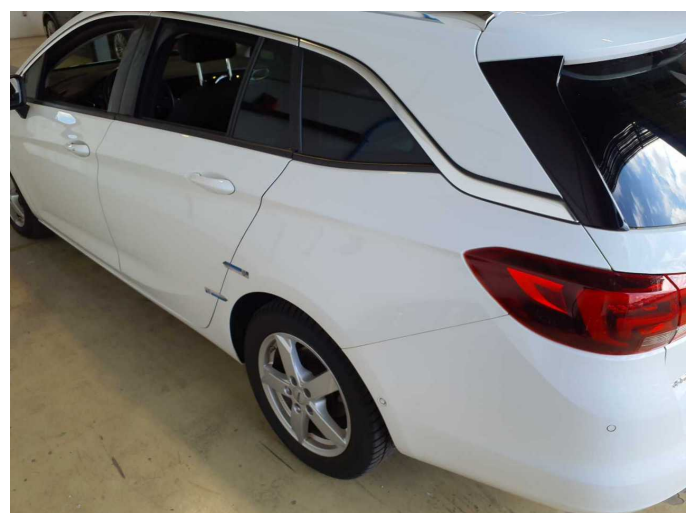
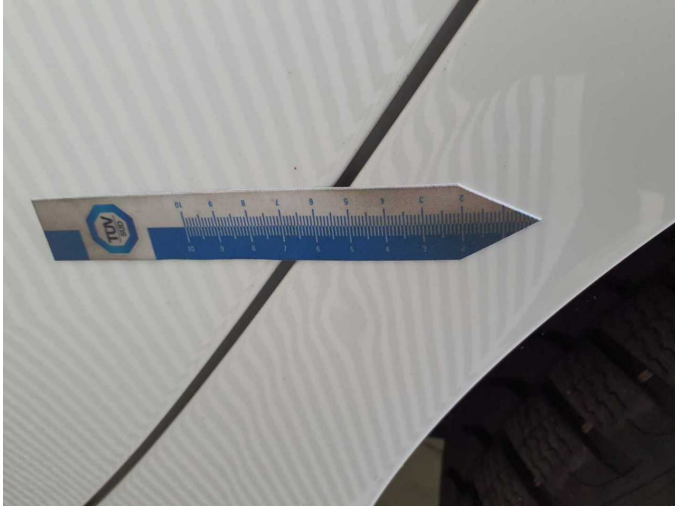
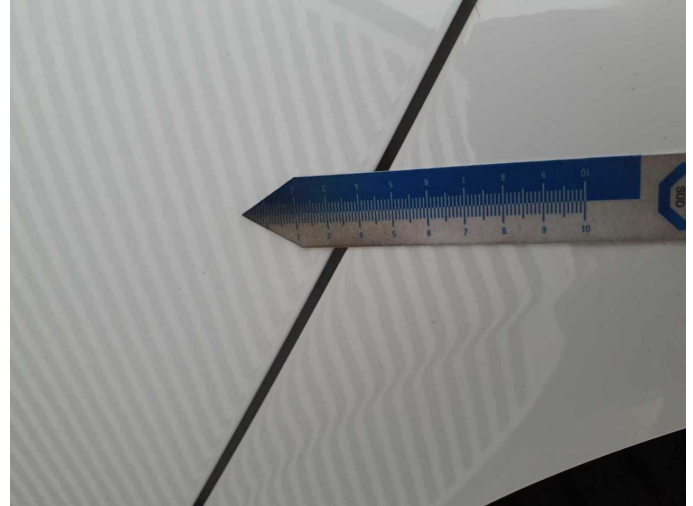
**Damage 4:** Side panel - rear left side: Side panel - dent(s) - Smart repair

| No. | Component group | Description |
|---|---|---|
| 4 | Side panel - rear left side | Side panel - dent(s) - Smart repair |

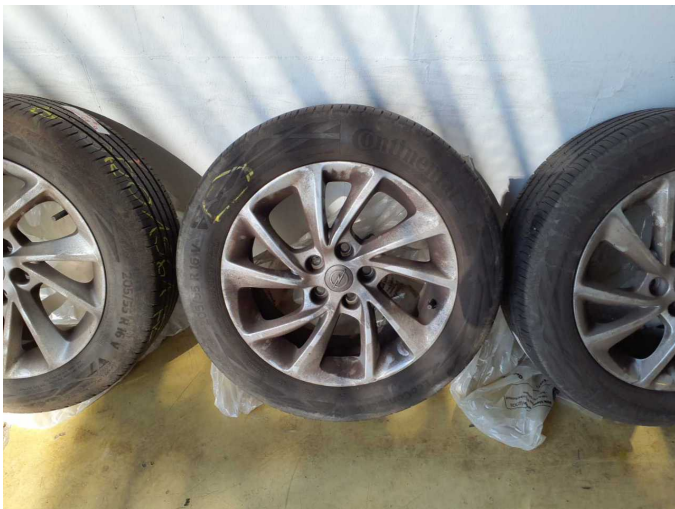
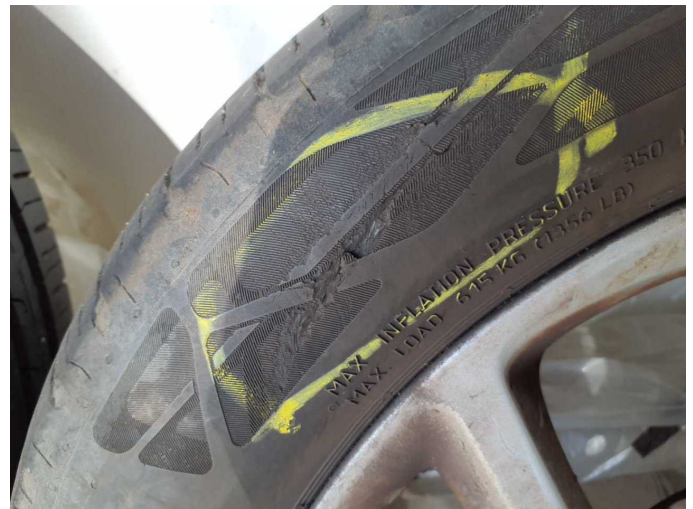
**Damage 5:** 2nd wheel set: 1 tyre - Porous / cracked - Replace

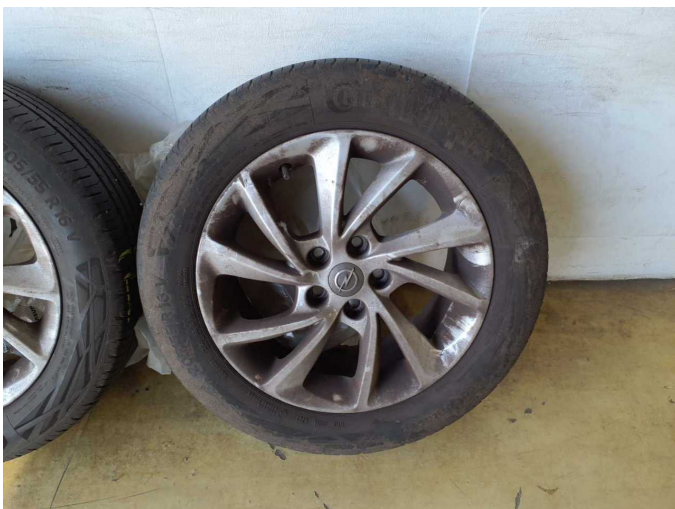
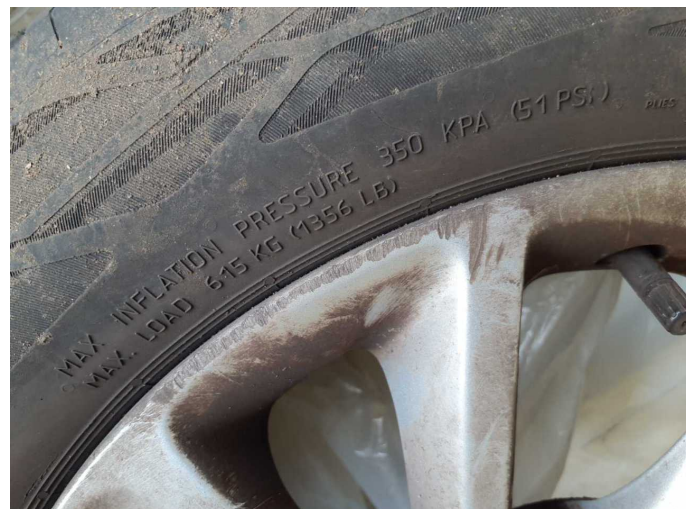
**Damage 6:** 2nd wheel set: 1 alloy rim - Scratch(es) - Replace

| No. | Component group | Description |
|---|---|---|
| 6 | 2nd wheel set | 1 alloy rim - Scratch(es) - Replace |

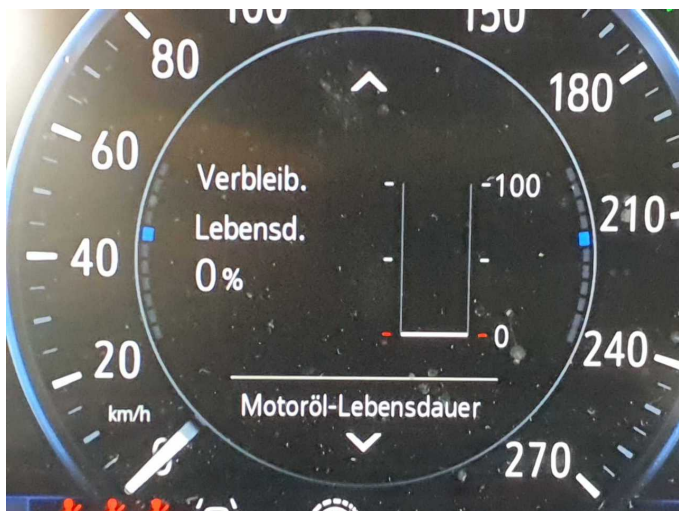
**Damage 7:** Misc.: Inspection / maintenance - Due - Replace

| No. | Component group | Description |
|---|---|---|
| 7 | Misc. | Inspection / maintenance - Due - Replace |

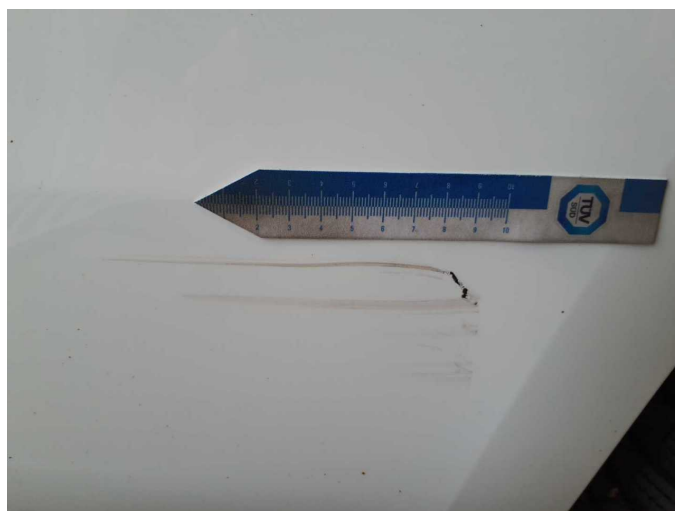
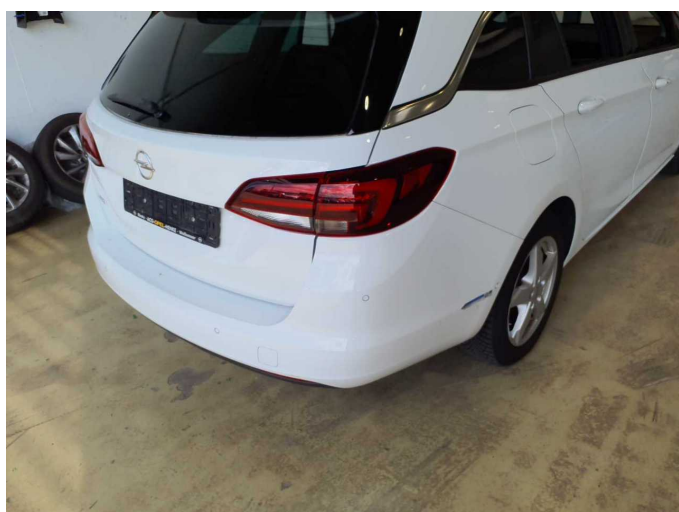
**Damage 8:** Rear bumper: Rear bumper - Scratch(es) - Paint

| No. | Component group | Description |
|---|---|---|
| 8 | Rear bumper | Rear bumper - Scratch(es) - Paint |

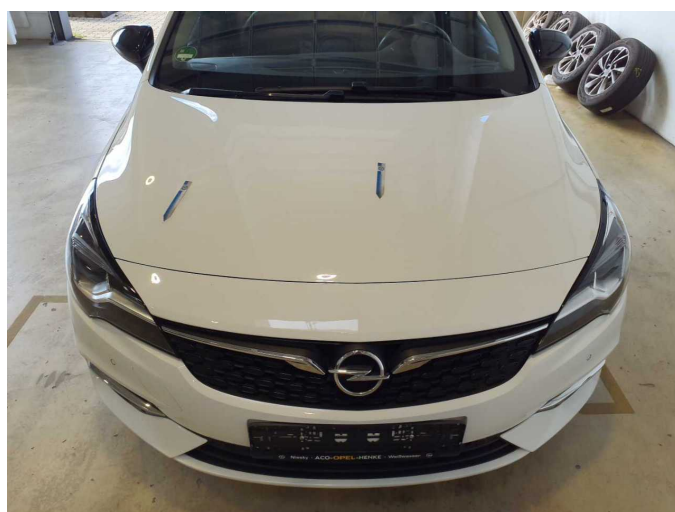
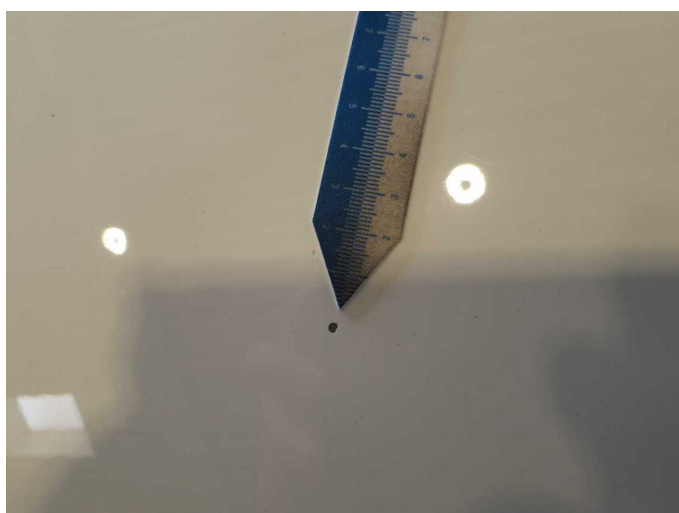
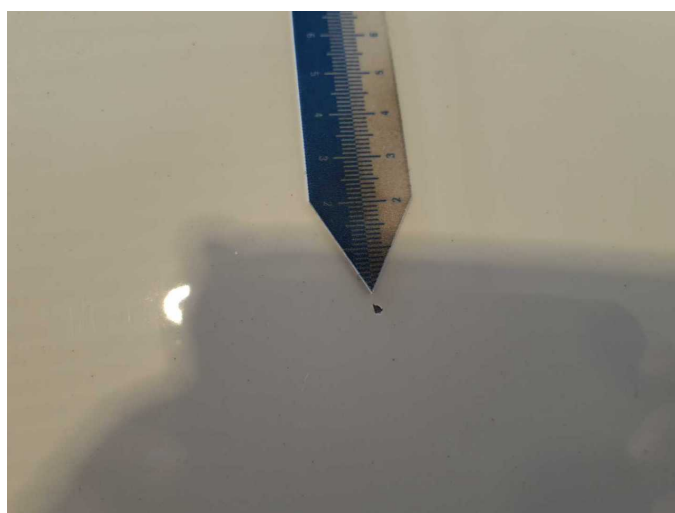
**Damage 9:** Bonnet: Bonnet - Stone chips - Paint

| No. | Component group | Description |
|---|---|---|
| 9 | Bonnet | Bonnet - Stone chips - Paint |

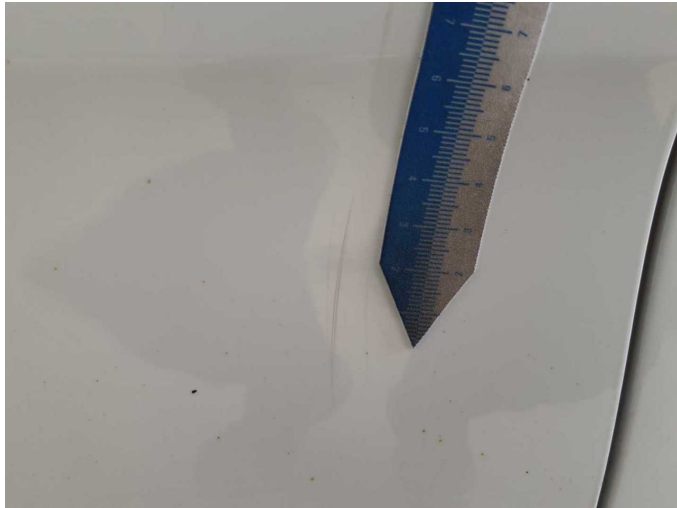
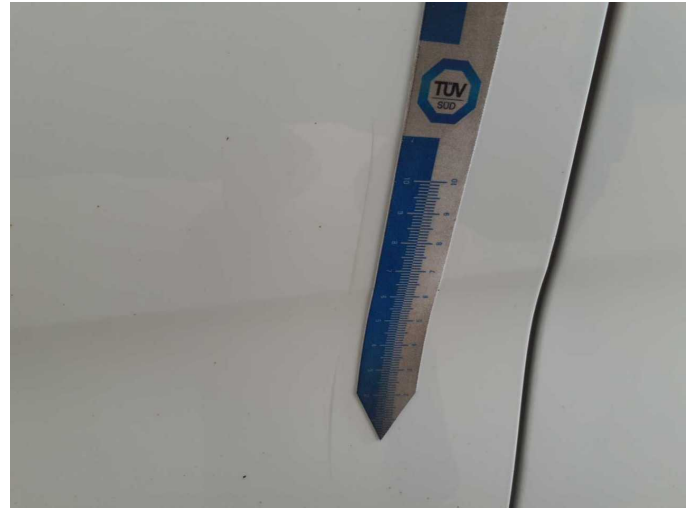
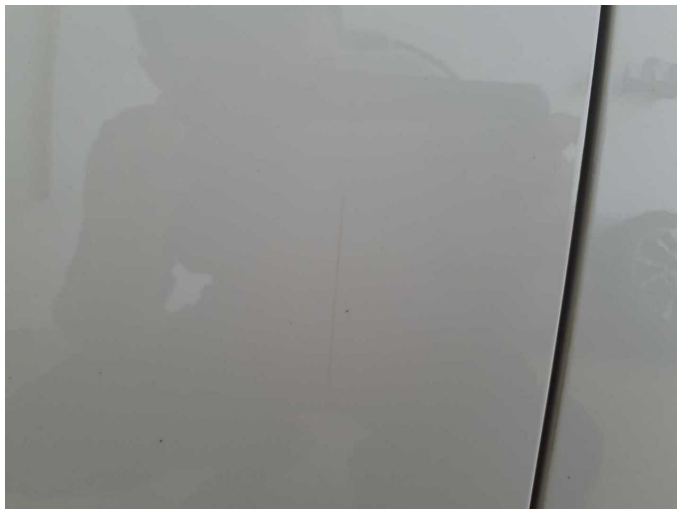
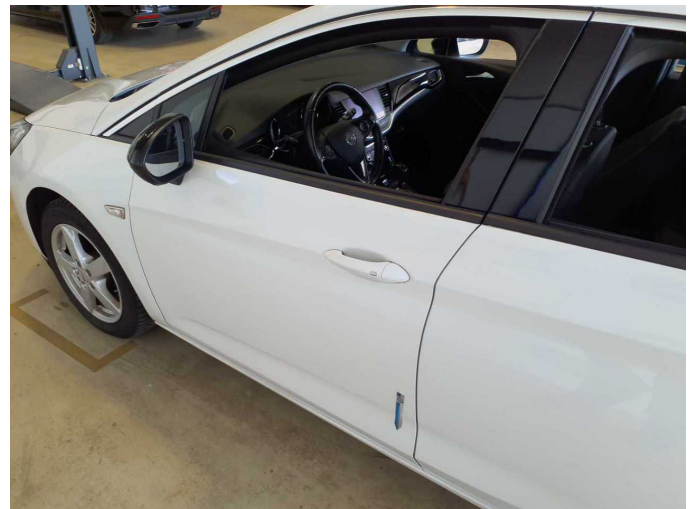
**Damage 10:** Door - front left side: Door - Scratch(es) - Paint

| No. | Component group | Description |
|---|---|---|
| 10 | Door - front left side | Door - Scratch(es) - Paint |

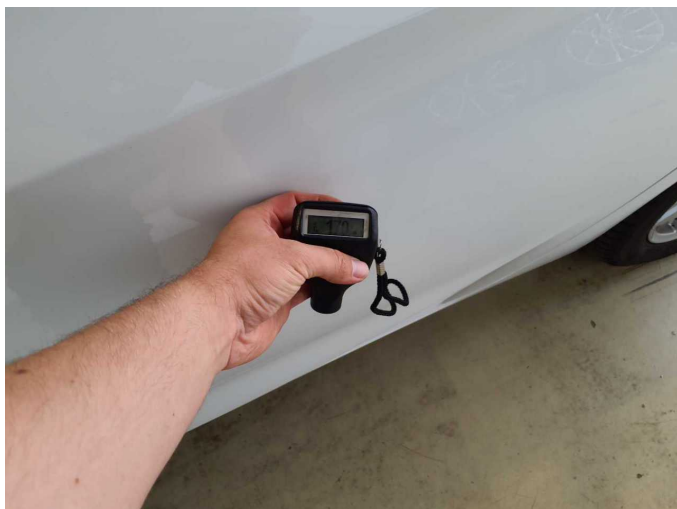
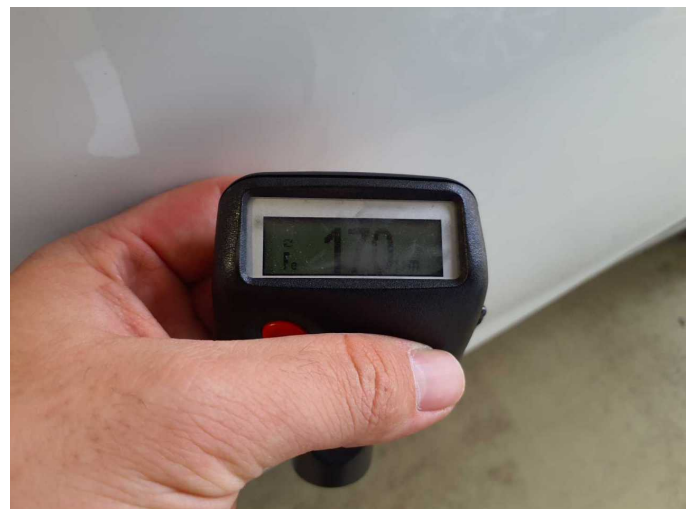
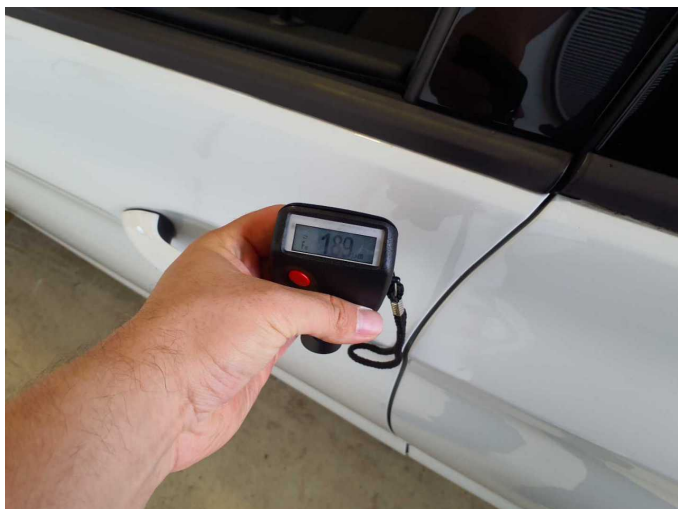
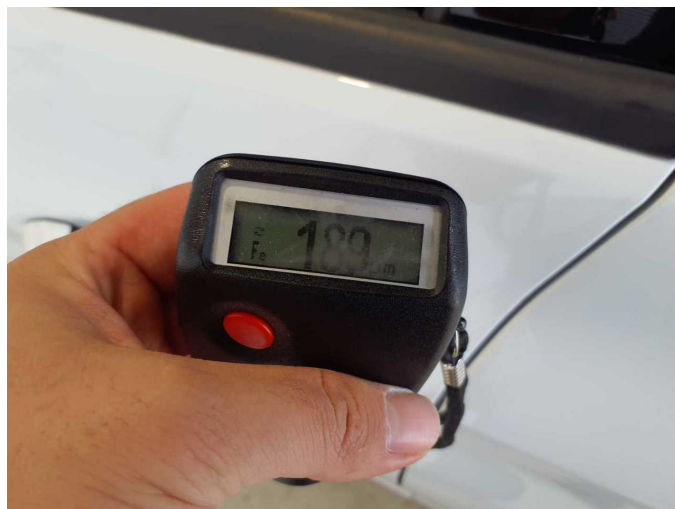
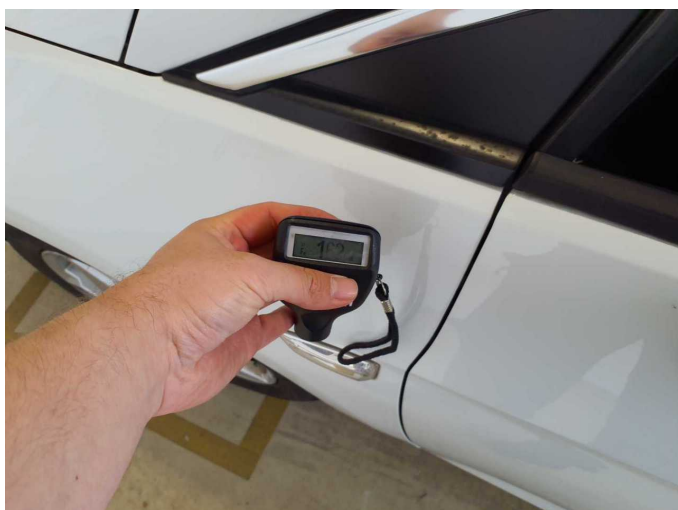
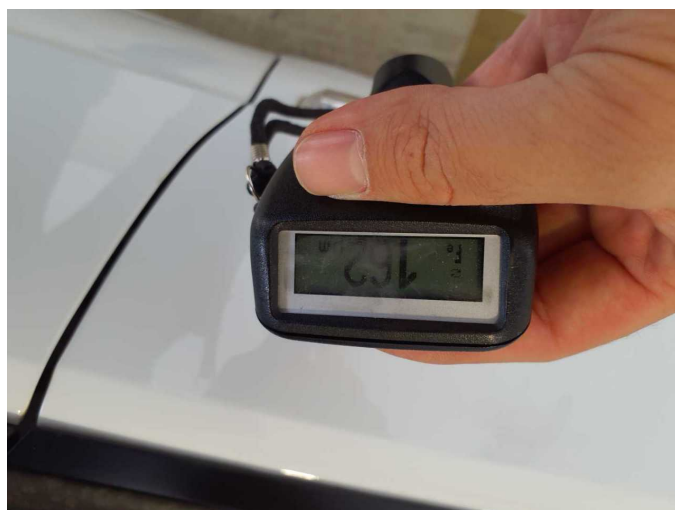
1 Mudguard - left side, Door - rear left side, Door - front left side, Professionally carried out

| Mudguard - left side | 162 µm | Door - rear left side | 170 µm |
| Door - front left side | 189 µm | | |

**Repainting 1:** Mudguard - left side, Door - rear left side, Door - front left side
