Expertise

Protocol number: 46265880  
Order No. / Reference: 26454366  
Inspection date: 30 Jun 2026

Manufacturer: Volkswagen

Model: Touran 1.5 TSI ACT OPF DSG Comfortline

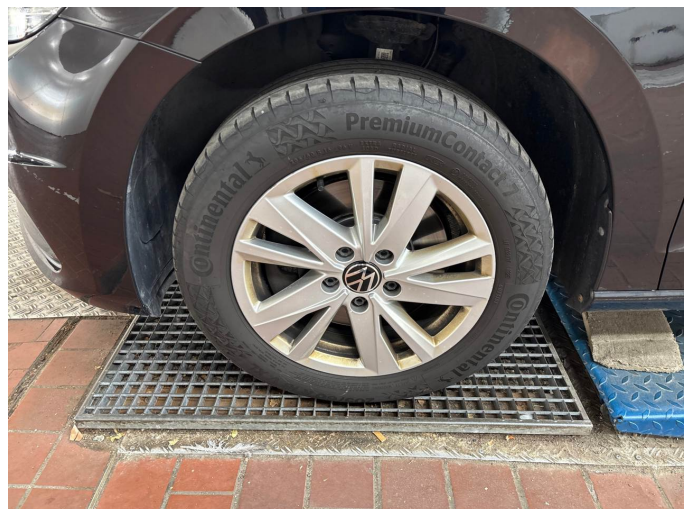
Figure 12: Mounted tyres

| # | Tyre size | Type of tyre | Manufacturer | Tread depth |
|---|---|---|---|---|
| 1) | 205/60 R16 96V | Summer tyres on Light alloy | Continental | 4mm / 4mm |
| 2) | 205/60 R16 96V | Summer tyres on Light alloy | Continental | 6mm / 6mm |

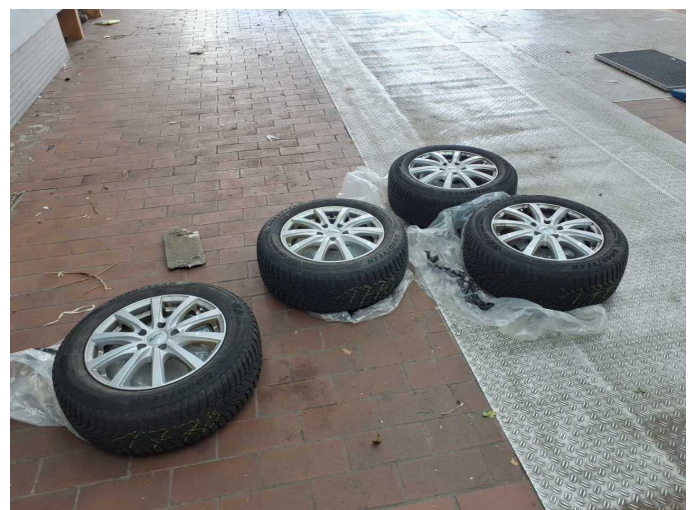
Figure 16: Additional tyres

| # | Tyre size | Type of tyre | Manufacturer | Tread depth |
|---|---|---|---|---|
| 1) | 205/60 R16 96H | Winter tyres on Light alloy | Goodyear | 7mm / 7mm |
| 2) | 205/60 R16 96H | Winter tyres on Light alloy | Goodyear | 7mm / 7mm |

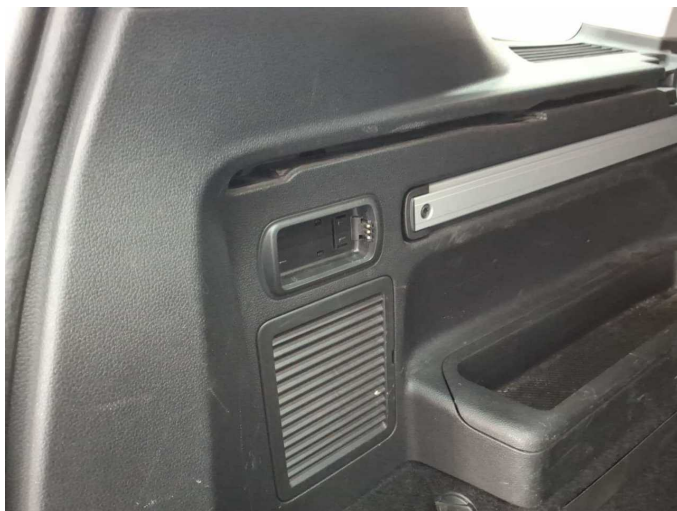
**Damage 2:** Misc.: Misc. (Laderaum Licht) - Missing - Replace

| No. | Component group | Description |
|---|---|---|
| 2 | Misc. | Misc. (Laderaum Licht) - Missing - Replace |

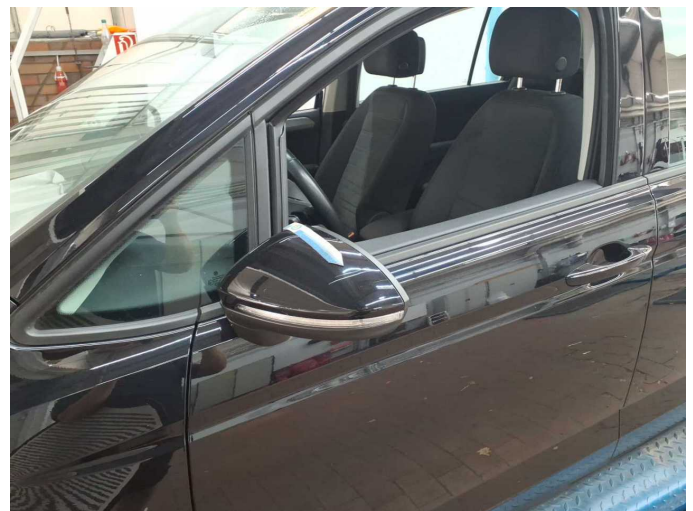
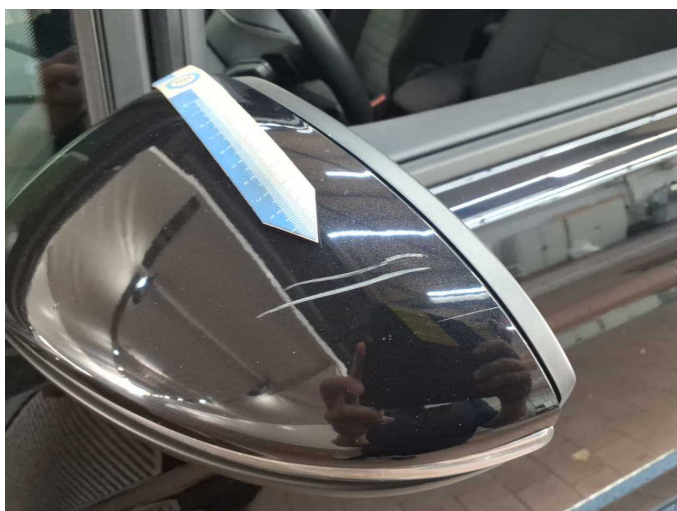
**Damage 3:** Wing mirror - left side: Cap - Scratch(es) - Smart repair

| No. | Component group | Description |
|---|---|---|
| 3 | Wing mirror - left side | Cap - Scratch(es) - Smart repair |

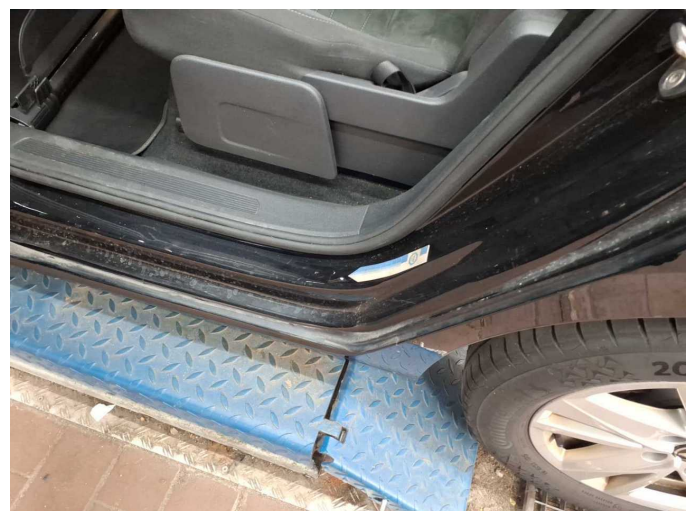
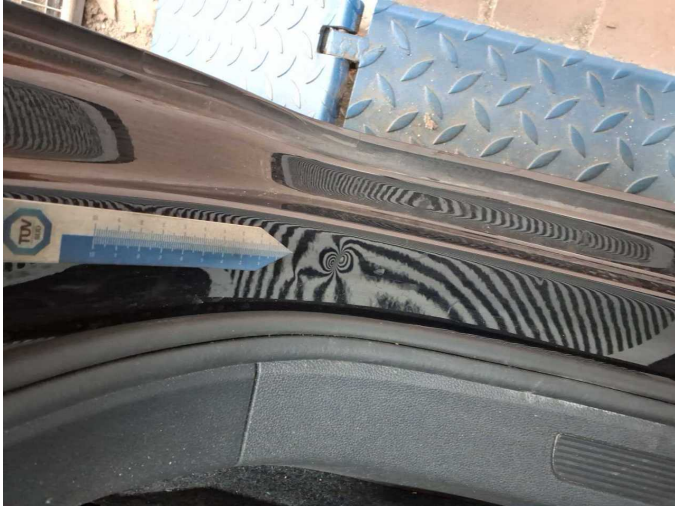
**Damage 4:** Side panel - rear left side: Sill - dent(s) - Smart repair

| No. | Component group | Description |
|---|---|---|
| 4 | Side panel - rear left side | Sill - dent(s) - Smart repair |

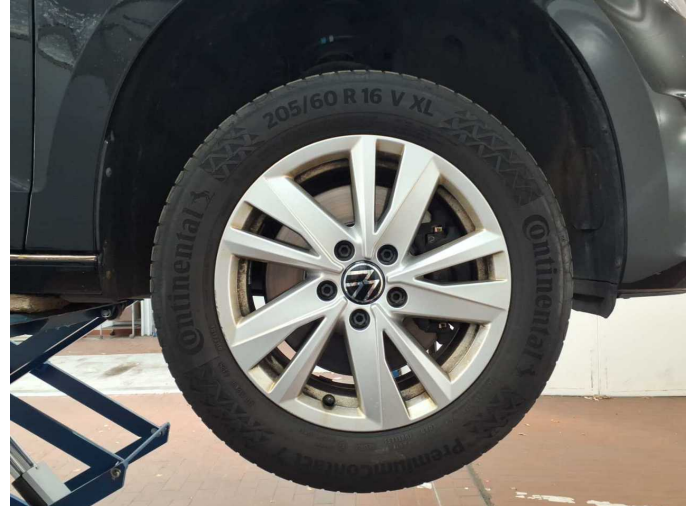
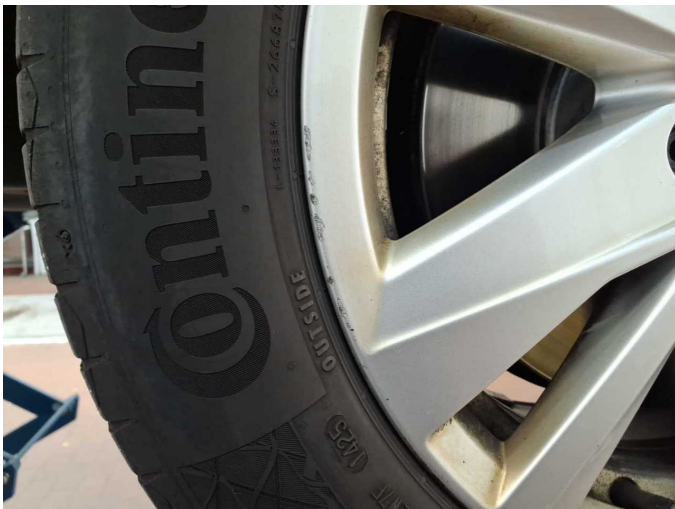
**Damage 5:** Wheel / tyres: Alloy rim - front right side - Scratch(es) - Loss in value

| No. | Component group | Description |
|---|---|---|
| 5 | Wheel / tyres | Alloy rim - front right side - Scratch(es) - Loss in value |

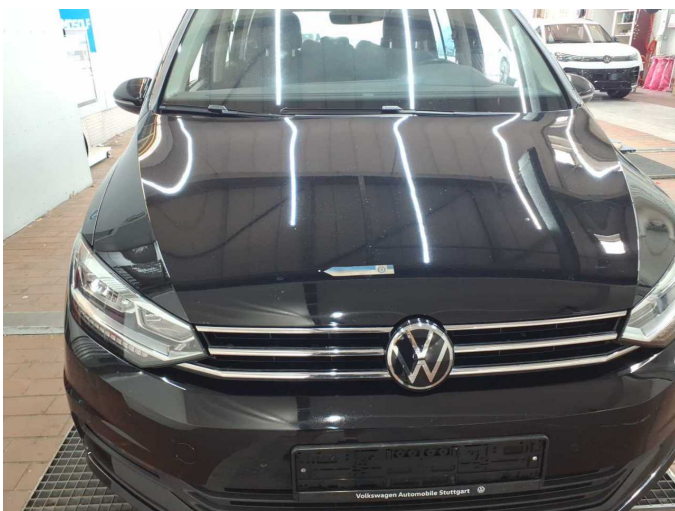
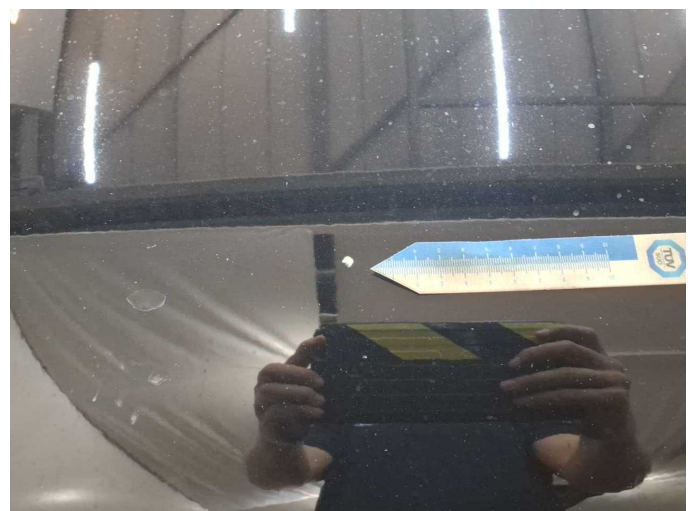
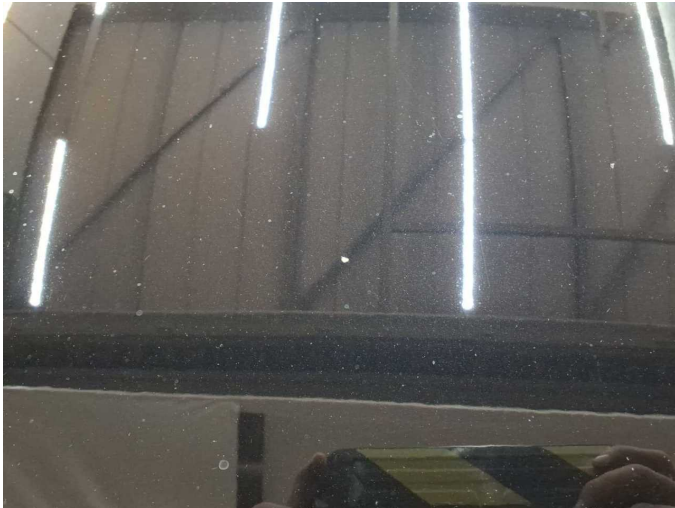
**Damage 7:** Bonnet: Bonnet - Stone chips - Paint

| No. | Component group | Description |
|---|---|---|
| 7 | Bonnet | Bonnet - Stone chips - Paint |

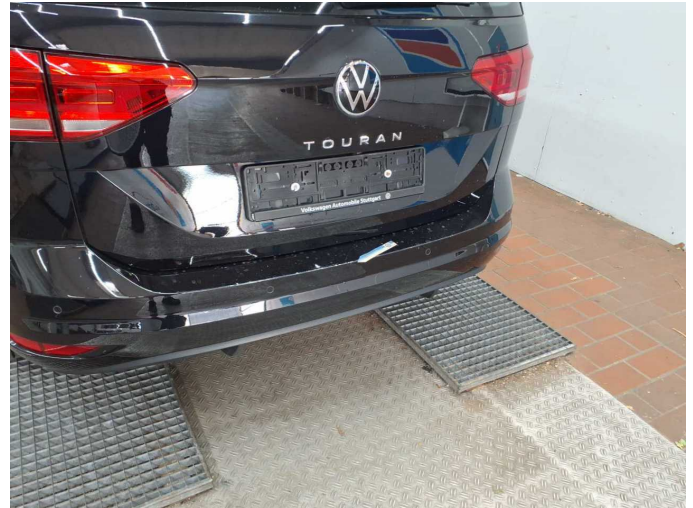
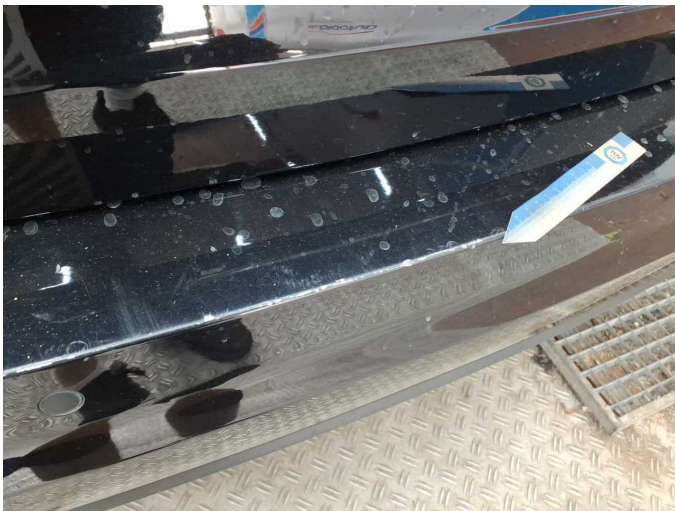
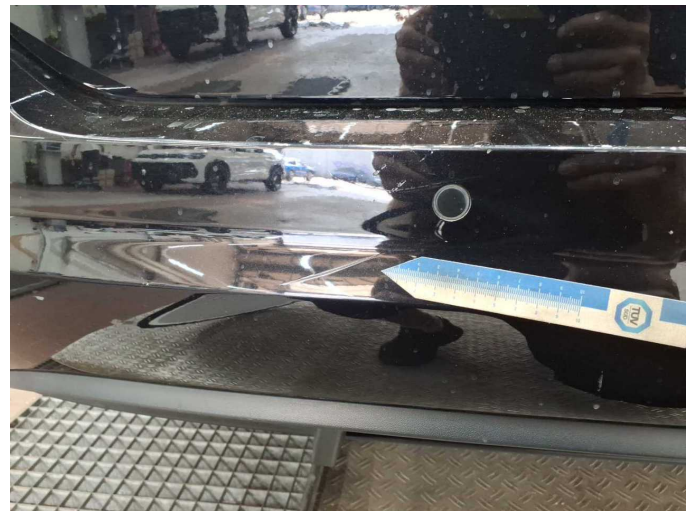
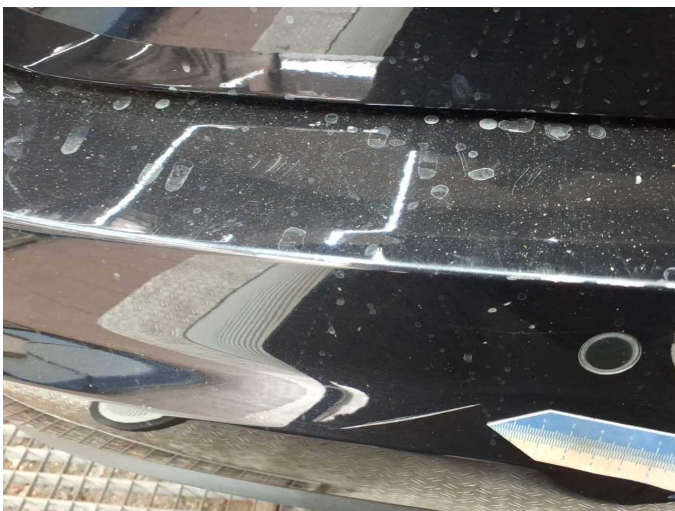
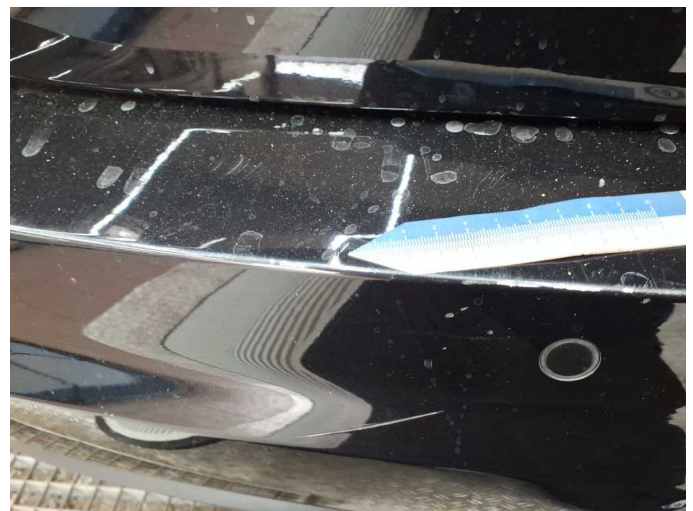
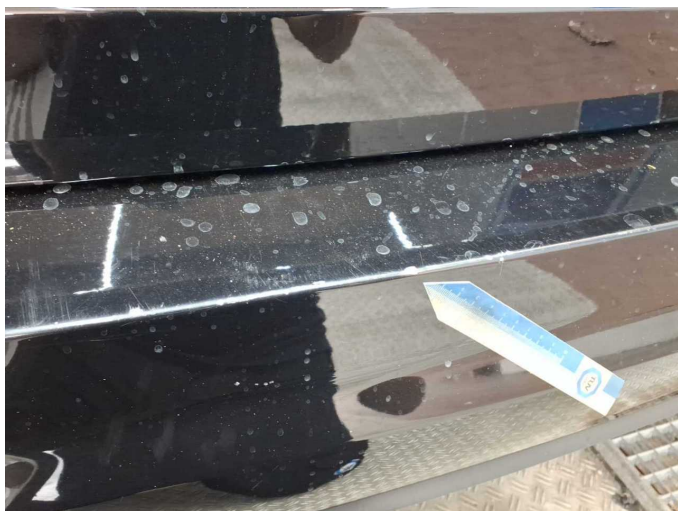
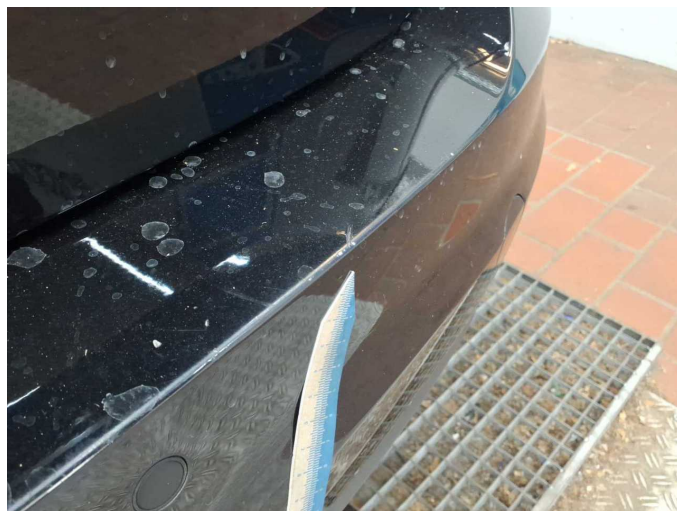
**Damage 8:** Rear bumper: Rear bumper - Scratch(es) - Paint

| No. | Component group | Description |
|---|---|---|
| 8 | Rear bumper | Rear bumper - Scratch(es) - Paint |

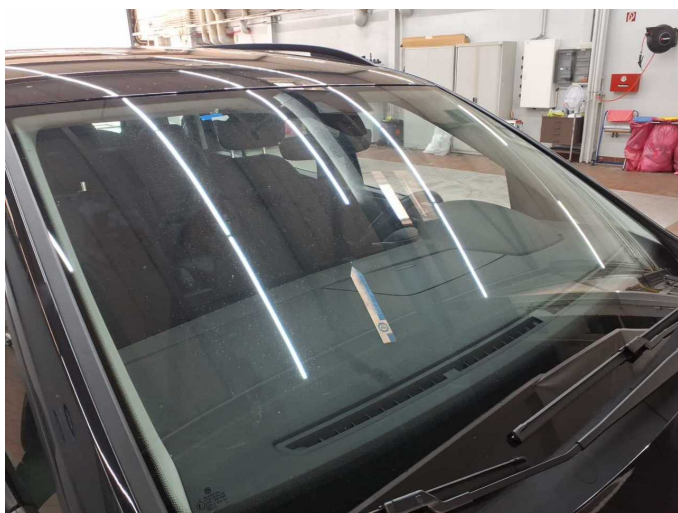
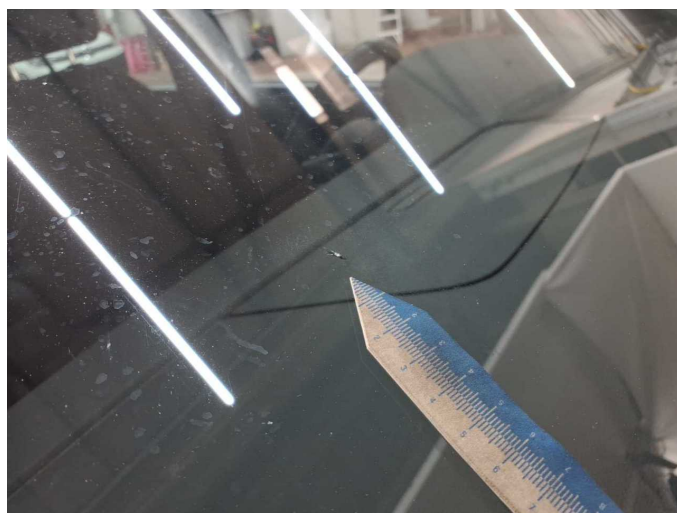
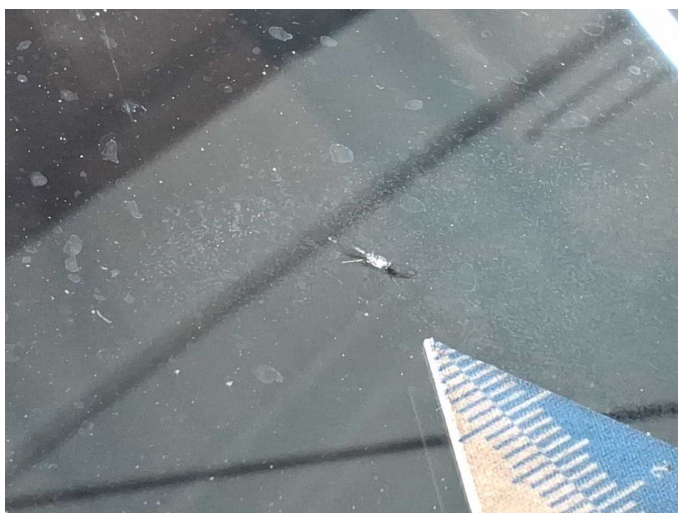
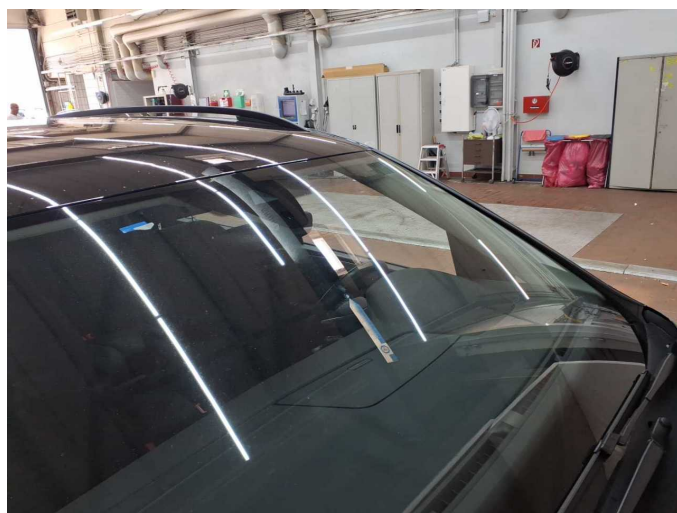
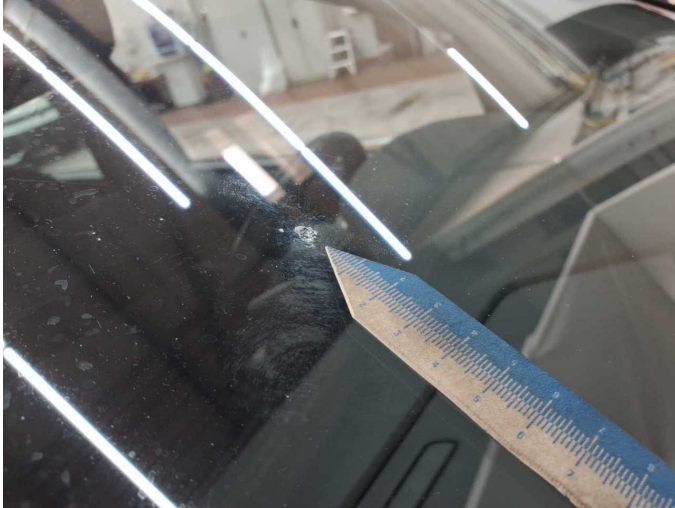
**Damage 9:** Vehicle glazing: Windscreen - Stone chips - Replace

| No. | Component group | Description |
|---|---|---|
| 9 | Vehicle glazing | Windscreen - Stone chips - Replace |
