Expertise

Protocol number: 46298936  
Order No. / Reference: 26639997  
Inspection date: 1 Jul 2026

Manufacturer: Ford

Model: Focus Turnier 2.0 EcoBlue Start-Stopp-System  
COOL&CONNECT

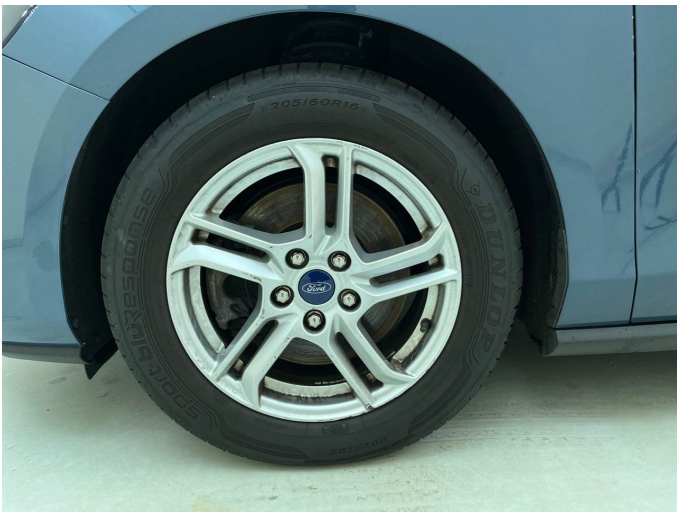
Figure 12: Mounted tyres

| # | Tyre size | Type of tyre | Manufacturer | Tread depth |
|---|---|---|---|---|
| 1) | 205/60 R16 92V | Summer tyres on Light alloy | Goodyear | 5mm / 5mm |
| 2) | 205/60 R16 92V | Summer tyres on Light alloy | Goodyear | 4mm / 4mm |

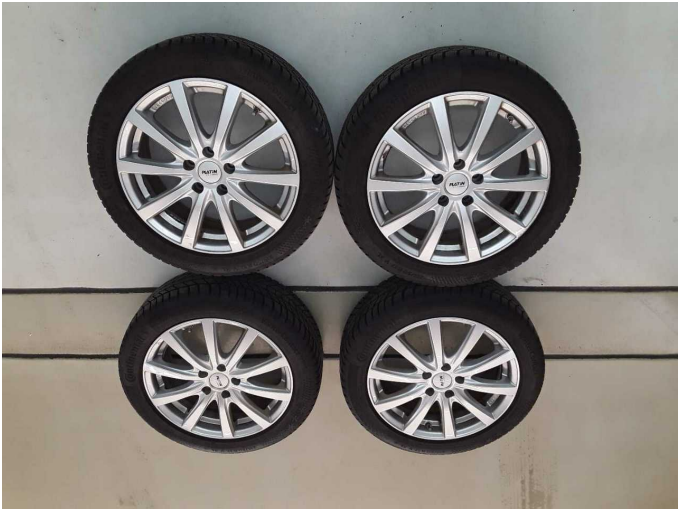
Figure 16: Additional tyres

| # | Tyre size | Type of tyre | Manufacturer | Tread depth |
|---|---|---|---|---|
| 1) | 215/50 R17 95V | Winter tyres on Light alloy | Continental | 6mm / 6mm |
| 2) | 215/50 R17 95V | Winter tyres on Light alloy | Continental | 7mm / 6mm |

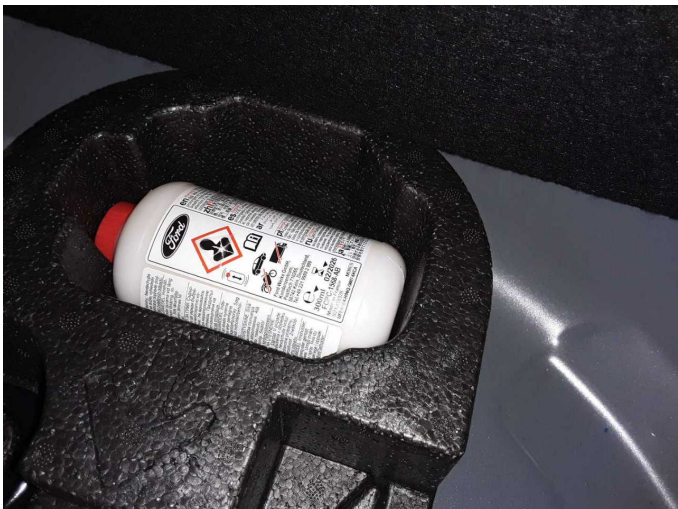
| No. | Component group | Description |
|---|---|---|
| 1 | Equipment | Tirefit filler - Due - Replace |

Damage 1: Equipment: Tirefit filler - Due - Replace

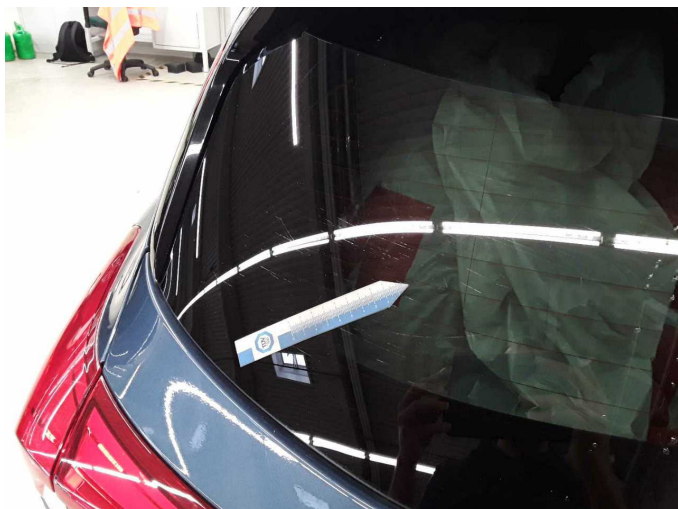
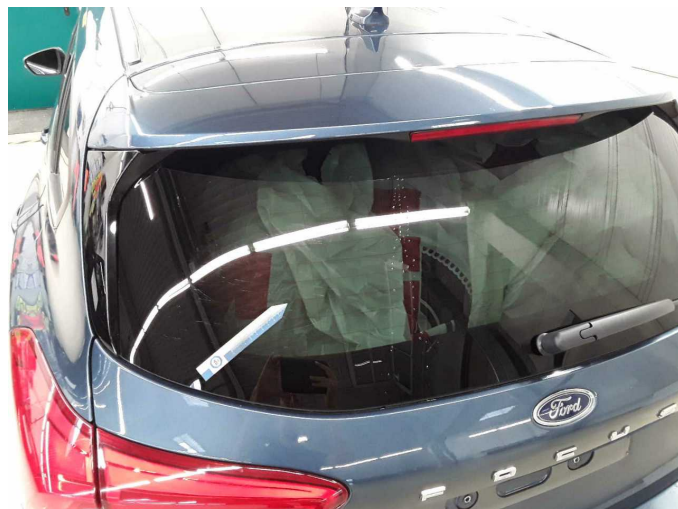
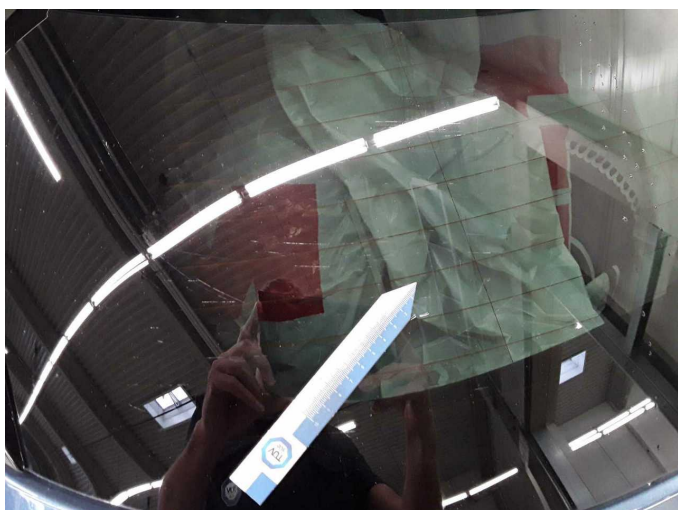
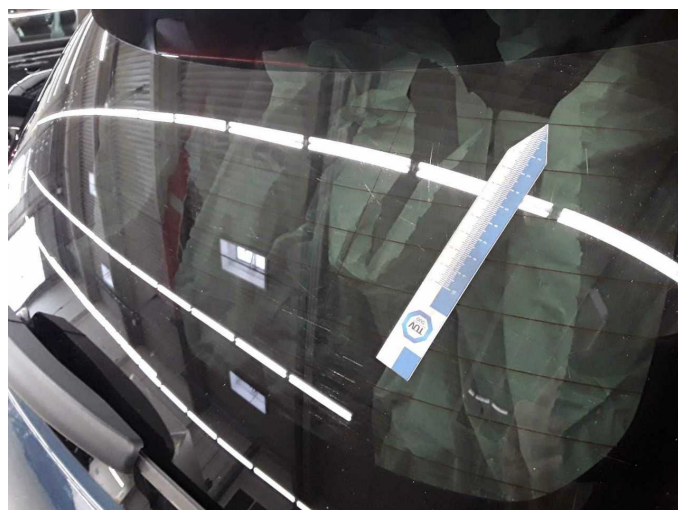
| No. | Component group | Description |
|---|---|---|
| 2 | Vehicle glazing | Rear window - Scratched - Loss in value |

**Damage 2:** Vehicle glazing: Rear window - Scratched - Loss in value

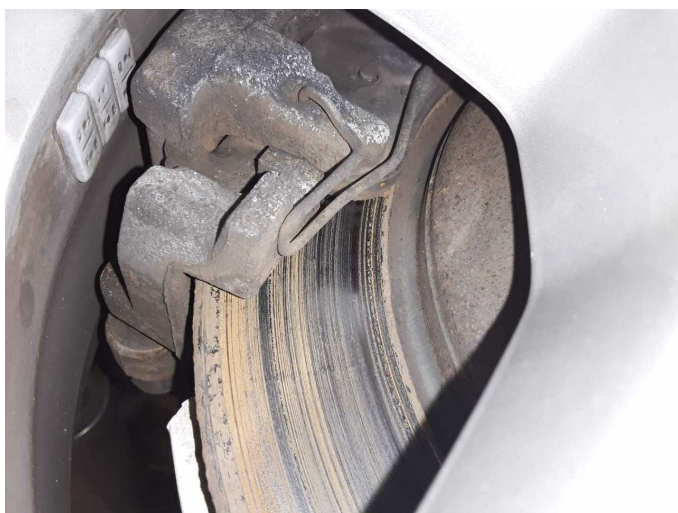
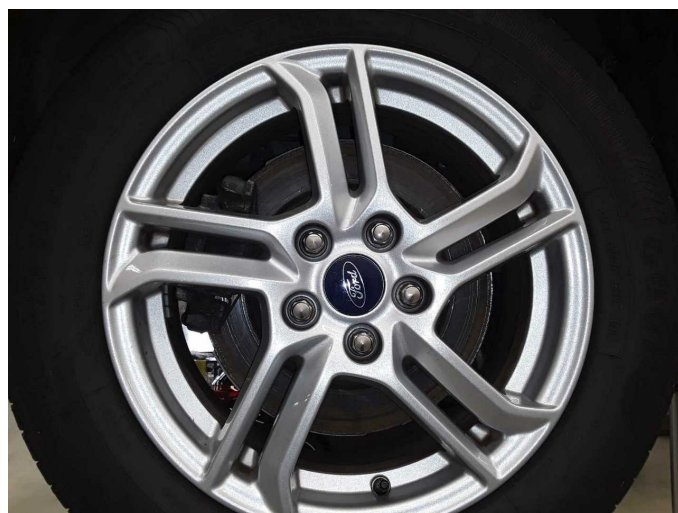
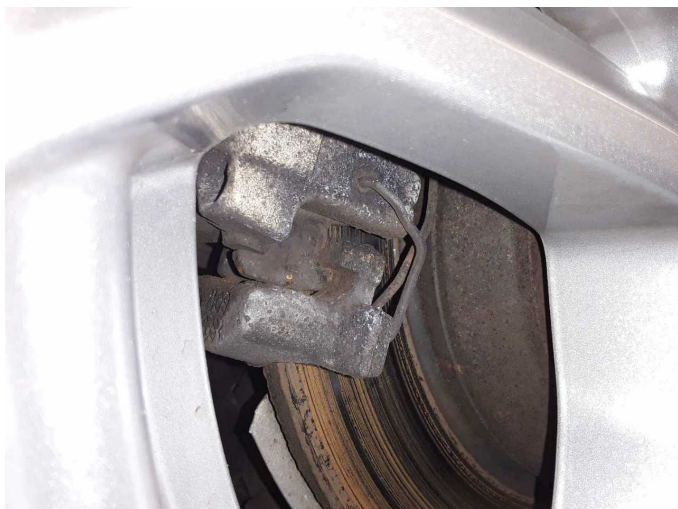
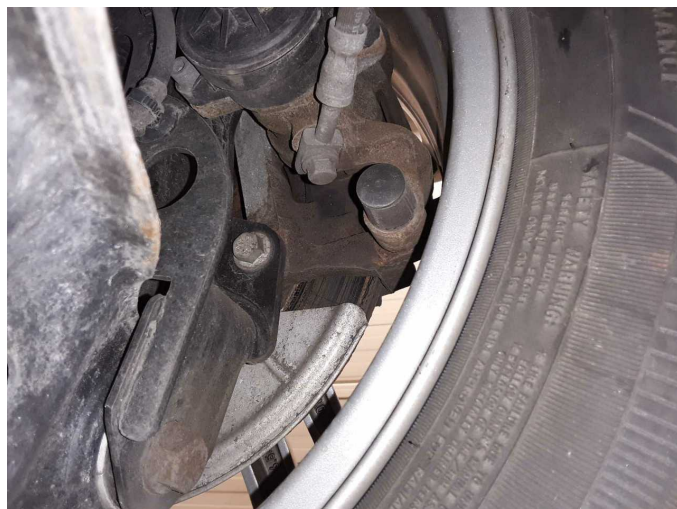
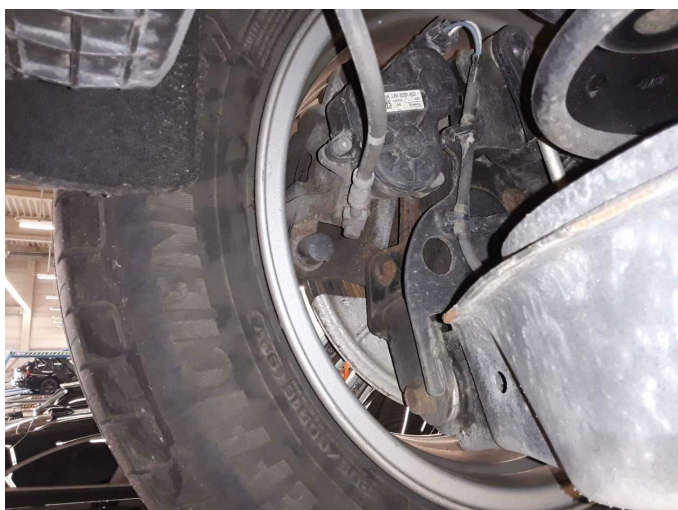
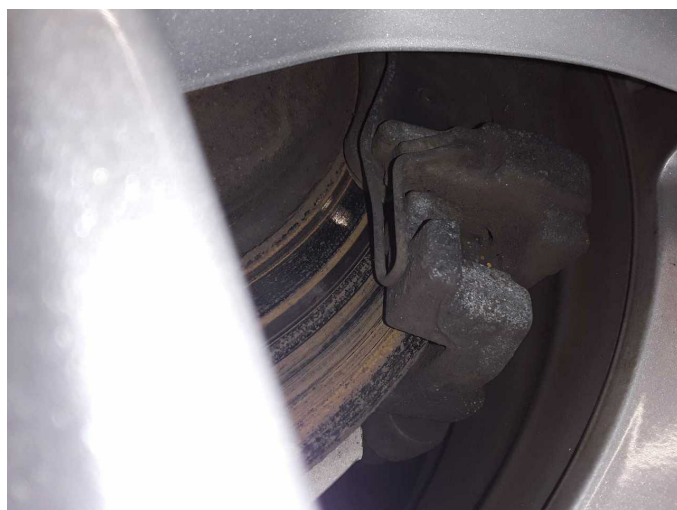
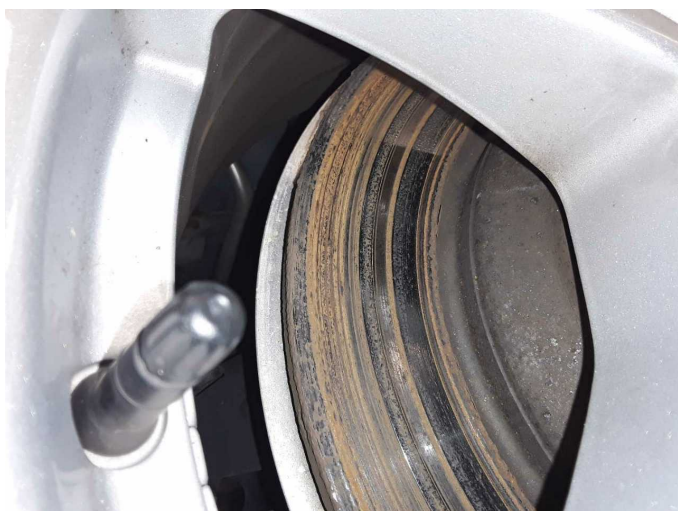
| No. | Component group | Description |
|---|---|---|
| 3 | Braking system | Brake discs and pads - rear - Worn - Replace |

**Damage 3:** Braking system: Brake discs and pads - rear - Worn - Replace

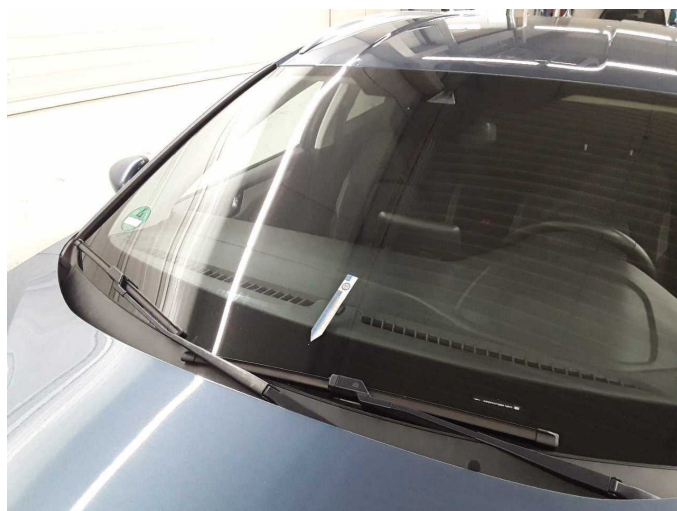
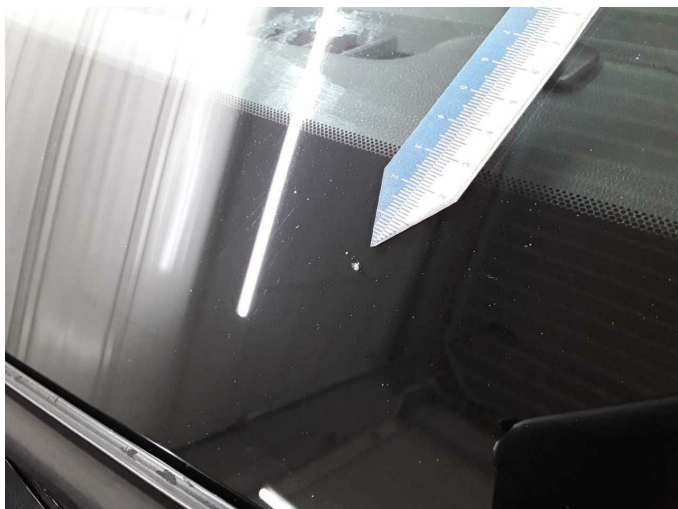
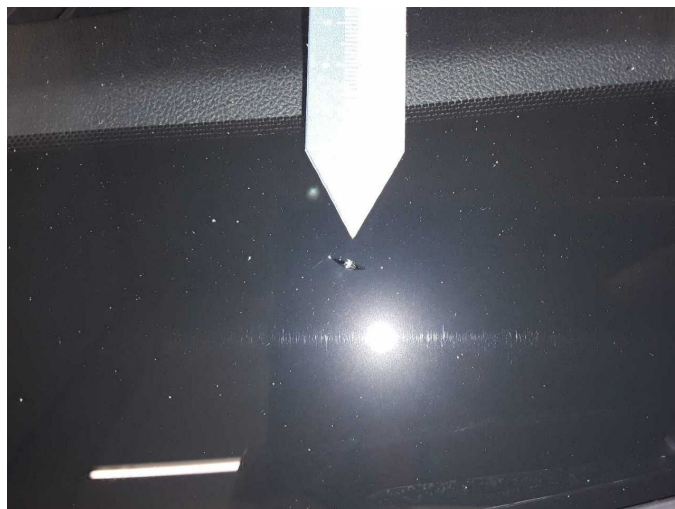
| No. | Component group | Description |
|---|---|---|
| 4 | Vehicle glazing | Windscreen - Stone chips - Replace |

**Damage 4:** Vehicle glazing: Windscreen - Stone chips - Replace

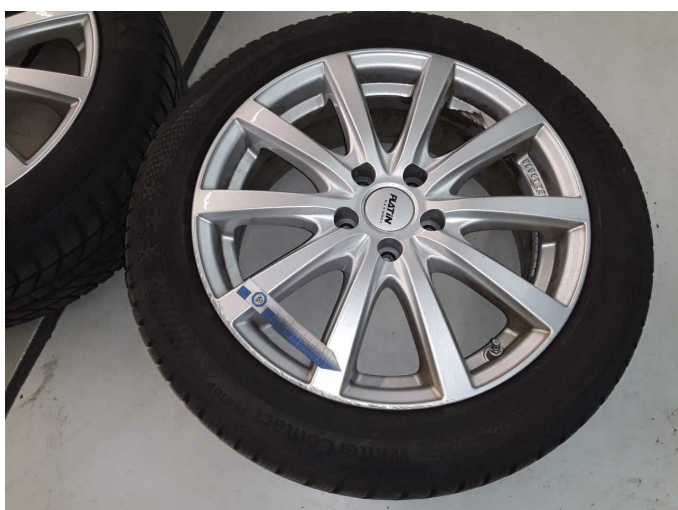
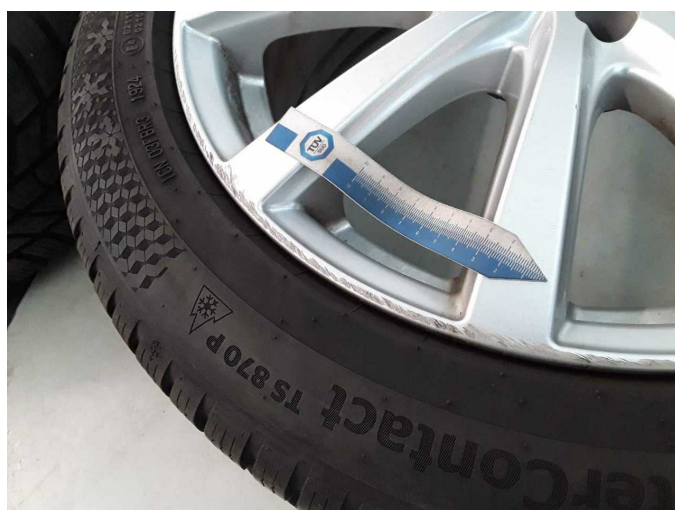
| No. | Component group | Description |
|---|---|---|
| 1 | 2nd wheel set | 1 alloy rim - Scratched - No deduction |

**Wear and tear 1:** 2nd wheel set: 1 alloy rim - Scratched - No deduction

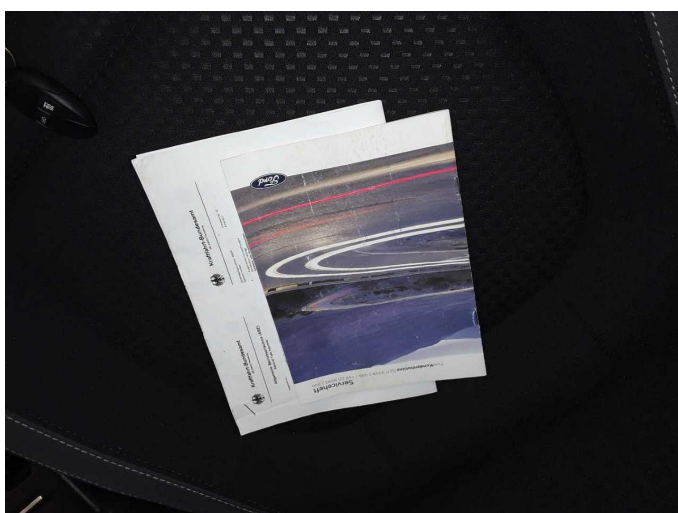
Documents - Owner's manual

**Missing part 1:** Documents: Owner's manual - Missing - Replace

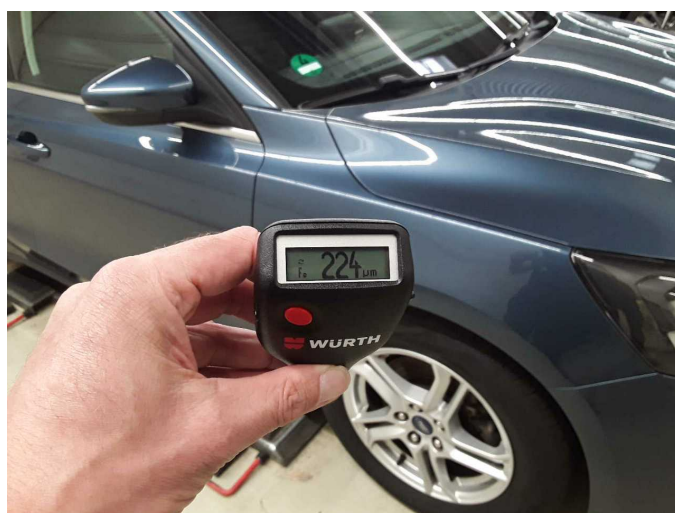
| 1 | Mudguard - right side, Professionally carried out, Invoice of repair done Non-existent |

| Mudguard - right side | 224 µm |

**Mudguard - right side:** 224 µm
