Expertise

Protocol number: 46920934  
Order No. / Reference: 26765664  
Inspection date: 6 Aug 2026

Manufacturer: Volkswagen

Model: Polo 1.0 TSI DSG OPF Highline

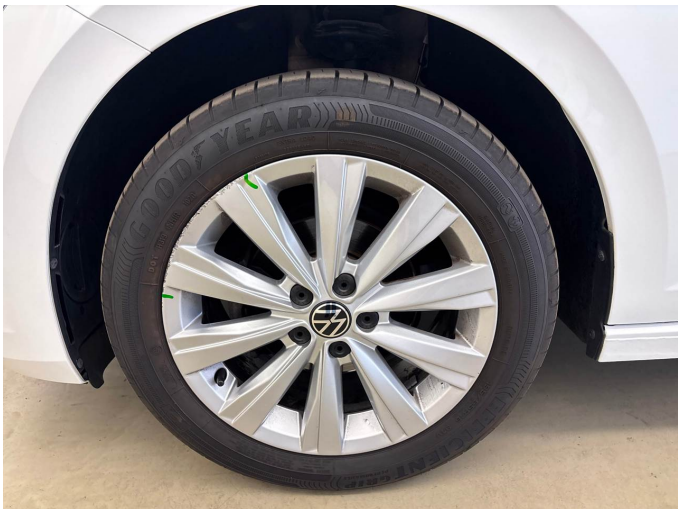
Figure 12: Mounted tyres

| # | Tyre size | Type of tyre | Manufacturer | Tread depth |
|---|---|---|---|---|
| 1) | 195/55 R16 91V | Summer tyres on Light alloy | Goodyear | 5mm / 5mm |
| 2) | 195/55 R16 91V | Summer tyres on Light alloy | Goodyear | 5mm / 5mm |

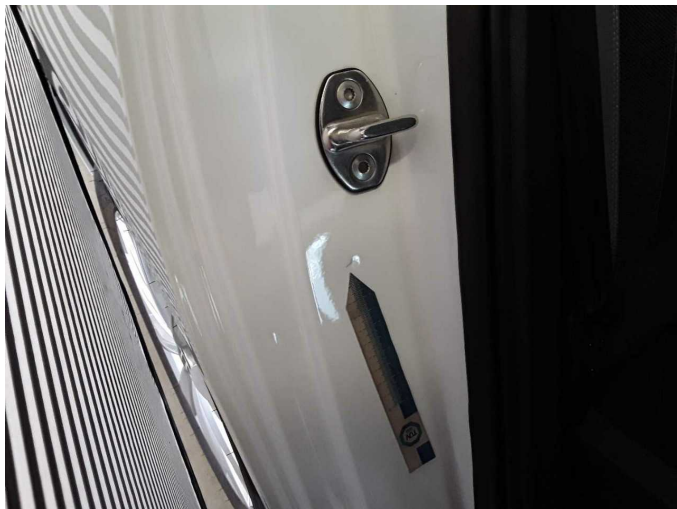
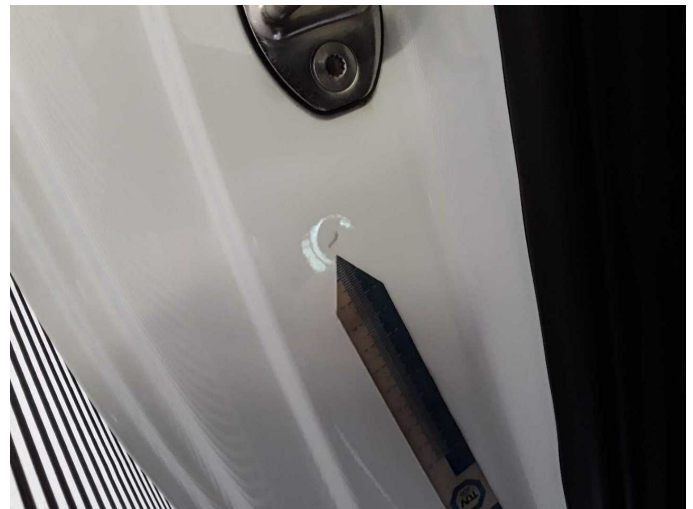
| No. | Component group | Description |
|---|---|---|
| 2 | Side panel - rear right side | Sill - Dent / paintcoat damage - Smart repair |

**Damage 2:** Side panel - rear right side: Sill - Dent / paintcoat damage - Smart repair

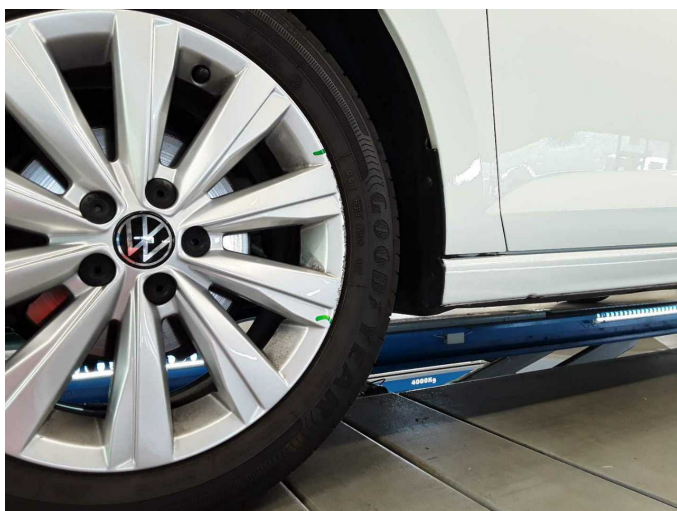
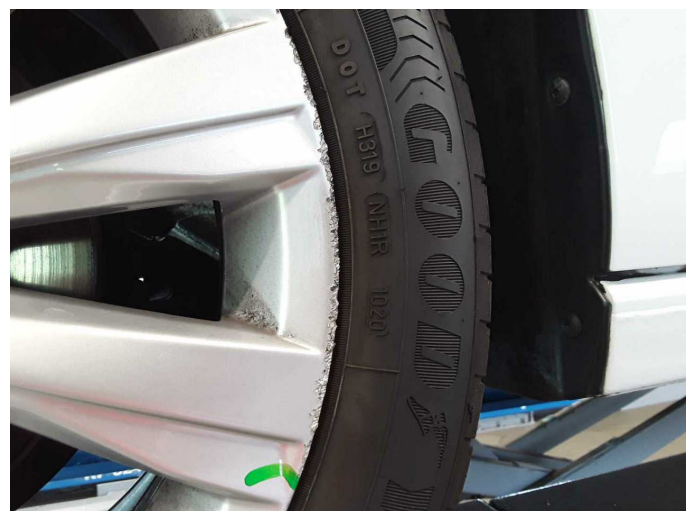
| No. | Component group | Description |
|---|---|---|
| 3 | Wheel / tyres | Alloy rim - front left side - Scratched - Replace |

**Damage 3:** Wheel / tyres: Alloy rim - front left side - Scratched - Replace

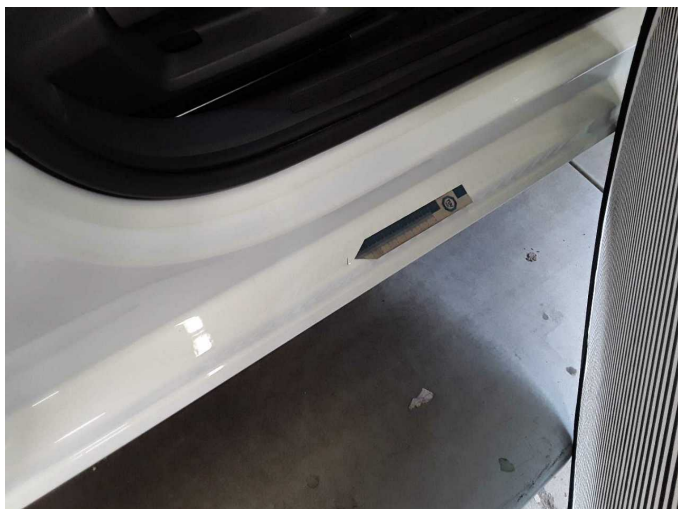
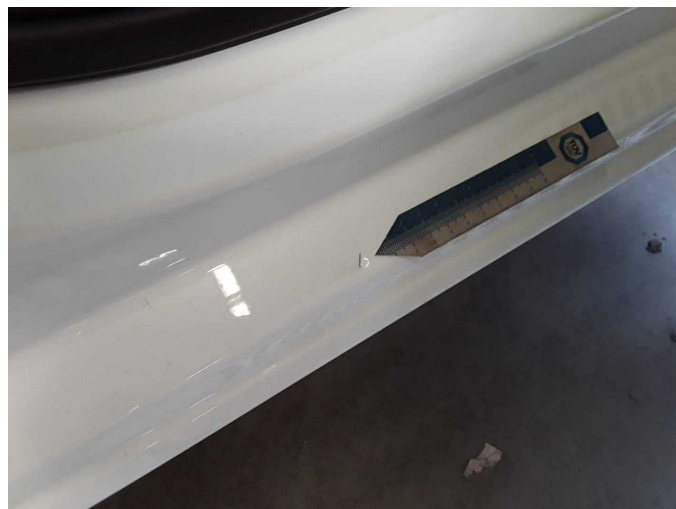
| No. | Component group | Description |
|---|---|---|
| 4 | Sill - right side | Sill - Dent / paintcoat damage - Repair and paint |

**Damage 4:** Sill - right side: Sill - Dent / paintcoat damage - Repair and paint

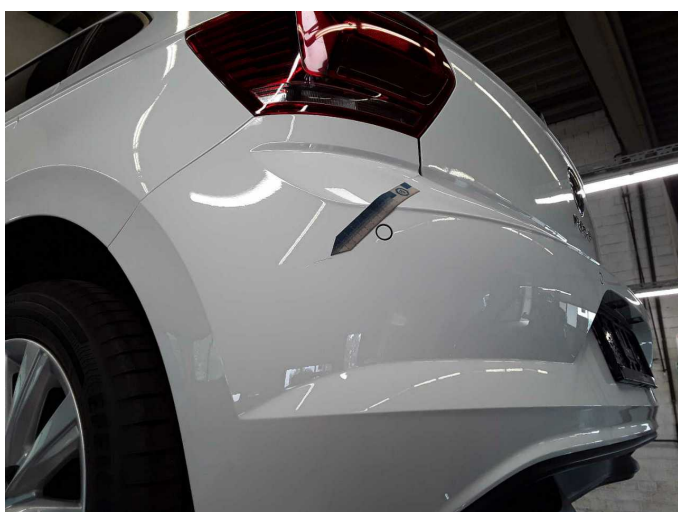
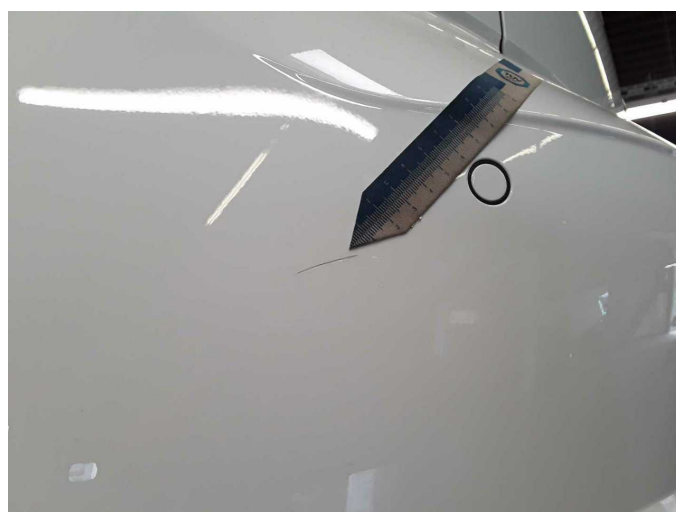
| No. | Component group | Description |
|---|---|---|
| 5 | Rear bumper | Rear bumper - Scratched - Paint |

**Damage 5:** Rear bumper: Rear bumper - Scratched - Paint

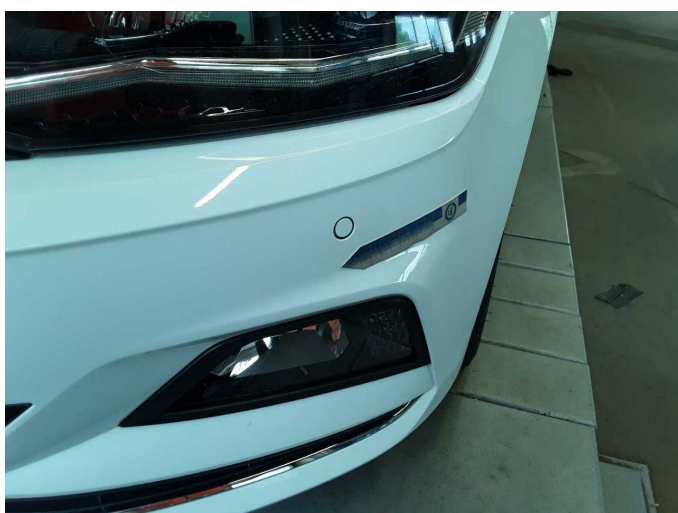
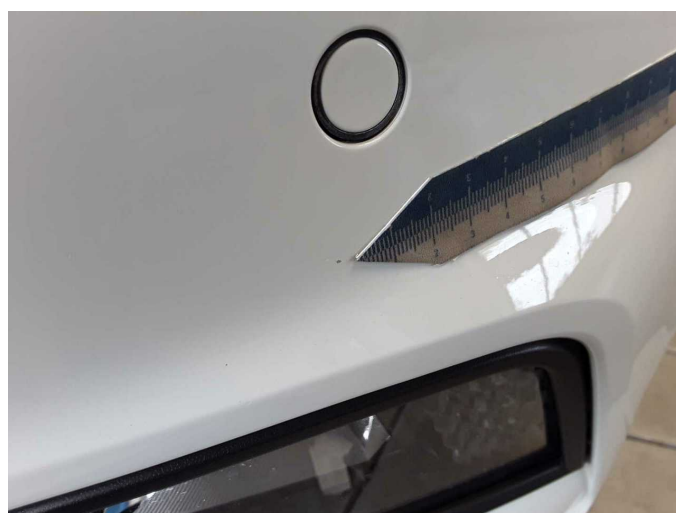
| No. | Component group | Description |
|---|---|---|
| 1 | Front bumper | Front bumper - Stone chips - No deduction |

**Wear and tear 1:** Front bumper: Front bumper - Stone chips - No deduction

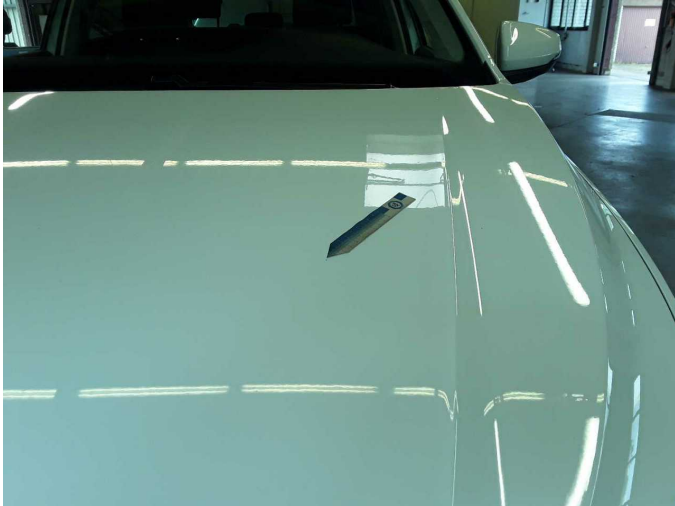
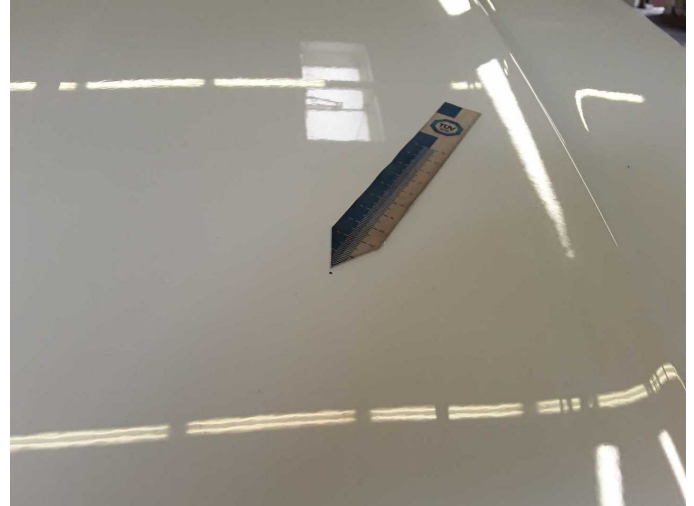
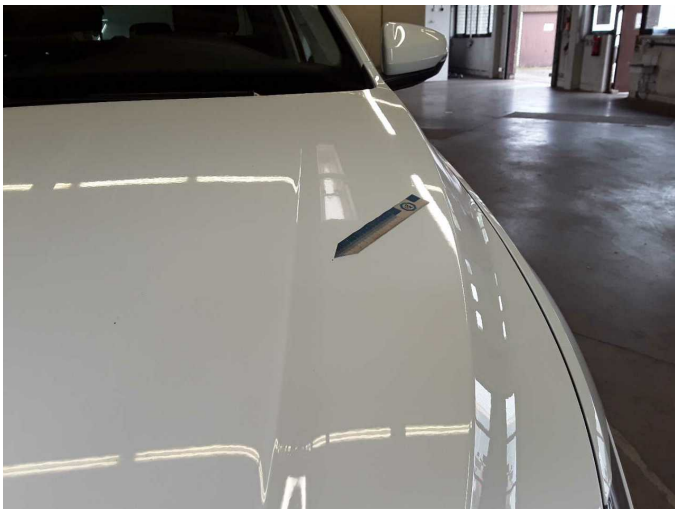
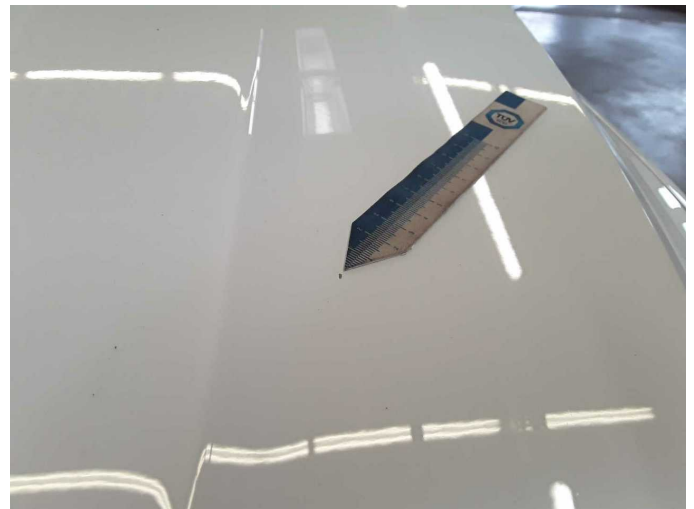
| No. | Component group | Description |
|---|---|---|
| 2 | Bonnet | Bonnet - Stone chips - No deduction |

**Wear and tear 2:** Bonnet: Bonnet - Stone chips - No deduction
