Expertise

Protocol number: 46562792  
Order No. / Reference: 26703390  
Inspection date: 14 Jul 2026

Manufacturer: Opel

Model: Astra 1.5 D Automatik GS Line

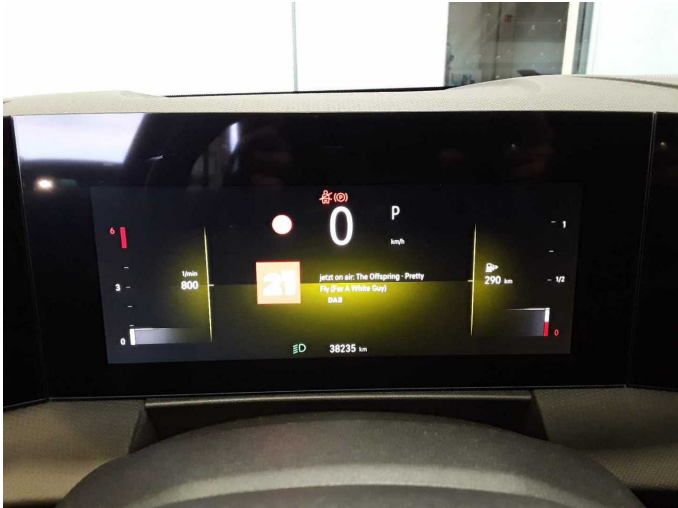
Figure 7: Instrument cluster

Mileage (Read) 38,235 km

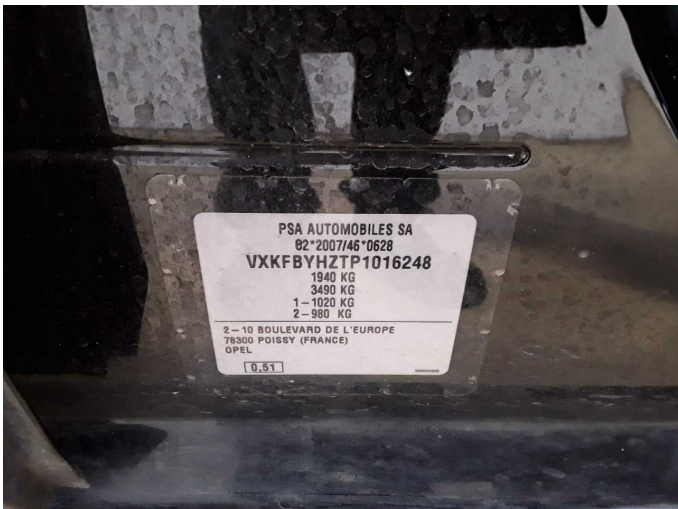
Figure 11: VIN

| VIN comparison | The vehicle identification number (VIN) was read from the vehicle and its conformity with the submitted documents was confirmed by the undersigned during the inspection. |

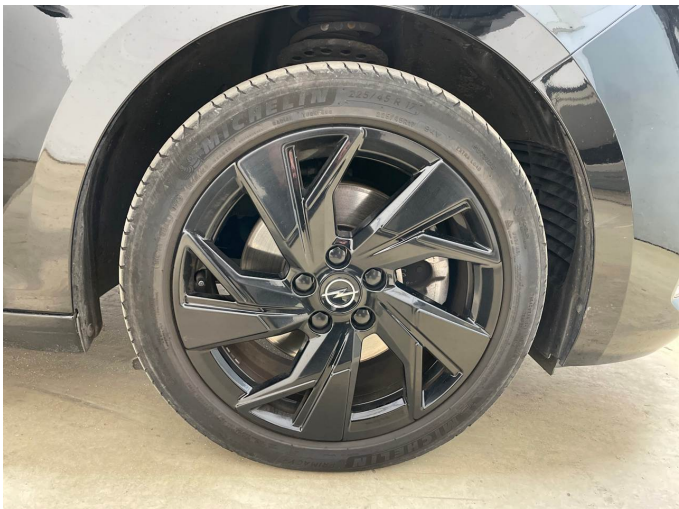
Figure 12: Mounted tyres

| Tyres | | | |
|---|---|---|---|
| 1) | 225/45 R17 94V | Summer tyres on Light alloy | 4mm / 4mm |
| 2) | 225/45 R17 94V | Summer tyres on Light alloy | 5mm / 5mm |

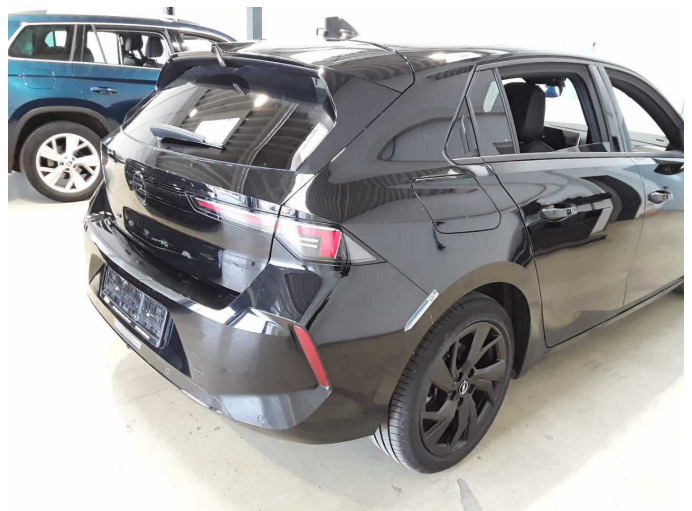
Damage 1: Rear bumper: Rear bumper - Scratched - Smart repair

| No. | Component group | Description |
|---|---|---|
| 1 | Rear bumper | Rear bumper - Scratched - Smart repair |

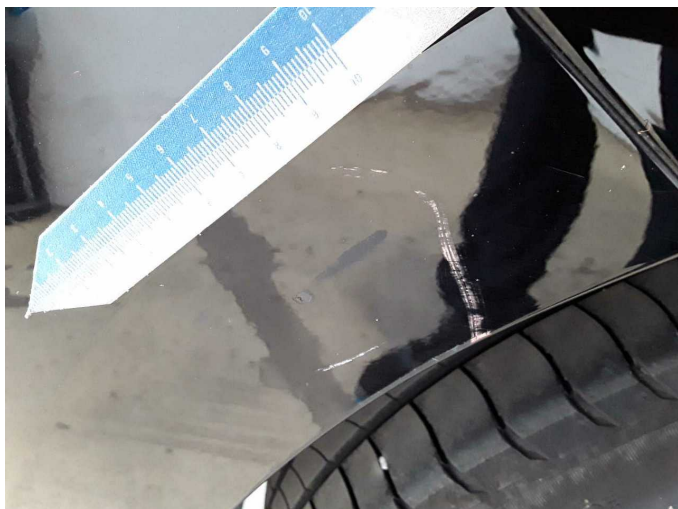
**Damage 1:** Rear bumper: Rear bumper - Scratched - Smart repair

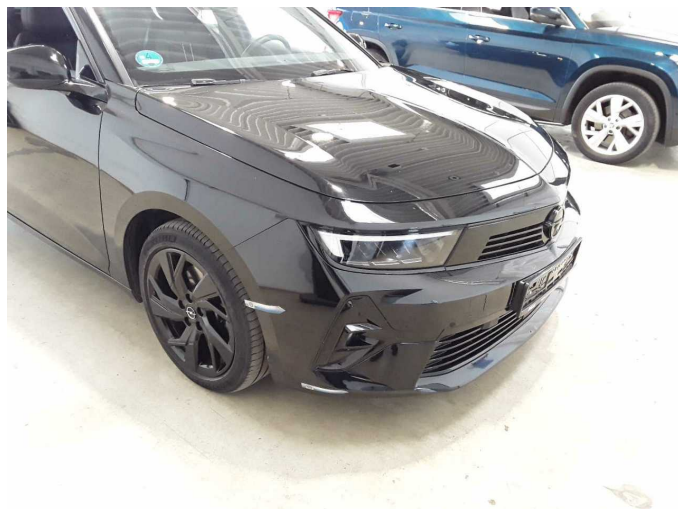
**Damage 2:** Front bumper: Front bumper - Scratch(es) - Paint

| No. | Component group | Description |
|---|---|---|
| 2 | Front bumper | Front bumper - Scratch(es) - Paint |

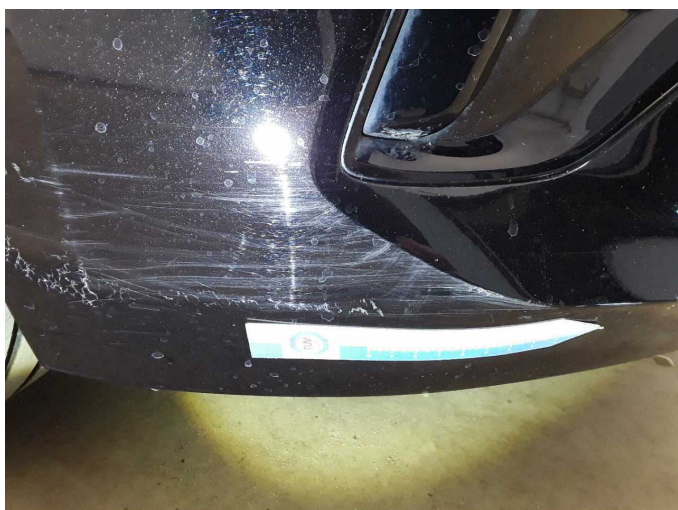
**Damage 2:** Front bumper: Front bumper - Scratch(es) - Paint

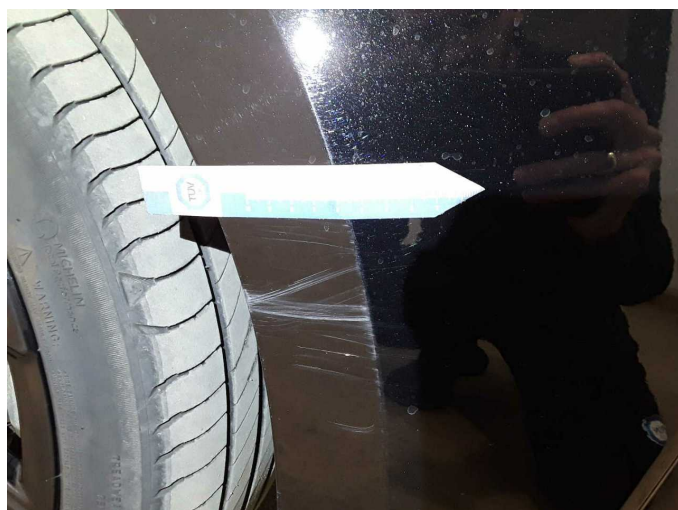
**Damage 2:** Front bumper: Front bumper - Scratch(es) - Paint
