Expertise

Protocol number: 46572781  
Order No. / Reference: 26657642  
Inspection date: 17 Jul 2026

Manufacturer: Skoda  
VIN: TMBLE9NY1PF056599

Model: Enyaq iV 80x

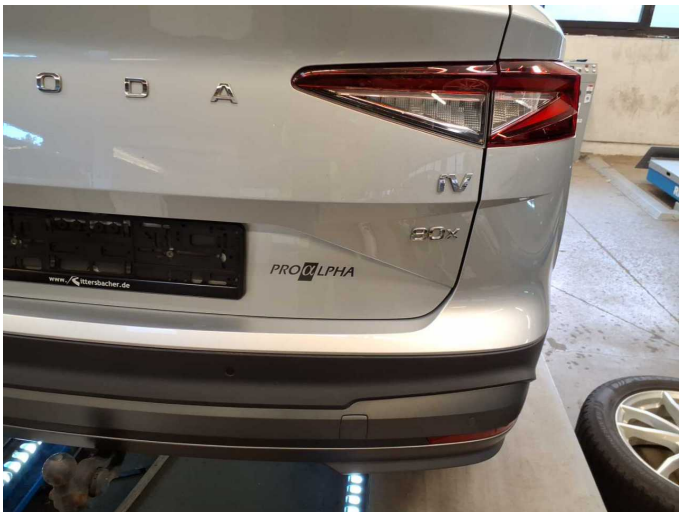
Damage 1: Boot lid / rear door: Boot lid - Glued / labelled - De-glue / neutralise

| No. | Component group | Description |
|---|---|---|
| 1 | Boot lid / rear door | Boot lid - Glued / labelled - De-glue / neutralise |

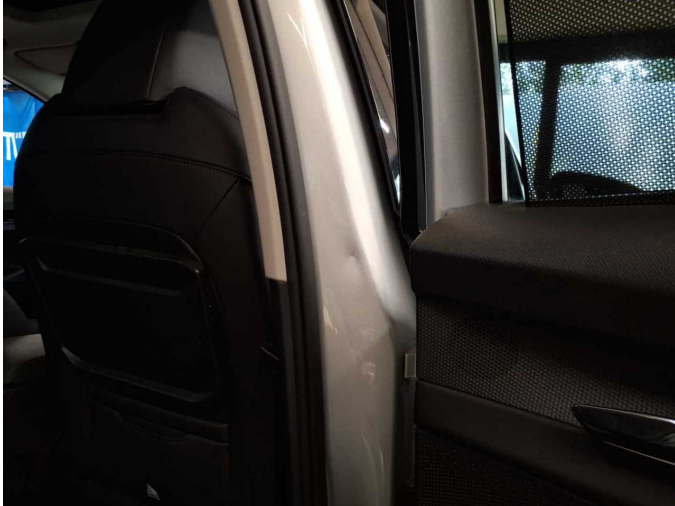
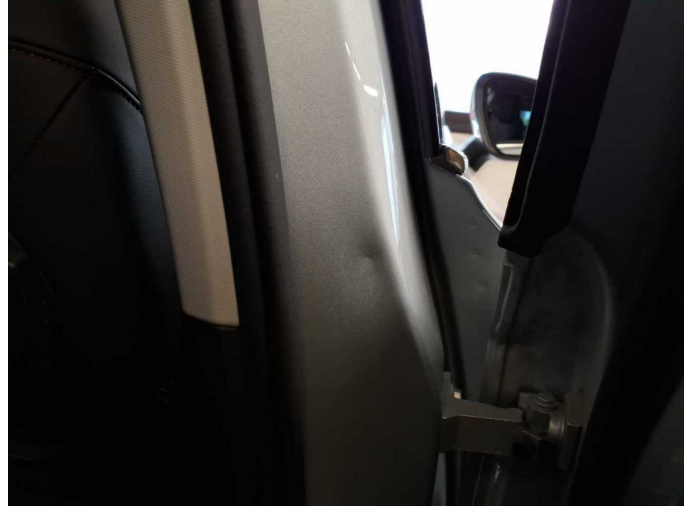
**Damage 2:** Body: B-pillar - right side - dent(s) - Smooth repair work

| No. | Component group | Description |
|---|---|---|
| 2 | Body | B-pillar - right side - dent(s) - Smooth repair work |

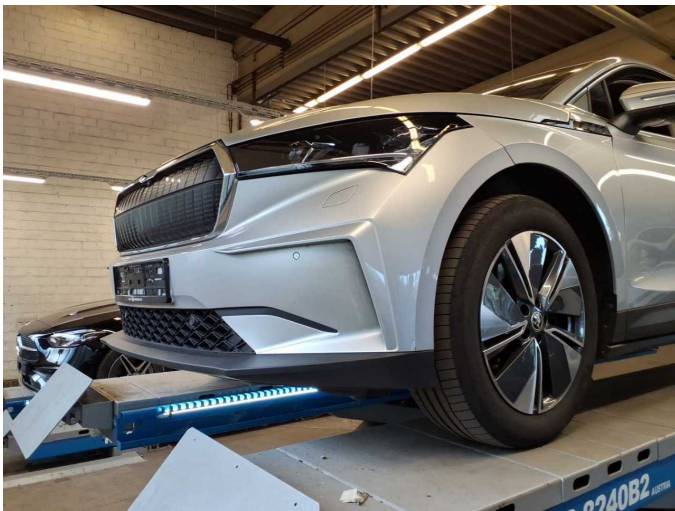
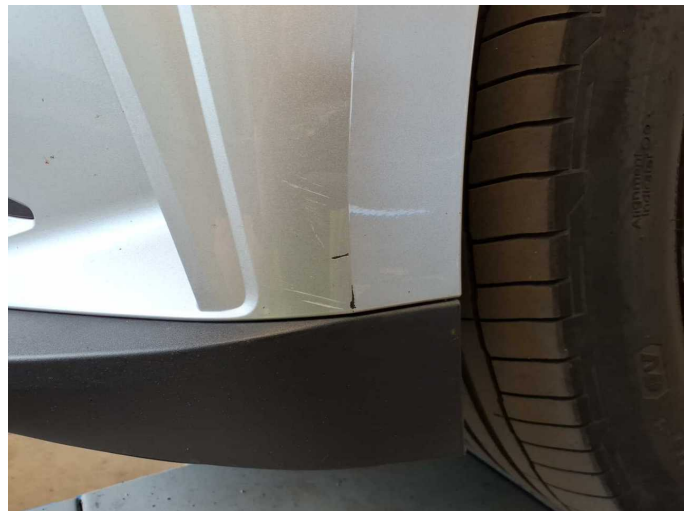
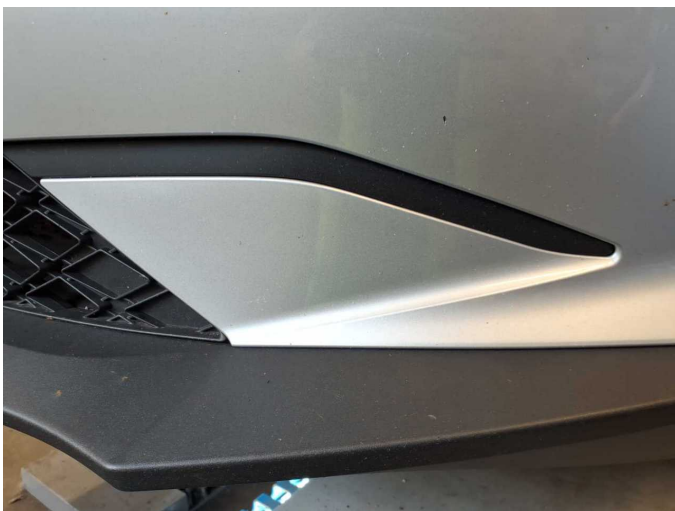
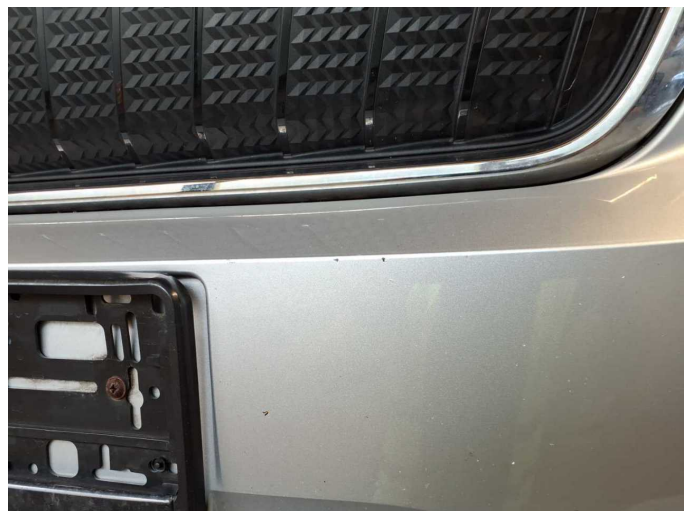
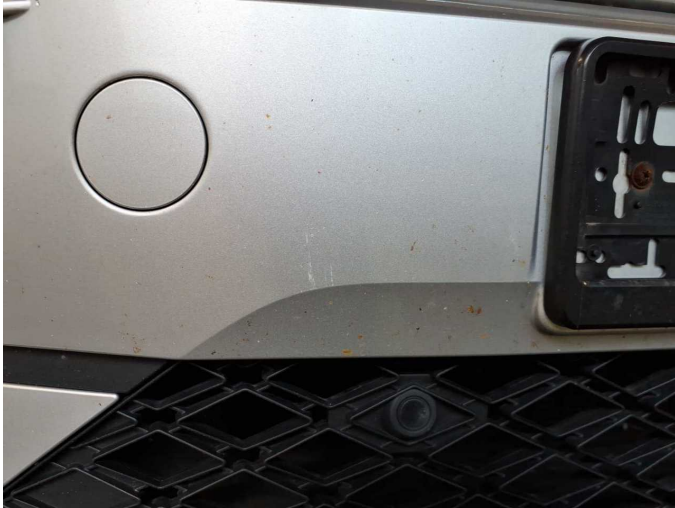
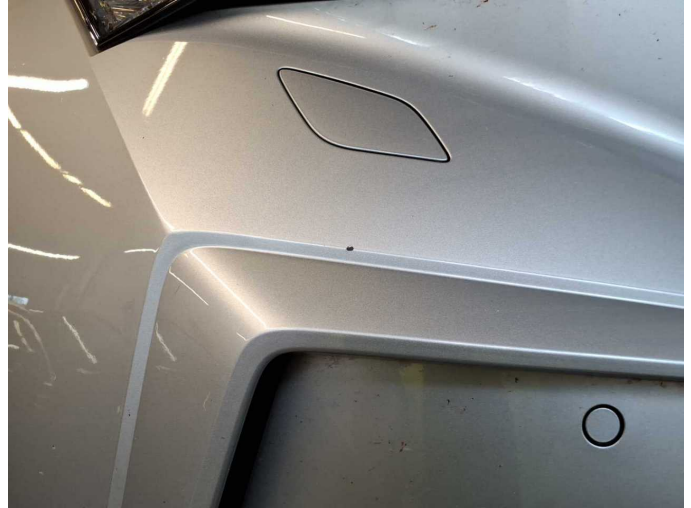
**Damage 4:** Front bumper: Front bumper (+ Kratzer) - Stone chips - Paint

| No. | Component group | Description |
|---|---|---|
| 4 | Front bumper | Front bumper (+ Kratzer) - Stone chips - Paint |

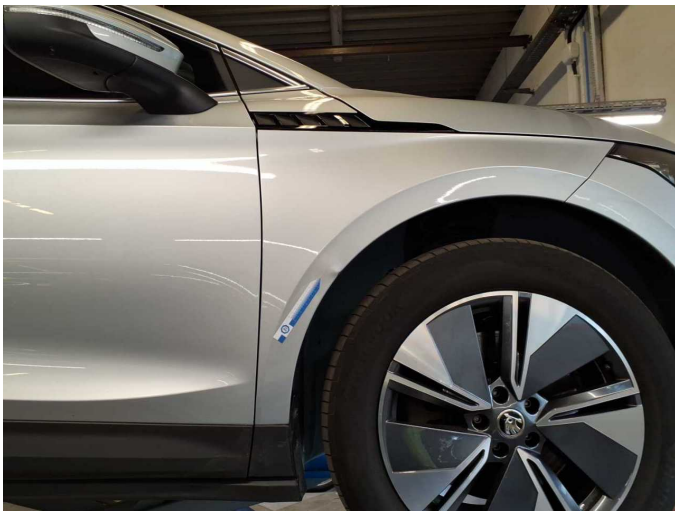
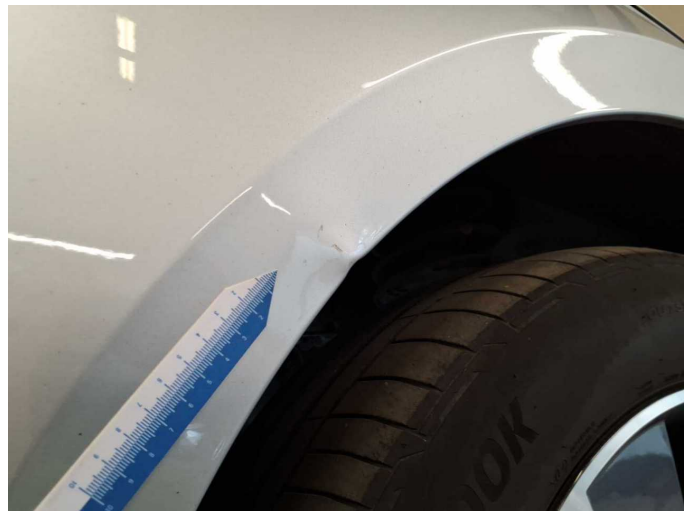
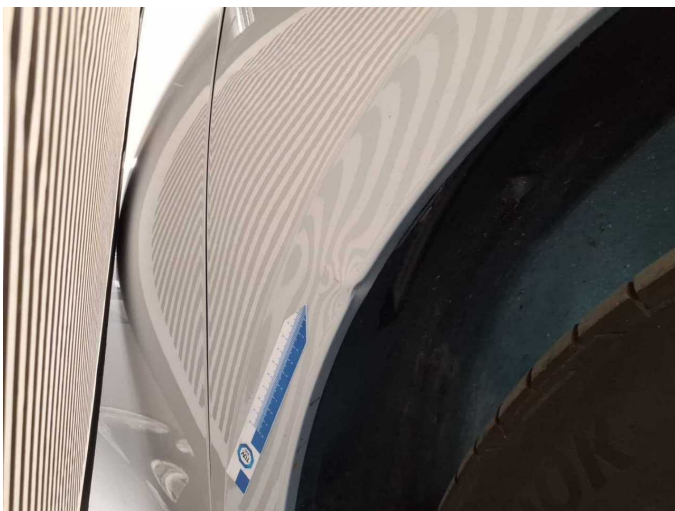
**Damage 5:** Mudguard - right side: Mudguard - right side - Deformed - Repair and paint

| No. | Component group | Description |
|---|---|---|
| 5 | Mudguard - right side | Mudguard - right side - Deformed - Repair and paint |

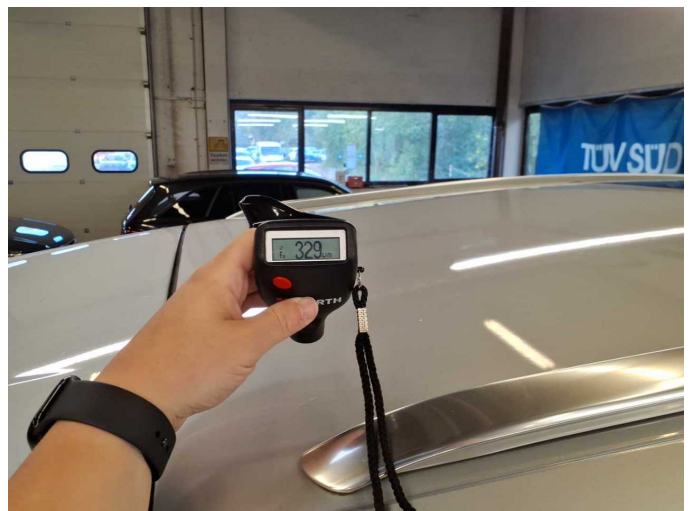
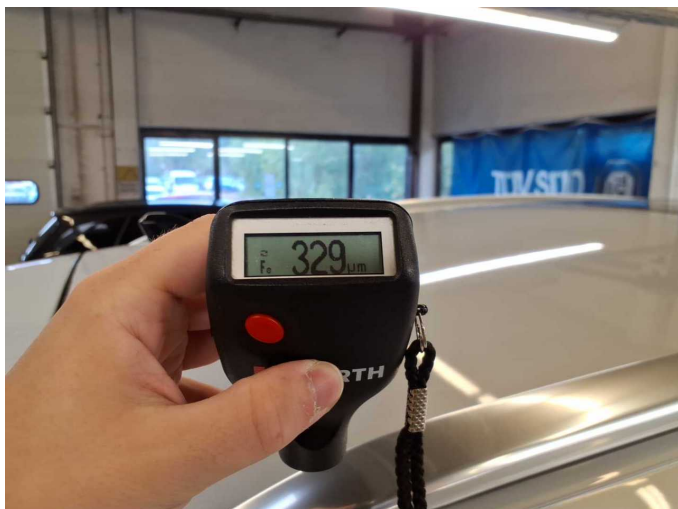
| No. | Repainting |
|---|---|
| 1 | Roof, Professionally carried out, Invoice of repair done Non-existent |

| Roof | 329 µm |

**Repainting 1:** Roof

**Repainting 1: Roof**
