Expertise

Protocol number: 46902160  
Order No. / Reference: 26809510  
Inspection date: 3 Aug 2026

Manufacturer: Mercedes-Benz  
VIN: W1K5M1CB8PN346037

Model: CLA 200 d Shooting Brake AMG Line

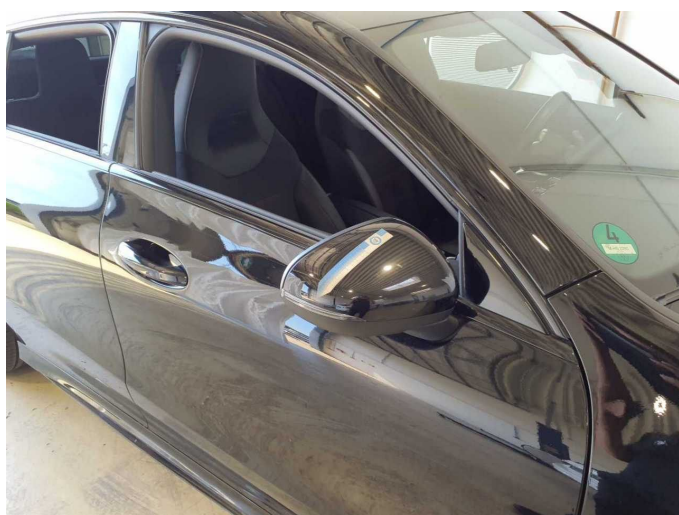
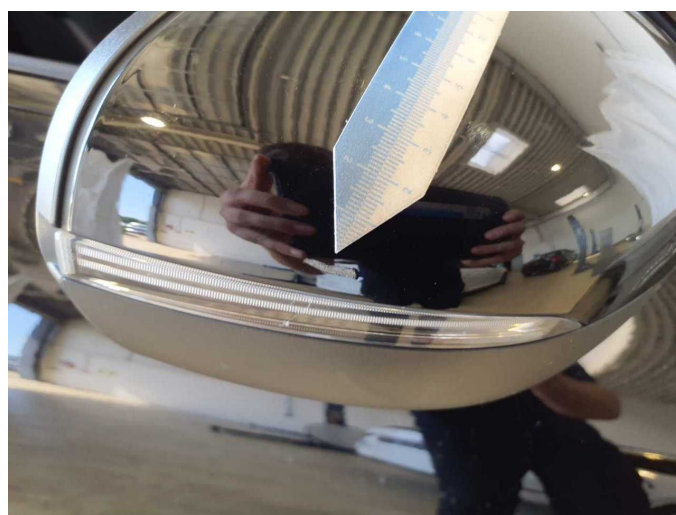
| No. | Component group | Description |
|---|---|---|
| 2 | Wing mirror - right side | Cap - Scratch(es) - Smart repair |

**Damage 2:** Wing mirror - right side: Cap - Scratch(es) - Smart repair

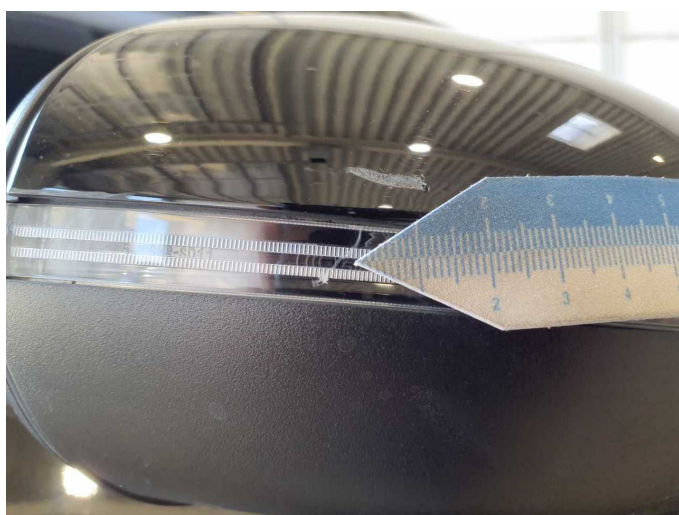
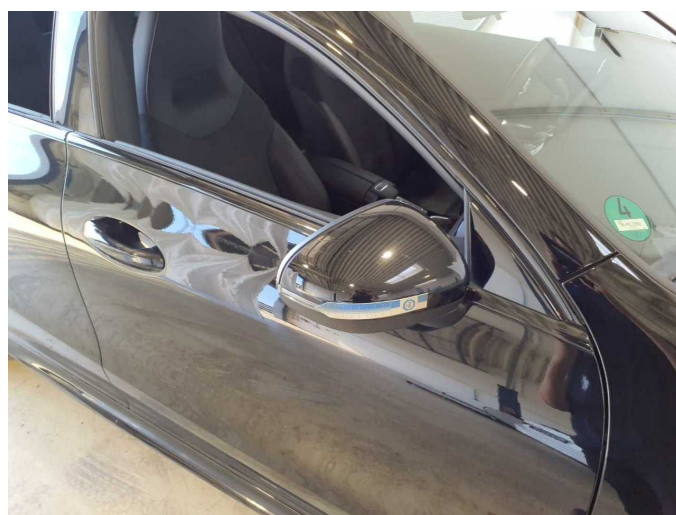
| No. | Component group | Description |
|---|---|---|
| 3 | Indicator - front | Mirror - right side - Scratch(es) - Replace |

**Damage 3:** Indicator - front: Mirror - right side - Scratch(es) - Replace

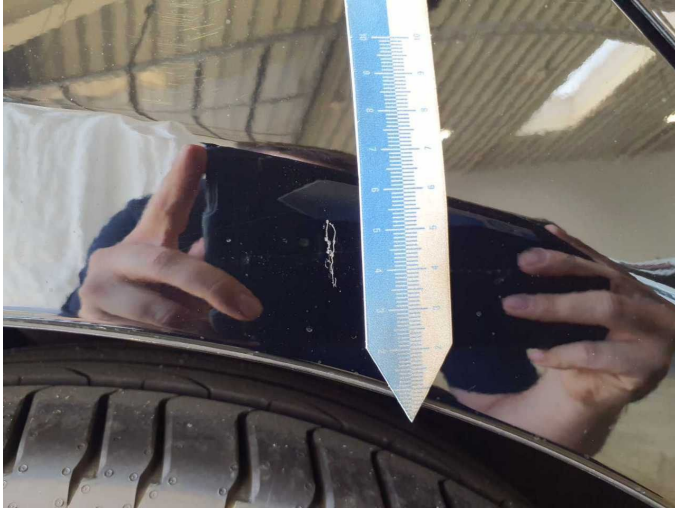
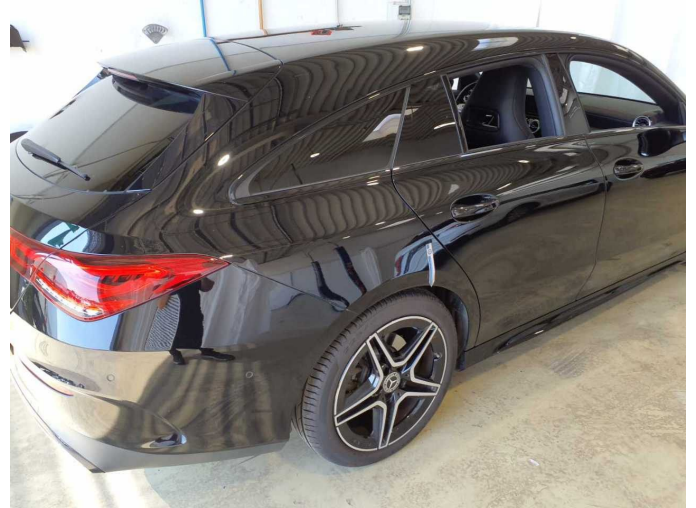
| No. | Component group | Description |
|---|---|---|
| 4 | Side panel - rear right side | Side panel - Scratch(es) - Smart repair |

**Damage 4:** Side panel - rear right side: Side panel - Scratch(es) - Smart repair

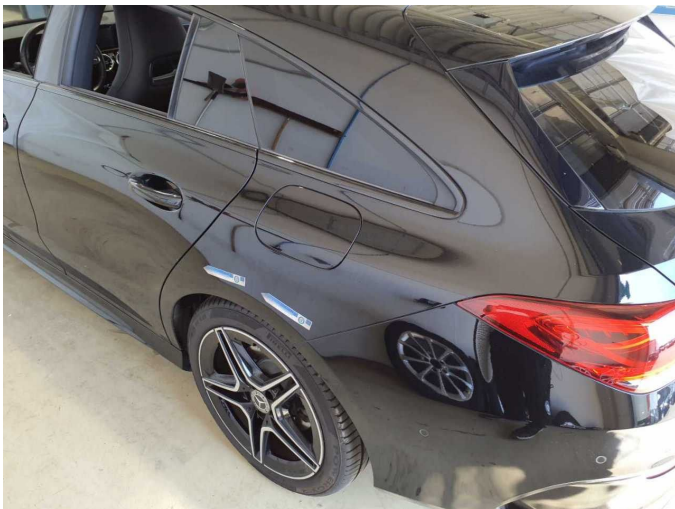
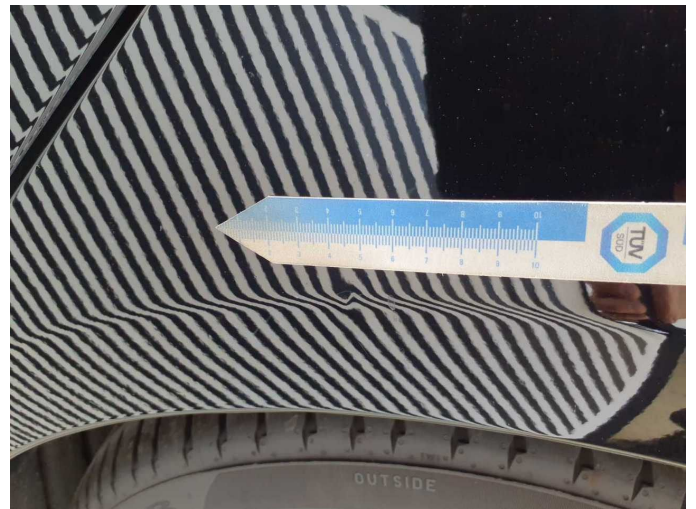
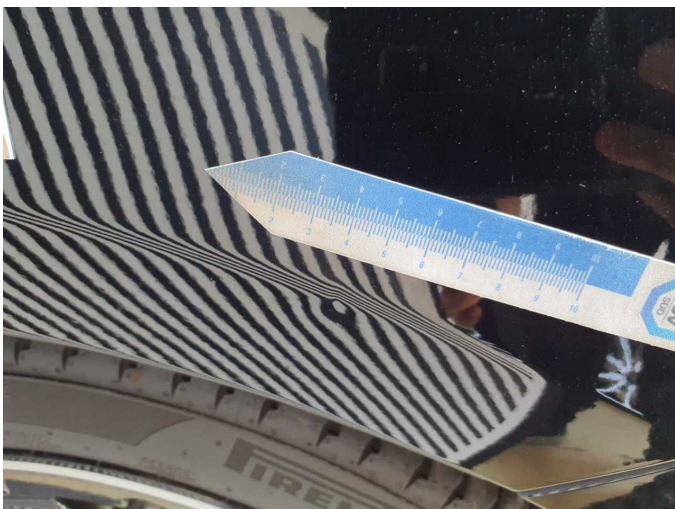
| No. | Component group | Description |
|---|---|---|
| 5 | Side panel - rear left side | Side panel - dent(s) - Smart repair |

**Damage 5:** Side panel - rear left side: Side panel - dent(s) - Smart repair

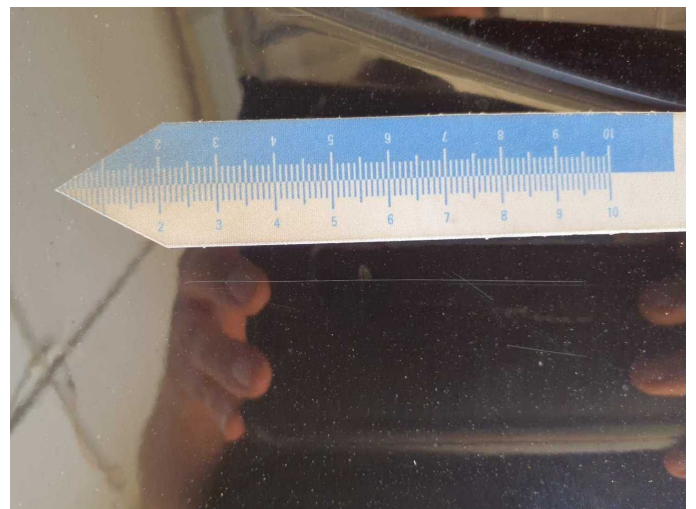
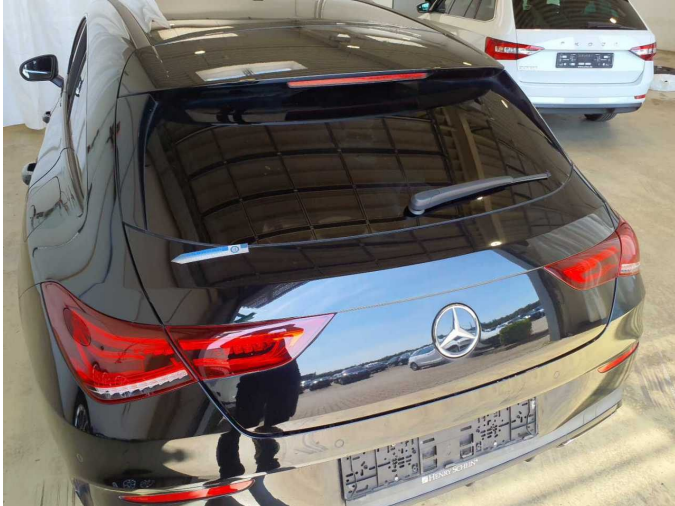
| No. | Component group | Description |
|---|---|---|
| 6 | Boot lid / rear door | Boot lid - Scratch(es) - Smart repair |

**Damage 6:** Boot lid / rear door: Boot lid - Scratch(es) - Smart repair

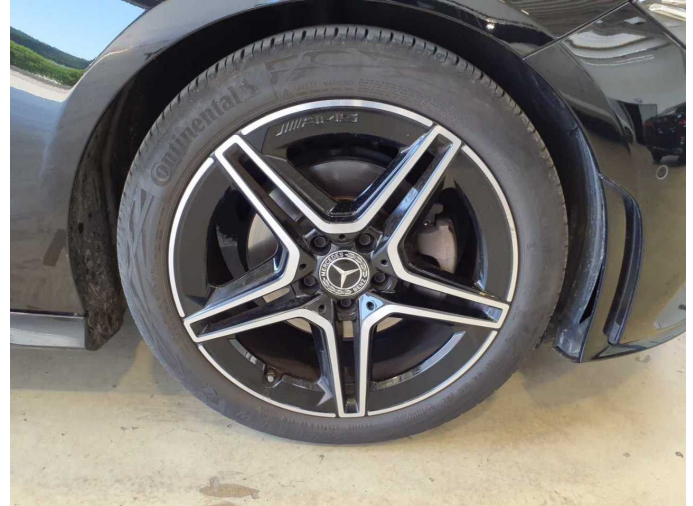
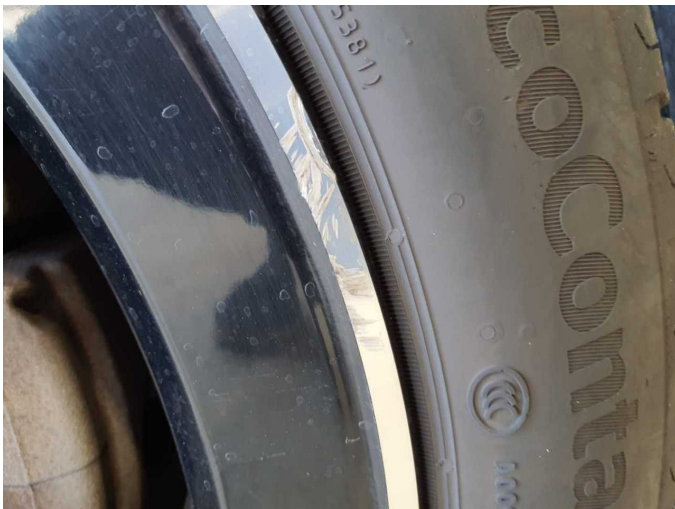
| No. | Component group | Description |
|---|---|---|
| 8 | Wheel / tyres | Alloy rim - front right side - Scratch(es) - Loss in value |

**Damage 8:** Wheel / tyres: Alloy rim - front right side - Scratch(es) - Loss in value

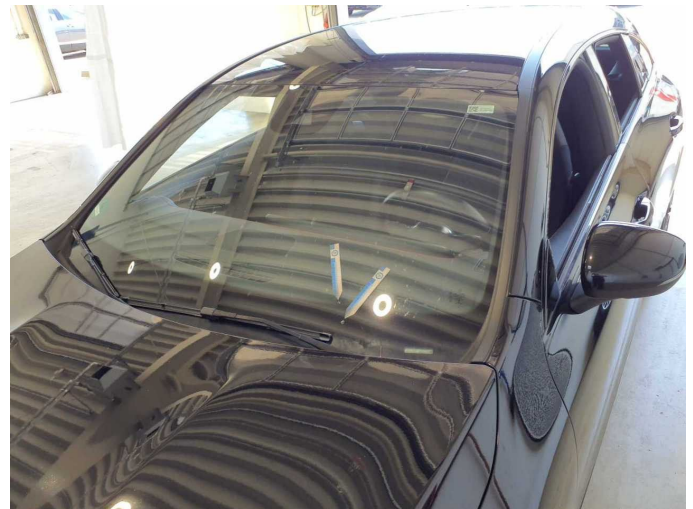
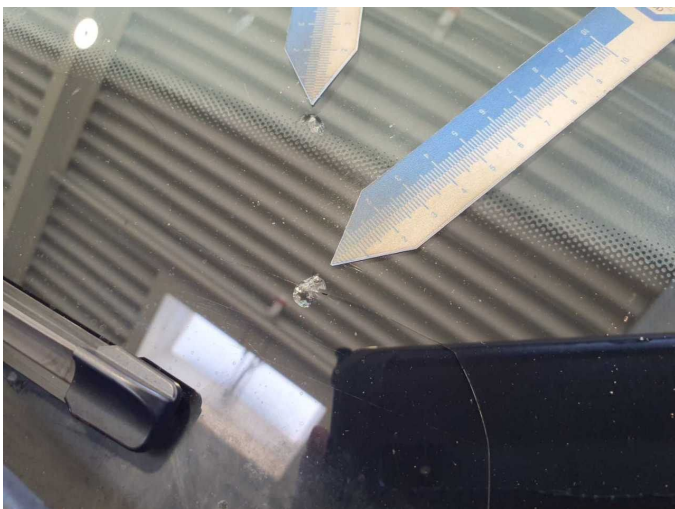
| No. | Component group | Description |
|---|---|---|
| 9 | Vehicle glazing | Windscreen - Broken / torn - Replace |

**Damage 9:** Vehicle glazing: Windscreen - Broken / torn - Replace

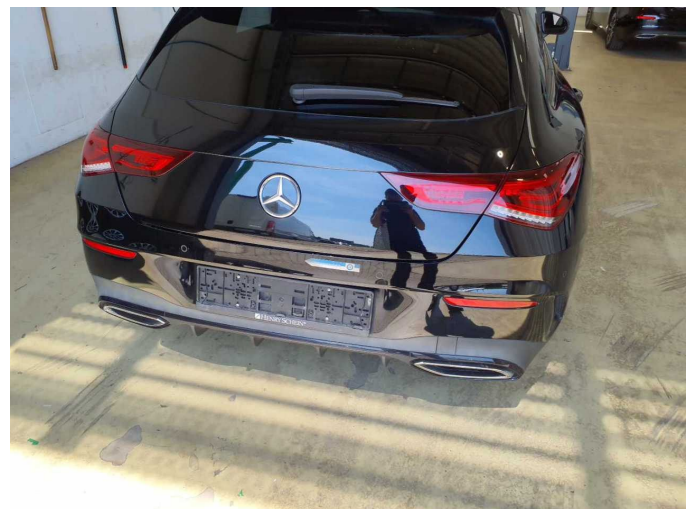
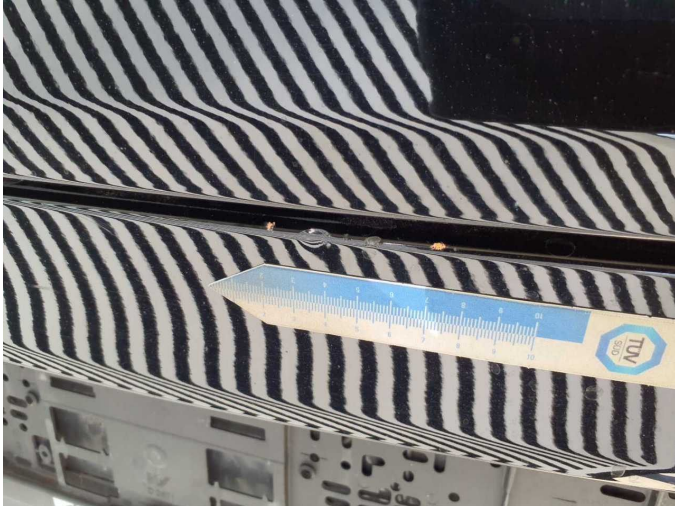
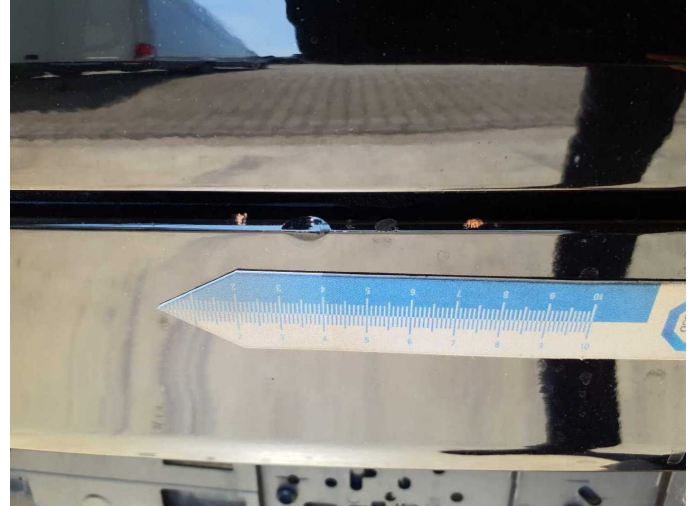
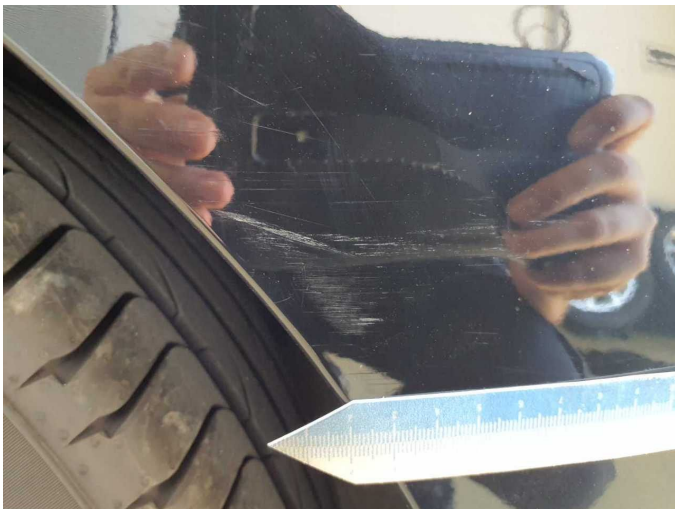
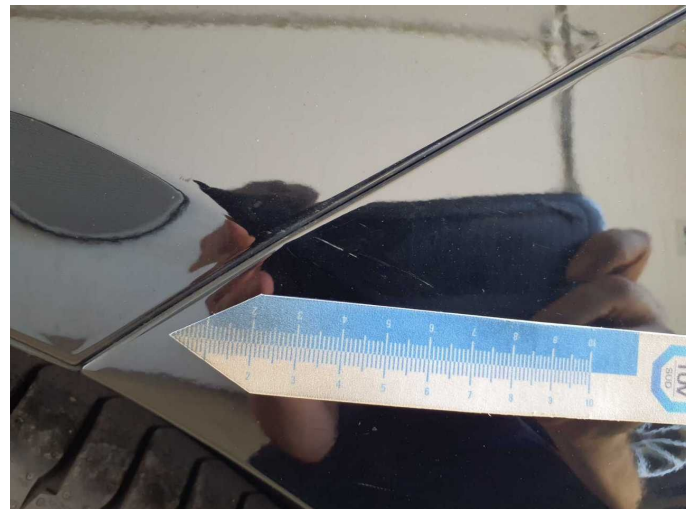
| No. | Component group | Description |
|---|---|---|
| 10 | Rear bumper | Rear bumper - Dent / paintcoat damage - Repair and paint |

**Damage 10:** Rear bumper: Rear bumper - Dent / paintcoat damage - Repair and paint

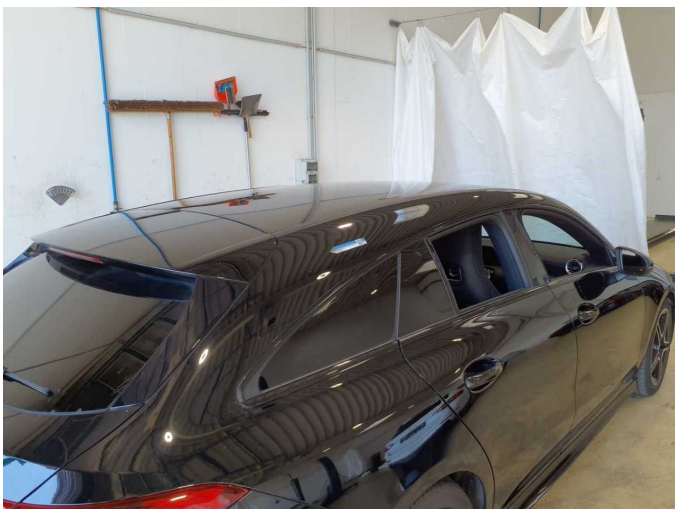
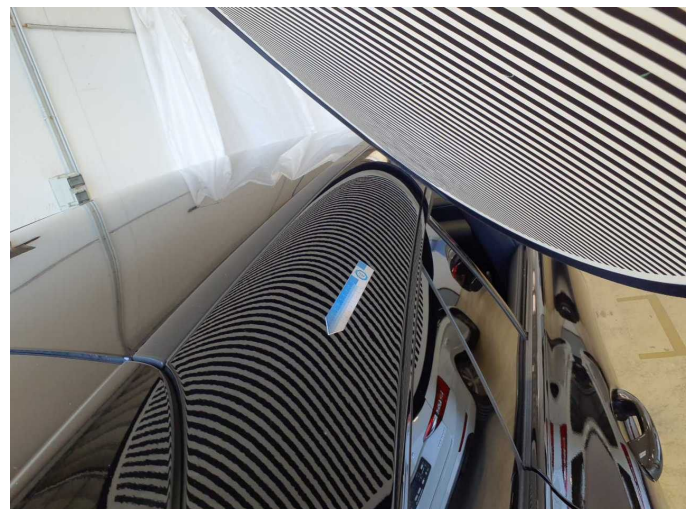
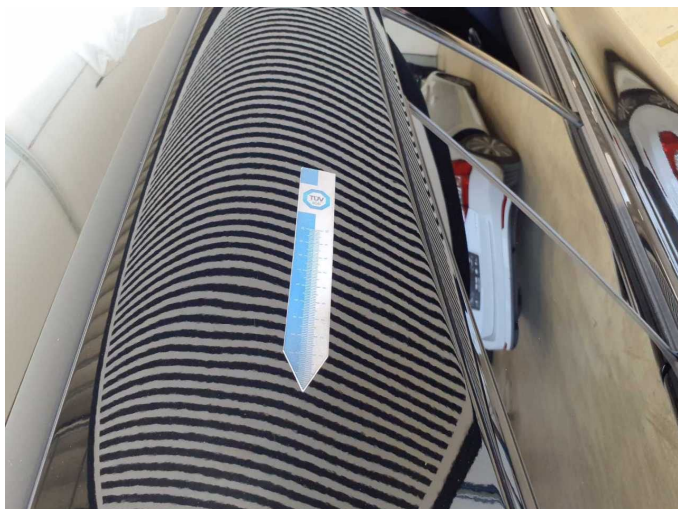
| No. | Component group | Description |
|---|---|---|
| 9 | Roof | Roof rail - right side - dent(s) - Smooth repair work |

**Wear and tear 9:** Roof: Roof rail - right side - dent(s) - Smooth repair work
