Expertise

Protocol number: 46821073  
Order No. / Reference: 26832798  
Inspection date: 31 Jul 2026

Model: GLC 300 de 4Matic 9G-TRONIC AMG Line

VIN: W1N2539111V333864

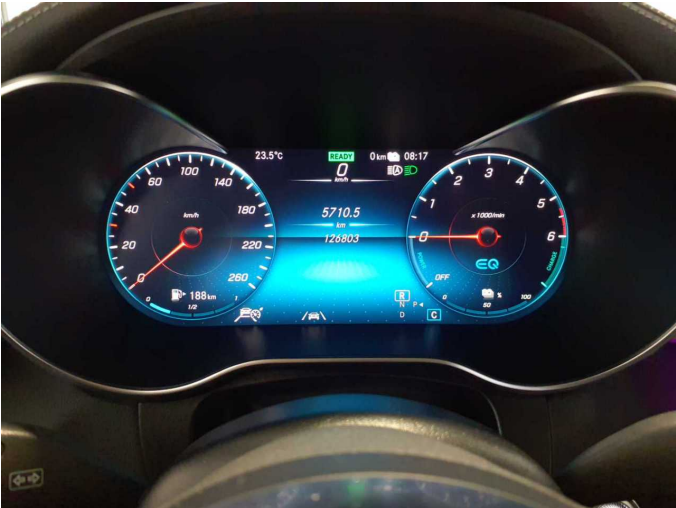
Figure 7: Instrument cluster

**Vehicle Identification number** W1N2539111V333864  
**Mileage (Read)** 126,803 km  
**First registration** 18 Nov 2021  
**Number of holders** 2  
**Next periodical technical inspection** 11/2026  
(Report not on hand)

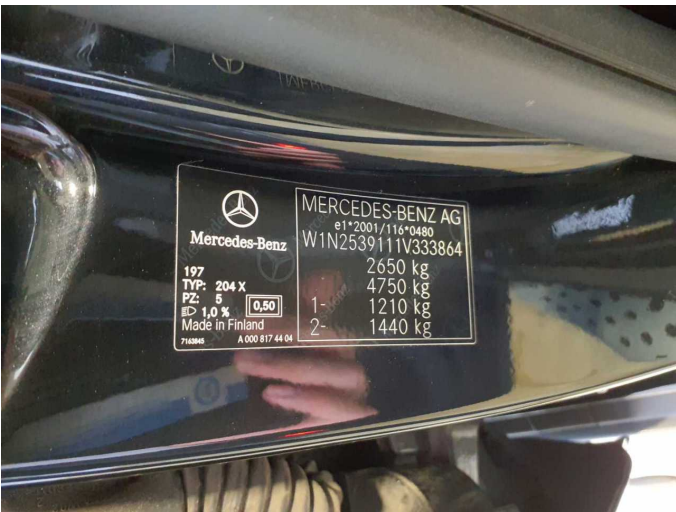
Figure 11: VIN

| VIN comparison | The vehicle identification number (VIN) was read from the vehicle and its conformity with the submitted documents was confirmed by the undersigned during the inspection. |

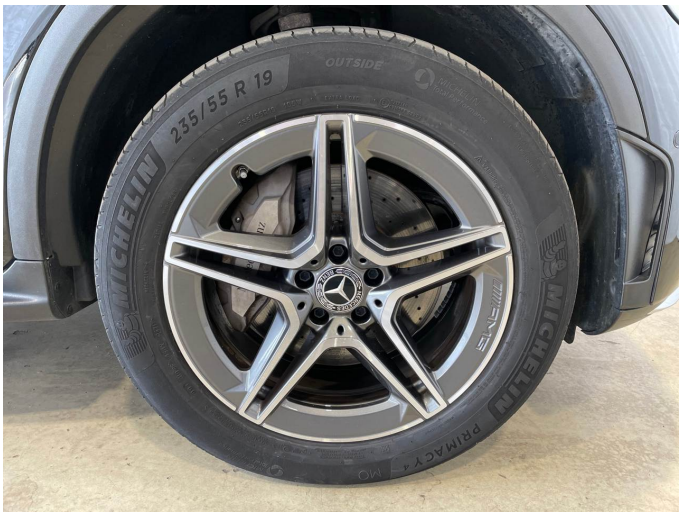
Figure 12: Mounted tyres

| # | Tyre size | Type of tyre | Manufacturer | Tread depth |
|---|---|---|---|---|
| 1) | 235/55 R19 105W | Summer tyres on Light alloy | Michelin | 4mm / 4mm |
| 2) | 235/55 R19 105W | Summer tyres on Light alloy | Michelin | 4mm / 4mm |

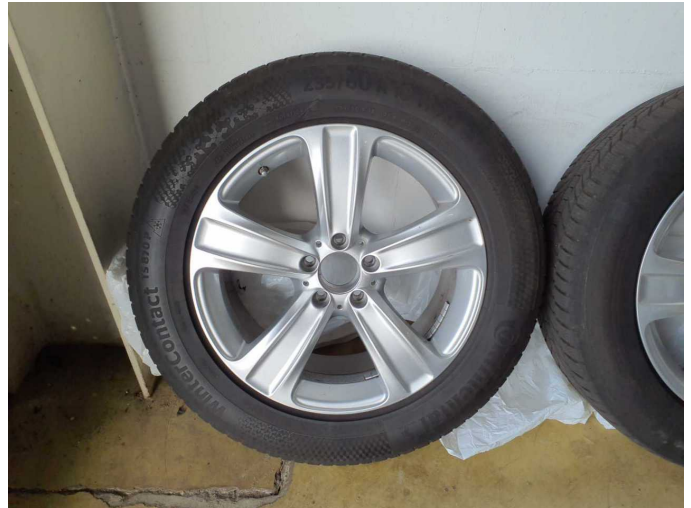
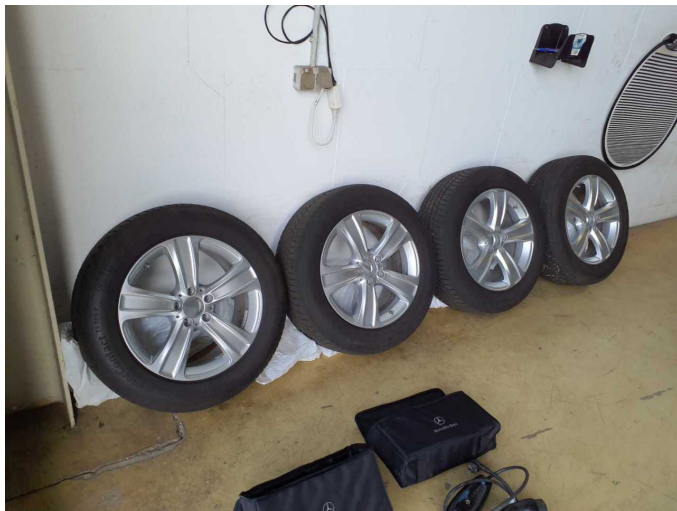
Figure 14: Additional tyres

| # | Tyre size | Type of tyre | Manufacturer | Tread depth |
|---|---|---|---|---|
| 1) | 235/60 R18 107H | Winter tyres on Light alloy | Continental | 5mm / 5mm |
| 2) | 235/60 R18 107H | Winter tyres on Light alloy | Continental | 6mm / 6mm |

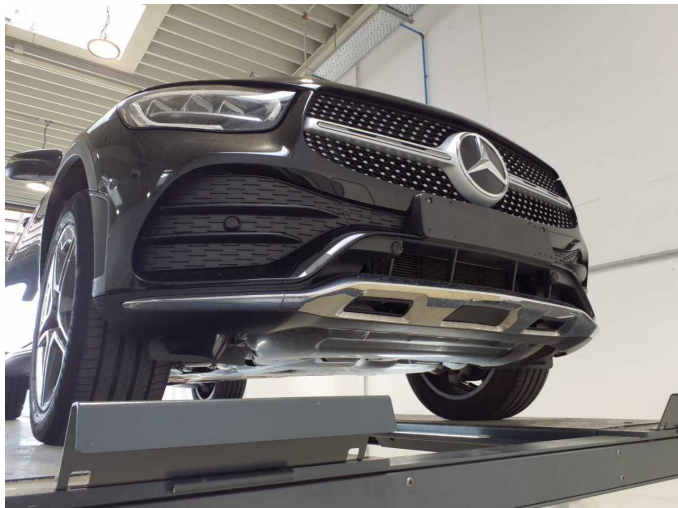
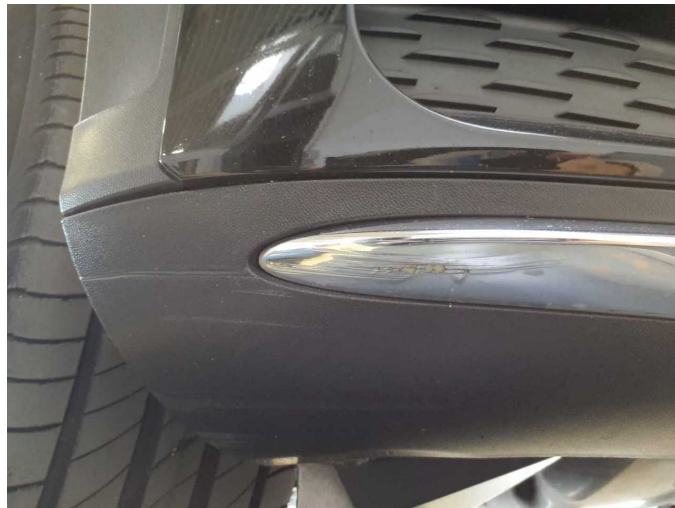
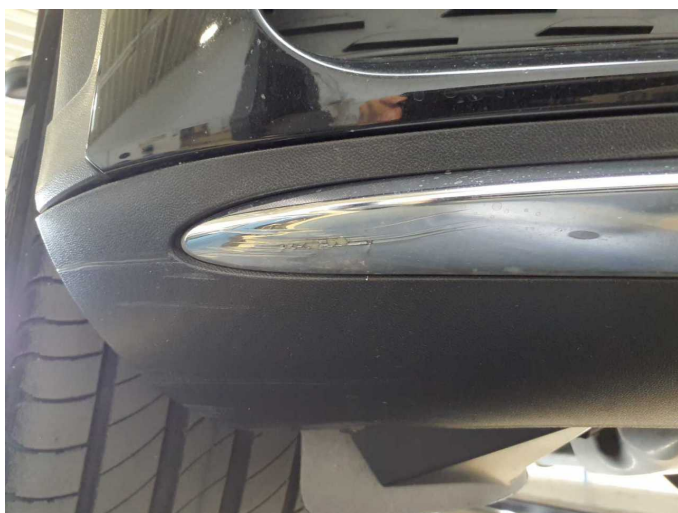
| No. | Component group | Description |
|---|---|---|
| 1 | Front bumper | Spoiler (Zusätzlich Zierleiste Kratzer) - Scratch(es) - Loss in value |

**Damage 1:** Front bumper: Spoiler (Zusätzlich Zierleiste Kratzer) - Scratch(es) - Loss in value

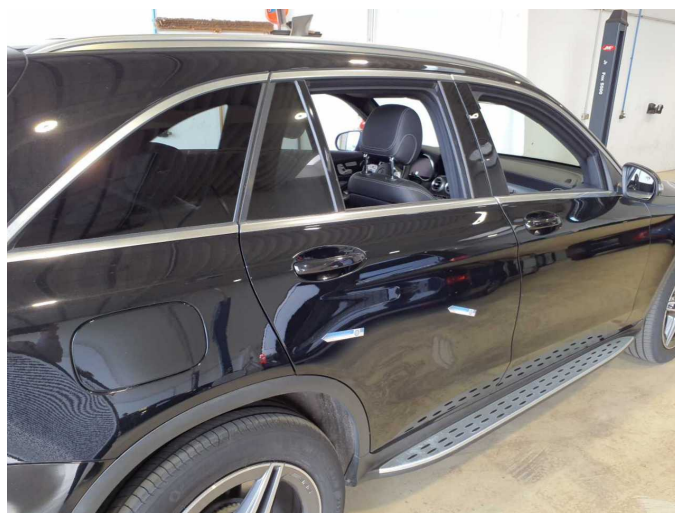
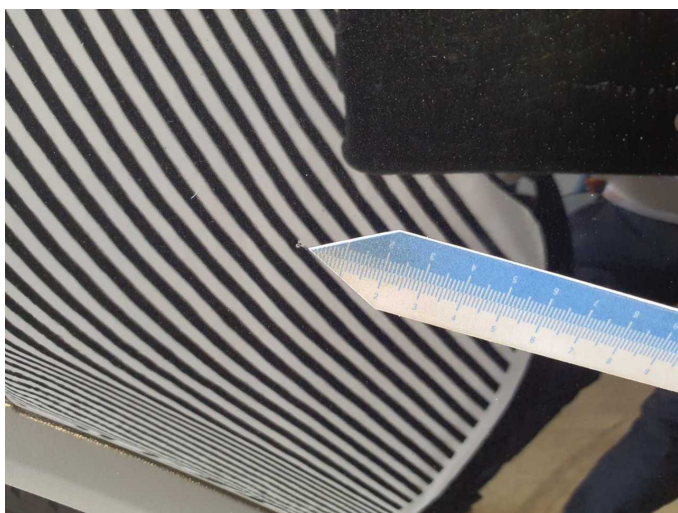
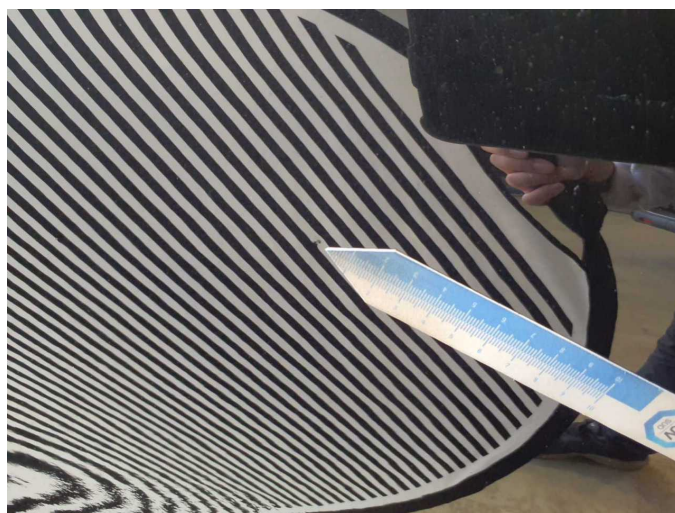
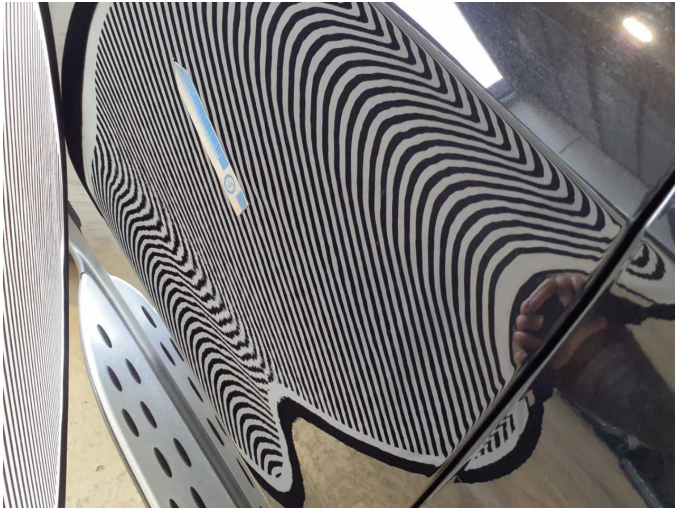
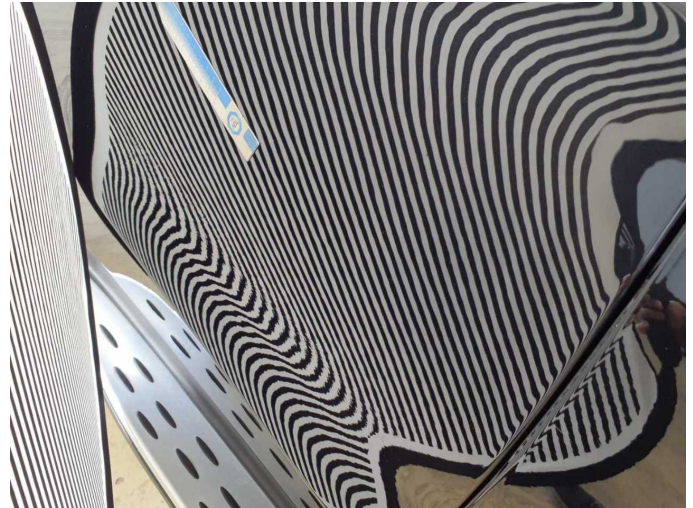
| No. | Component group | Description |
|---|---|---|
| 2 | Door - rear right side | Door (Einschlüsse und wellig) - Unprofessionally repaired - Repair and paint |

**Damage 2:** Door - rear right side: Door (Einschlüsse und wellig) - Unprofessionally repaired - Repair and paint

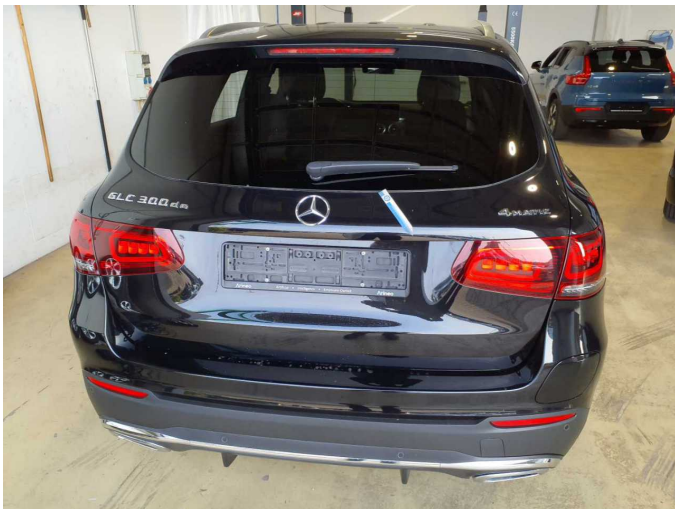
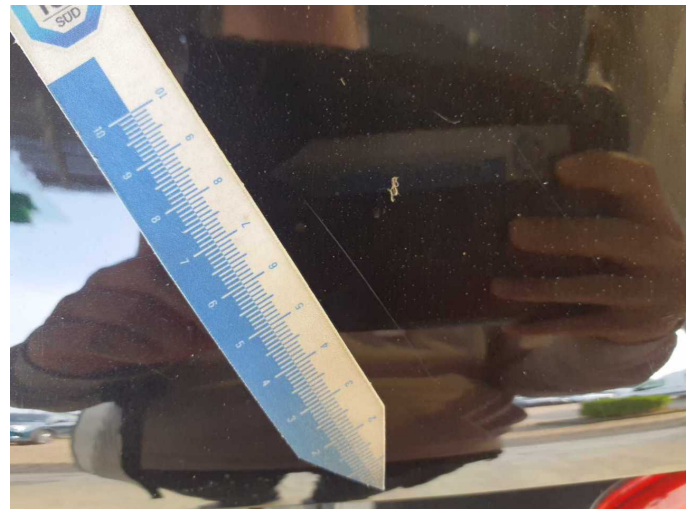
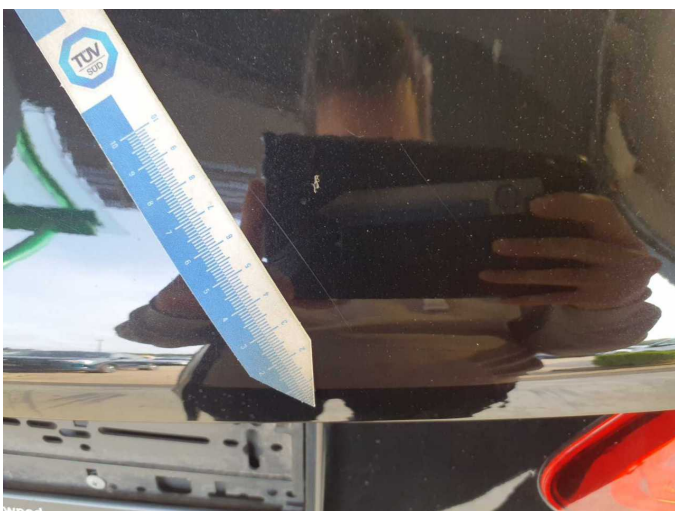
| No. | Component group | Description |
|---|---|---|
| 3 | Boot lid / rear door | Boot lid - Scratch(es) - Paint |

**Damage 3:** Boot lid / rear door: Boot lid - Scratch(es) - Paint

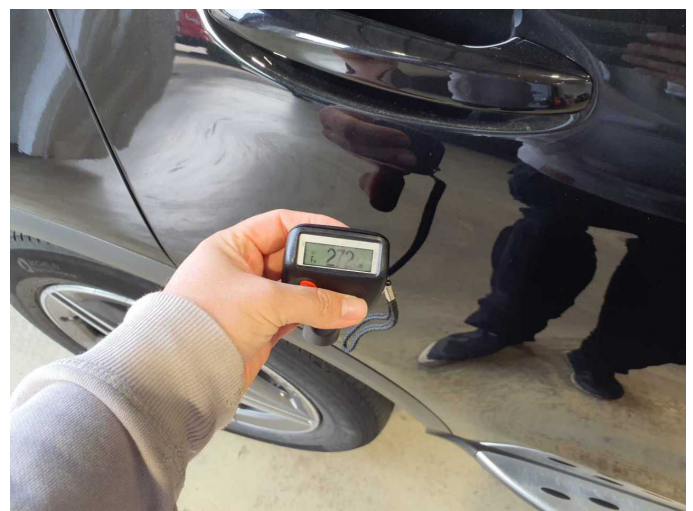
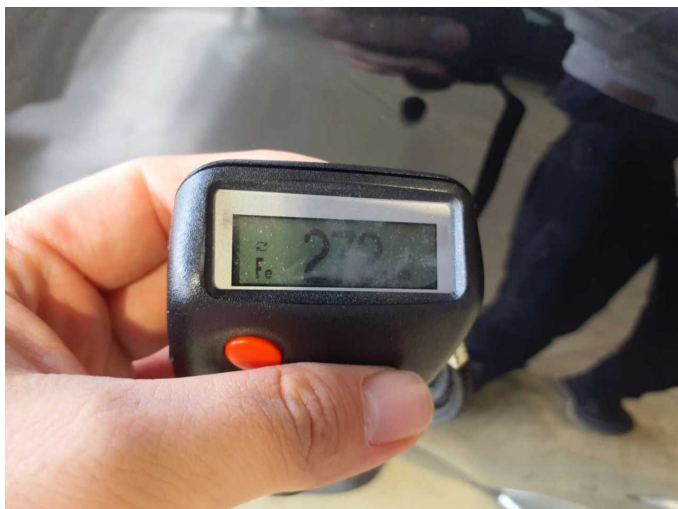
- 1 Door - rear right side, Unprofessionally carried out

Door - rear right side 272 µm |

**Repainting 1:** Door - rear right side
