Expertise

Protocol number: 46661553  
Order No. / Reference: 26611608  
Inspection date: 22 Jul 2026

Manufacturer: Mercedes-Benz  
VIN: W1KEG1BB4PF030508

Model: EQE 300 Electric Art

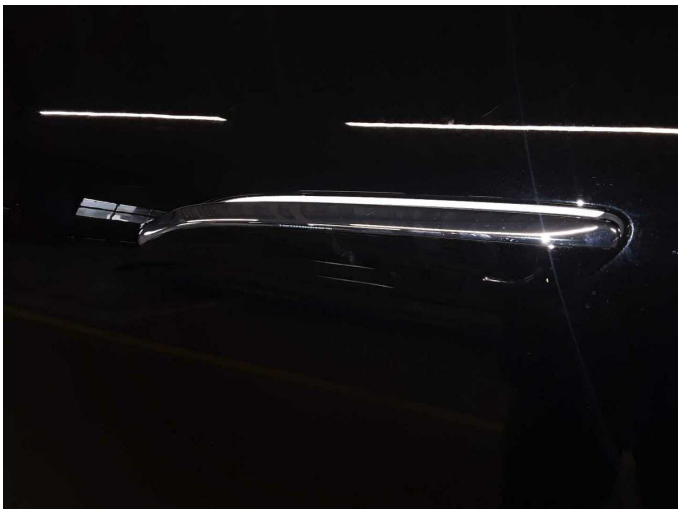
| No. | Component group | Description |
|---|---|---|
| 1 | Door - front left side | Door handle - outside - Scratch(es) - Smart repair |

Damage 1: Door - front left side: Door handle - outside - Scratch(es) - Smart repair

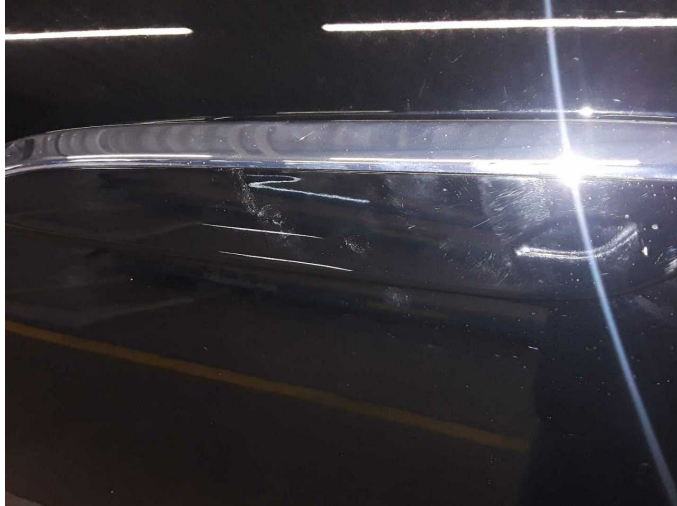
**Damage 1:** Door - front left side: Door handle - outside - Scratch(es) - Smart repair

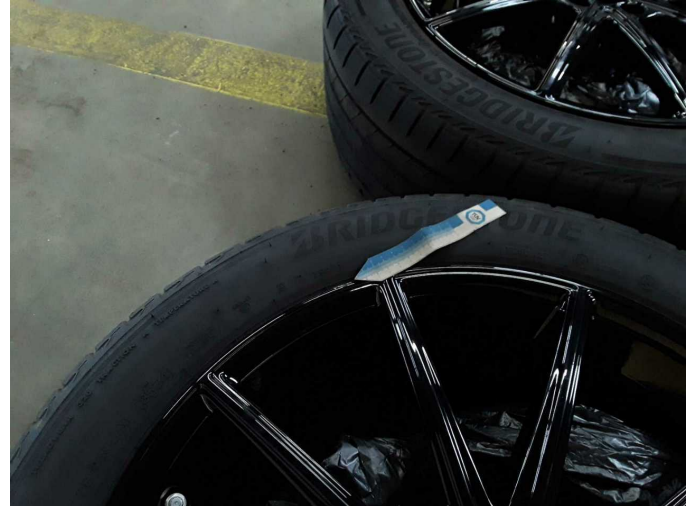
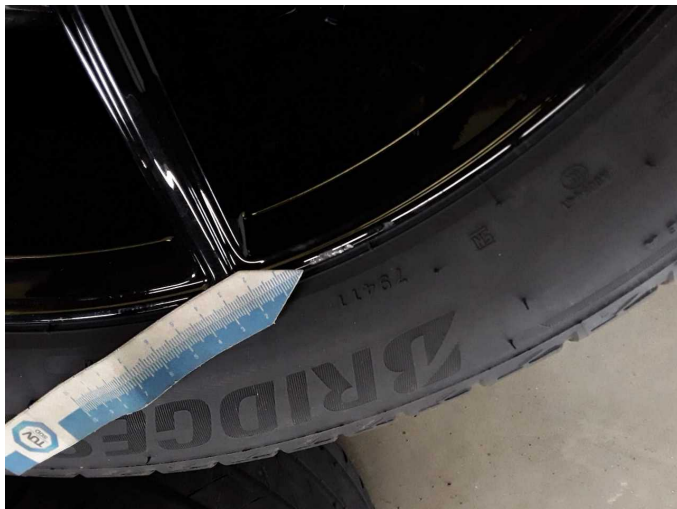
| No. | Component group | Description |
|---|---|---|
| 2 | 2nd wheel set | 1 alloy rim - Scratched - Loss in value |

**Damage 2:** 2nd wheel set: 1 alloy rim - Scratched - Loss in value

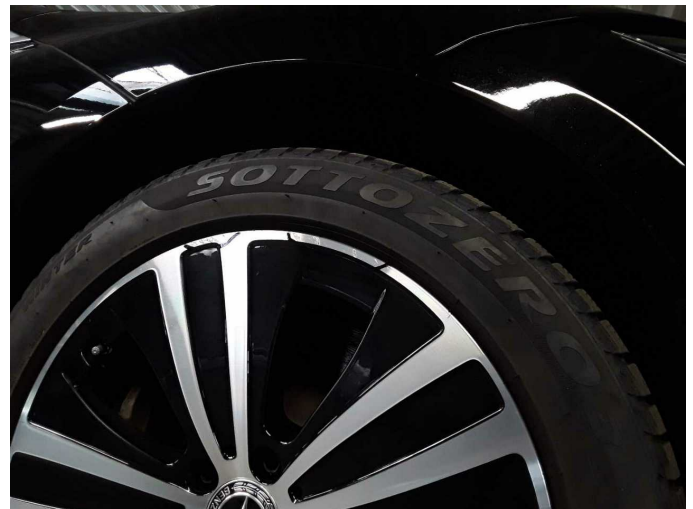
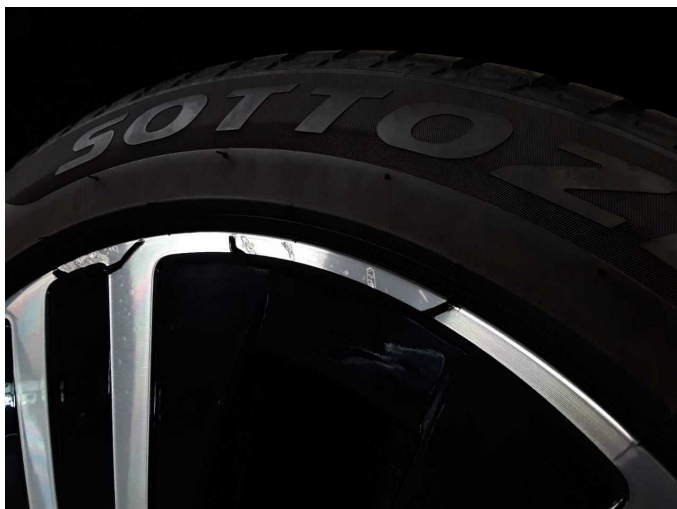
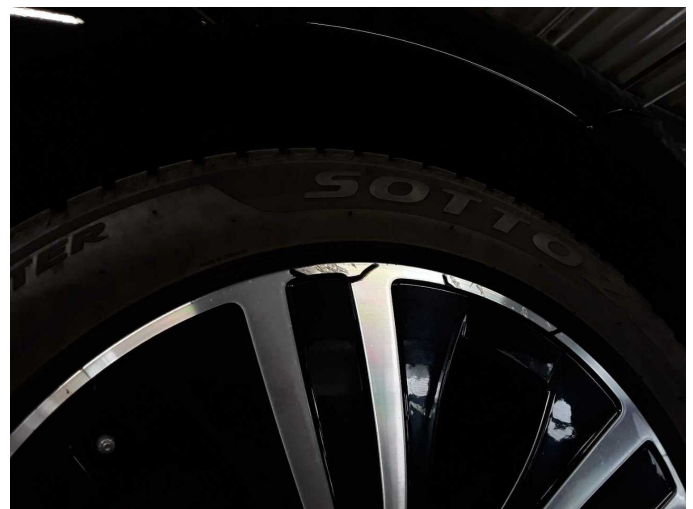
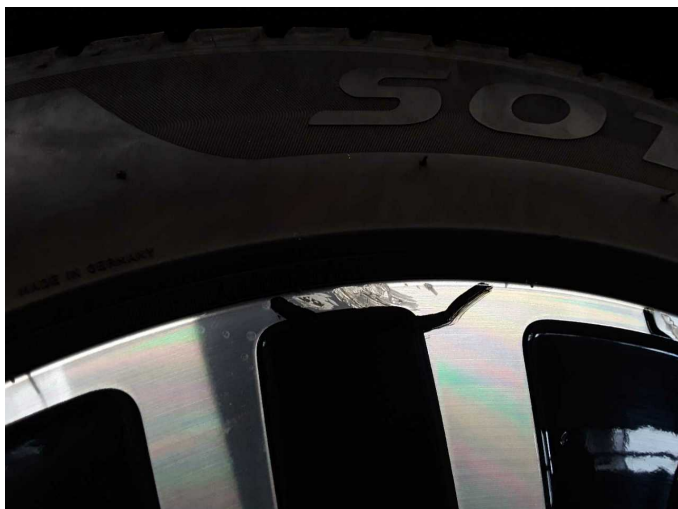
| No. | Component group | Description |
|---|---|---|
| 3 | Wheel / tyres | Alloy rim - front right side - Scratched - Loss in value |

**Damage 3:** Wheel / tyres: Alloy rim - front right side - Scratched - Loss in value

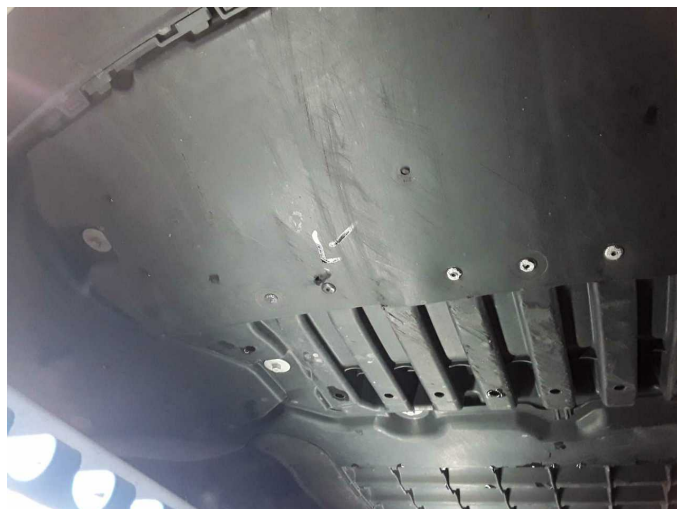
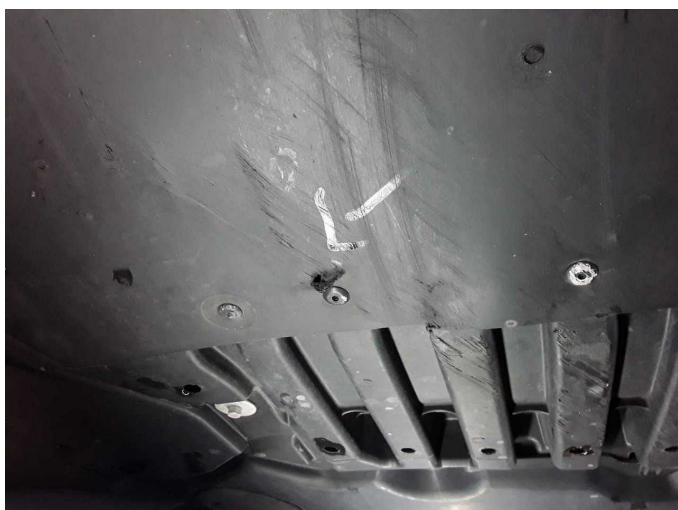
| No. | Component group | Description |
|---|---|---|
| 4 | Body | Underbody panelling - Broken / torn - Replace |

**Damage 4:** Body: Underbody panelling - Broken / torn - Replace

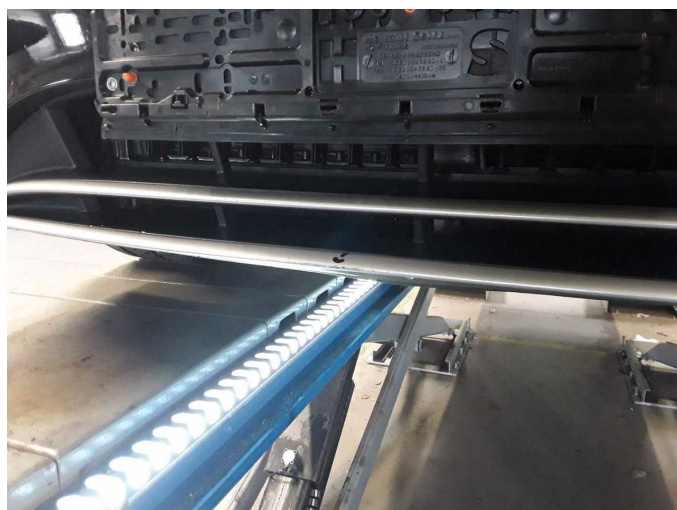
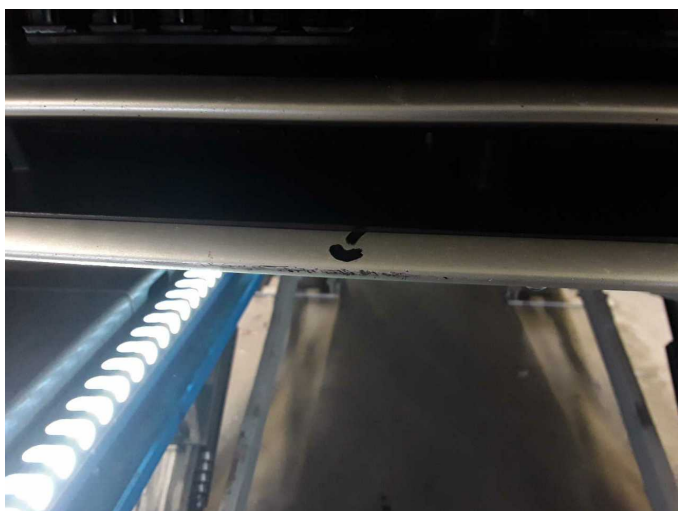
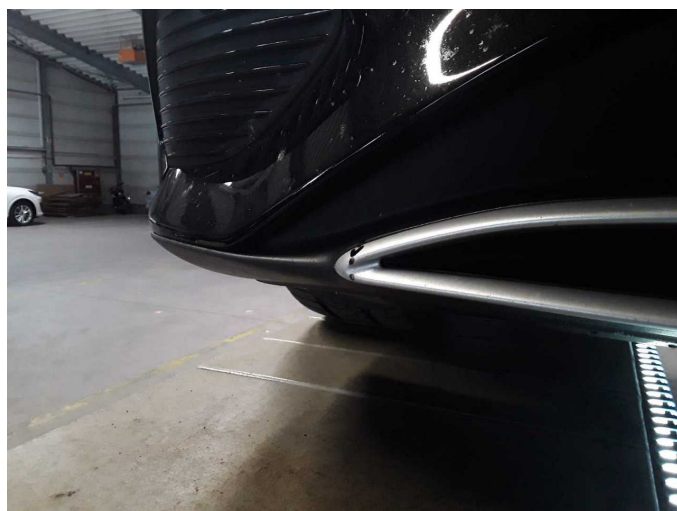
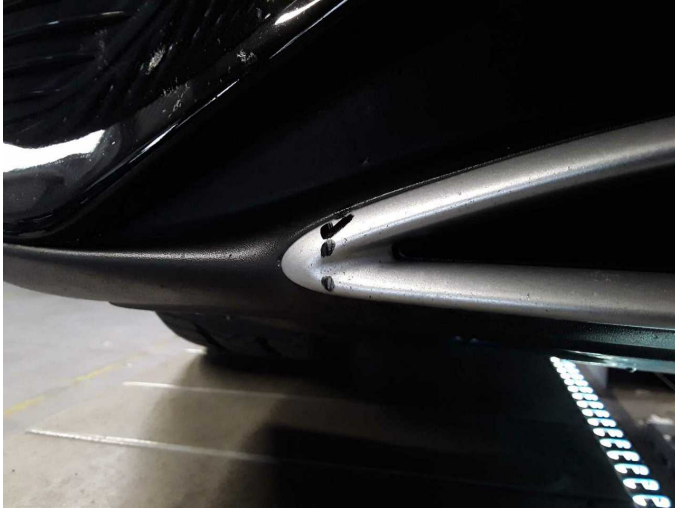
| No. | Component group | Description |
|---|---|---|
| 6 | Front bumper | Spoiler (Zierleiste) - Scratched - Replace |

**Damage 6:** Front bumper: Spoiler (Zierleiste) - Scratched - Replace

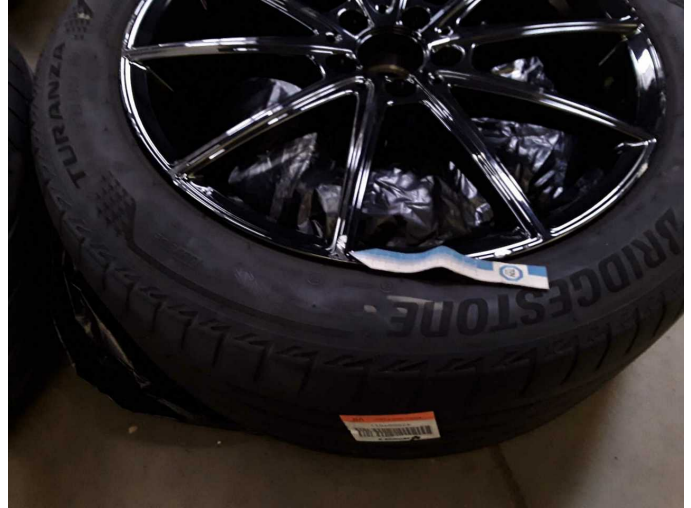
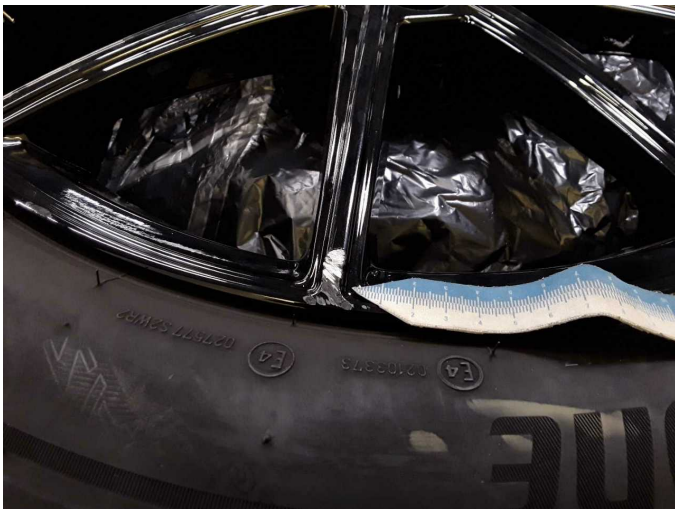
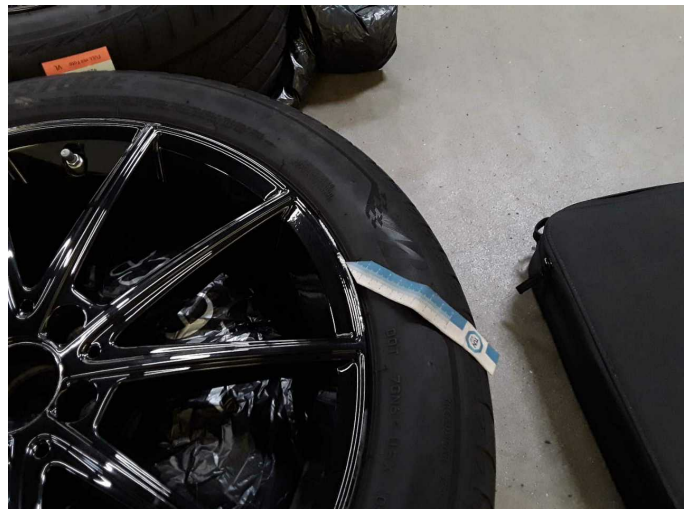
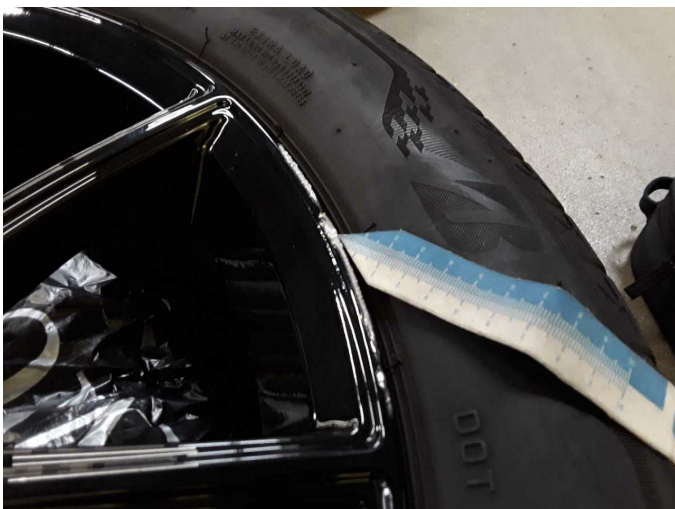
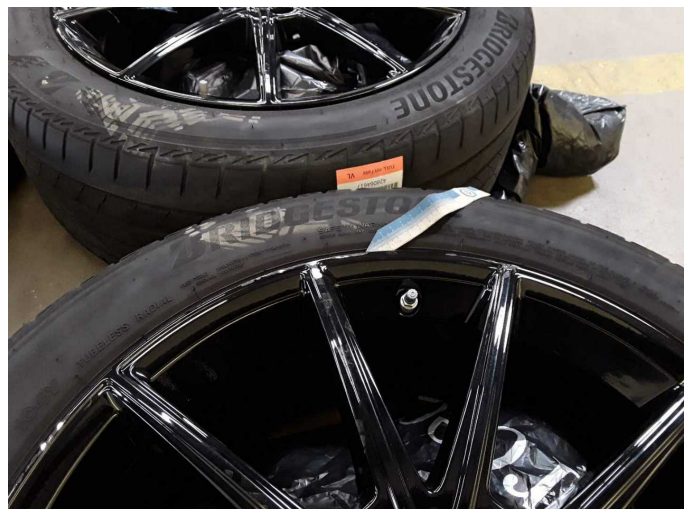
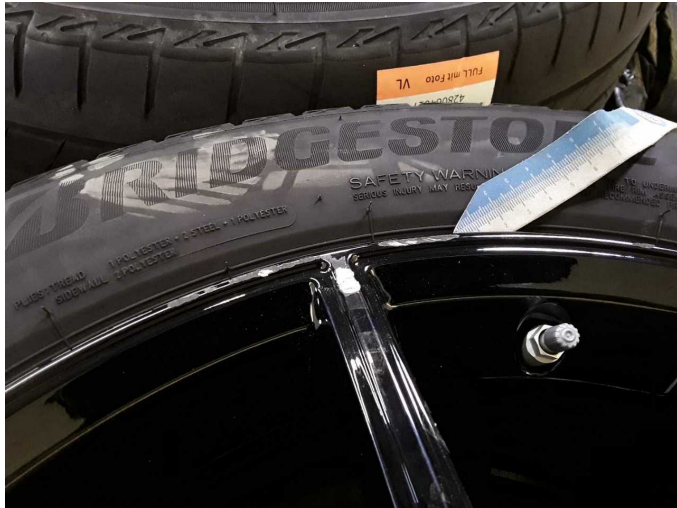
| No. | Component group | Description |
|---|---|---|
| 7 | 2nd wheel set | 1 alloy rim (Materialabtrag) - Scratched - Replace |

**Damage 7:** 2nd wheel set: 1 alloy rim (Materialabtrag) - Scratched - Replace

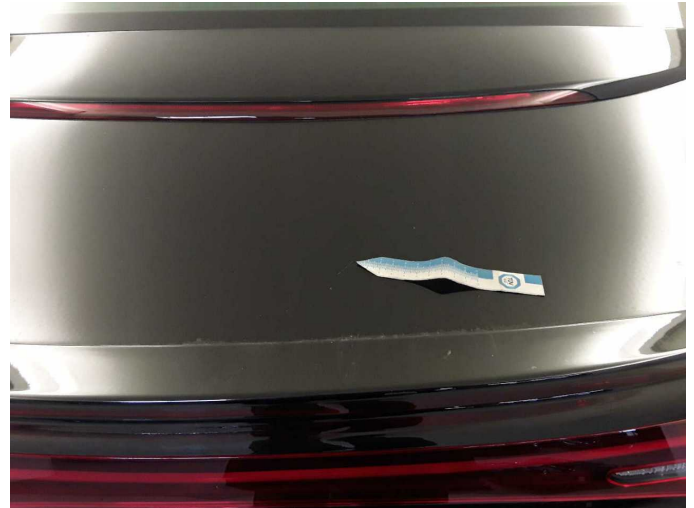
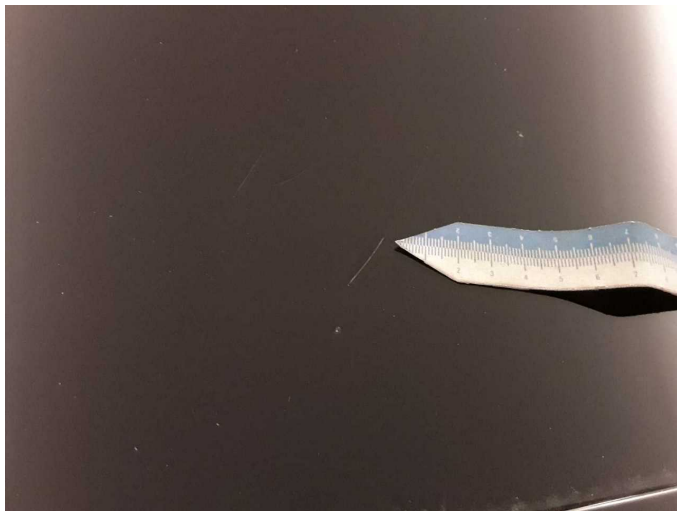
| No. | Component group | Description |
|---|---|---|
| 8 | Boot lid / rear door | Boot lid - Scratch(es) - Paint |

**Damage 8:** Boot lid / rear door: Boot lid - Scratch(es) - Paint

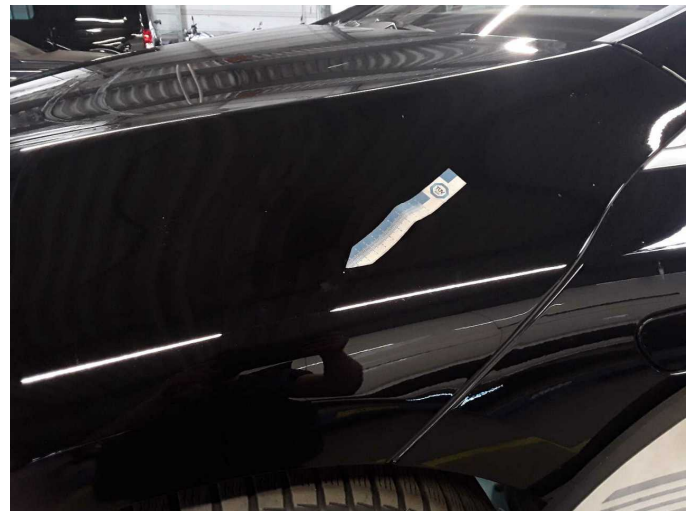
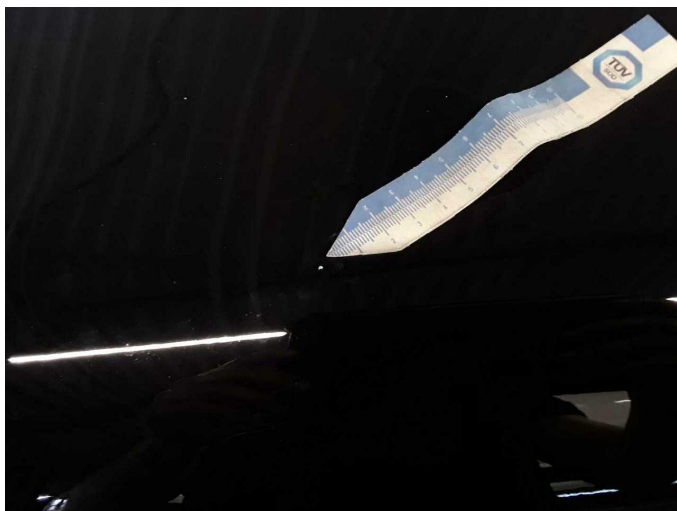
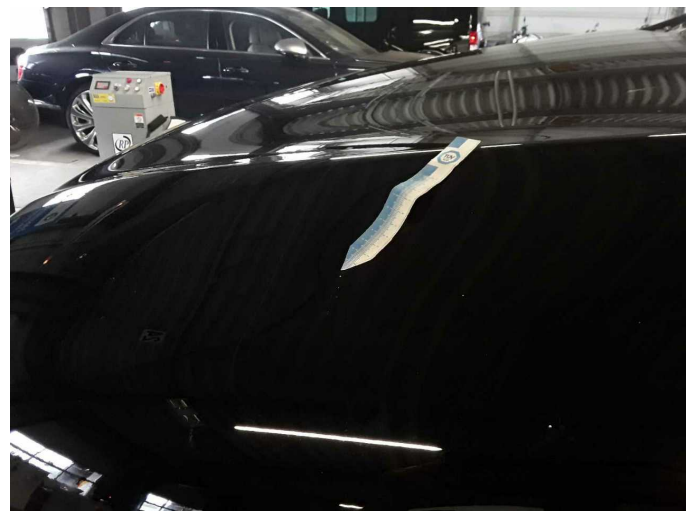
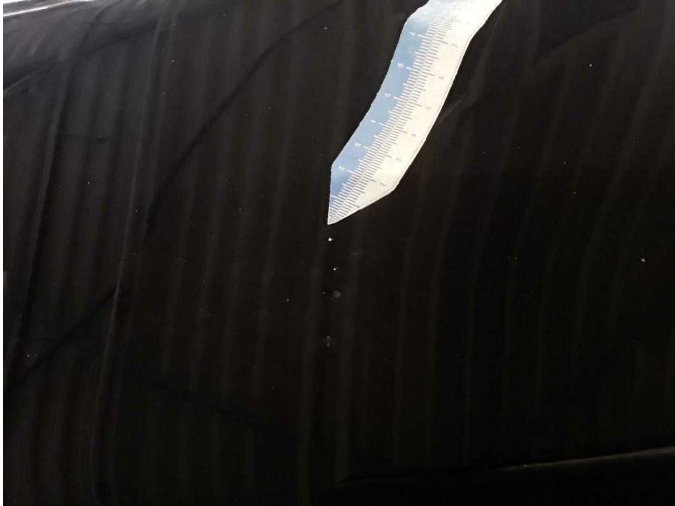
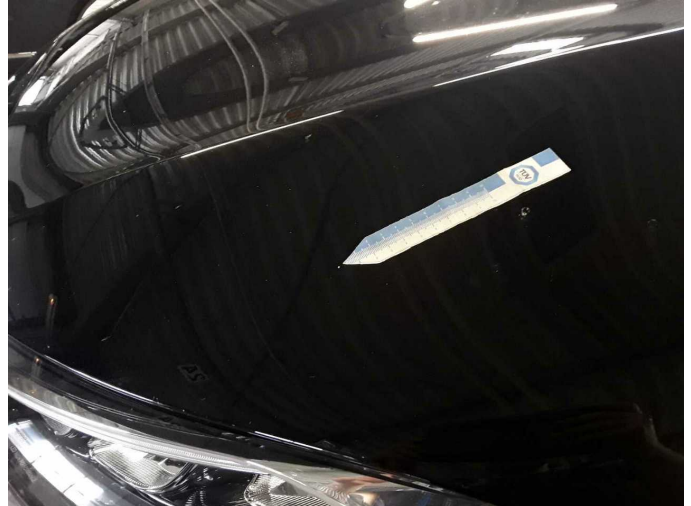
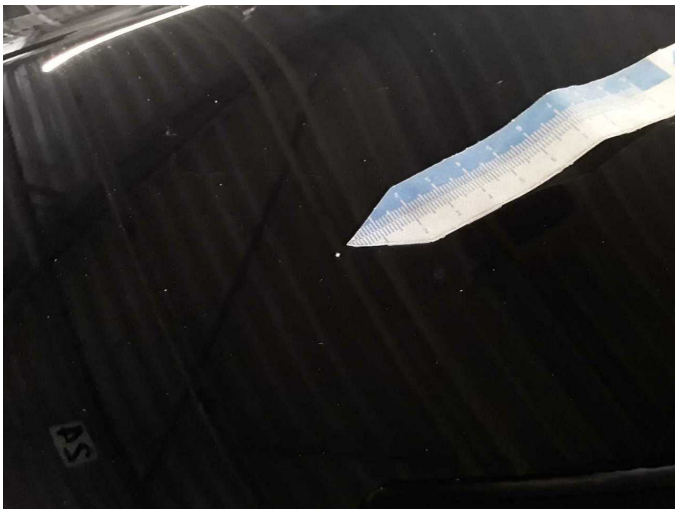
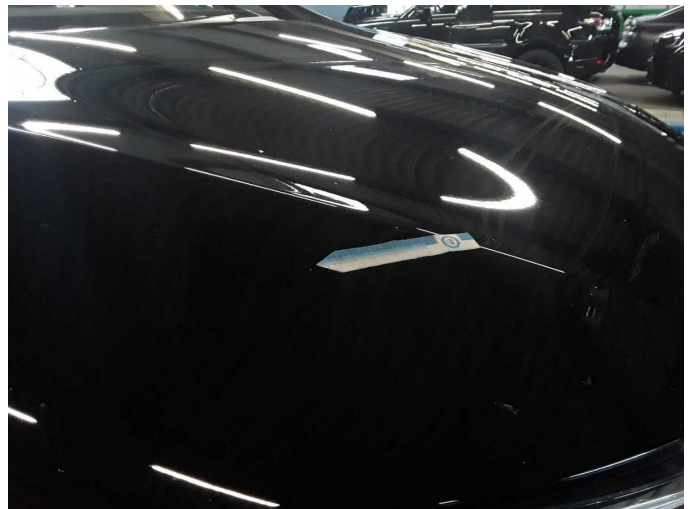
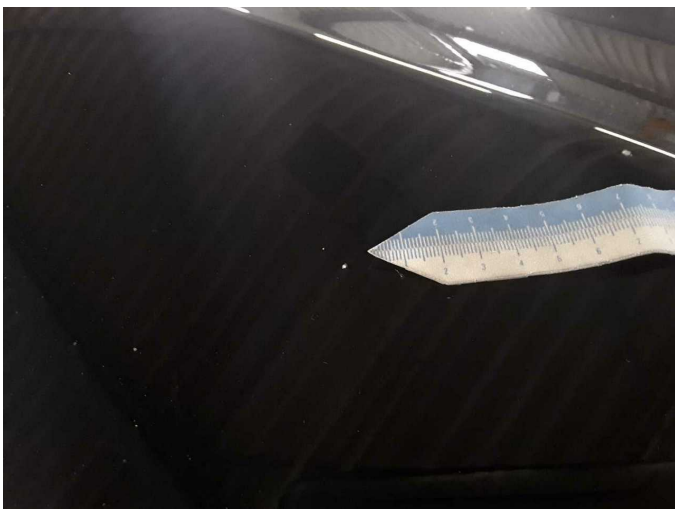
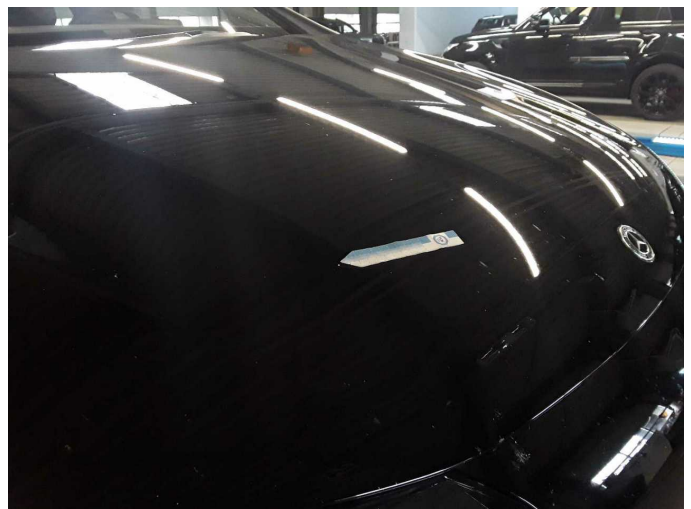
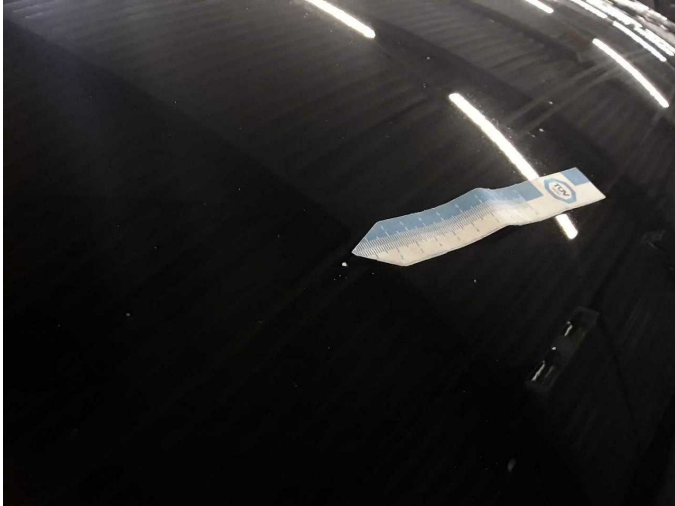
| No. | Component group | Description |
|---|---|---|
| 9 | Bonnet | Bonnet - Stone chips - Paint |

**Damage 9:** Bonnet: Bonnet - Stone chips - Paint

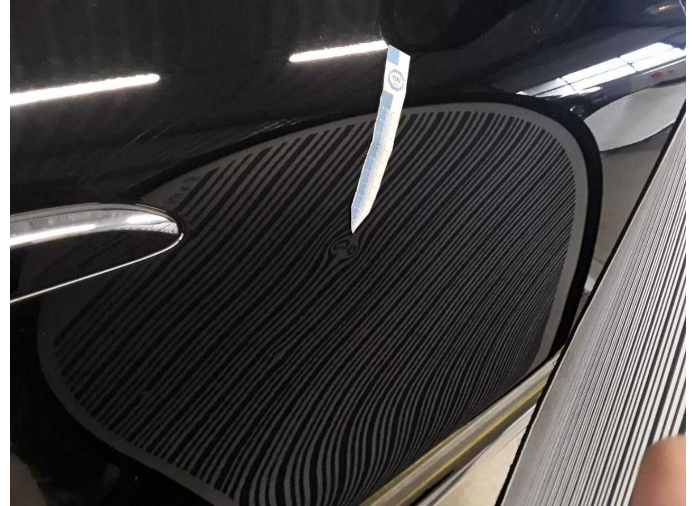
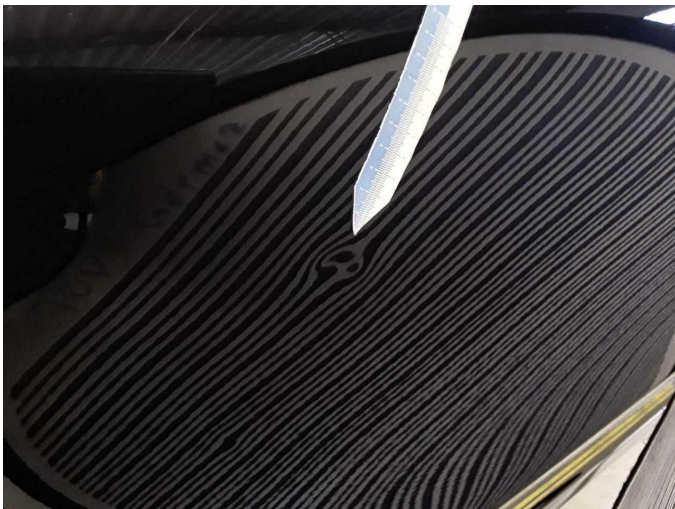
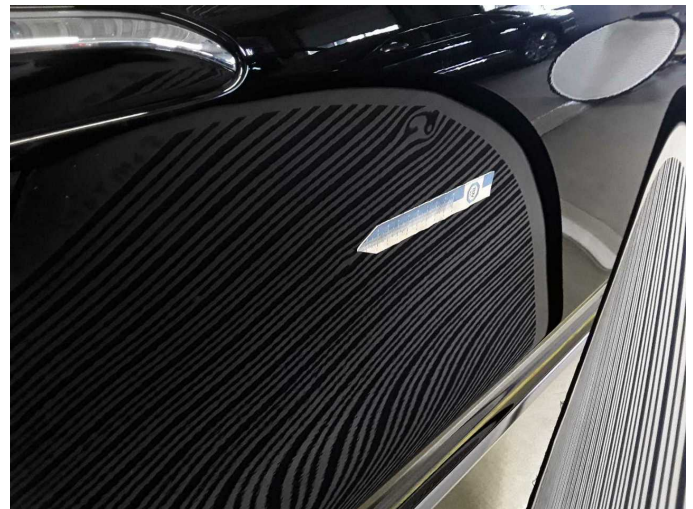
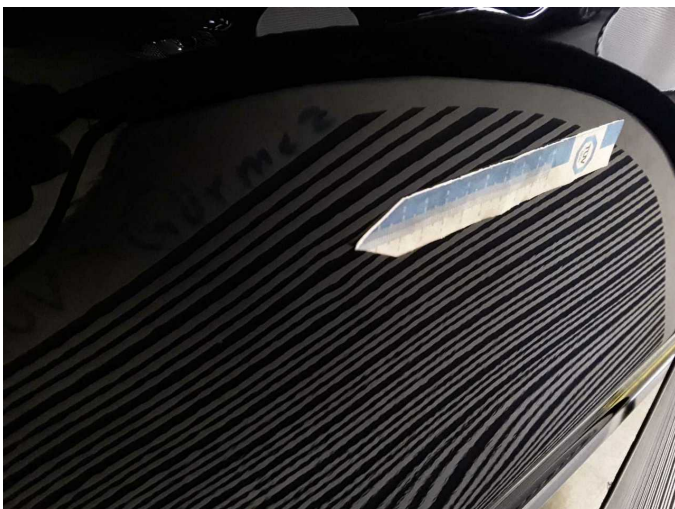
| No. | Component group | Description |
|---|---|---|
| 10 | Door - front right side | Door - dent(s) - Repair and paint |

**Damage 10:** Door - front right side: Door - dent(s) - Repair and paint

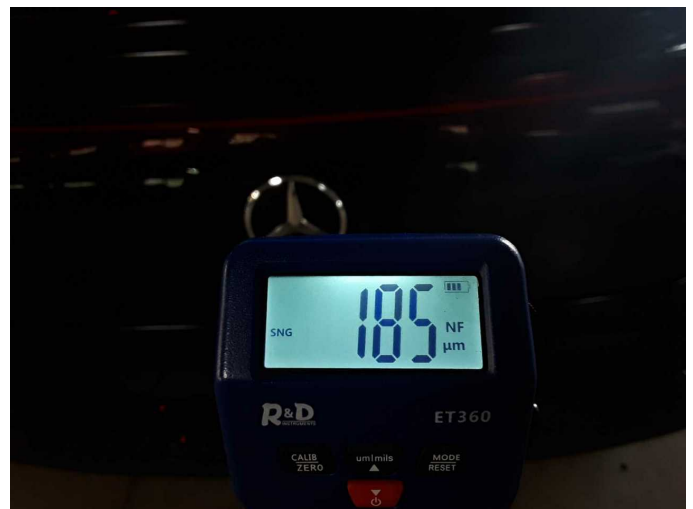
| 1 | Boot lid / rear door, Professionally carried out |

**Repainting 1:** Boot lid / rear door

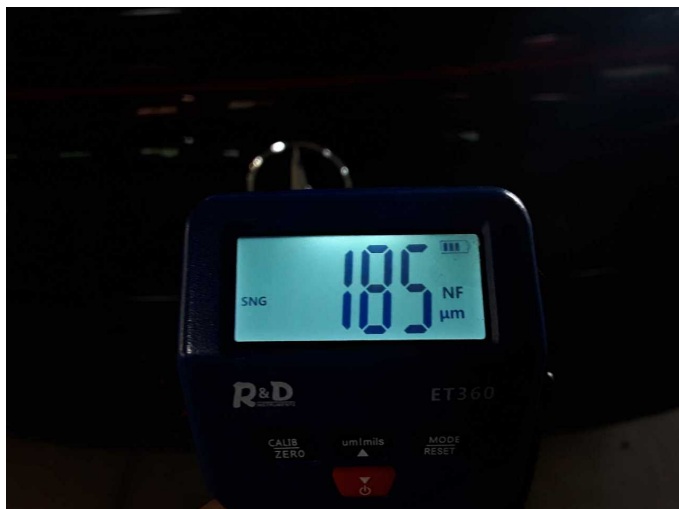
| Boot lid / rear door | 185 µm |

Boot lid / rear door: 185 µm
