Expertise

Protocol number: 46460399  
Order No. / Reference: 26603467  
Inspection date: 13 Jul 2026

Manufacturer: Opel

Model: Grandland X Plug-in-Hybrid 1.6 DI Start/Stop Aut Business  
Edition

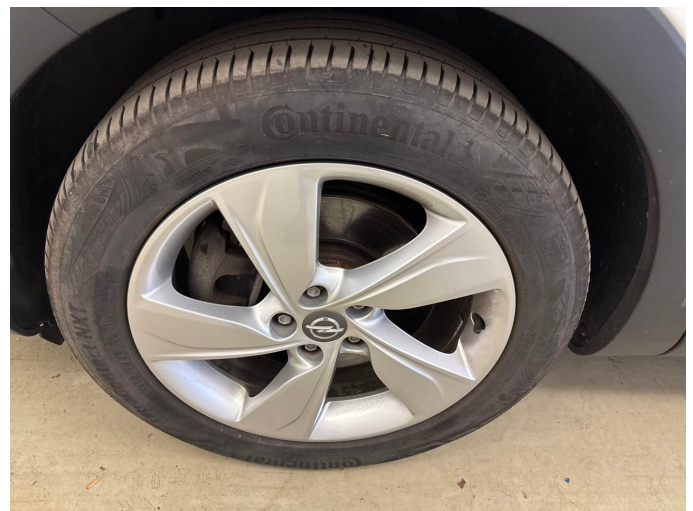
Figure 12: Mounted tyres

| # | Tyre size | Type of tyre | Manufacturer | Tread depth |
|---|---|---|---|---|
| 1) | 225/55 R18 102V | Summer tyres on Light alloy | Continental | 4mm / 4mm |
| 2) | 225/55 R18 102V | Summer tyres on Light alloy | Continental | 4mm / 4mm |

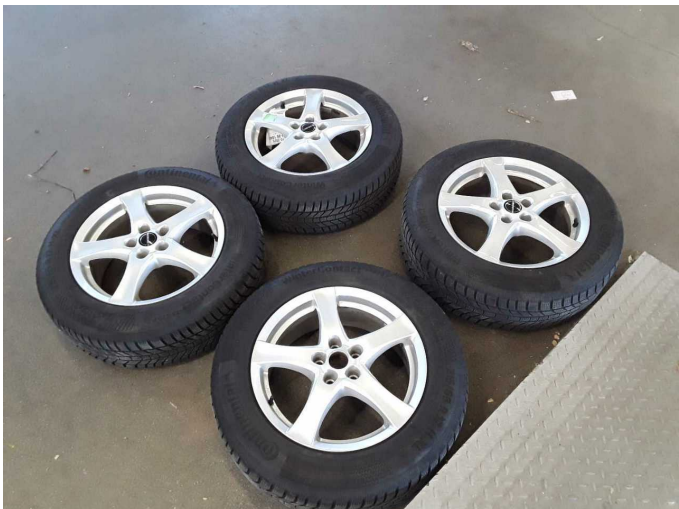
Figure 18: Additional tyres

| # | Tyre size | Type of tyre | Manufacturer | Tread depth |
|---|---|---|---|---|
| 1) | 215/65 R17 103H | Winter tyres on Light alloy | Continental | 5mm / 5mm |
| 2) | 215/65 R17 103H | Winter tyres on Light alloy | Continental | 5mm / 5mm |

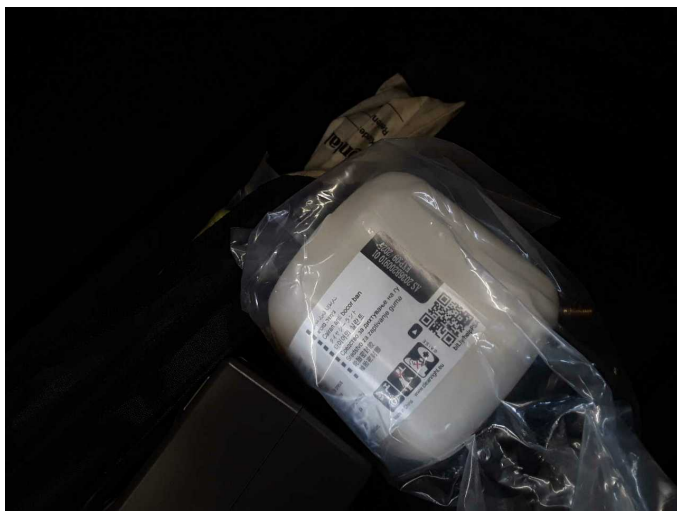
| No. | Component group | Description |
|---|---|---|
| 1 | Equipment | Tirefit filler - Expired - Replace |

Damage 1: Equipment: Tirefit filler - Expired - Replace

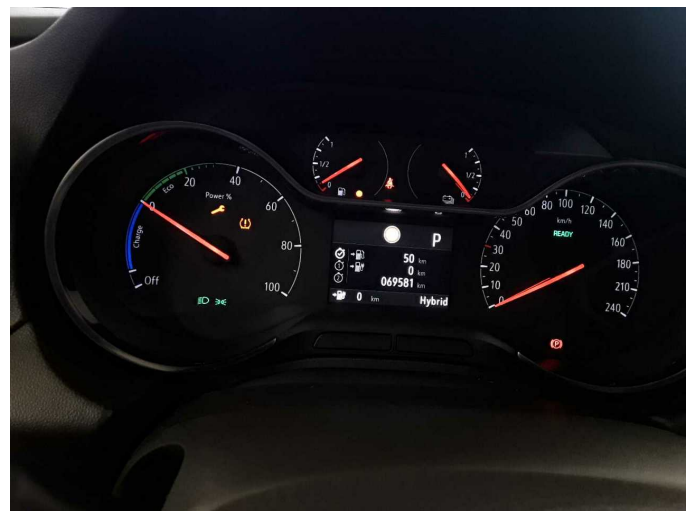
| No. | Component group | Description |
|---|---|---|
| 2 | Wheel / tyres | Pressure sensor (Reifendruck) - on - Perform diagnosis |

Damage 2: Wheel / tyres: Pressure sensor (Reifendruck) - on - Perform diagnosis

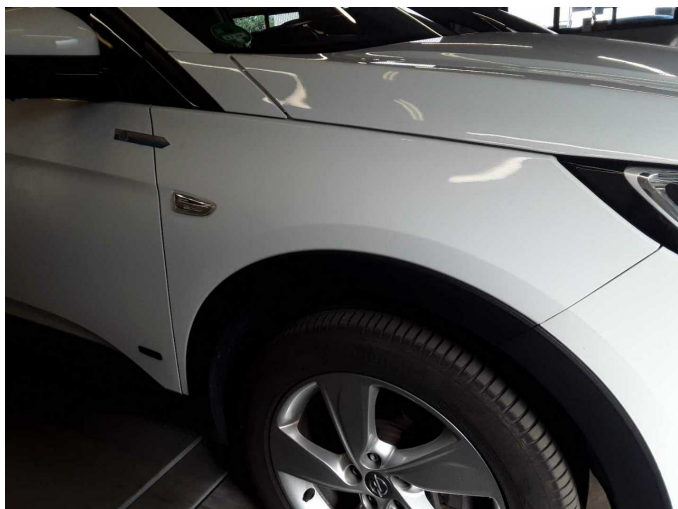
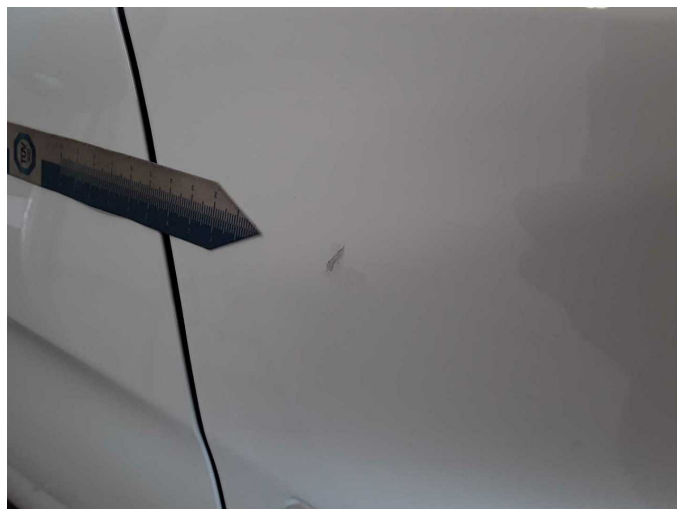
| No. | Component group | Description |
|---|---|---|
| 3 | Mudguard - right side | Mudguard - right side - Scratch(es) - Smart repair |

**Damage 3:** Mudguard - right side: Mudguard - right side - Scratch(es) - Smart repair

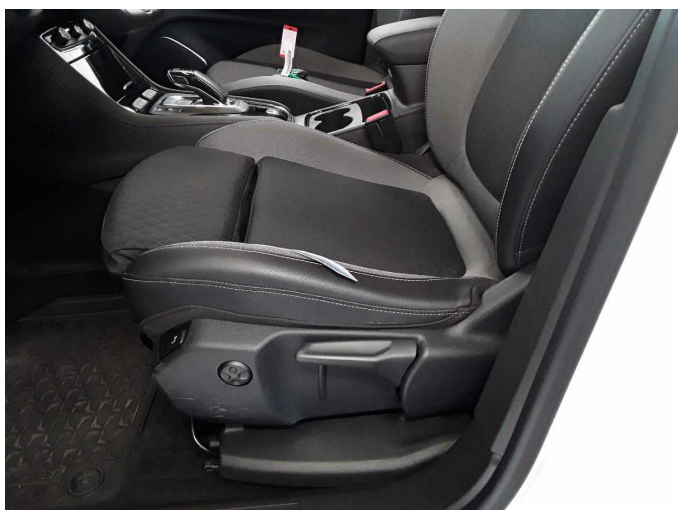
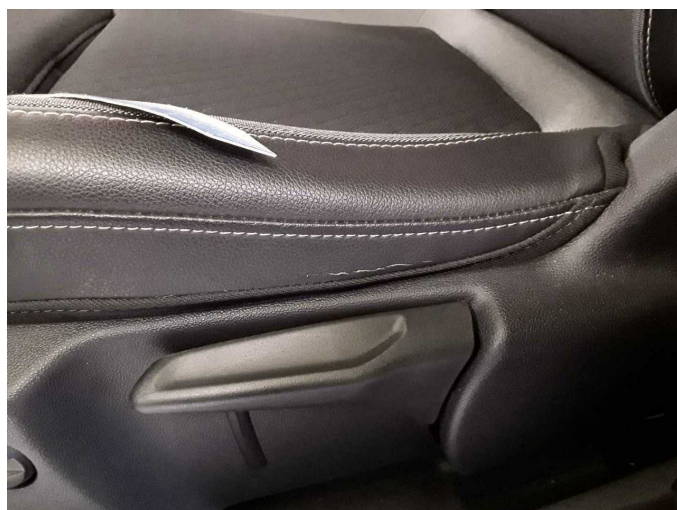
| No. | Component group | Description |
|---|---|---|
| 4 | Seat - front | Seat cover - left side - Porous / cracked - Smart repair |

**Damage 4:** Seat - front: Seat cover - left side - Porous / cracked - Smart repair

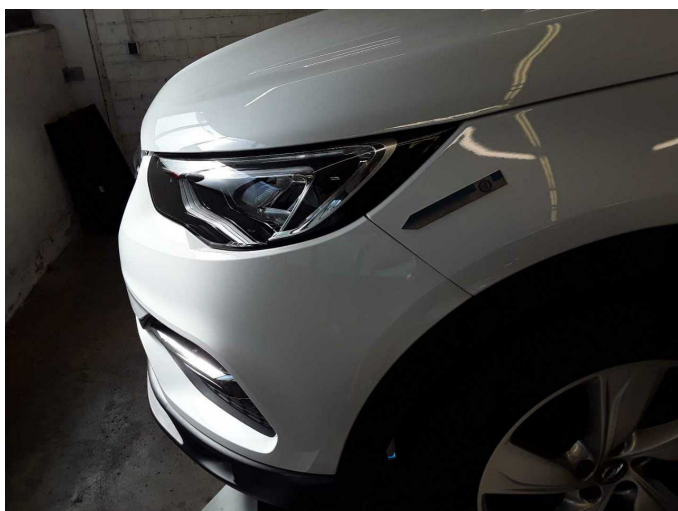
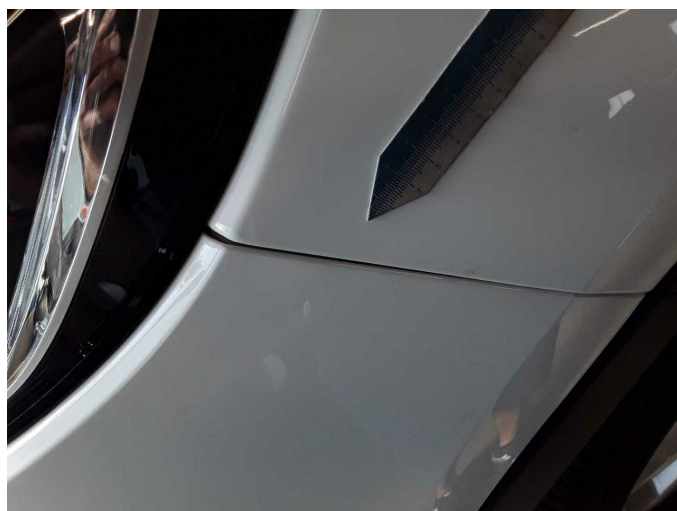
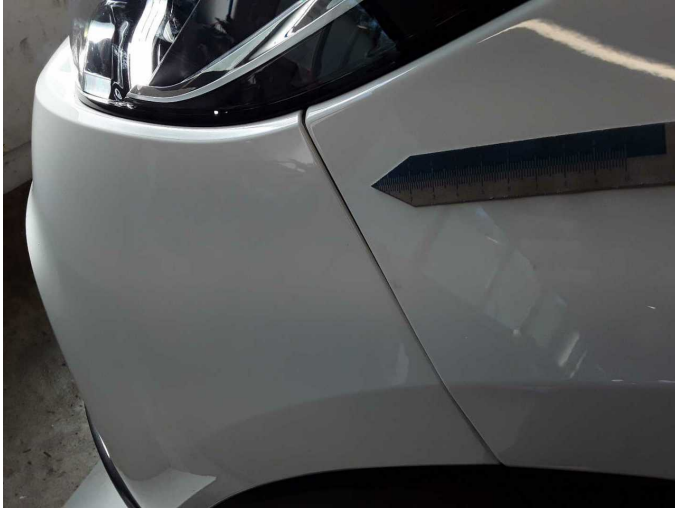
| No. | Component group | Description |
|---|---|---|
| 5 | Front bumper | Front bumper - Malposition - Set / adjust |

**Damage 5:** Front bumper: Front bumper - Malposition - Set / adjust

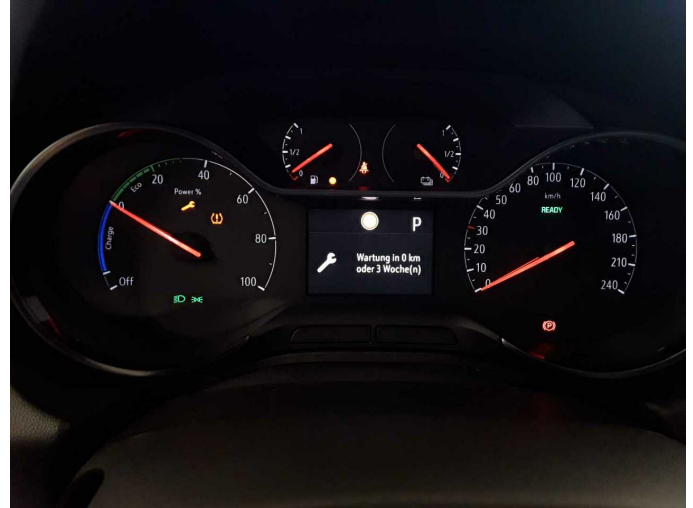
| No. | Component group | Description |
|---|---|---|
| 6 | Misc. | Inspection / maintenance - Due - Perform |

**Damage 6:** Misc.: Inspection / maintenance - Due - Perform
