Expertise

Protocol number: 46515078  
Order No. / Reference: 26584573  
Inspection date: 1 Jul 2026

Manufacturer: Polestar

Model: 2 Dual Motor 78kWh

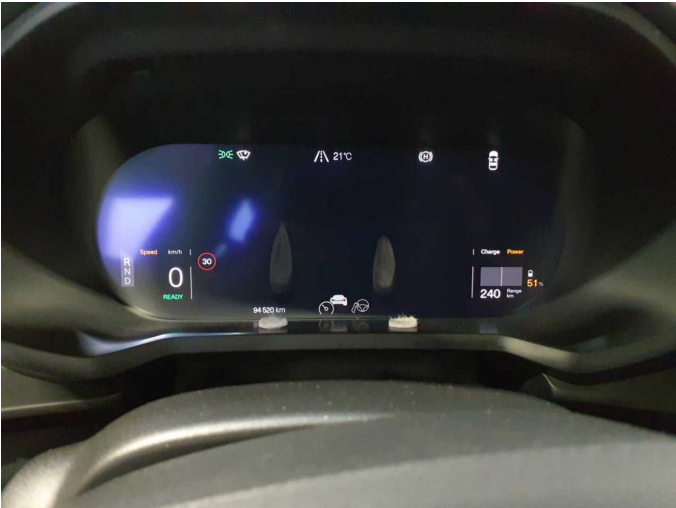
| Vehicle details | |
|---|---|
| Mileage (Read) | 94,520 km |

Figure 7: Instrument cluster

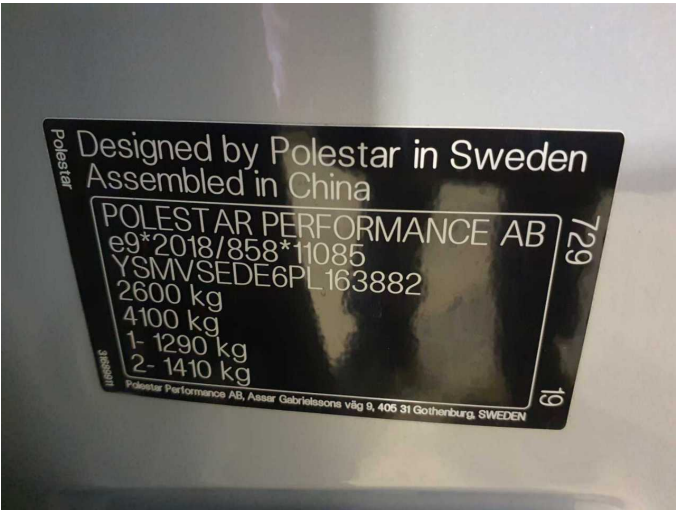
| VIN comparison | The vehicle identification number (VIN) was read from the vehicle and its conformity with the submitted documents was confirmed by the undersigned during the inspection. |

Figure 11: VIN

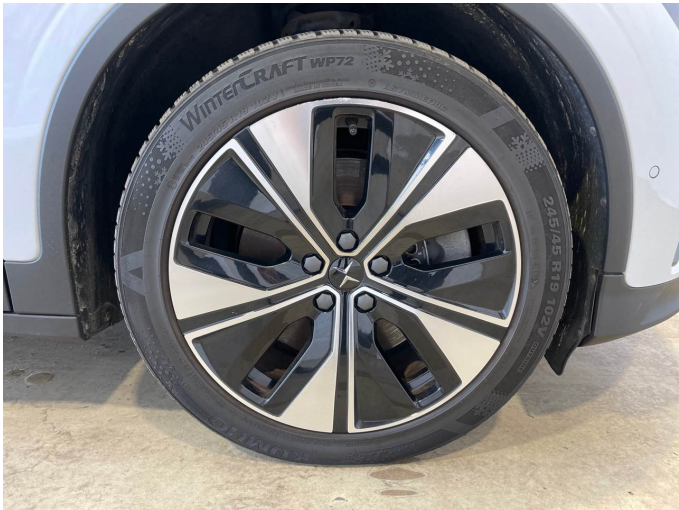
| Tyres | | | | |
|---|---|---|---|---|
| 1) | 245/45 R19 102V | Winter tyres on Light alloy | Kumho | 5mm / 5mm |
| 2) | 245/45 R19 102V | Winter tyres on Light alloy | Kumho | 5mm / 5mm |

Figure 12: Mounted tyres

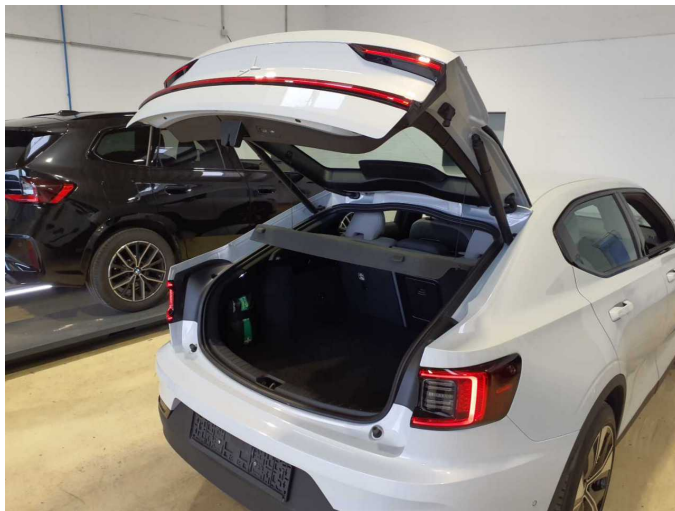
| No. | Component group | Description |
|---|---|---|
| 1 | Boot lid / rear door | Boot lid (Öffnet und schließt nicht elektrisch) - Functional / admissibility - Perform diagnosis |

**Damage 1:** Boot lid / rear door: Boot lid (Öffnet und schließt nicht elektrisch) - Functional / admissibility - Perform diagnosis

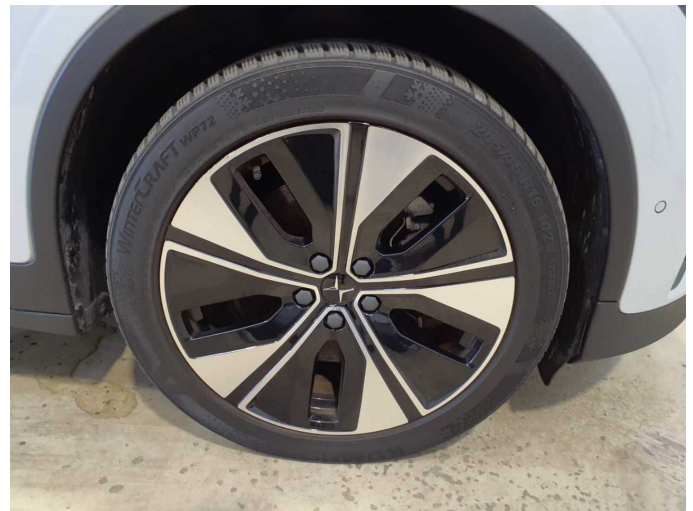
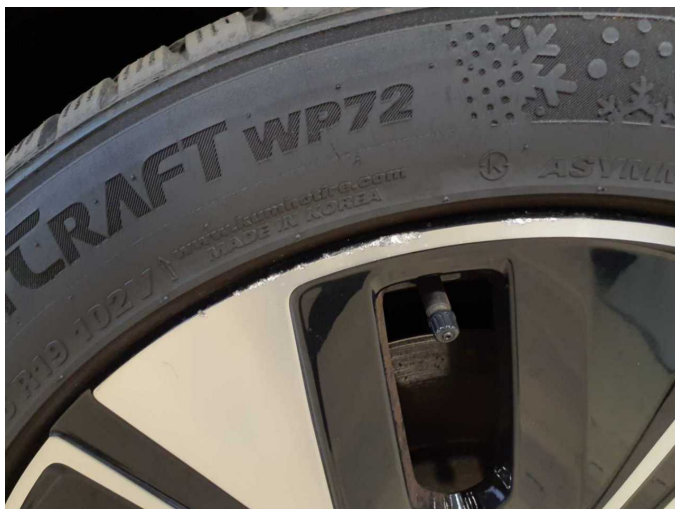
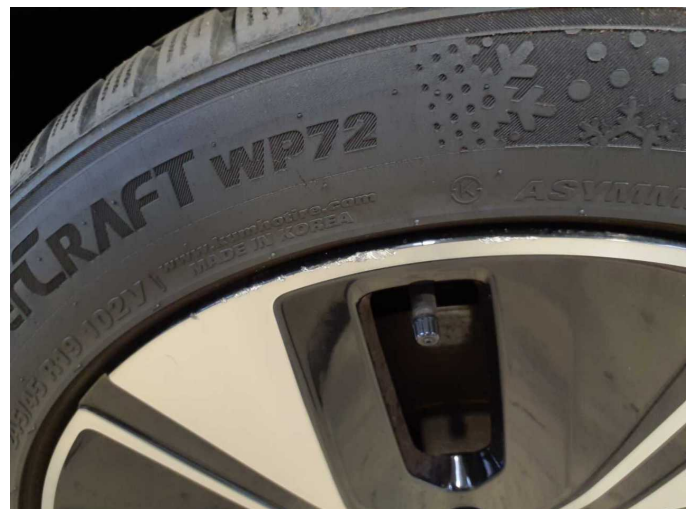
| No. | Component group | Description |
|---|---|---|
| 2 | Wheel / tyres | Alloy rim - front right side - Scratch(es) - Replace |

**Damage 2:** Wheel / tyres: Alloy rim - front right side - Scratch(es) - Replace
