Expertise

Protocol number: 46516716  
Order No. / Reference: 26431389  
Inspection date: 7 Jul 2026

Manufacturer: Volkswagen

Model: ID.4 Performance Upgrade Pro

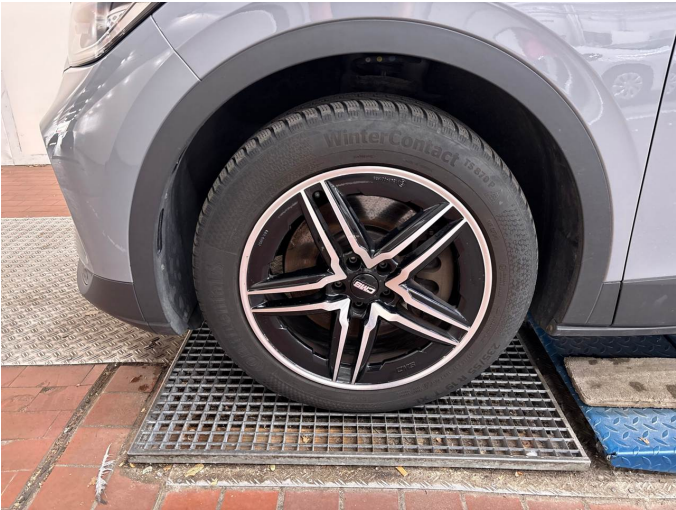
Figure 13: Mounted tyres

| # | Tyre size | Type of tyre | Manufacturer | Tread depth |
|---|---|---|---|---|
| 1) | 235/55 R19 105T | Winter tyres on Light alloy | Continental | 6mm / 6mm |
| 2) | 255/50 R19 107T | Winter tyres on Light alloy | Continental | 4mm / 4mm |

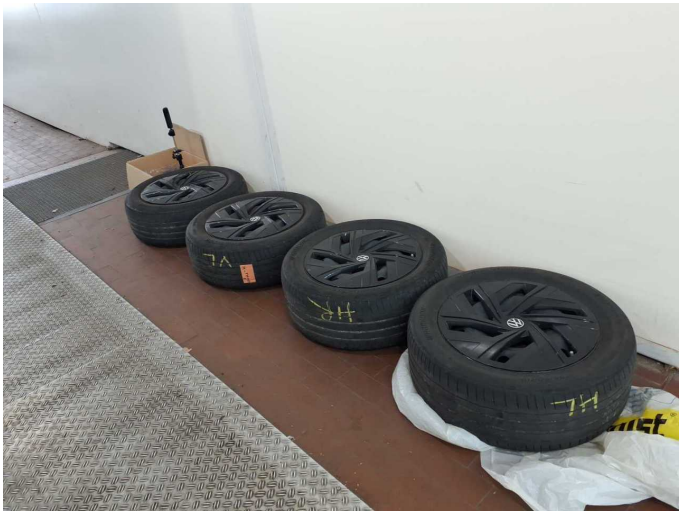
Figure 18: Additional tyres

| # | Tyre size | Type of tyre | Manufacturer | Tread depth |
|---|---|---|---|---|
| 1) | 235/55 R19 101H | Summer tyres on Steel rim with wheel cover | Hankook | 4mm / 4mm |
| 2) | 255/50 R19 103T | Summer tyres on Steel rim with wheel cover | Hankook | 3mm / 3mm |

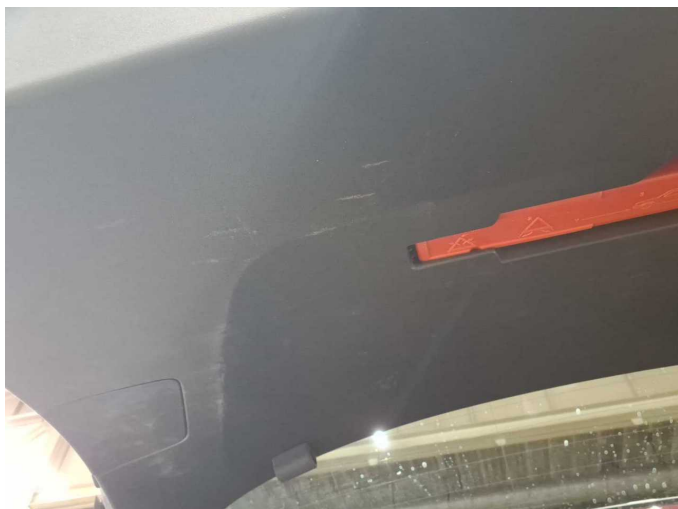
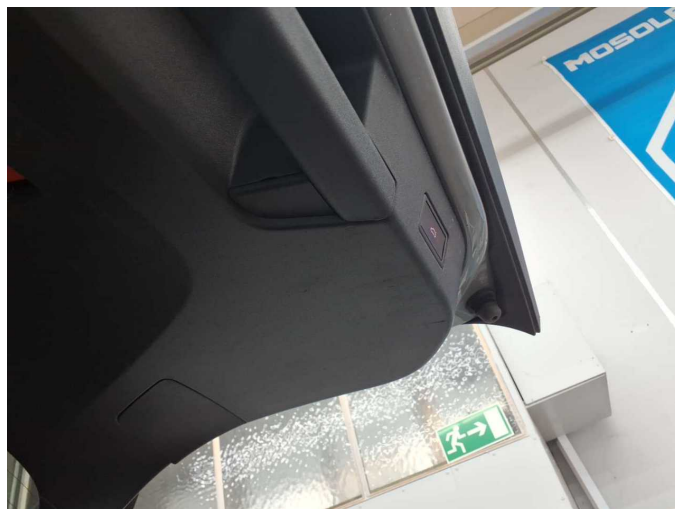
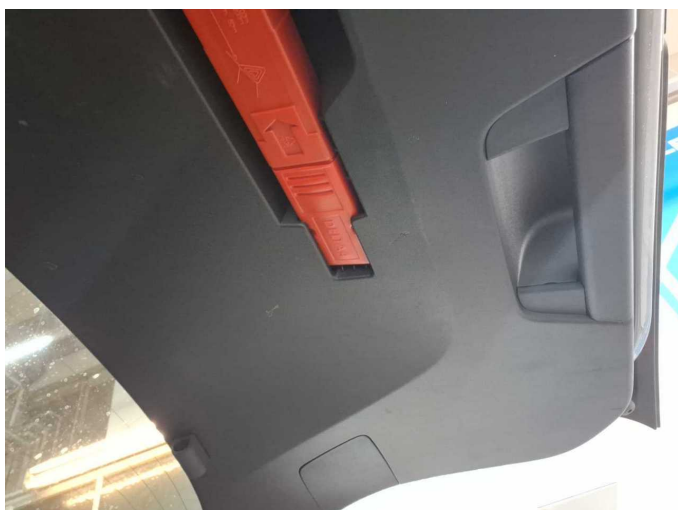
| No. | Component group | Description |
|---|---|---|
| 1 | Trim / covers | Boot lid - interior trim - Scratch(es) - Loss in value |

**Damage 1:** Trim / covers: Boot lid - interior trim - Scratch(es) - Loss in value

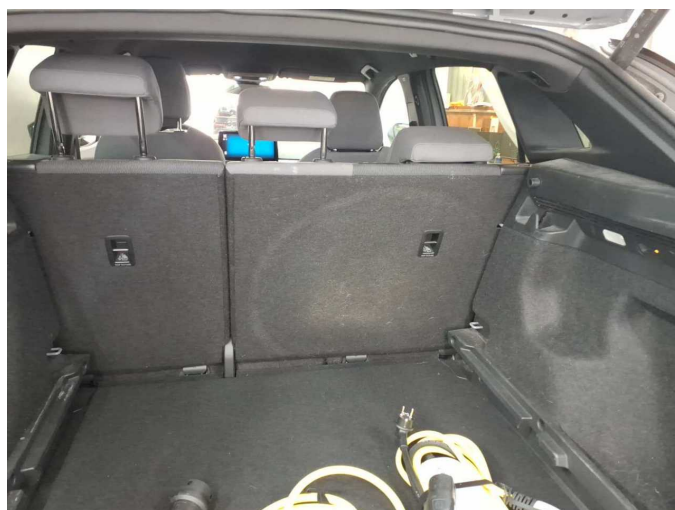
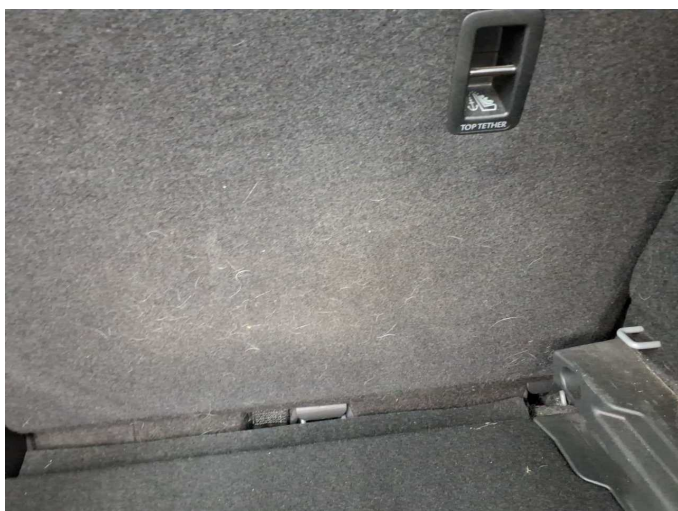
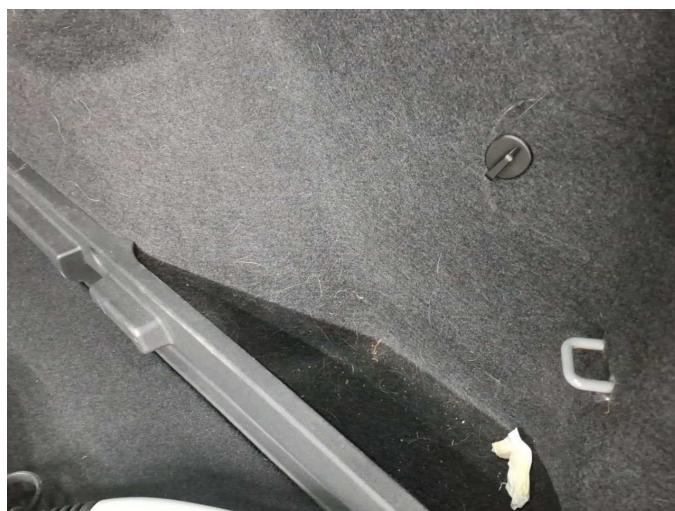
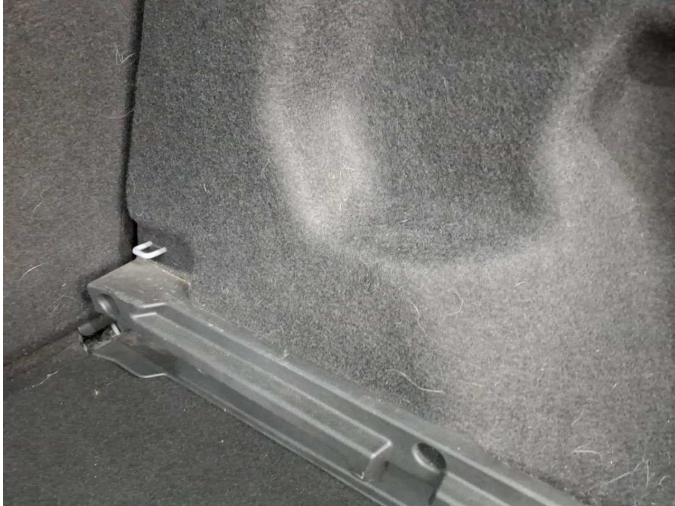
| No. | Component group | Description |
|---|---|---|
| 2 | Interior | Interior (Tierhaare) - Soiled - Clean |

**Damage 2:** Interior: Interior (Tierhaare) - Soiled - Clean

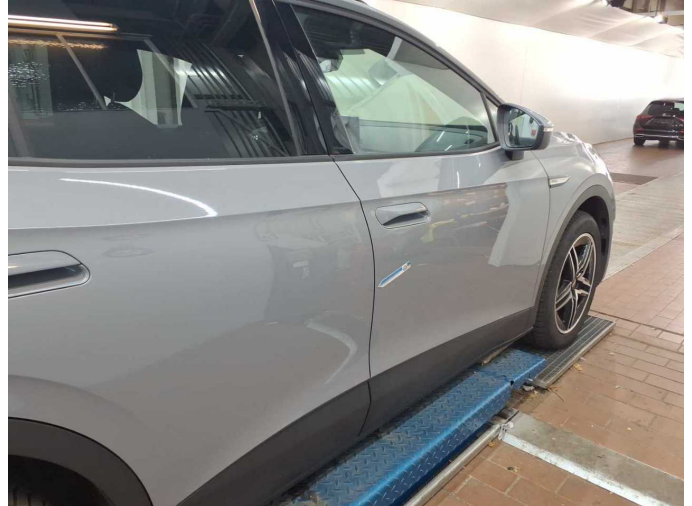
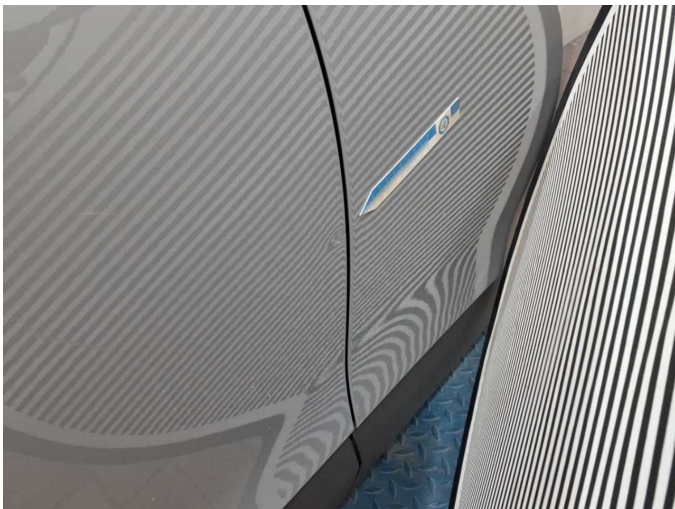
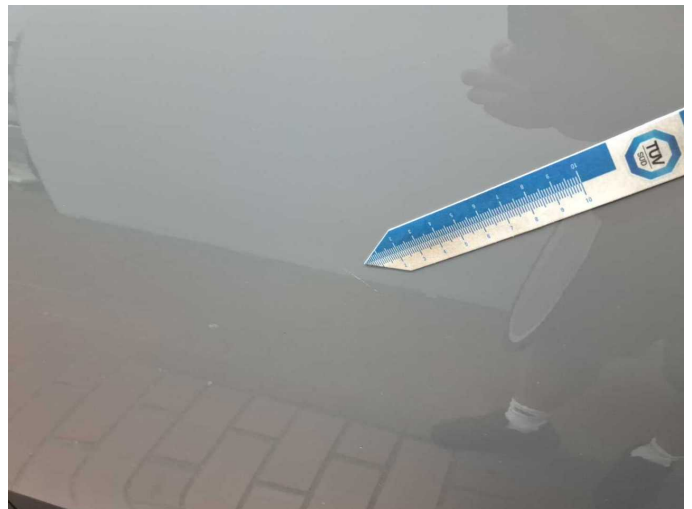
| No. | Component group | Description |
|---|---|---|
| 3 | Door - rear right side | Door (Mit Kratzer) - dent(s) - Repair and paint |

**Damage 3:** Door - rear right side: Door (Mit Kratzer) - dent(s) - Repair and paint

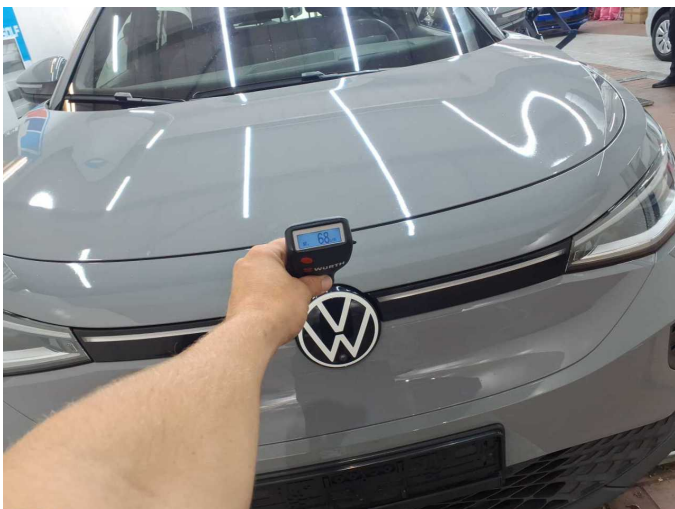
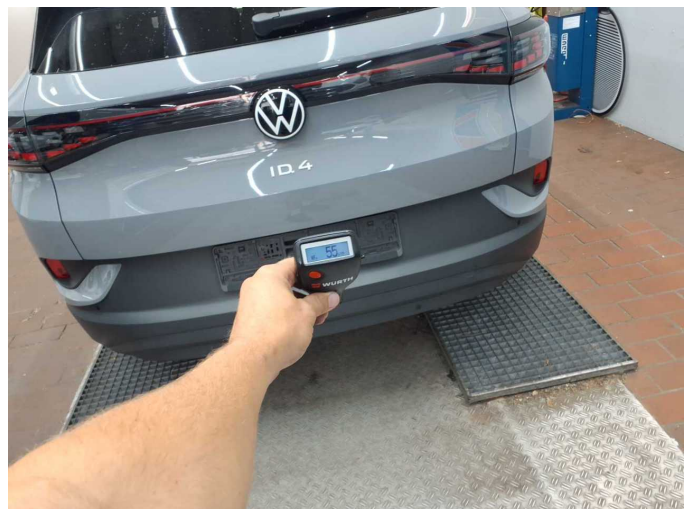
| No. | Previous damage | Extent of damage (Net) |
|---|---|---|
| 1 | Front, Rear, Provided by user / customer | 9.743,89 € |

According to available information previous damages were repaired at the vehicle. Traces of repairs, which allow conclusions about the area of repair, were not recognizable during the inspection.

**Previous damage 1:** Front, Rear
