Expertise

Protocol number: 46051586  
Order No. / Reference: 26528037  
Inspection date: 18 Jun 2026

| Manufacturer: Ford | Model: Focus 1.5 EcoBlue Start-Stopp-System Aut. TITANIUM X |

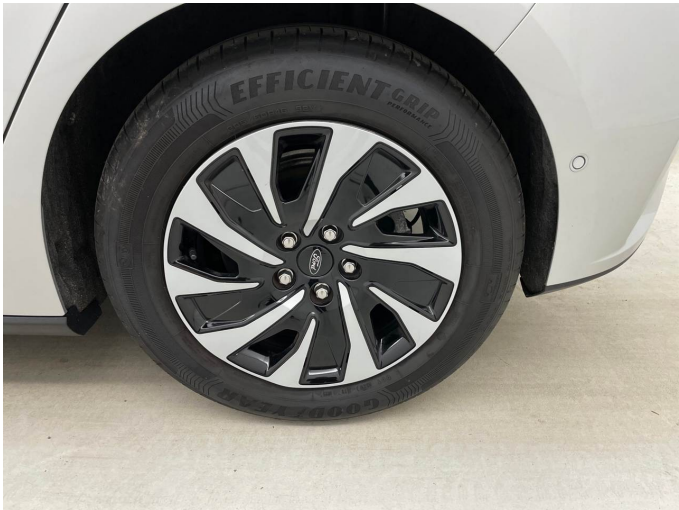
Figure 12: Mounted tyres

| # | Tyre size | Type of tyre | Manufacturer | Tread depth |
|---|---|---|---|---|
| 1) | 205/60 R16 92V | Summer tyres on Steel rim with wheel cover | Goodyear | 6mm / 6mm |
| 2) | 205/60 R16 92V | Summer tyres on Steel rim with wheel cover | Goodyear | 6mm / 6mm |

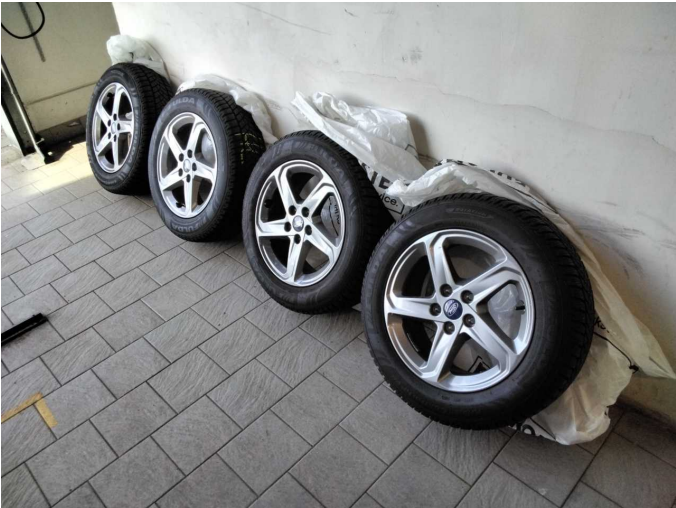
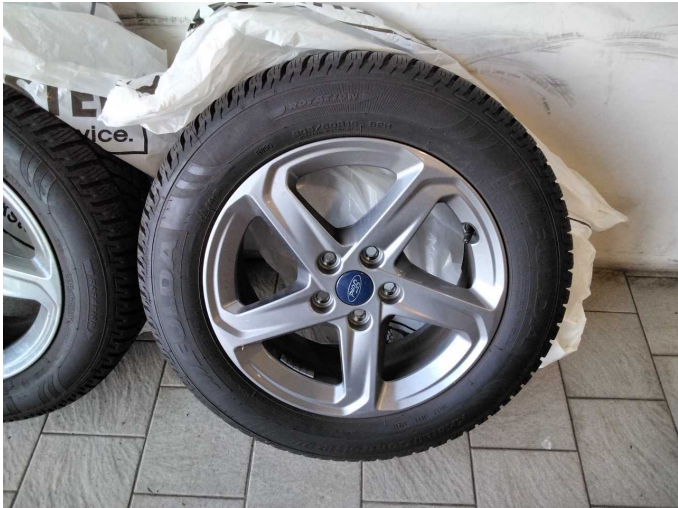
Figure 15: Additional tyres

| # | Tyre size | Type of tyre | Manufacturer | Tread depth |
|---|---|---|---|---|
| 1) | 205/60 R16 92H | Winter tyres on Light alloy | Fulda | 9mm / 9mm |
| 2) | 205/60 R16 92H | Winter tyres on Light alloy | Fulda | 8mm / 8mm |

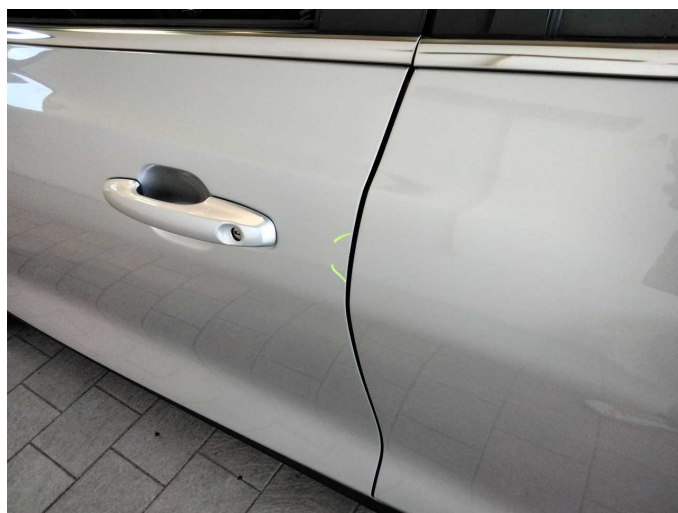
| No. | Component group | Description |
|---|---|---|
| 1 | Door - front left side | Door edge - Scratch(es) - Smart repair |

Damage 1: Door - front left side: Door edge - Scratch(es) - Smart repair

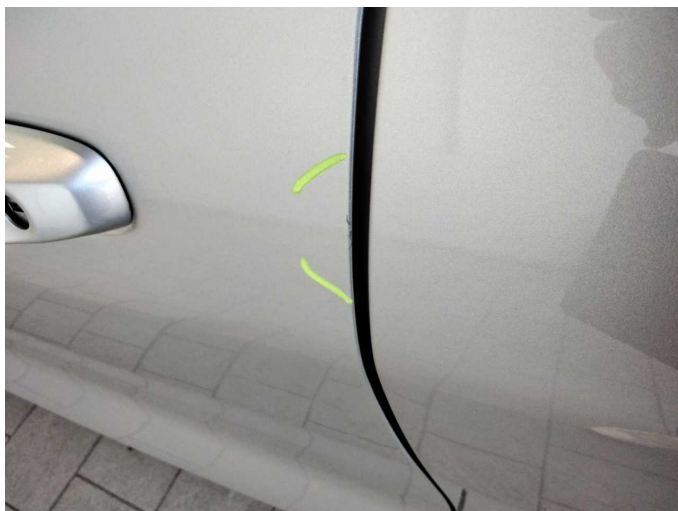
**Damage 1:** Door - front left side: Door edge - Scratch(es) - Smart repair

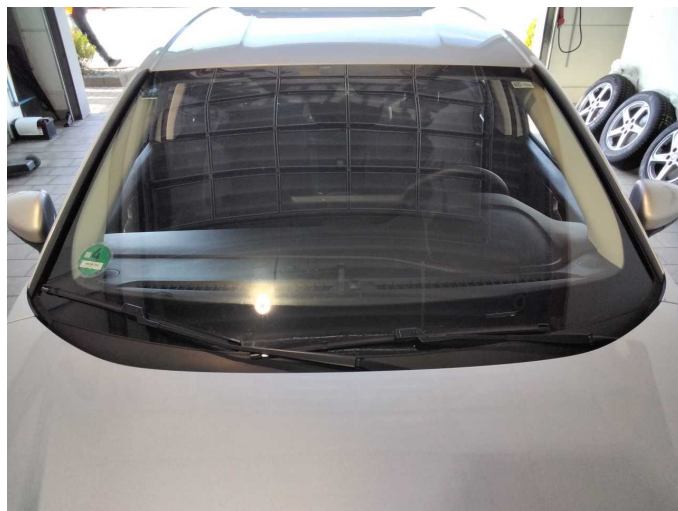
| No. | Component group | Description |
|---|---|---|
| 1 | Vehicle glazing | Windscreen - Stone chips - No deduction |

**Wear and tear 1:** Vehicle glazing: Windscreen - Stone chips - No deduction

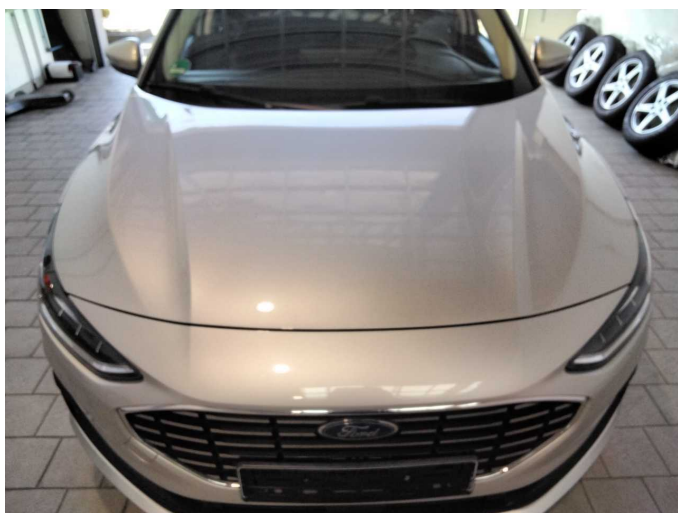
| No. | Component group | Description |
|---|---|---|
| 2 | Bonnet | Bonnet - Stone chips - No deduction |

**Wear and tear 2:** Bonnet: Bonnet - Stone chips - No deduction

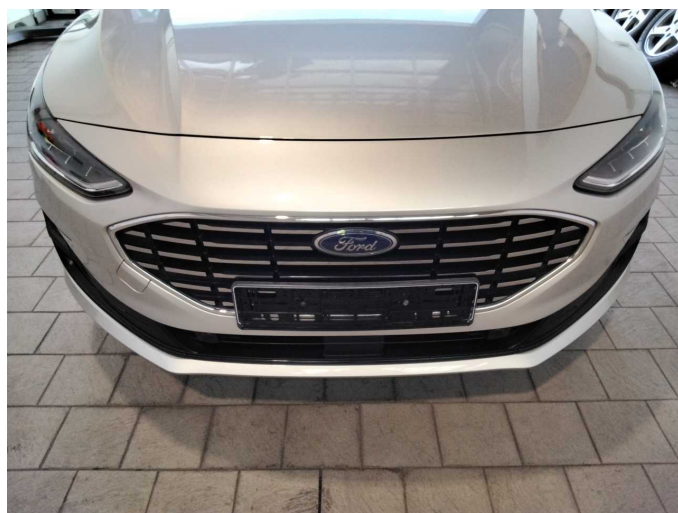
| No. | Component group | Description |
|---|---|---|
| 3 | Front bumper | Front bumper - Stone chips - No deduction |

**Wear and tear 3:** Front bumper: Front bumper - Stone chips - No deduction

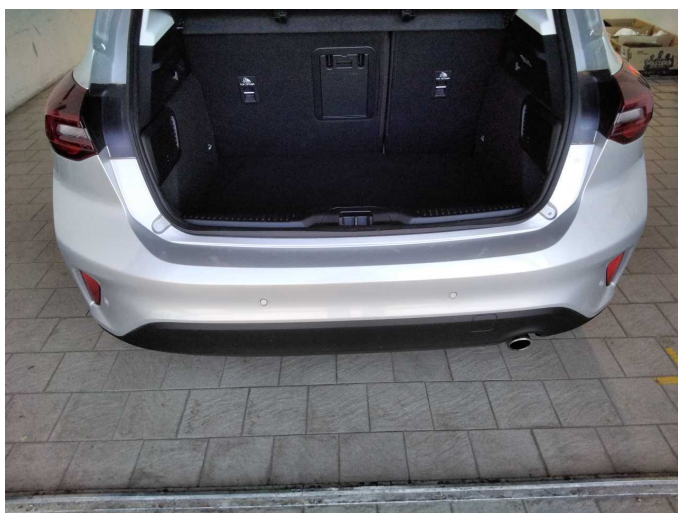
| No. | Component group | Description |
|---|---|---|
| 4 | Rear bumper | Rear bumper - Scratch(es) - No deduction |

**Wear and tear 4:** Rear bumper: Rear bumper - Scratch(es) - No deduction
