Expertise

Protocol number: 46562559  
Order No. / Reference: 26699627  
Inspection date: 10 Jul 2026

Manufacturer: Volkswagen  
VIN: WVVZZZCDXPW148955

Model: Golf 2.0 TDI SCR DSG Life

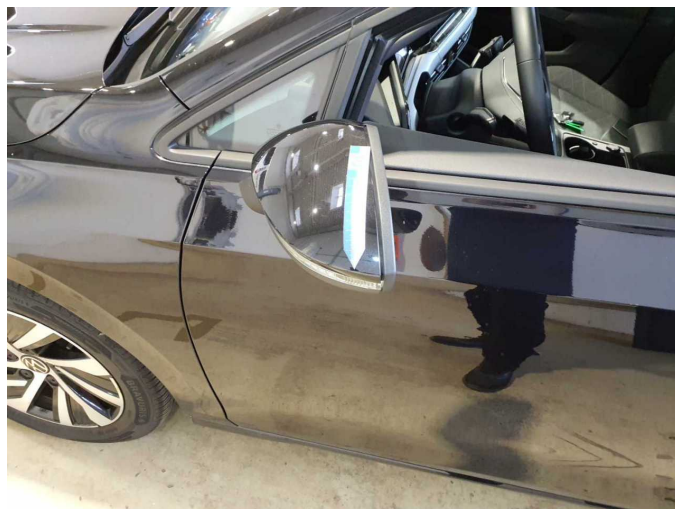
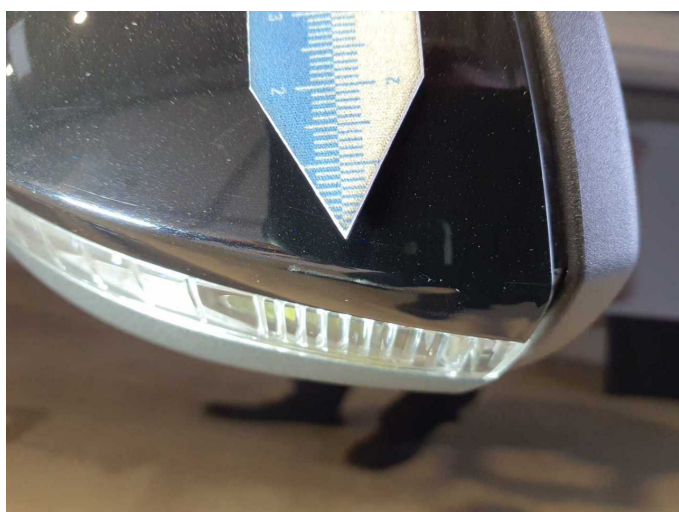
| No. | Component group | Description |
|---|---|---|
| 1 | Wing mirror - left side | Cap - Scratch(es) - Smart repair |

**Damage 1:** Wing mirror - left side: Cap - Scratch(es) - Smart repair

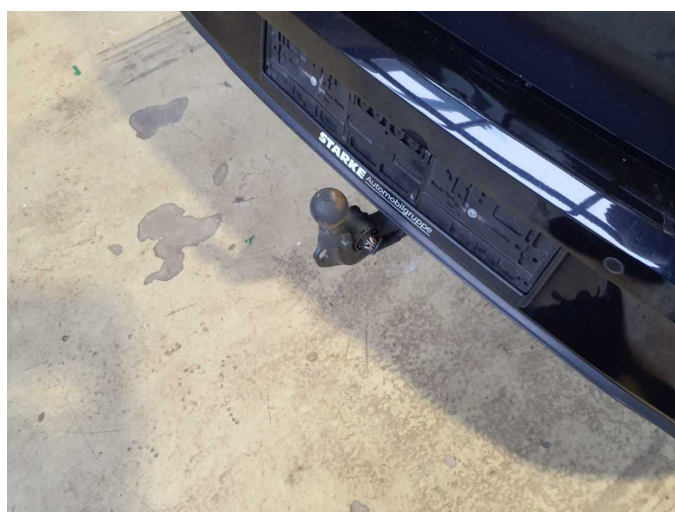
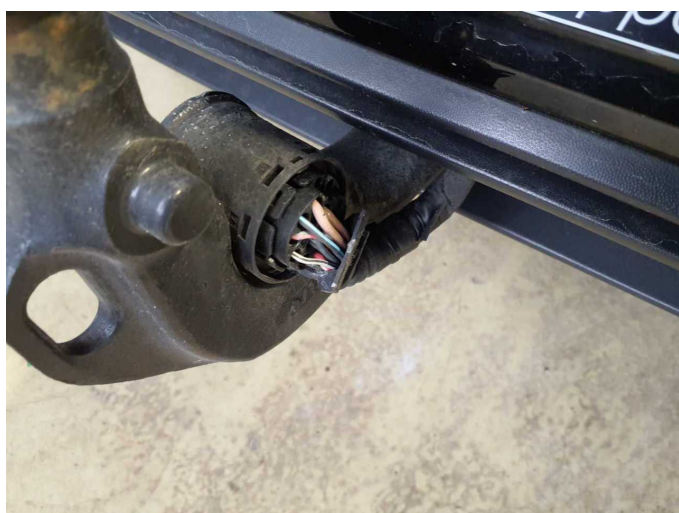
| No. | Component group | Description |
|---|---|---|
| 2 | Electrical system | Power socket - Broken / torn - Replace |

**Damage 2:** Electrical system: Power socket - Broken / torn - Replace

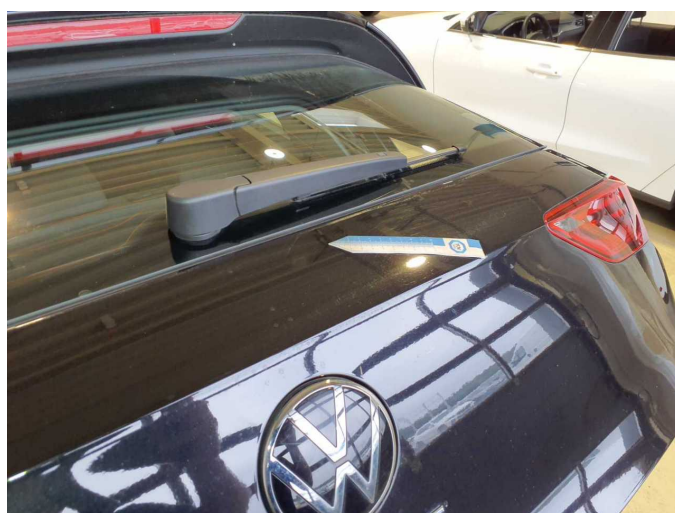
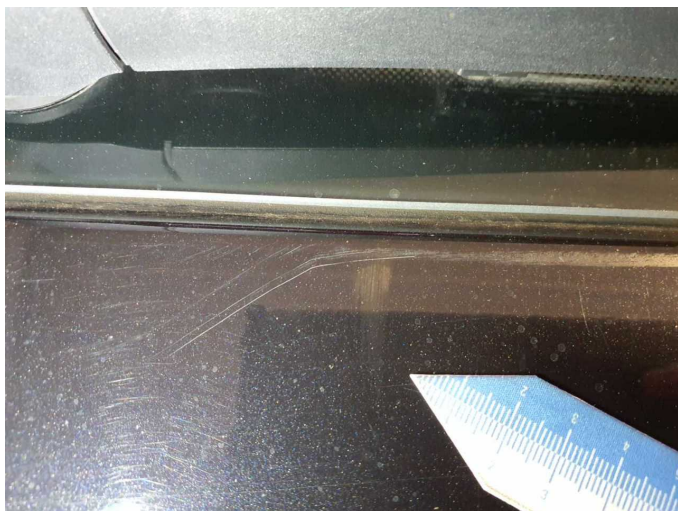
| No. | Component group | Description |
|---|---|---|
| 3 | Boot lid / rear door | Boot lid - Scratch(es) - Smart repair |

**Damage 3:** Boot lid / rear door: Boot lid - Scratch(es) - Smart repair

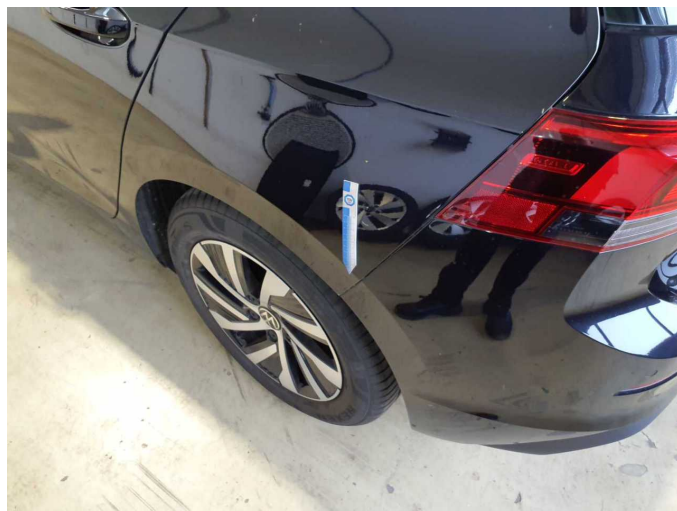
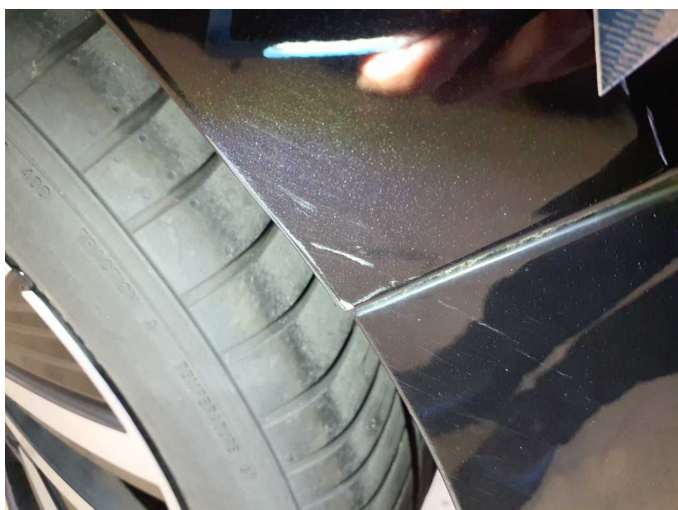
| No. | Component group | Description |
|---|---|---|
| 4 | Side panel - rear left side | Side panel - Scratch(es) - Smart repair |

**Damage 4:** Side panel - rear left side: Side panel - Scratch(es) - Smart repair

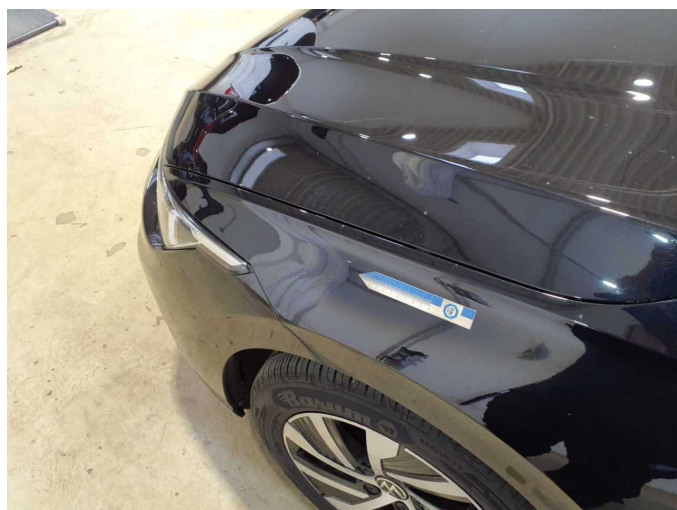
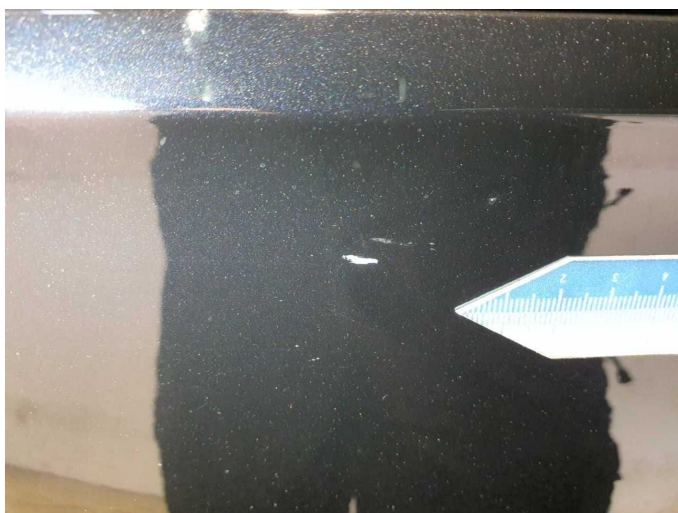
| No. | Component group | Description |
|---|---|---|
| 5 | Mudguard - left side | Mudguard - left side - Scratch(es) - Smart repair |

**Damage 5:** Mudguard - left side: Mudguard - left side - Scratch(es) - Smart repair

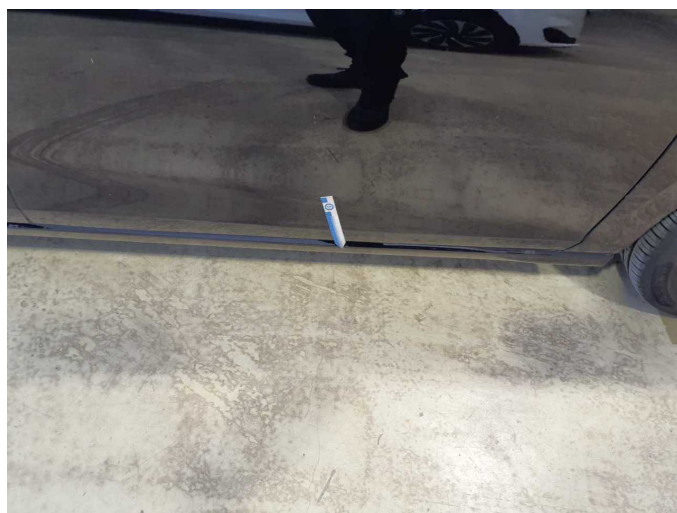
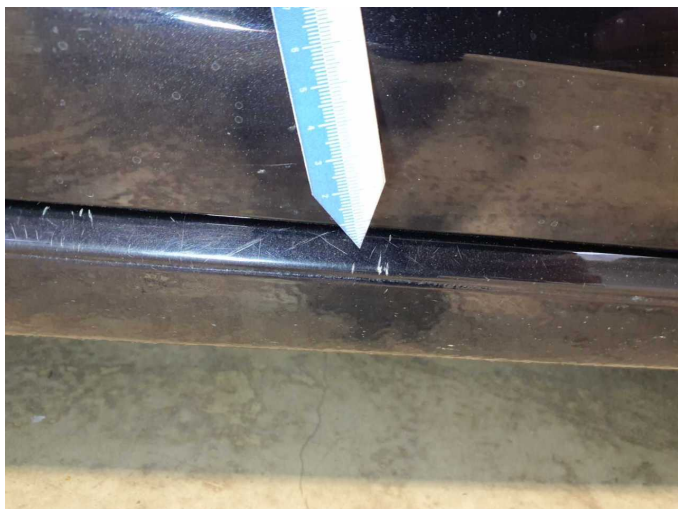
| No. | Component group | Description |
|---|---|---|
| 6 | Sill - right side | Sill - Scratch(es) - Smart repair |

**Damage 6:** Sill - right side: Sill - Scratch(es) - Smart repair

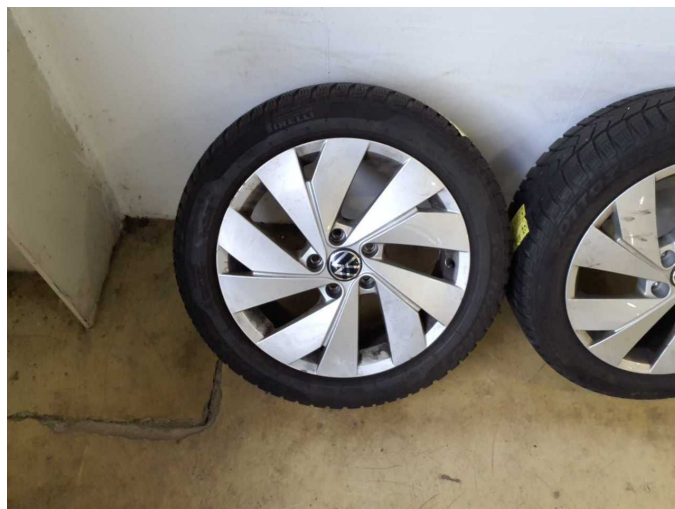
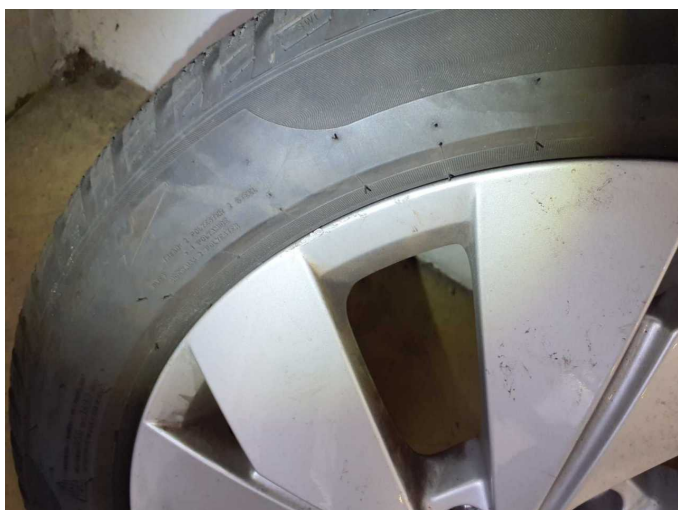
| No. | Component group | Description |
|---|---|---|
| 7 | 2nd wheel set | 1 alloy rim - Scratch(es) - Loss in value |

**Damage 7:** 2nd wheel set: 1 alloy rim - Scratch(es) - Loss in value

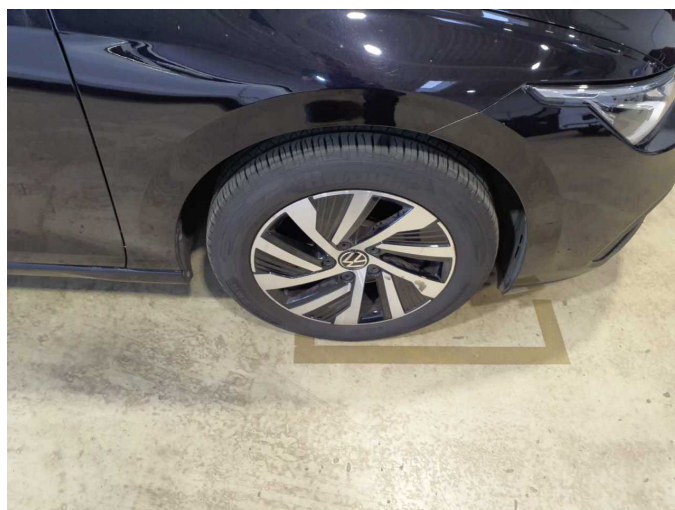
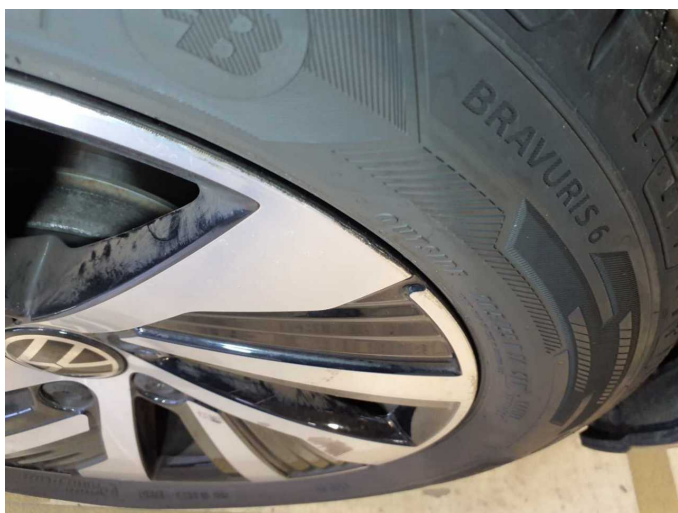
| No. | Component group | Description |
|---|---|---|
| 8 | Wheel / tyres | Alloy rim - front right side - Scratch(es) - Loss in value |

**Damage 8:** Wheel / tyres: Alloy rim - front right side - Scratch(es) - Loss in value

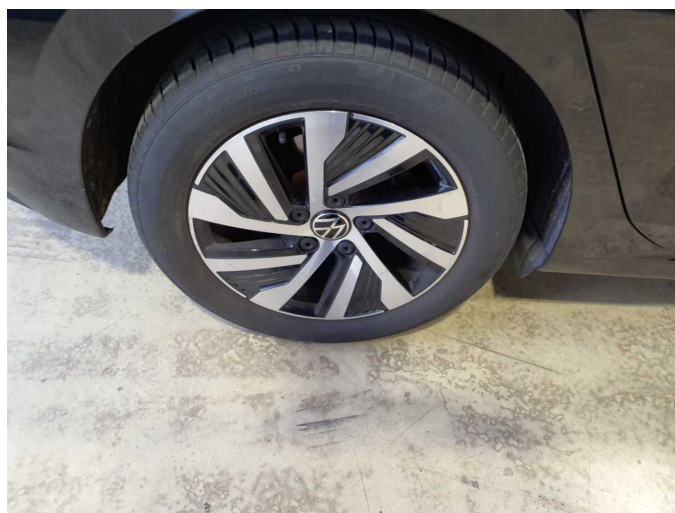
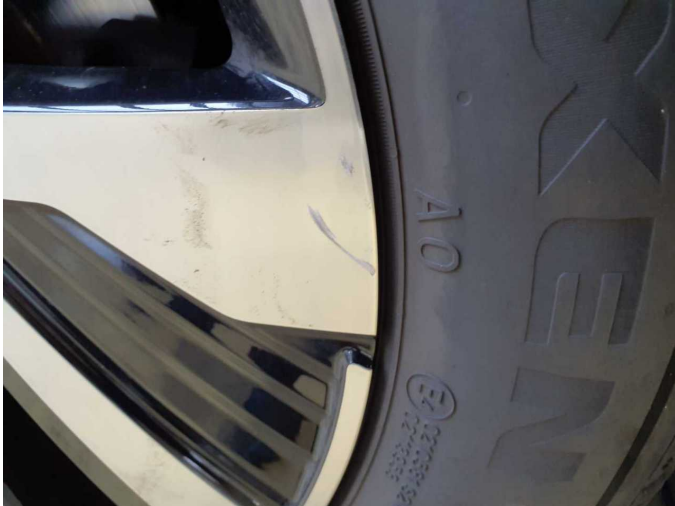
| No. | Component group | Description |
|---|---|---|
| 9 | Wheel / tyres | Alloy rim - rear right side - Scratch(es) - Loss in value |

**Damage 9:** Wheel / tyres: Alloy rim - rear right side - Scratch(es) - Loss in value

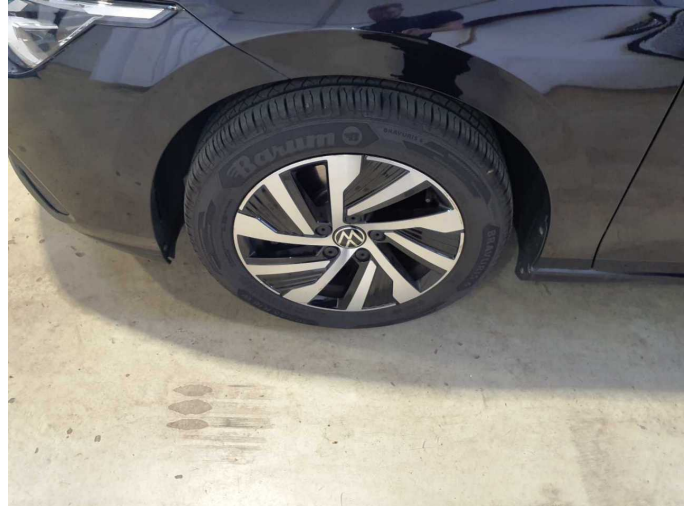
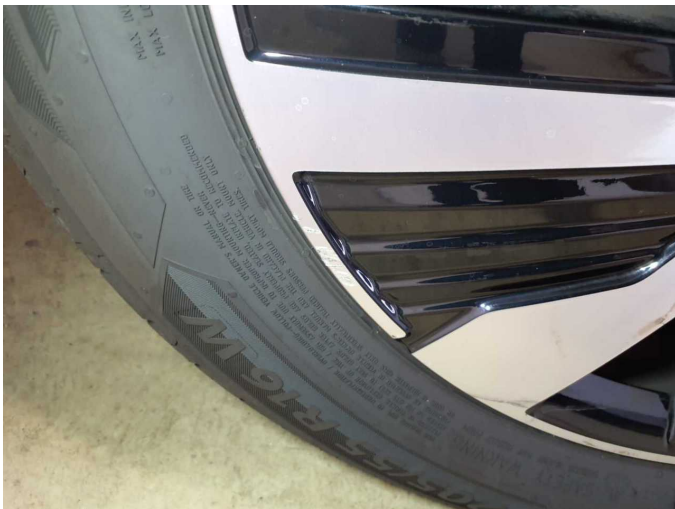
| No. | Component group | Description |
|---|---|---|
| 10 | Wheel / tyres | Alloy rim - front left side - Scratch(es) - Loss in value |

**Damage 10:** Wheel / tyres: Alloy rim - front left side - Scratch(es) - Loss in value

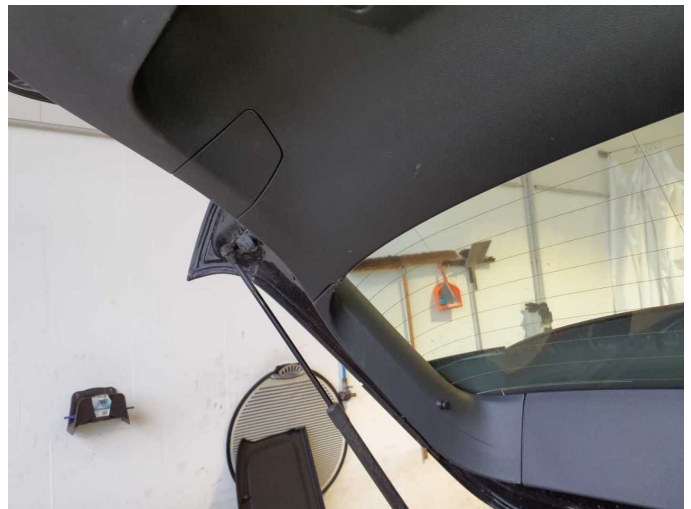
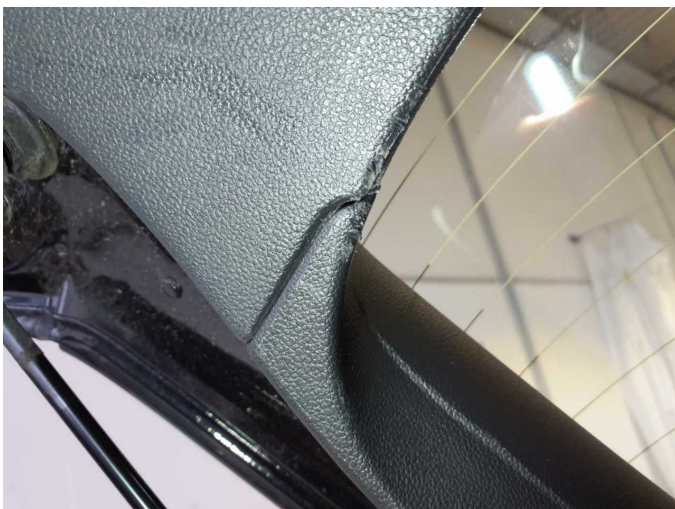
| No. | Component group | Description |
|---|---|---|
| 11 | Trim / covers | Boot lid - interior trim - Scratch(es) - Replace |

**Damage 11:** Trim / covers: Boot lid - interior trim - Scratch(es) - Replace

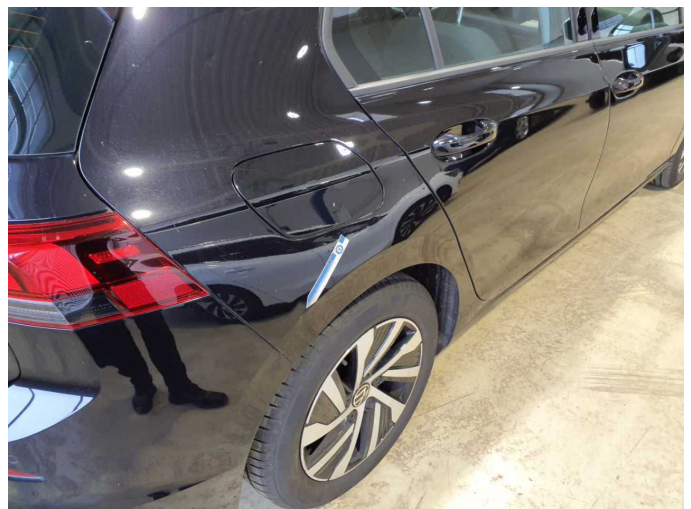
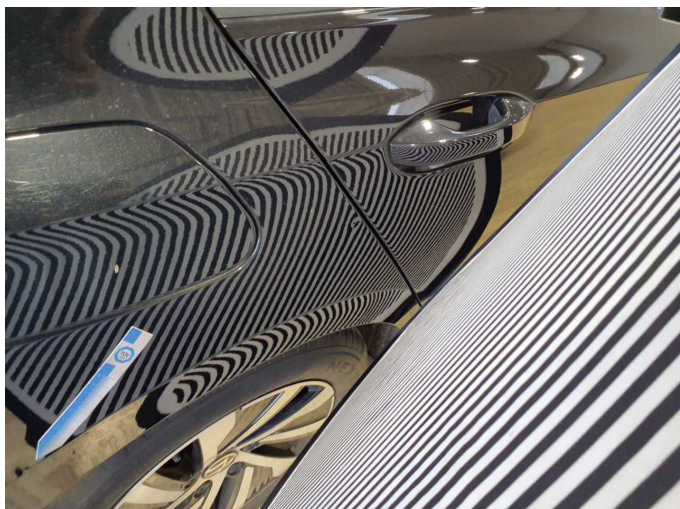
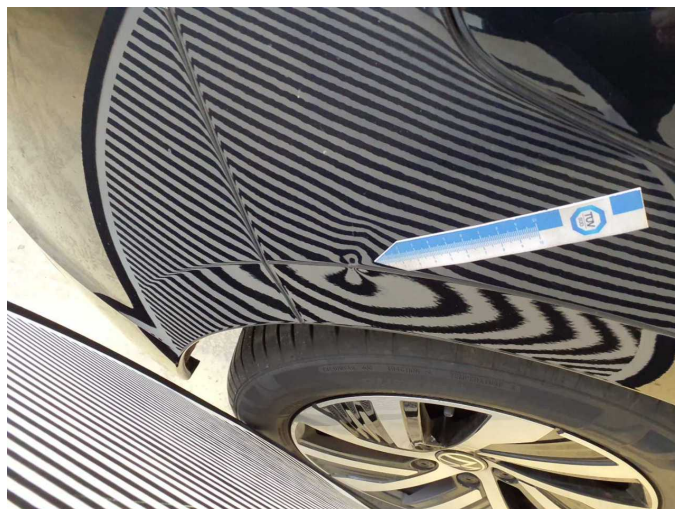
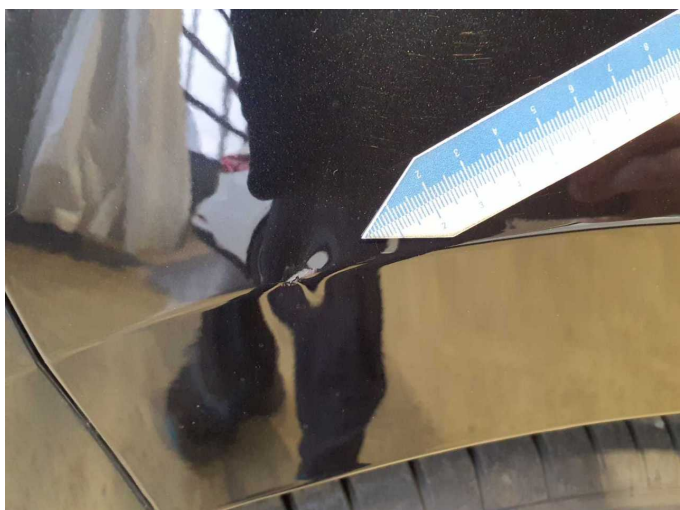
| No. | Component group | Description |
|---|---|---|
| 12 | Side panel - rear right side | Side panel - Dent / paintcoat damage - Repair and paint |

**Damage 12:** Side panel - rear right side: Side panel - Dent / paintcoat damage - Repair and paint

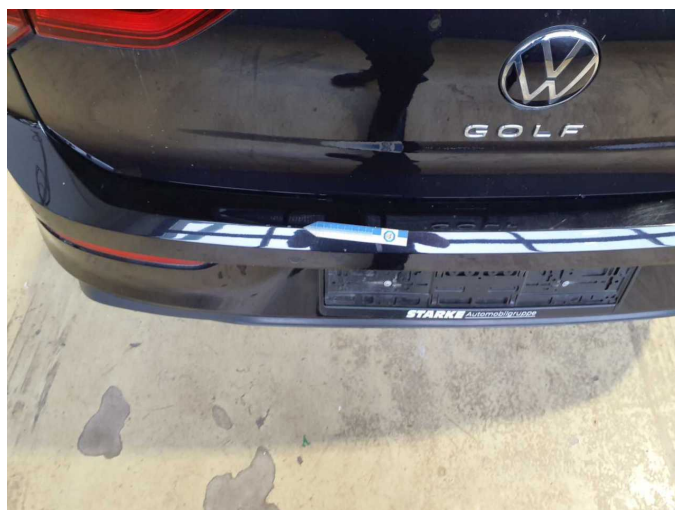
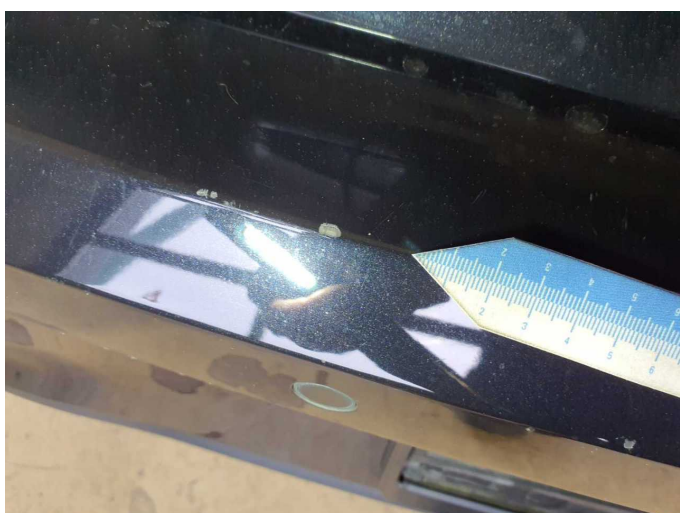
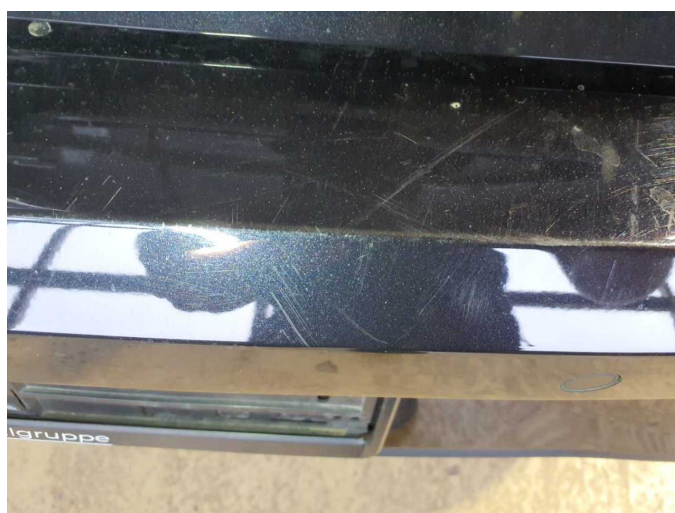
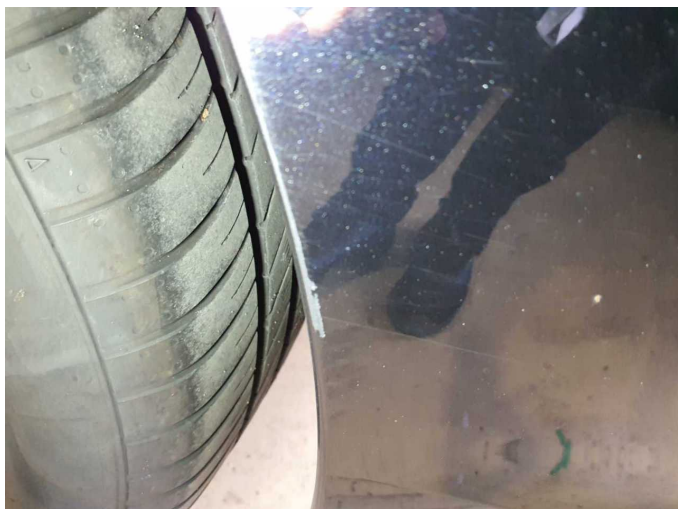
| No. | Component group | Description |
|---|---|---|
| 13 | Rear bumper | Rear bumper - Scratch(es) - Paint |

**Damage 13:** Rear bumper: Rear bumper - Scratch(es) - Paint

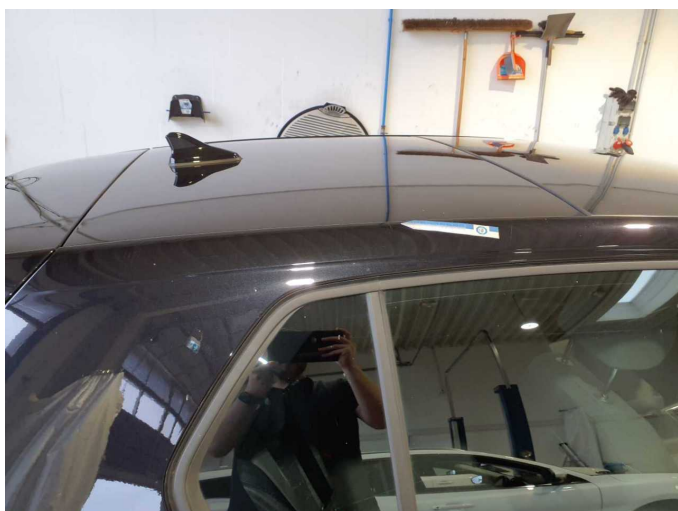
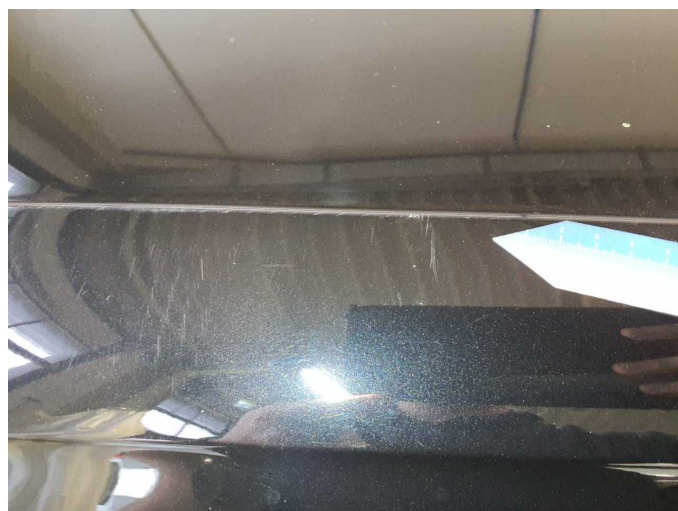
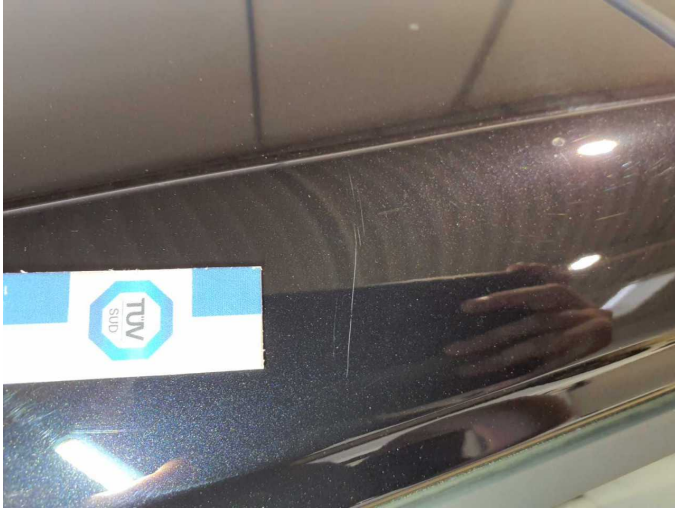
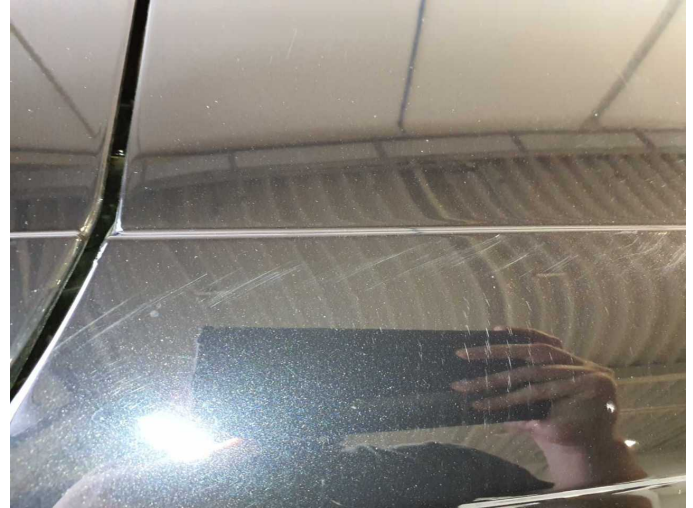
| No. | Component group | Description |
|---|---|---|
| 15 | Roof | Roof rail - right side - Scratch(es) - Paint |

**Damage 15:** Roof: Roof rail - right side - Scratch(es) - Paint

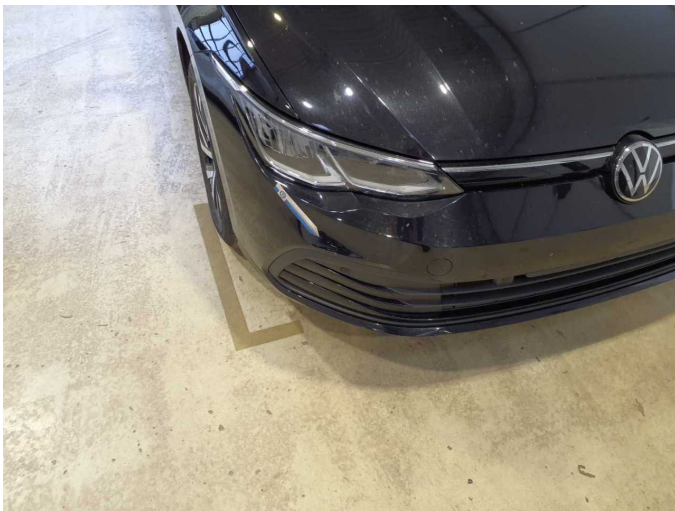
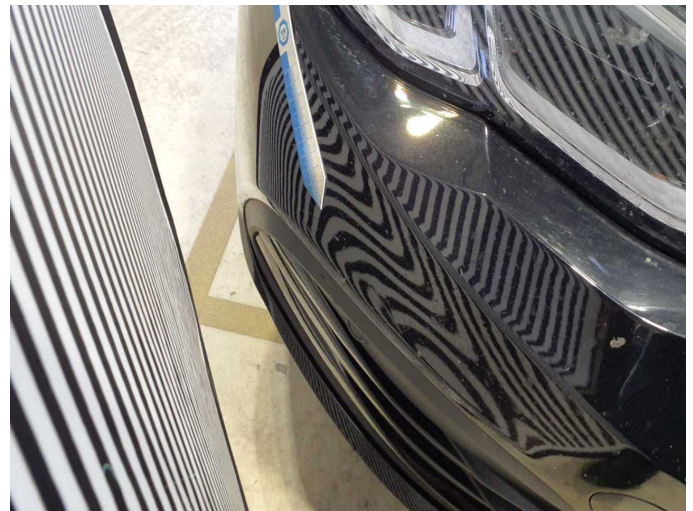
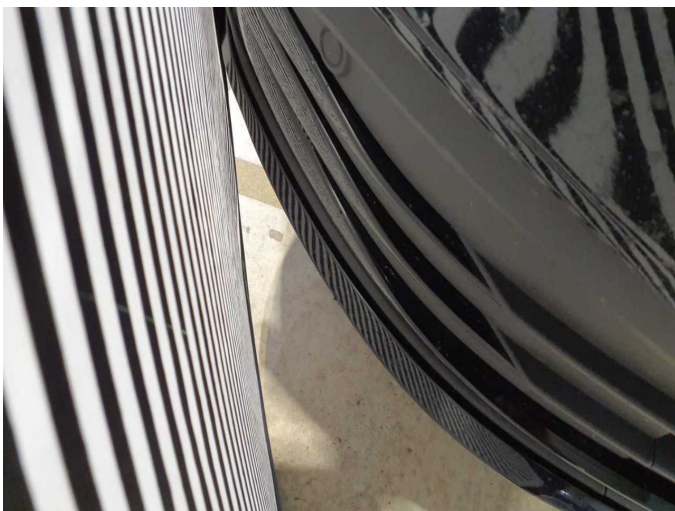
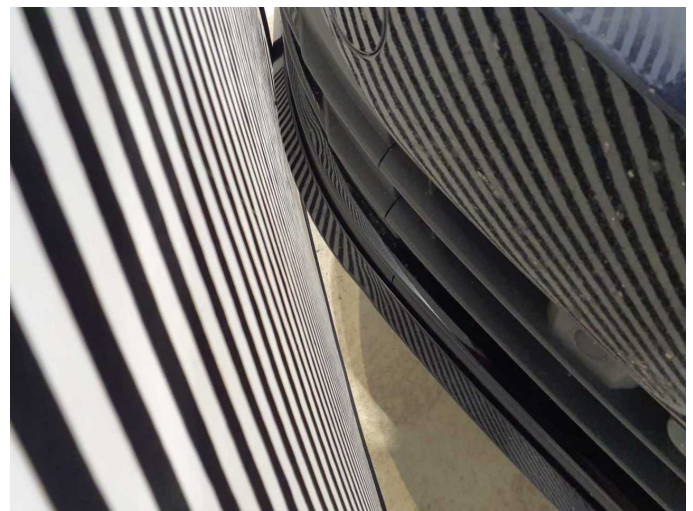
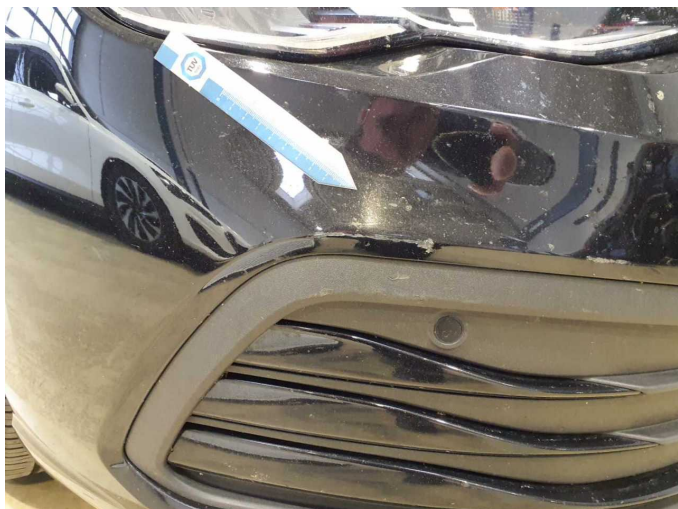
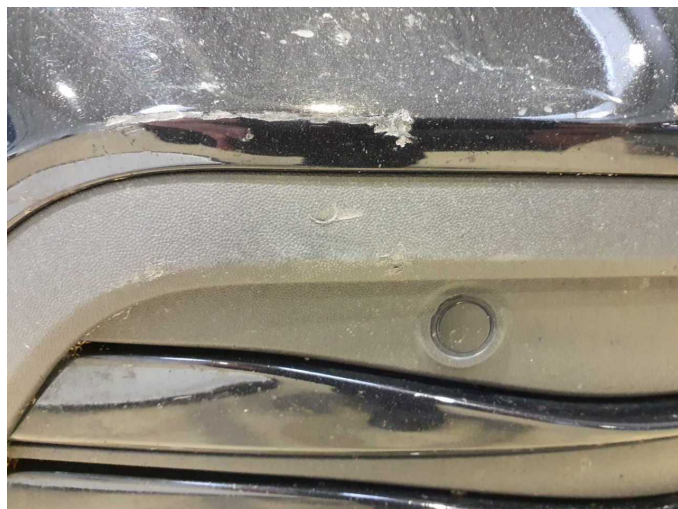
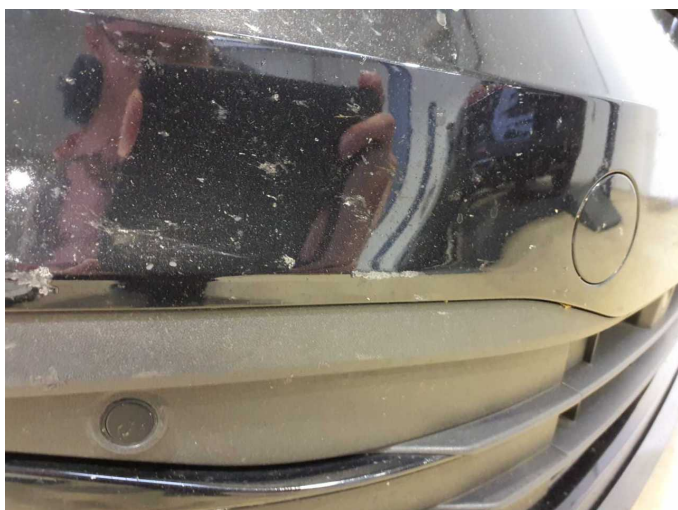
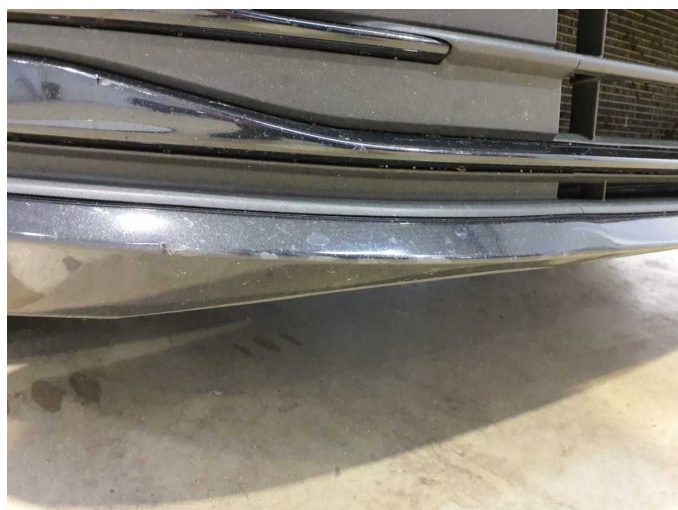
| No. | Component group | Description |
|---|---|---|
| 16 | Front bumper | Front bumper (Inklusive Blende erneuern) - Dent / paintcoat damage - Repair and paint |

**Damage 16:** Front bumper: Front bumper (Inklusive Blende erneuern) - Dent / paintcoat damage - Repair and paint

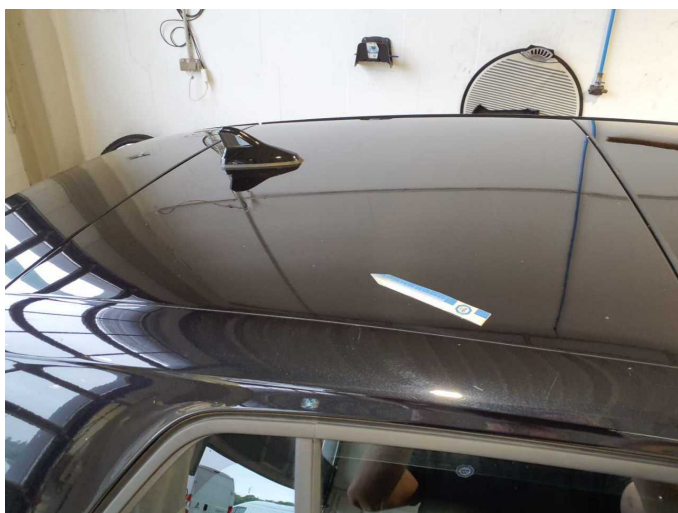
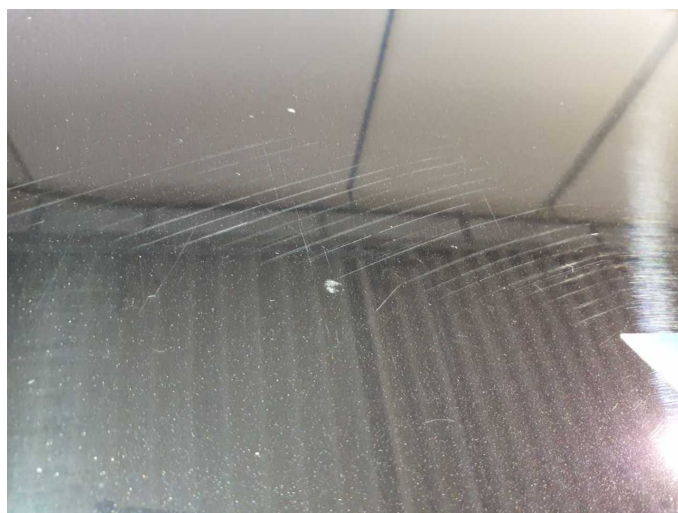
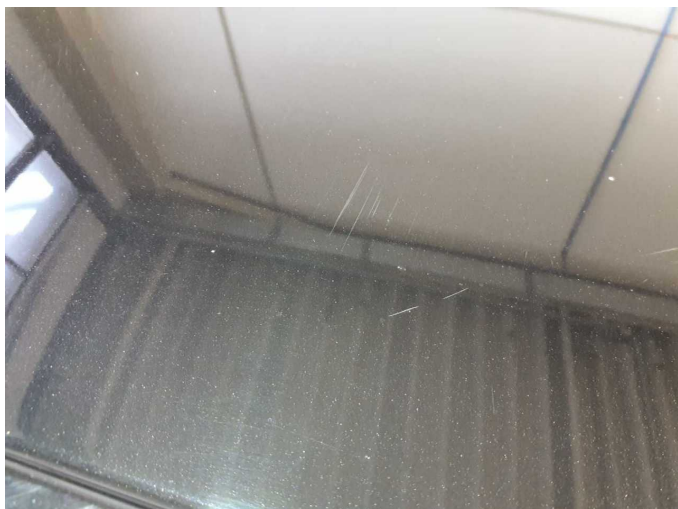
| No. | Component group | Description |
|---|---|---|
| 17 | Roof | Roof - Scratch(es) - Paint |

**Damage 17:** Roof: Roof - Scratch(es) - Paint
