Expertise

Protocol number: 47096249  
Order No. / Reference: 26867545  
Inspection date: 14 Aug 2026

Manufacturer: Volkswagen

Model: Tiguan 2.0 TDI SCR 4MOTION DSG URBAN SPORT

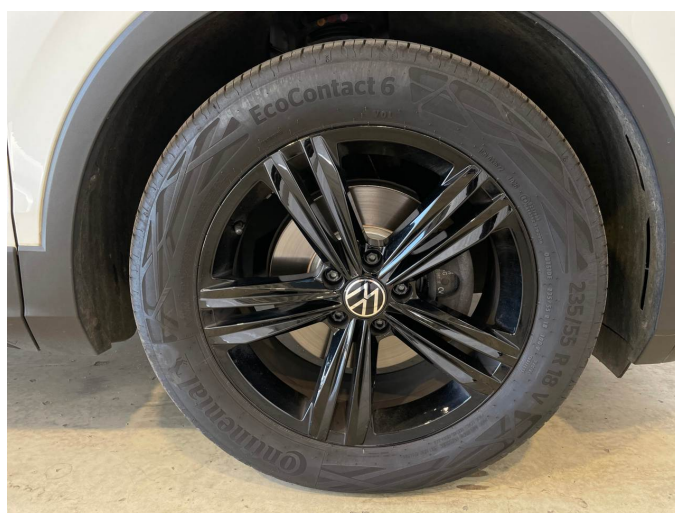
Figure 12: Mounted tyres

| # | Tyre size | Type of tyre | Manufacturer | Tread depth |
|---|---|---|---|---|
| 1) | 235/55 R18 100V | Summer tyres on Light alloy | Continental | 6mm / 6mm |
| 2) | 235/55 R18 100V | Summer tyres on Light alloy | Continental | 6mm / 6mm |

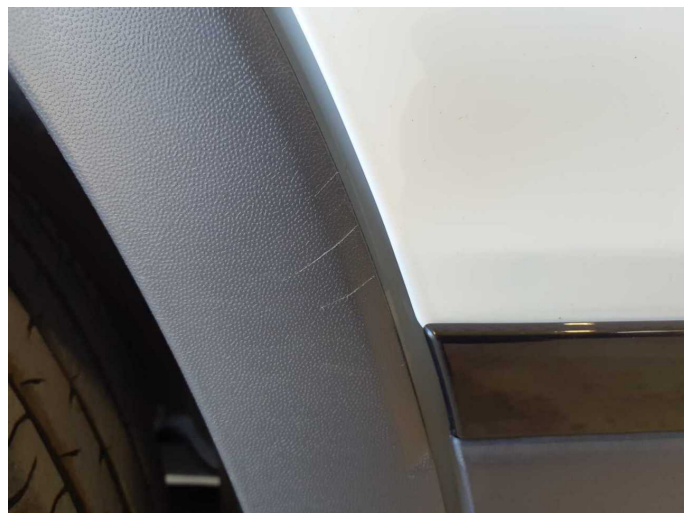
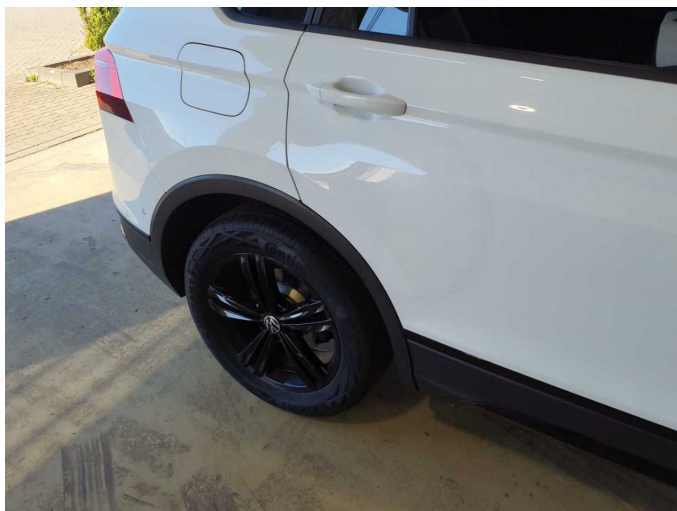
| No. | Component group | Description |
|---|---|---|
| 1 | Side panel - rear right side | Wheel well extension - Scratch(es) - Loss in value |

**Damage 1:** Side panel - rear right side: Wheel well extension - Scratch(es) - Loss in value

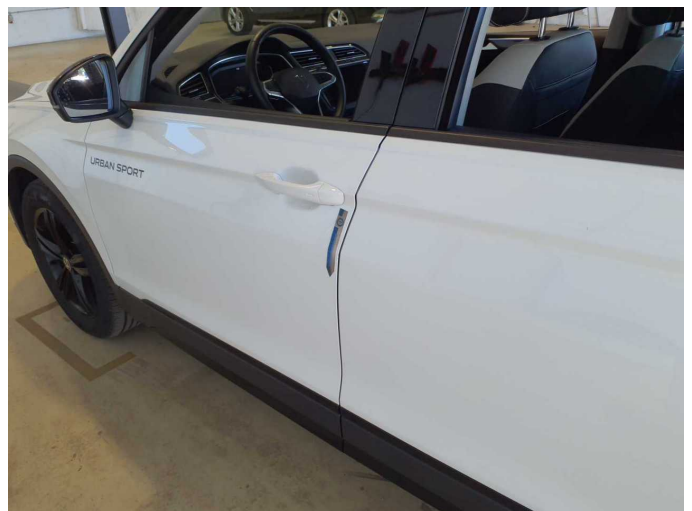
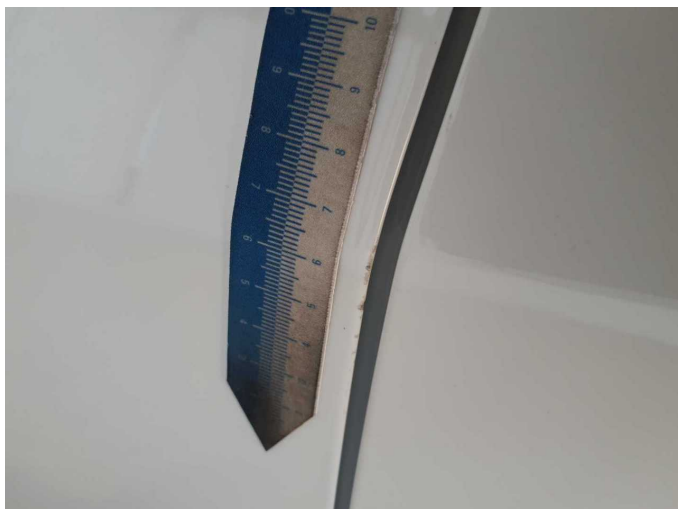
| No. | Component group | Description |
|---|---|---|
| 2 | Door - front left side | Door edge - Scratch(es) - Smart repair |

**Damage 2:** Door - front left side: Door edge - Scratch(es) - Smart repair

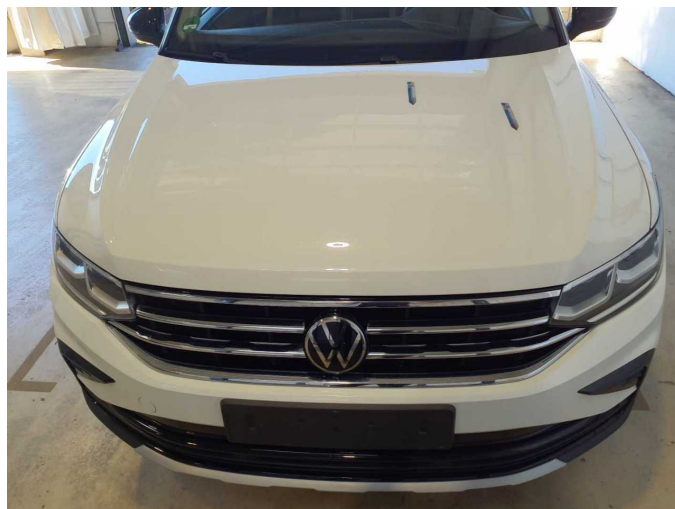
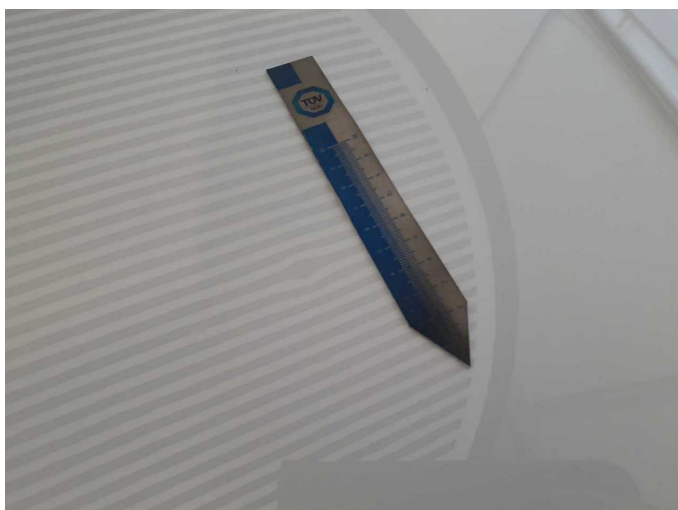
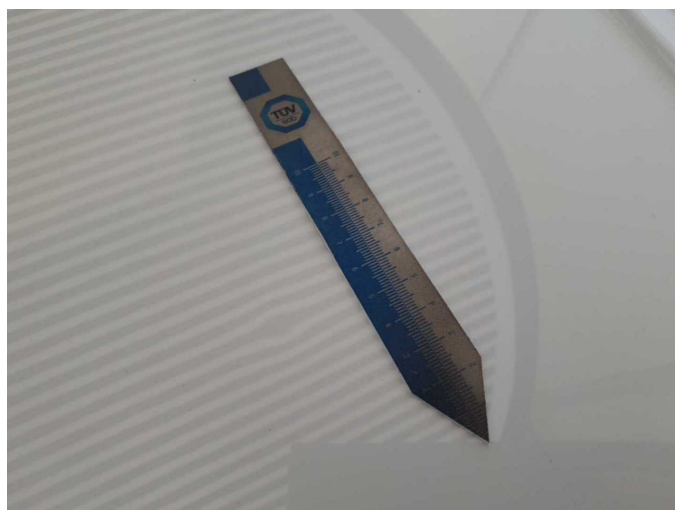
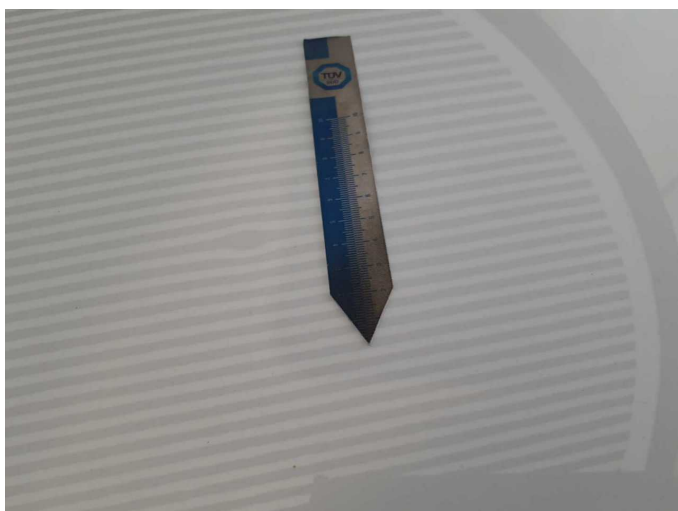
| No. | Component group | Description |
|---|---|---|
| 3 | Bonnet | Bonnet - dent(s) - Smooth repair work |

**Damage 3:** Bonnet: Bonnet - dent(s) - Smooth repair work

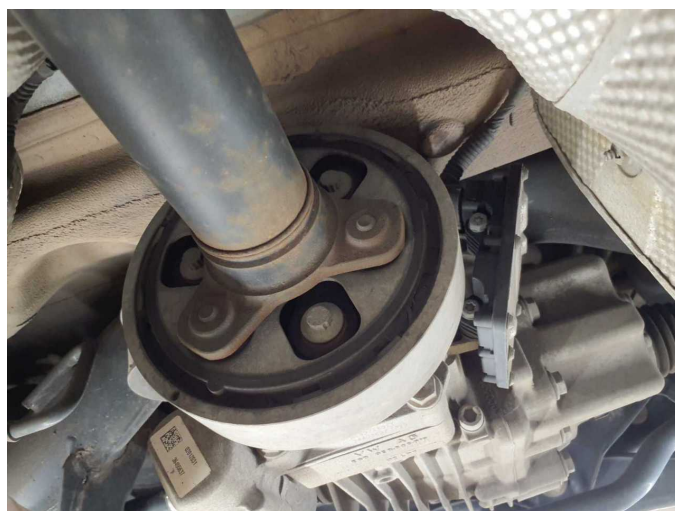
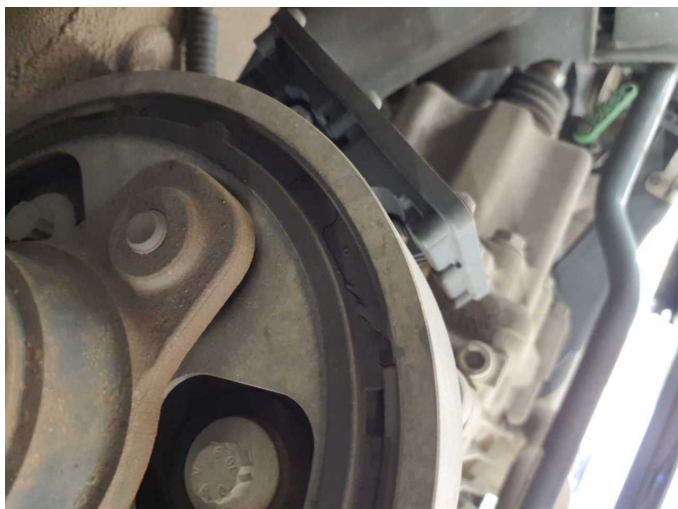
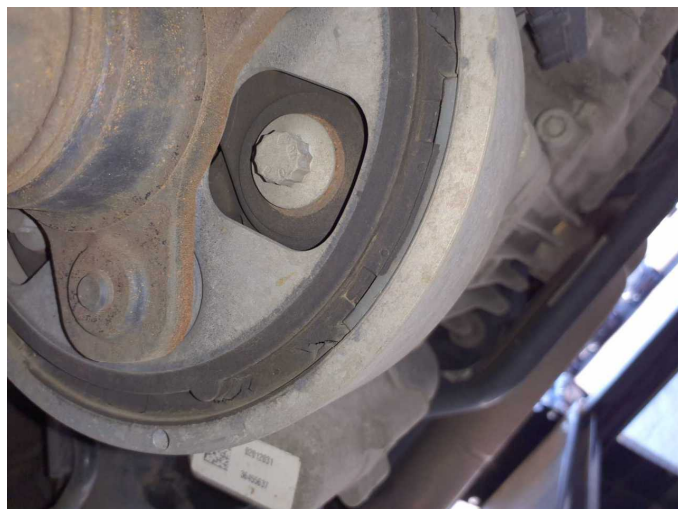
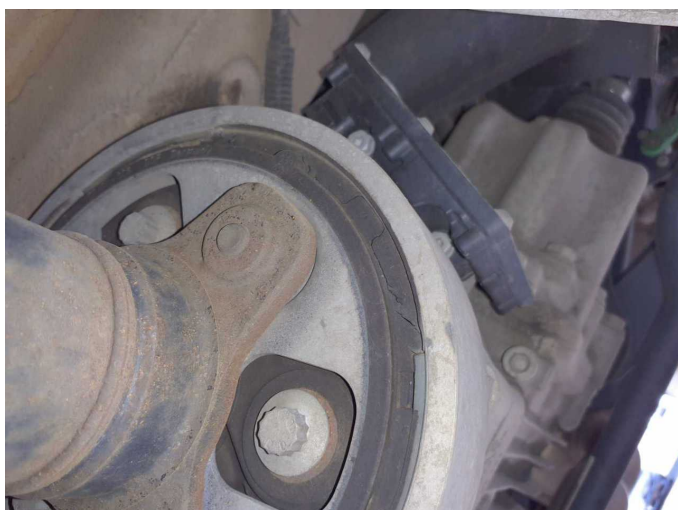
| No. | Component group | Description |
|---|---|---|
| 4 | Drive train | Drive train (Harddiscs) - Porous / cracked - Replace |

**Damage 4:** Drive train: Drive train (Harddiscs) - Porous / cracked - Replace

**Damage 4:** Drive train: Drive train (Harddiscscheibe) - Porous / cracked - Replace

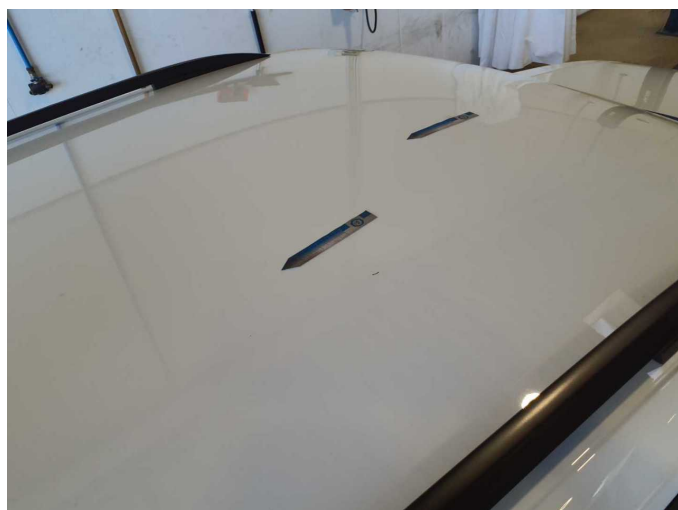
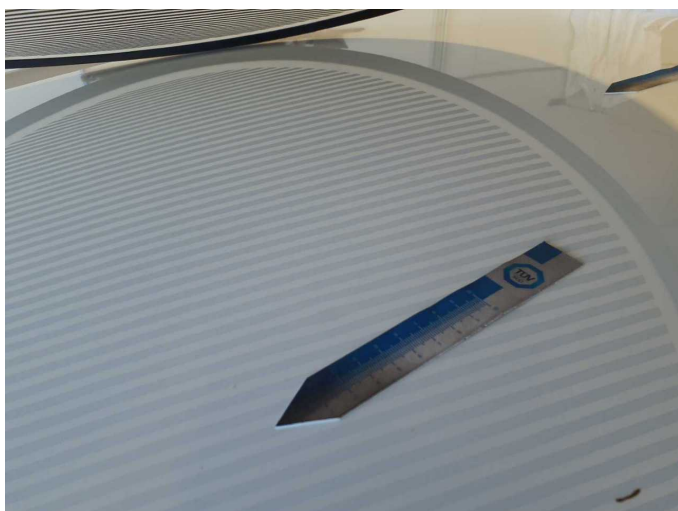
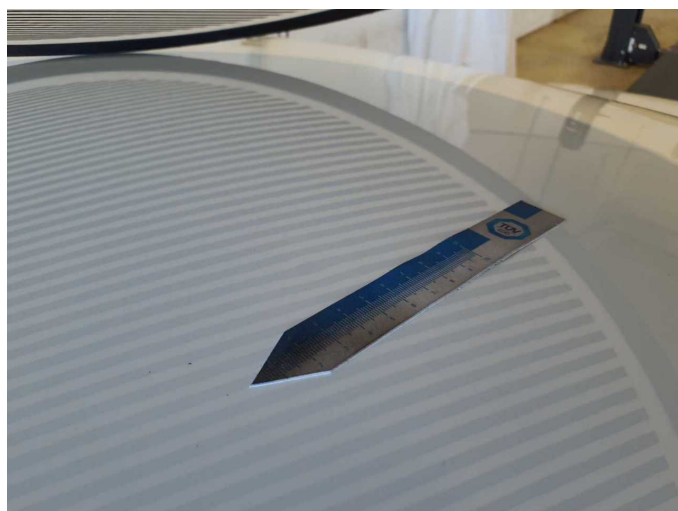
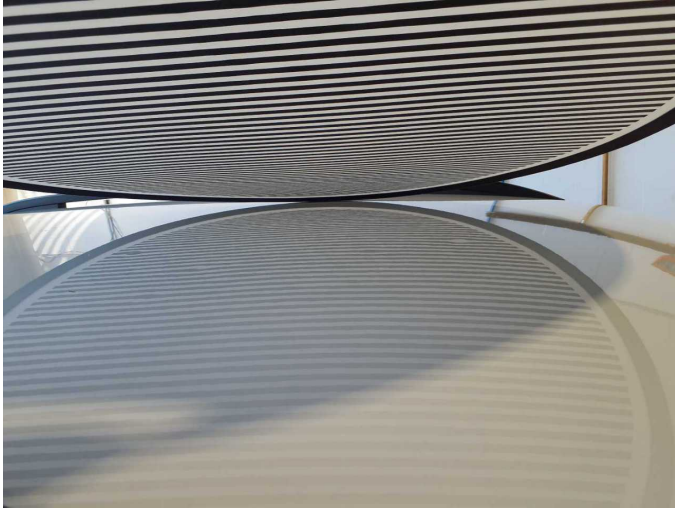
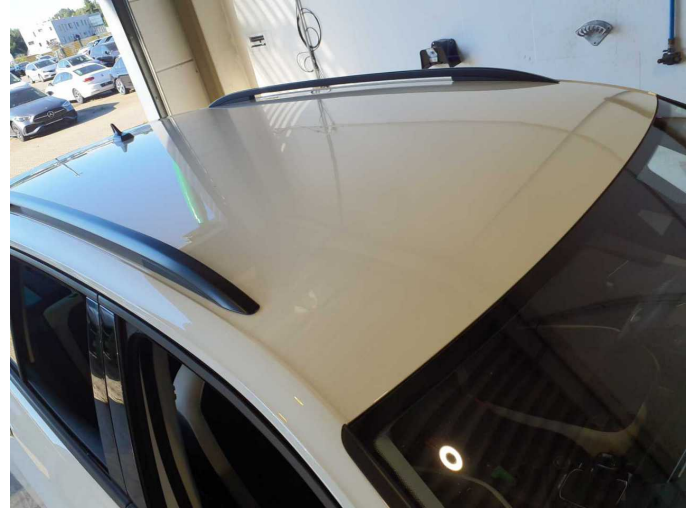
| No. | Component group | Description |
|---|---|---|
| 5 | Roof | Roof - Damage by hail - Smooth repair work |

**Damage 5:** Roof: Roof - Damage by hail - Smooth repair work
