## Expertise

Protocol number: 45885845  
Order No. / Reference: 26325803  
Inspection date: 10 Jun 2026

Manufacturer: Mercedes-Benz

Model: GLC 220 d 4Matic 9G-TRONIC AMG Line

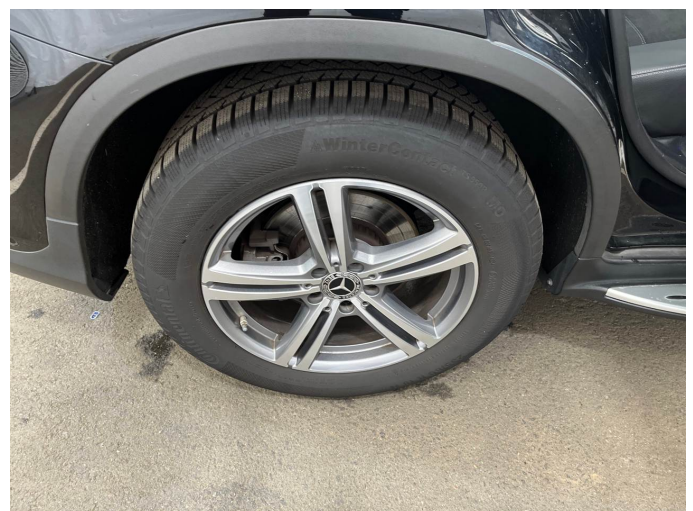
Figure 12: Mounted tyres

#	Tyre size	Type of tyre	Manufacturer	Tread depth
1)	235/60 R18 103H	Winter tyres on Light alloy	Continental	7mm / 7mm
2)	235/60 R18 103H	Winter tyres on Light alloy	Continental	7mm / 7mm

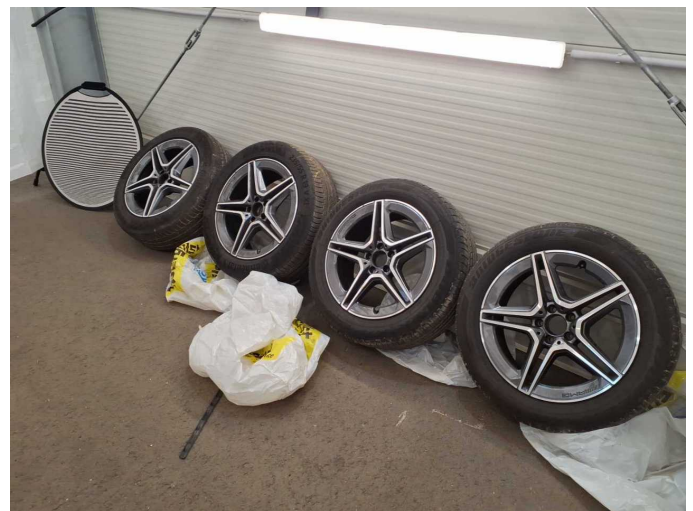
Figure 16: Additional tyres

#	Tyre size	Type of tyre	Manufacturer	Tread depth
1)	235/55 R19 101V	Summer tyres on Light alloy	Bridgestone	4mm / 4mm
2)	235/55 R19 105V	Summer tyres on Light alloy	Continental	6mm / 6mm

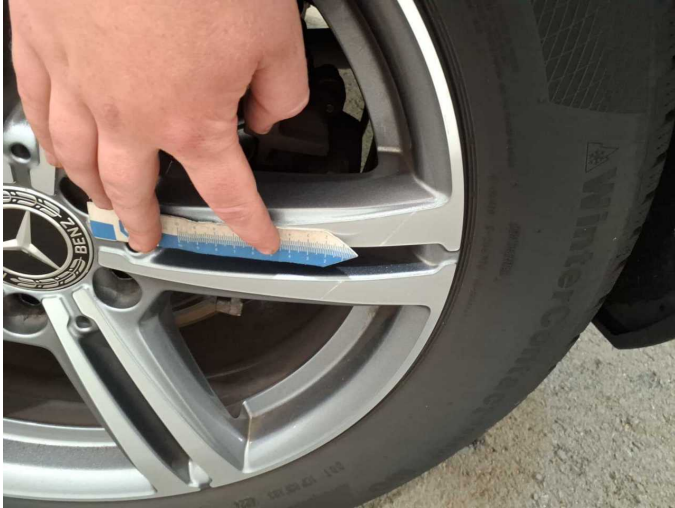
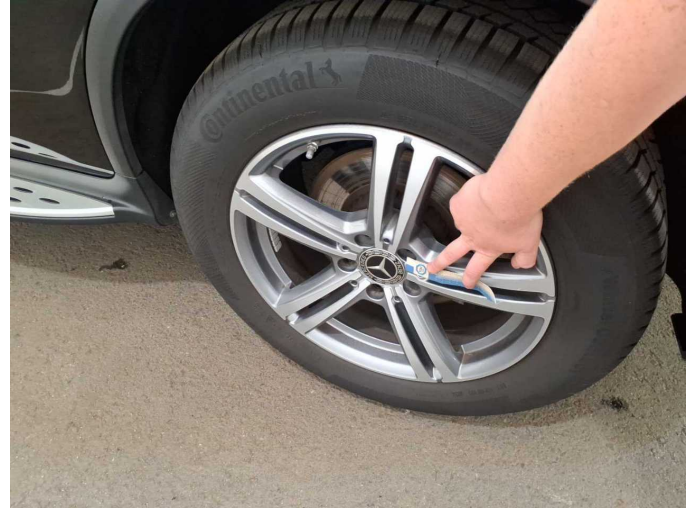
No.	Component group	Description
1	Wheel / tyres	Wheel rim - rear left side - Scratch(es) - Loss in value
2	Rear bumper	Rear bumper - Scratch(es) - Paint

**Damage 1:** Wheel / tyres: Wheel rim - rear left side - Scratch(es) - Loss in value

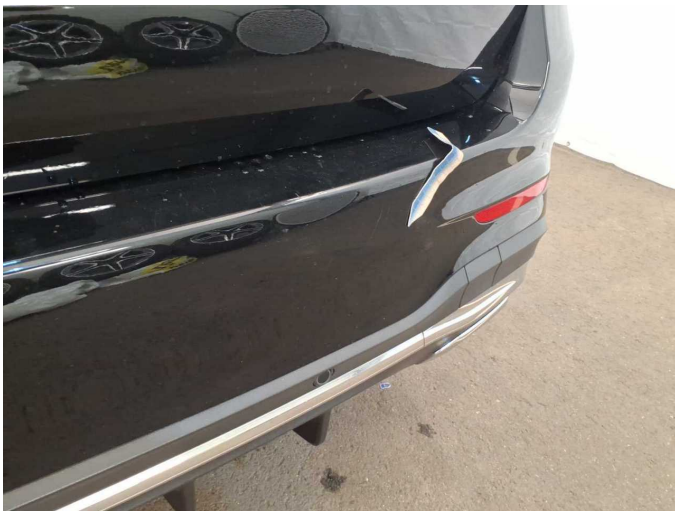
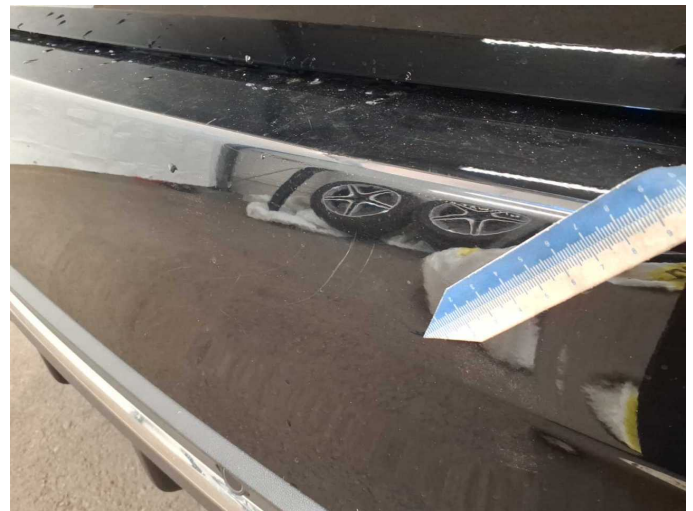
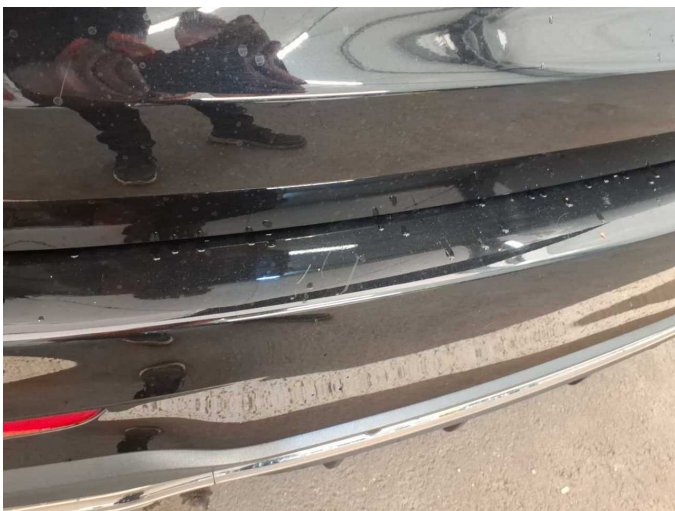
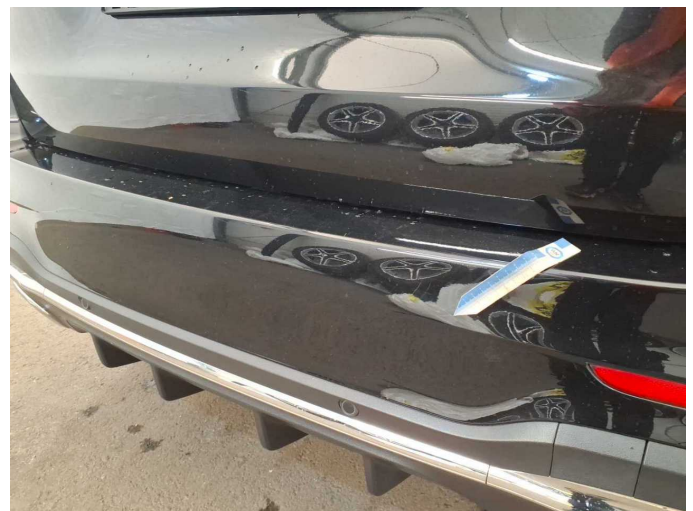
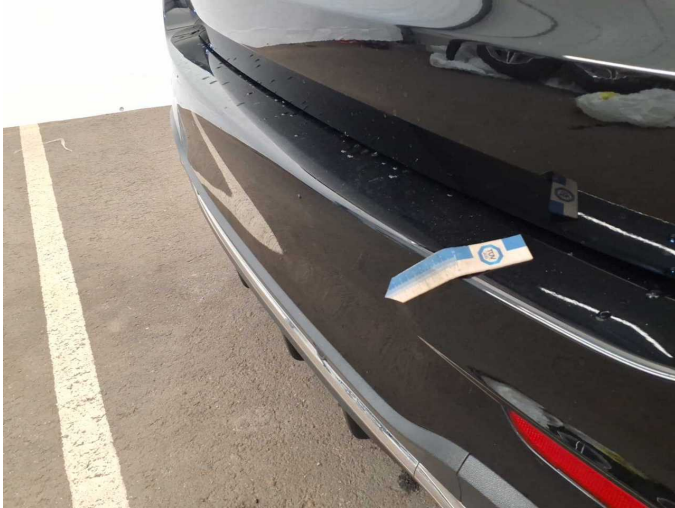
**Damage 2:** Rear bumper: Rear bumper - Scratch(es) - Paint

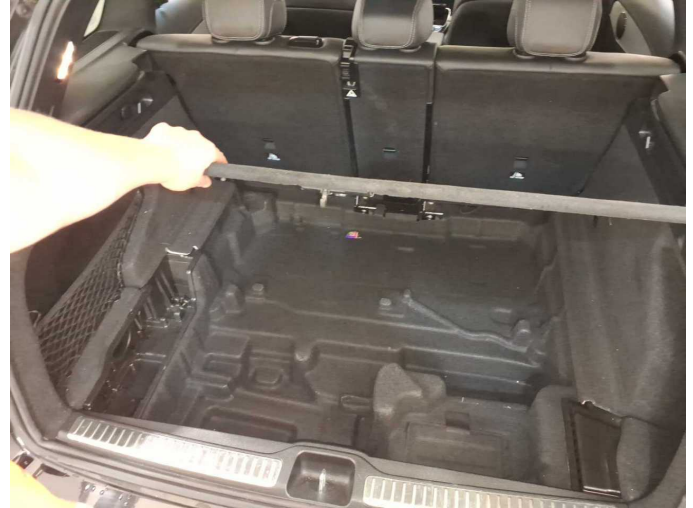
Interior - Separation net

**Missing part 1:** Interior: Separation net - Missing - Replace

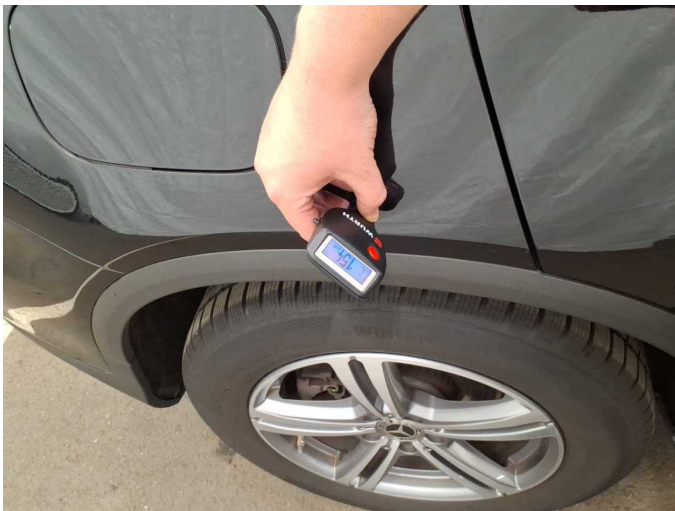
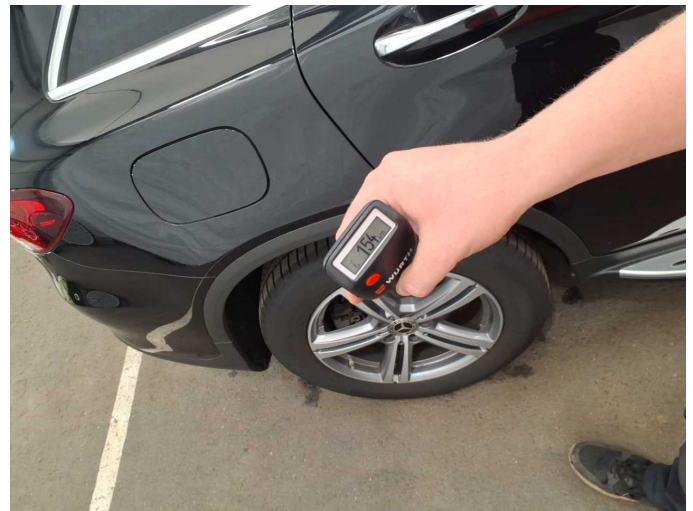
1 Side panel - rear right side, Professionally carried out, Invoice of repair done Non-existent

Side panel - rear right side 154 µm |

**Repainting 1:** Side panel - rear right side
